**METROPOLITAN GOVERNMENT OF NASHVILLE AND DAVIDSON COUNTY**

**STAFF RECOMMENDATION**  
**170-176 Second Avenue North**  
**July 21, 2021**

**Application:** Demolition  
**District:** Second Avenue Historic Preservation Zoning Overlay  
**Council District:** 19  
**Base Zoning:** DTC  
**Map and Parcel Number:** 09306206600 and 09302401900  
**Applicant:** Callen Trust, property owner  
**Project Lead:** Robin Zeigler, robin.zeigler@nashville.gov

**Description of Project:** The property owner requests to demolish four historic buildings in the Second Avenue Historic Preservation Zoning Overlay, damaged in the 2020 Christmas morning explosion.

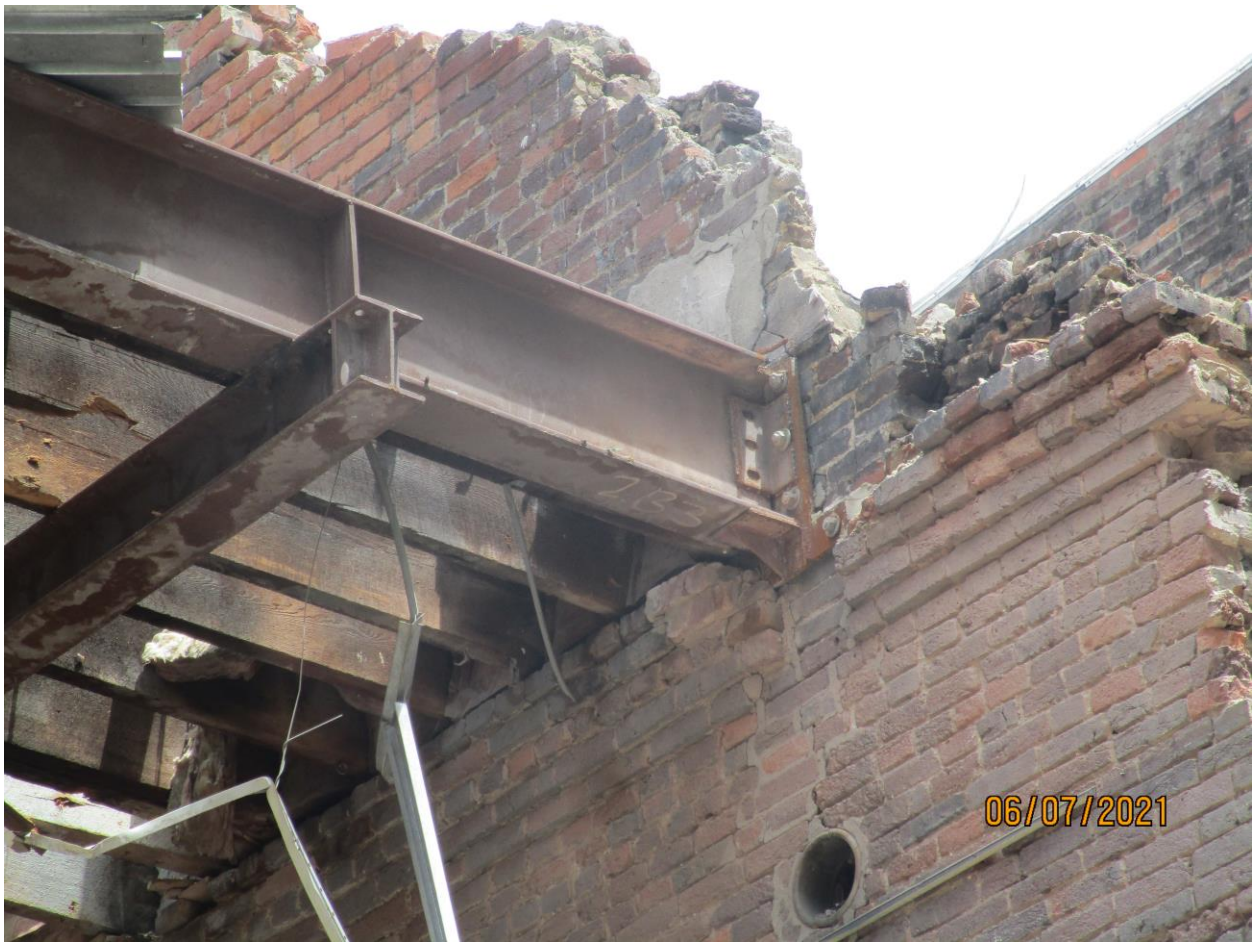
**Photograph 9: Close-up of Building 172.**

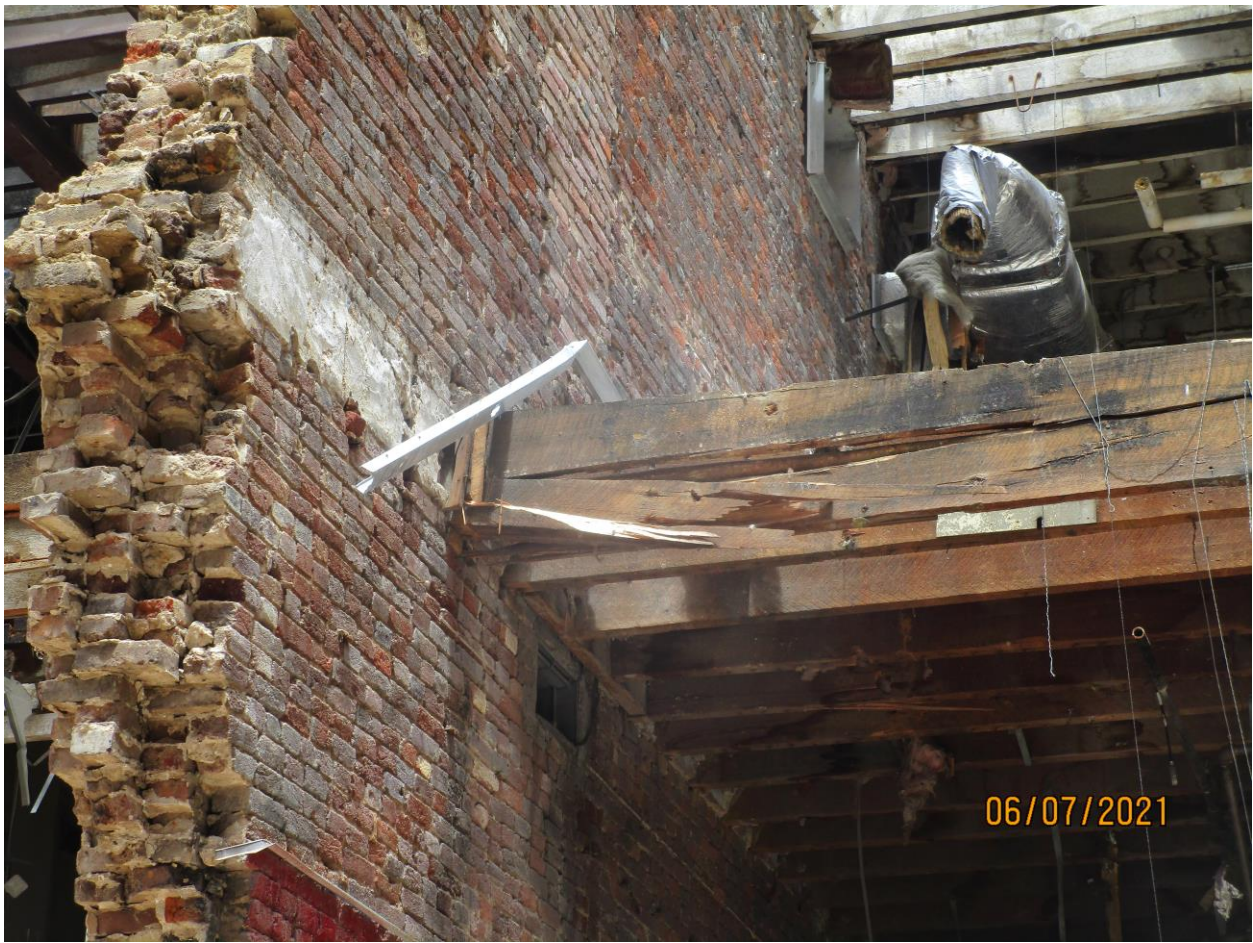
**Photograph 11: Close-up of Building 170.**

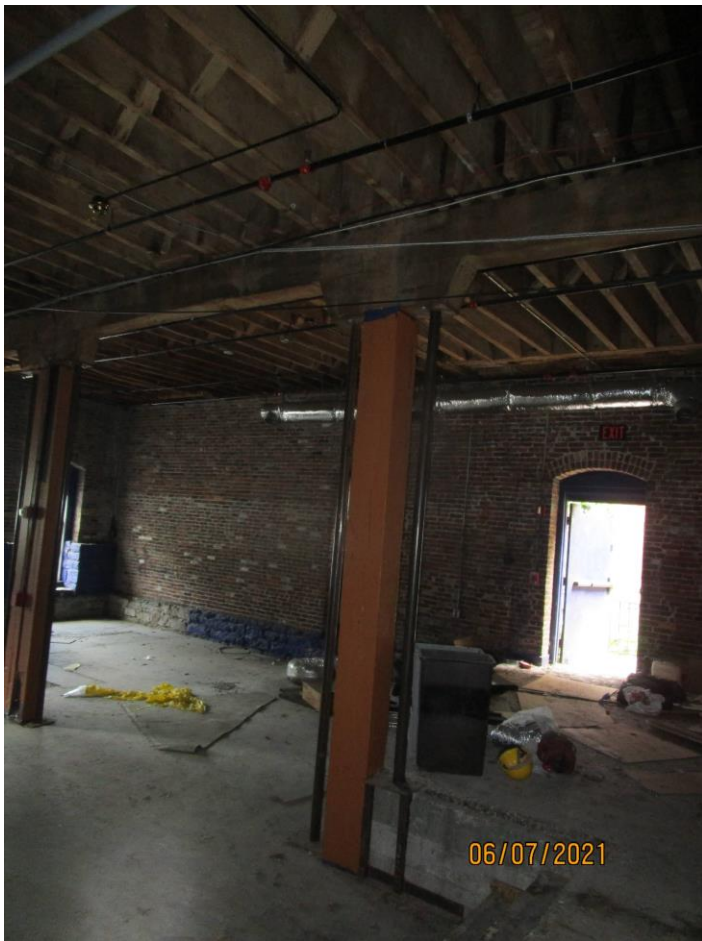
**Photograph 49: Basement of Building 174.**

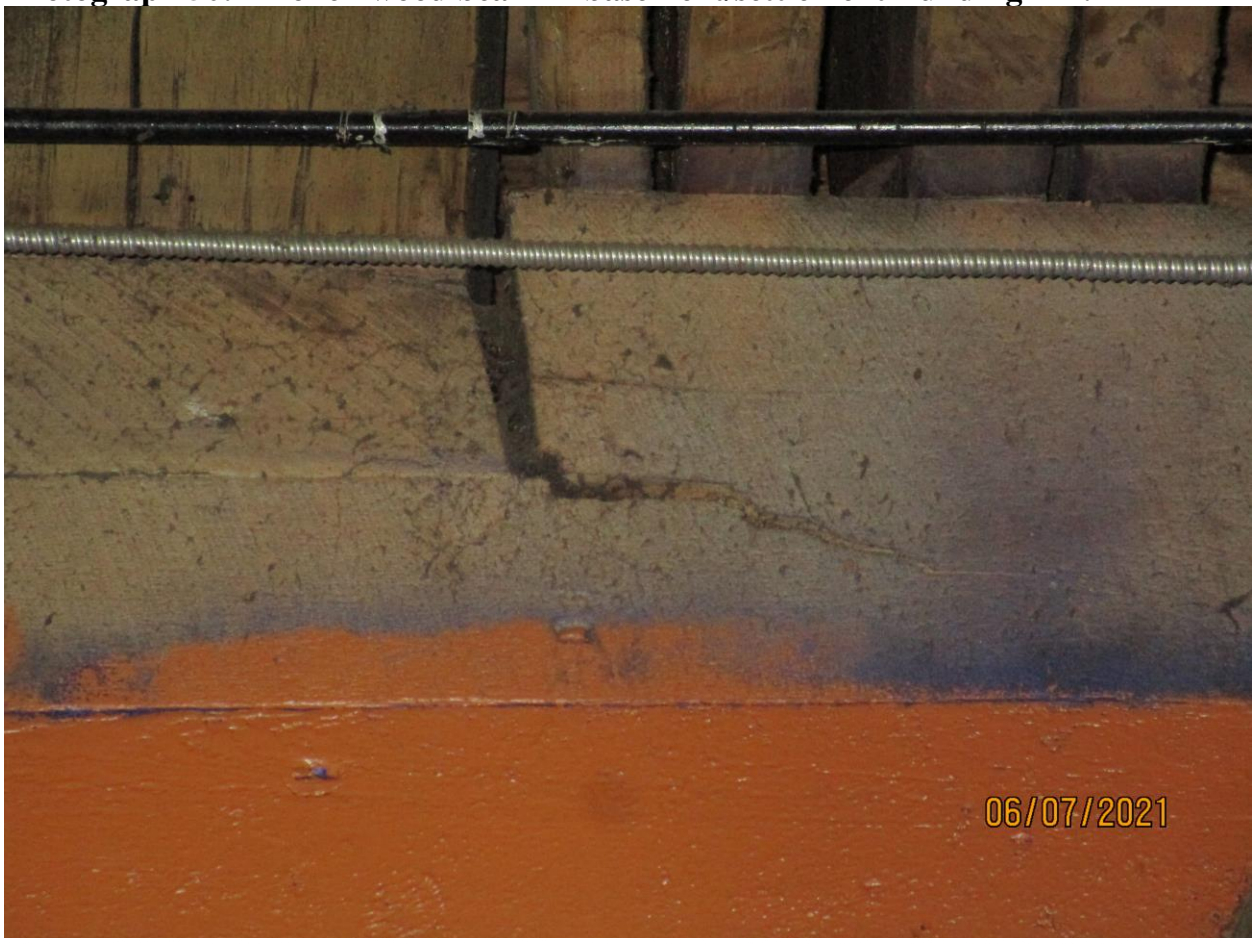
**Photograph 50: Broken wood beam in basement/settlement Building 174.**

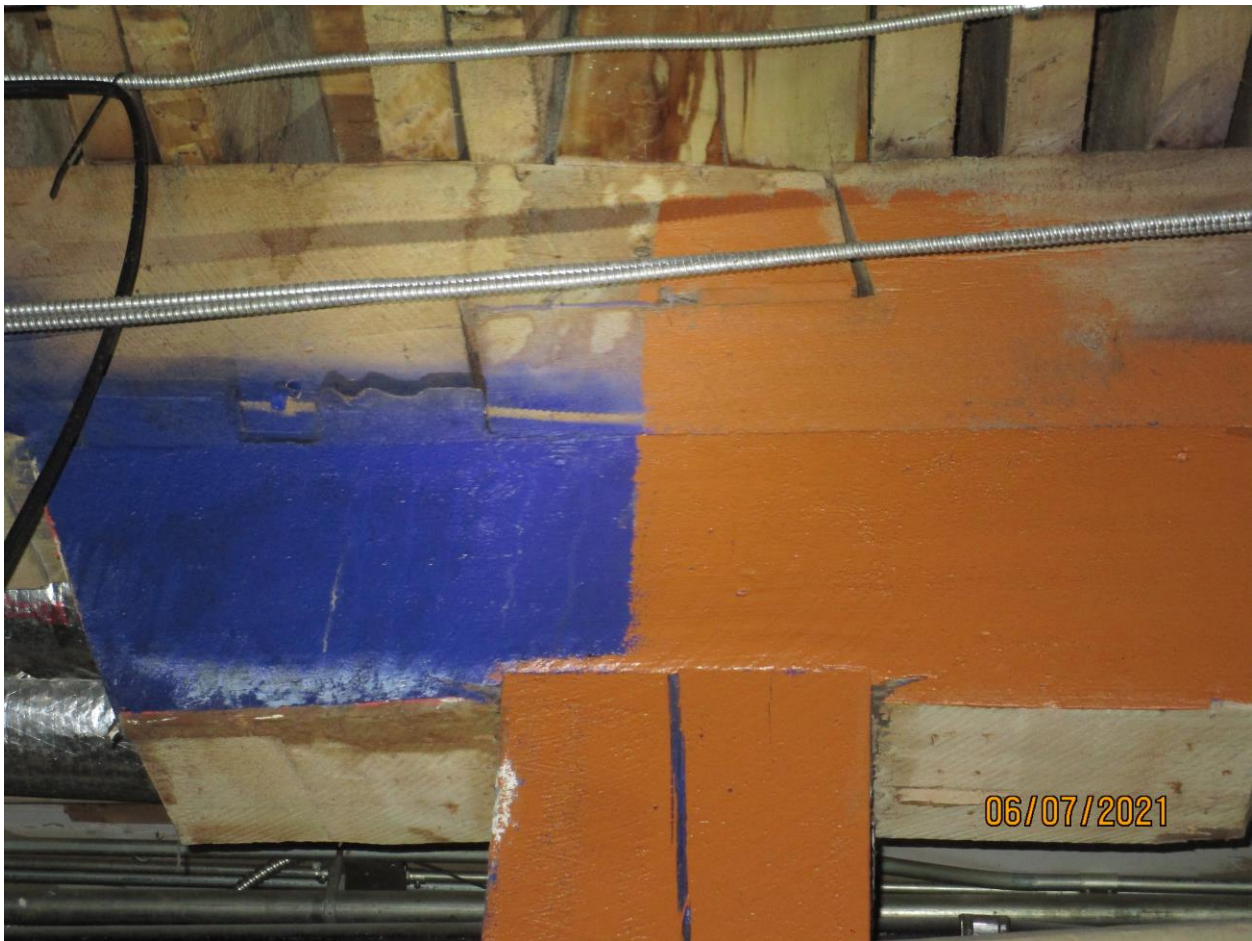
**Photograph 51: Broken wood beam in basement/settlement Building 174.**

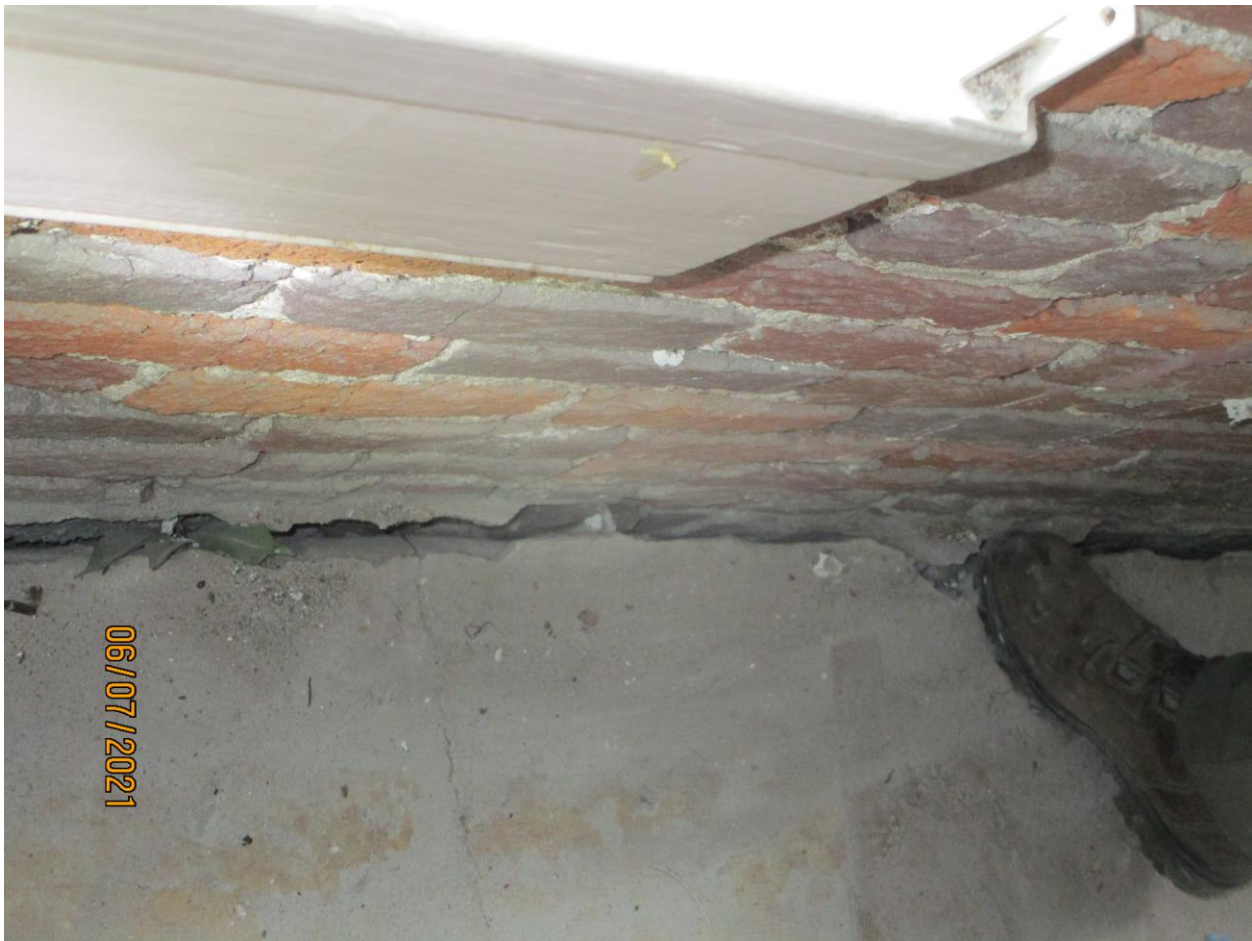
**Photograph 58: Rear wall second floor Building 176 (3/4" ± movement since concrete topping).**

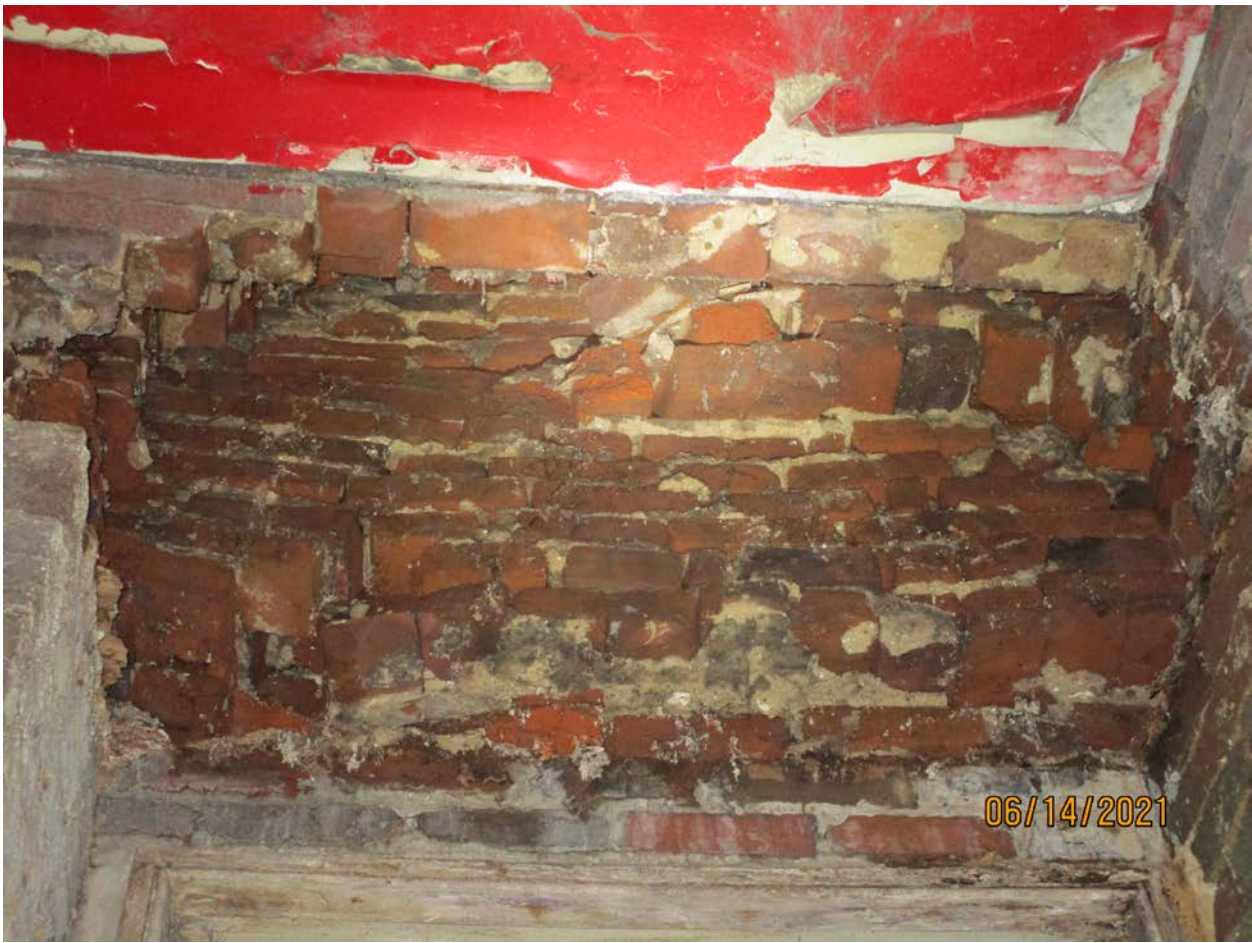
**Photograph 89: Recently fallen bricks at Building 176 (EMC photo #53 6/7/2021).**

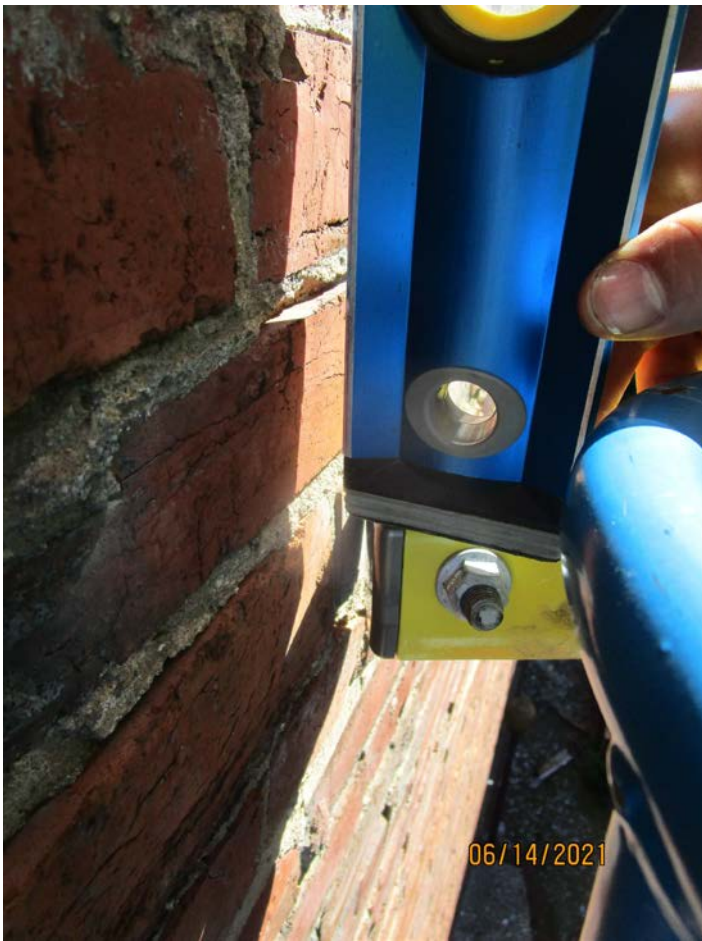
**Photograph 97: Out-of-plumb left-side wall of Building 170.**
