STAFF RECOMMENDATION
1702 Forrest Avenue
July 21, 2021

Application: Demolition: Economic Hardship
District: Lockeland Springs Historic Conservation Zoning Overlay
Council District: 06
Base Zoning: R6
Map and Parcel Number: 08310029700
Applicant: Nicole Piersiak
Project Lead: Joseph Rose joseph.rose@nashville.gov

<p>Description of Project: The applicant requests demolition of a contributing building due to extreme disrepair, arguing for economic hardship and demolition of a non-contributing outbuilding.</p> <p>Recommendation Summary: Staff recommends approval of full demolition of all structures at 1702 Forrest, finding that demolition meets section III.B (2) (b) as the necessary demolition required to repair the primary building will result in a non-contributing building and the outbuilding is a non-contributing building and the project meets section III.B (2) (a) as repairs are not possible in a manner that retain the historic building.</p>	<p>Attachments</p> <ul style="list-style-type: none">A: PhotographsB: Engineer Report-FieldsC: Engineer Report-Engineered Solutions and Thunder River ConstructionD: Diligent Home InspectionE: Purchase DocumentationF: Tax HistoryG: Appraisal H

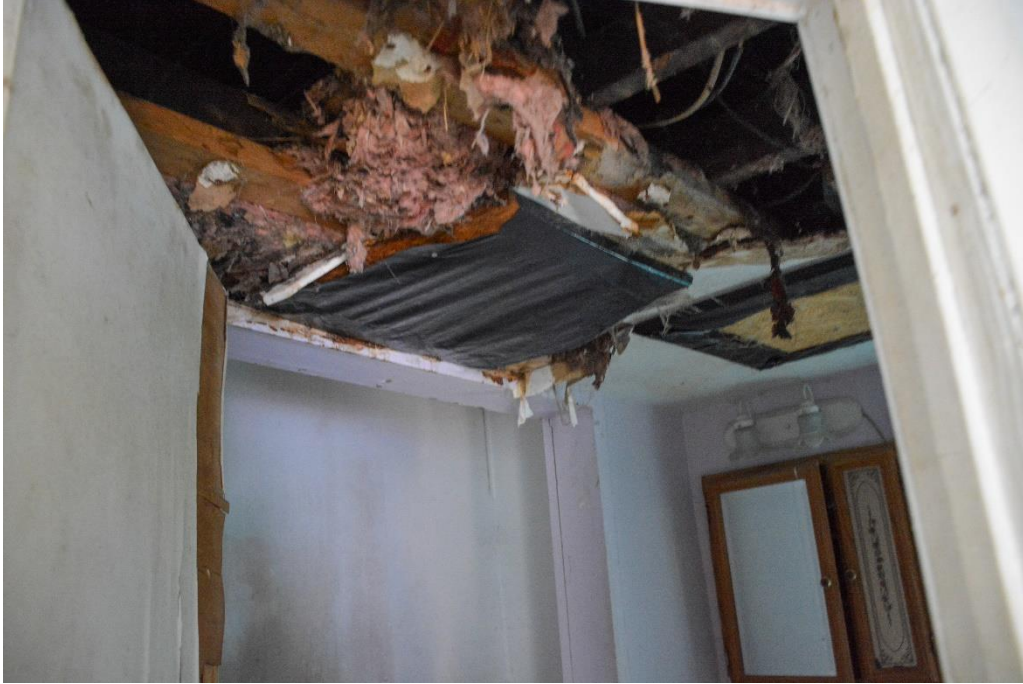
Photo 3: Interior Ceiling Condition

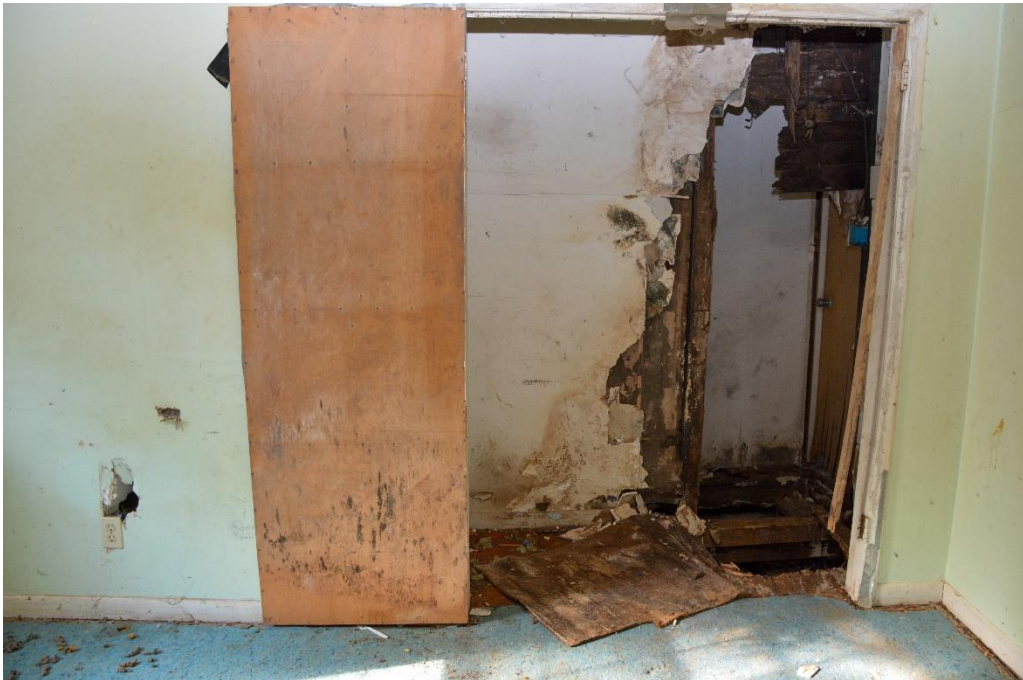
Photo 4: Interior Bedroom Closet and Basement Stair Beyond

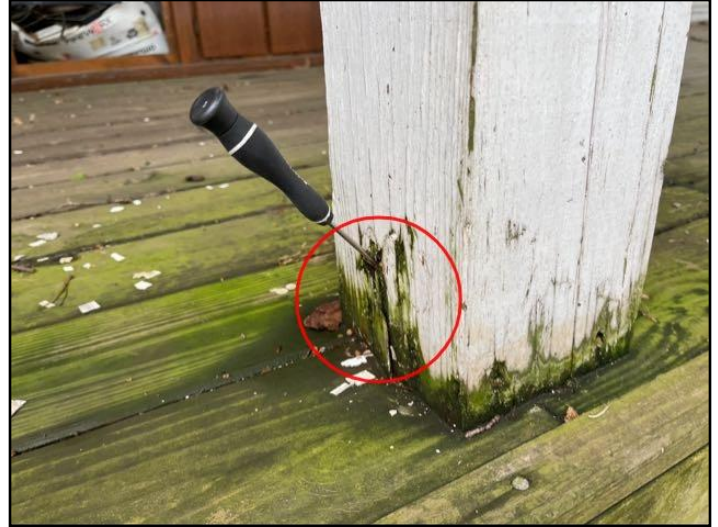
7. Heavy rot and deterioration

Due to the severity of the issues noted, immediate repair or replacement by a licensed and qualified contractor is recommended. Further damage will likely be found during repairs.

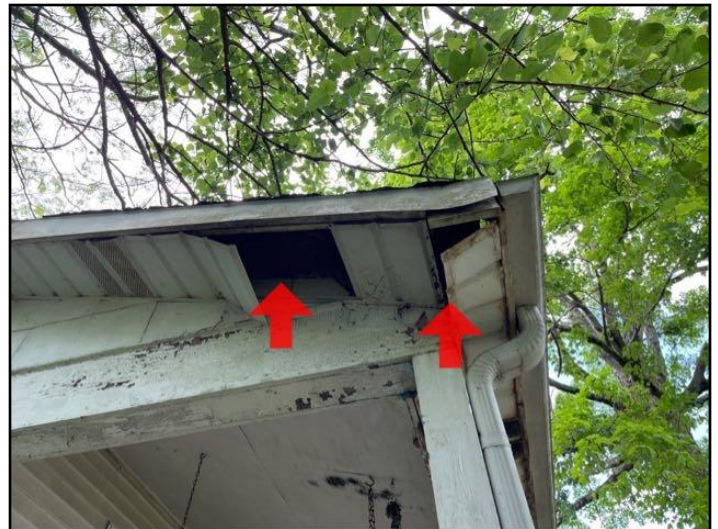
10. Soffit and fascia damaged or missing

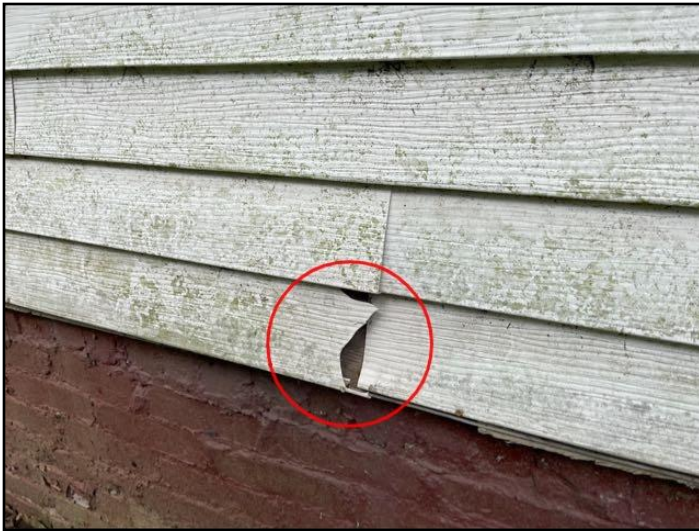
11. Vinyl siding damaged

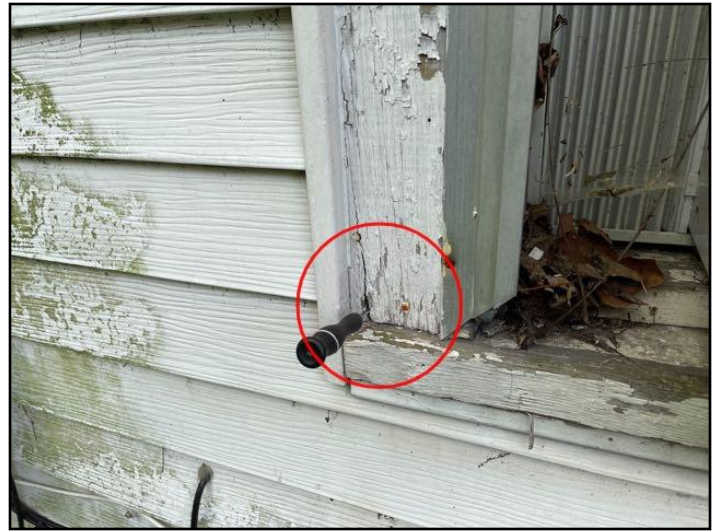
12. Rot in window trim

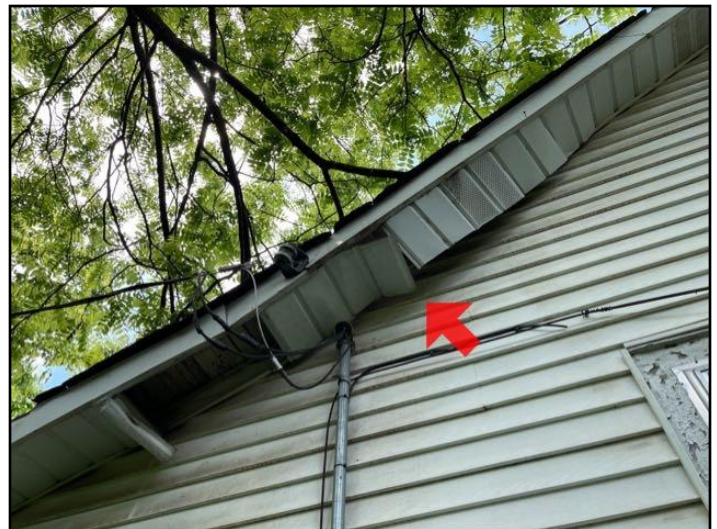
14. Loose soffit

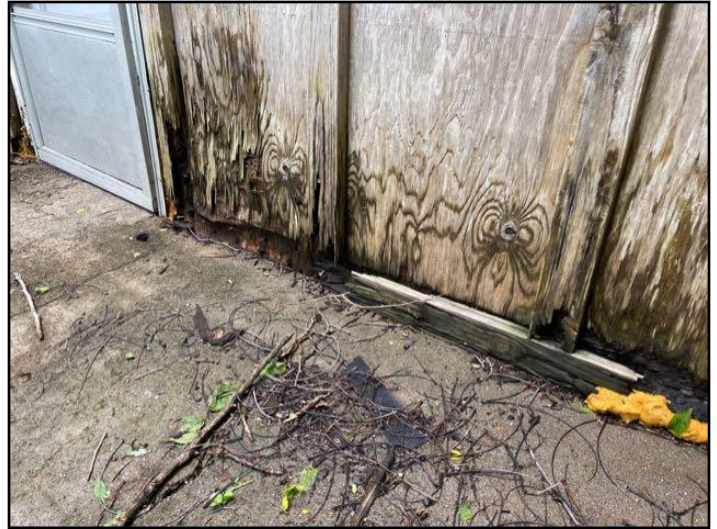
16. Heavy deterioration in wood siding

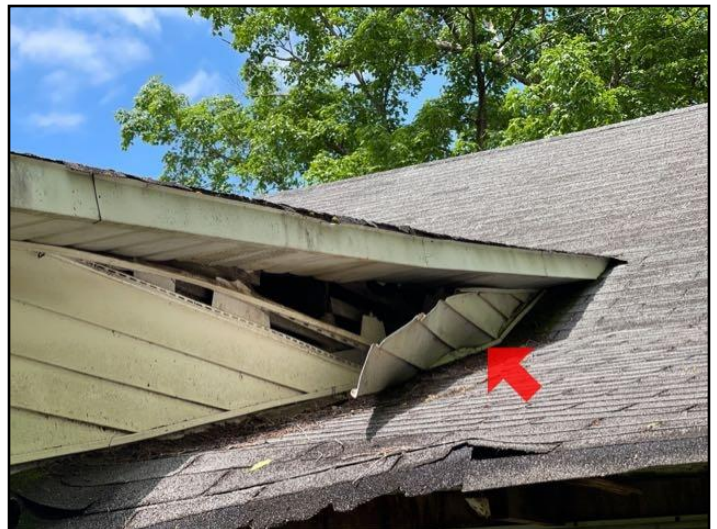
18. Vinyl siding falling off home

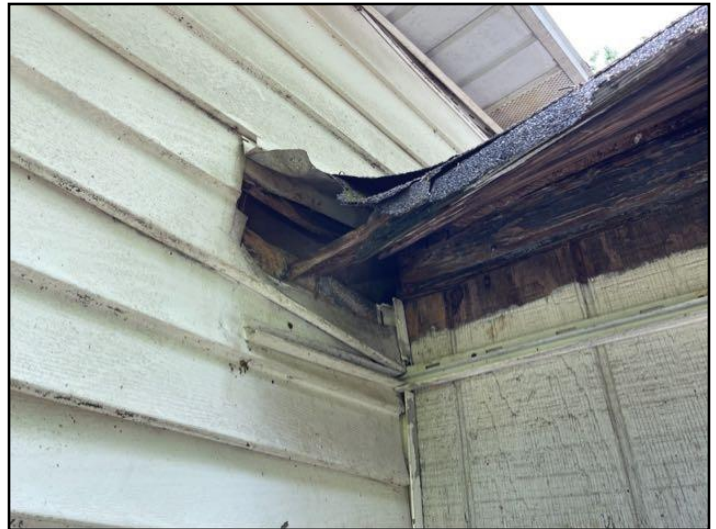
20. Holes in siding

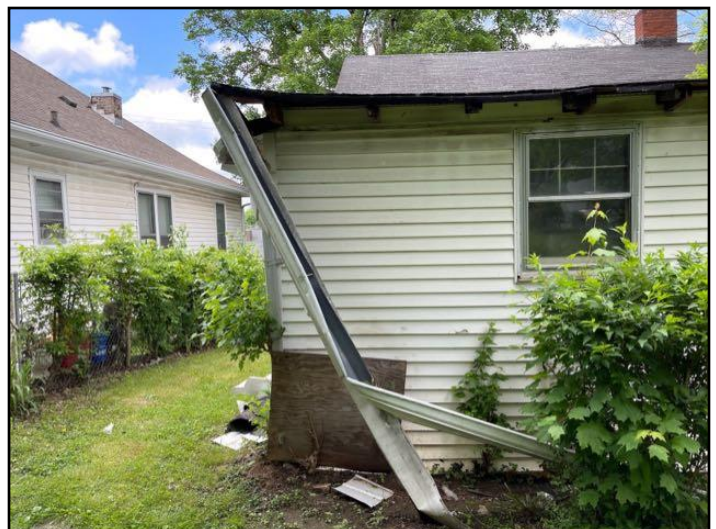
22. Gutter/fascia falling off home

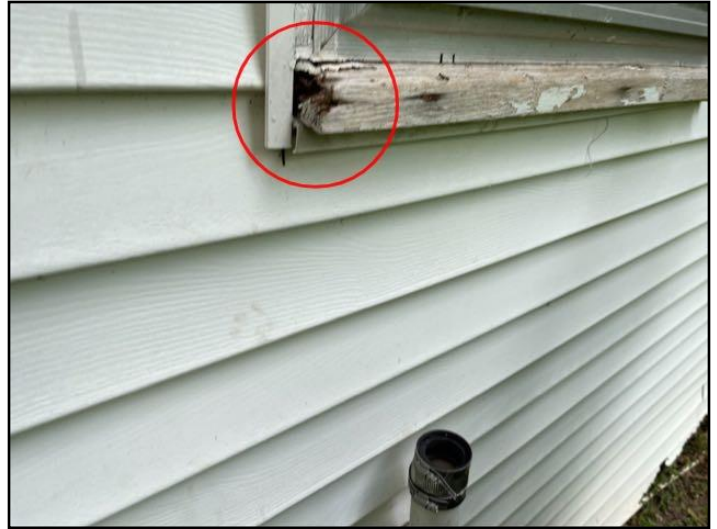
24. Rot in window trim

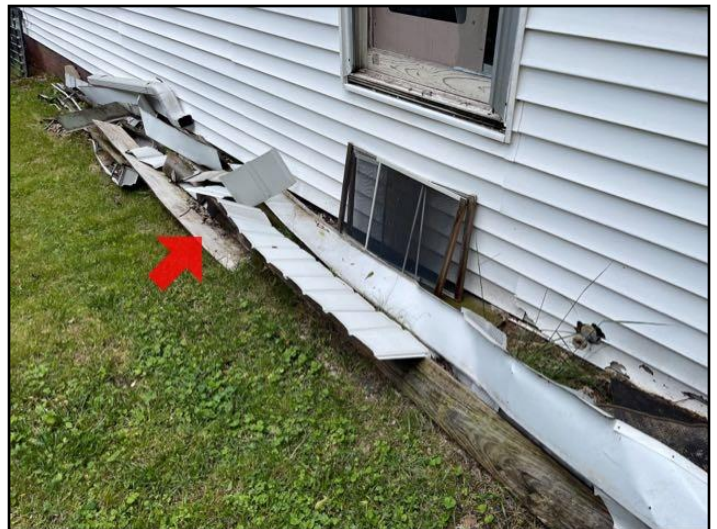
26. Debris piled against home

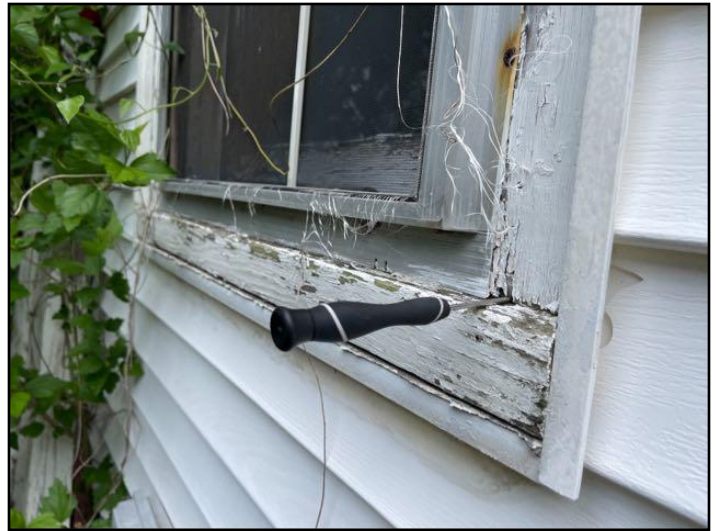
28. Window rot

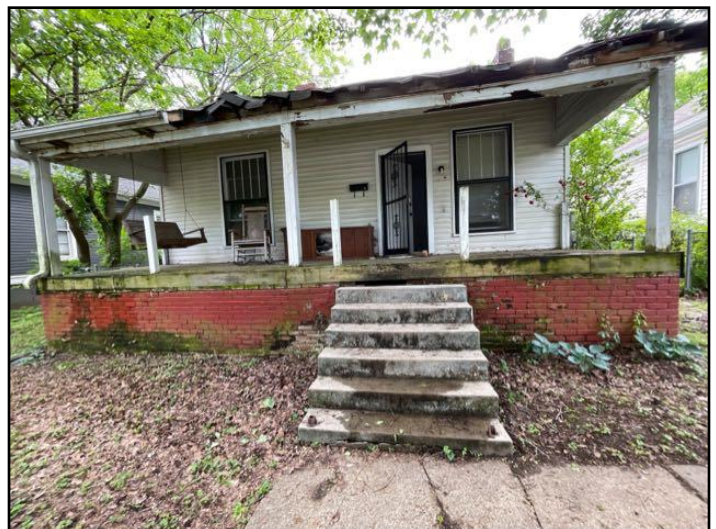
3. Condition: • [Missing](#)

30. Missing

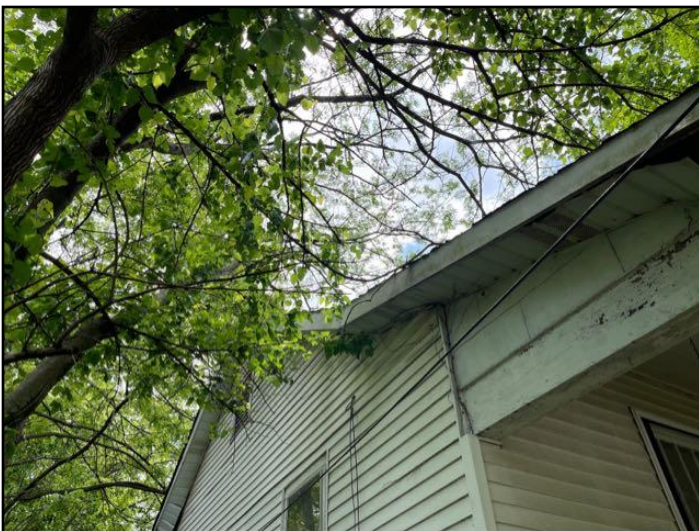
4. Condition: • [Trees or shrubs too close to building](#)

31. Trees or shrubs too close to building

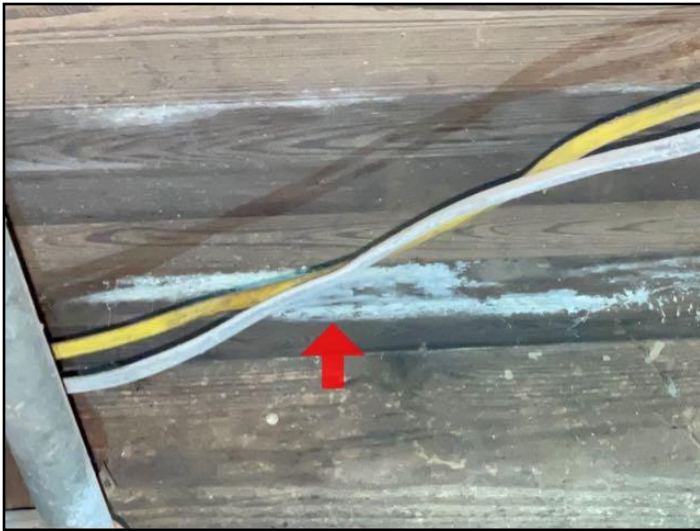
Significant levels of microbial growth (possible mold) were observed on materials in locations throughout the crawlspace and interior of the home. The observed growth was well beyond levels typically found within vented crawlspaces in Middle Tennessee. The presence of microbial growth at this level serves as an indicator of long-term environmental issues within the crawlspace which, if not addressed, can result in further damage to materials, as well as an unhealthy environment for occupants of the home. For further information or a deeper evaluation, please contact the DILIGENT office.

36. Heavy Microbial Growth

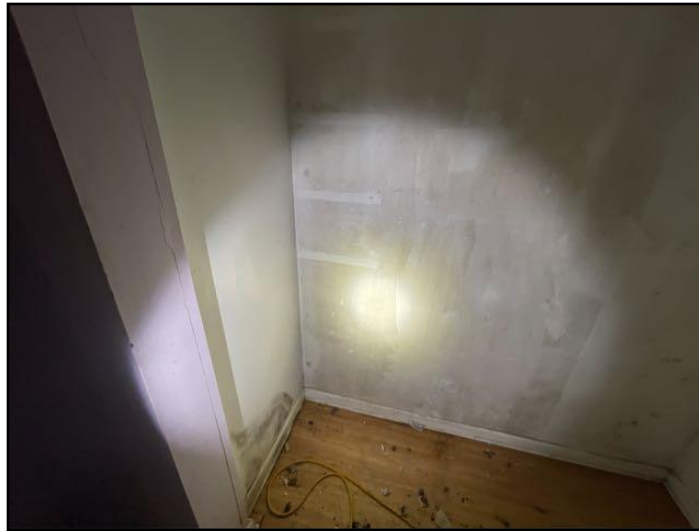
40. Microbial Growth - interior

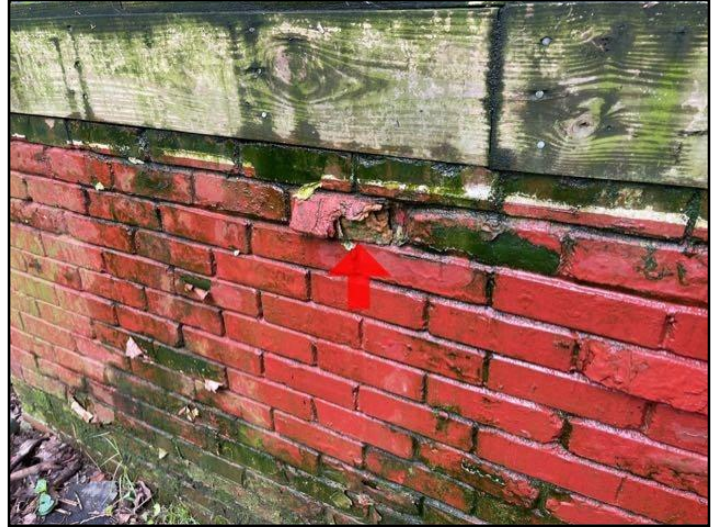
- Evidence of movement and masonry deterioration was noted in the brick foundation wall in multiple locations.
- The bottom side of the foundation wall footing was exposed in multiple locations.

42. masonry deterioration

Due to the advanced level of deterioration and insect damage along with the poor general condition of floor system/foundation materials, the viability of the structure could not be verified by a visual only inspection. All issues should be repaired or replaced, as needed, by a licensed and qualified structural contractor under the guidance of a licensed and qualified structural engineer. Large scale renovation and/or replacement will likely be required.

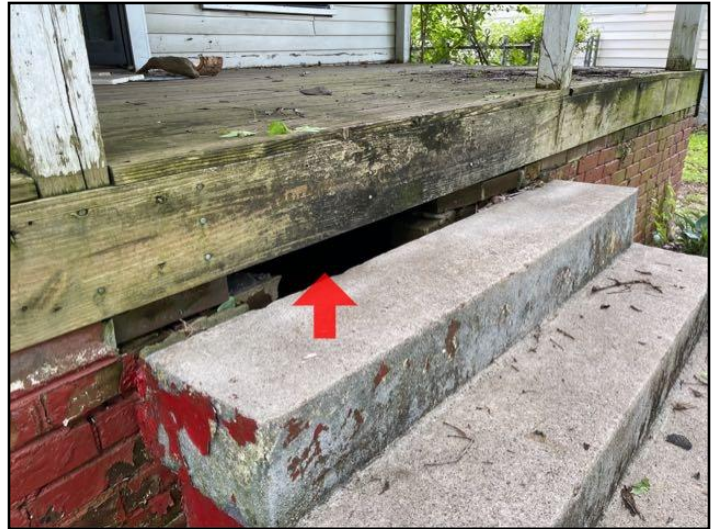
- Holes were present in the foundation wall that easily allow pest intrusion.
- Live animals and animal carcasses were present inside the crawlspace during the inspection.

44. Hole in foundation wall

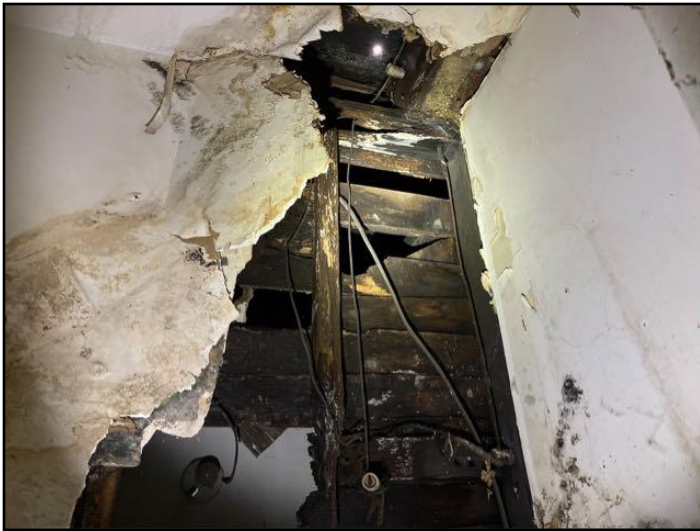
- Extensive insect damage was present throughout the floor framing of the home.
- Rot and deterioration resulting from active moisture was noted on various floor framing members and wall framing members.

45. Severe deterioration of wall framing

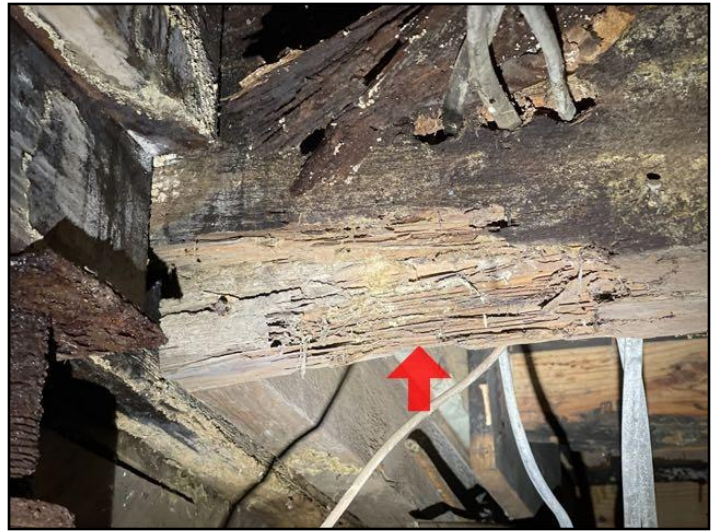
46. Extensive insect damage in floor framing

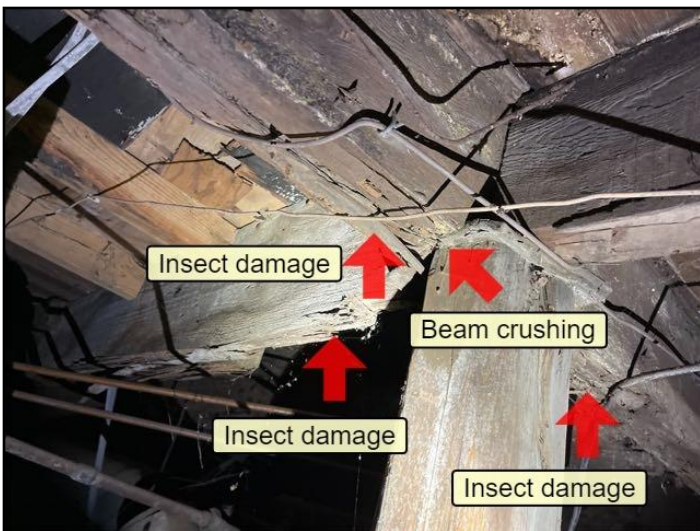
- A built-up beam was crushed due to extensive insect damage.
- Beams were spliced together, poorly supported at the ends and not in contact with joists.

47. Beam crushing

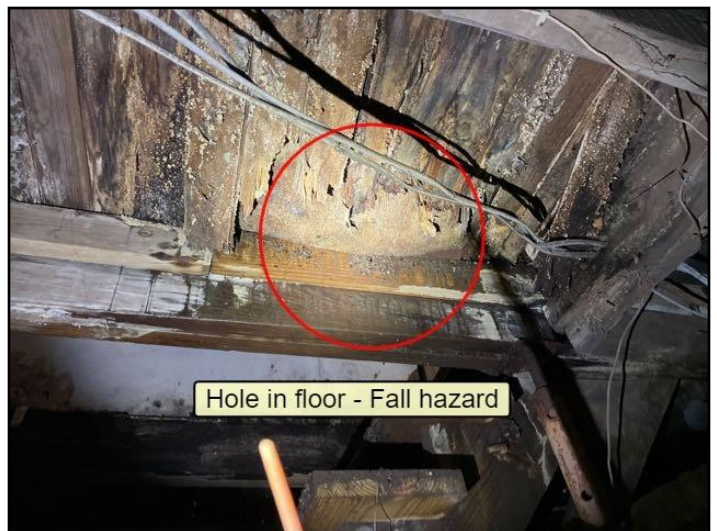
48. Hole in floor sheathing from rot

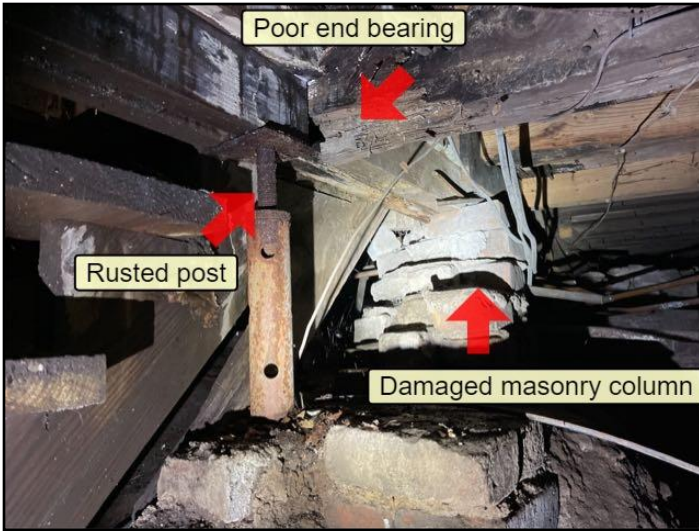
49. Multiple issues

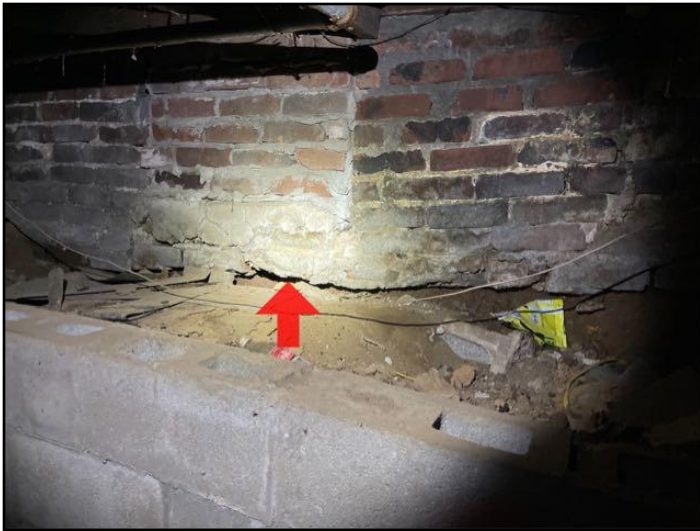
53. Foundation wall footing exposed

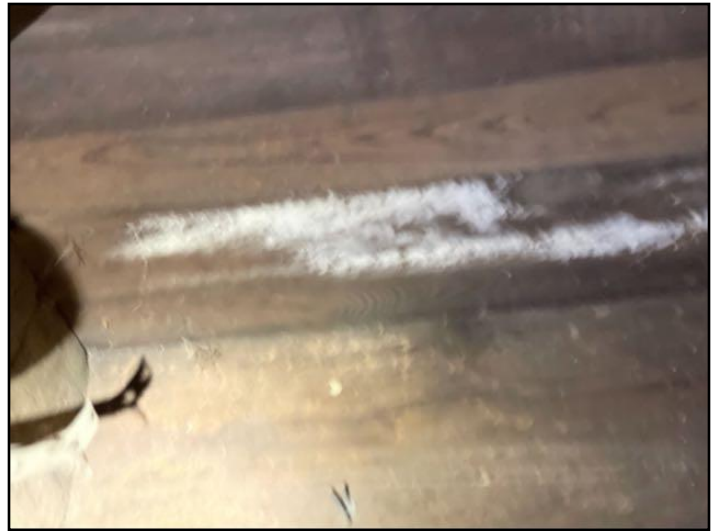
54. Microbial growth

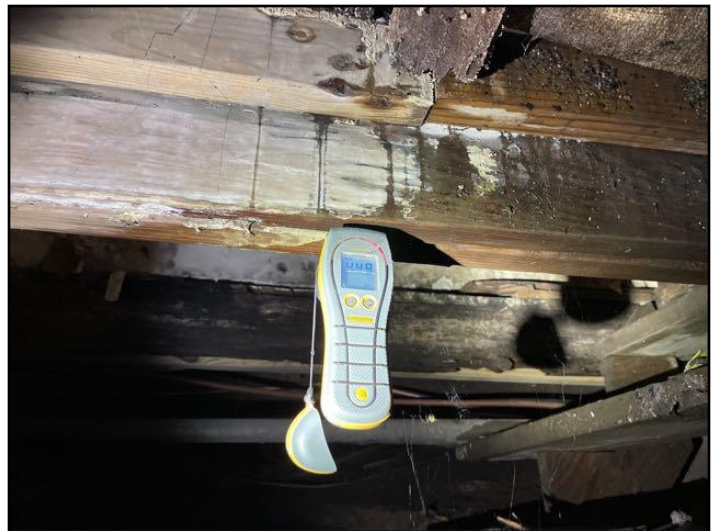
56. Active moisture

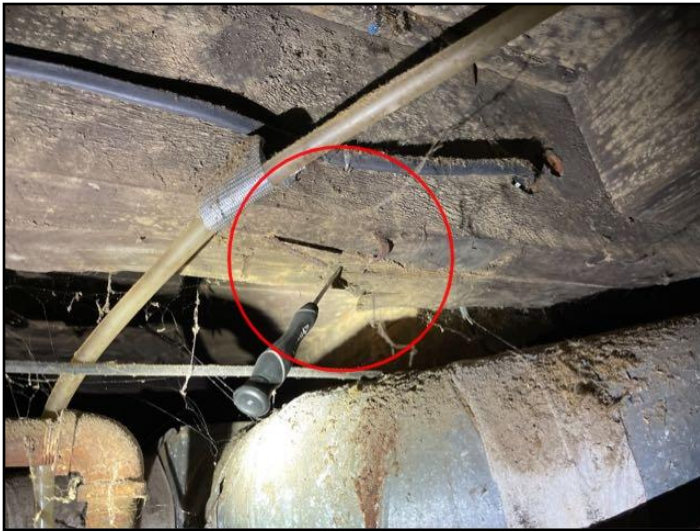
57. Rot in built-up beam

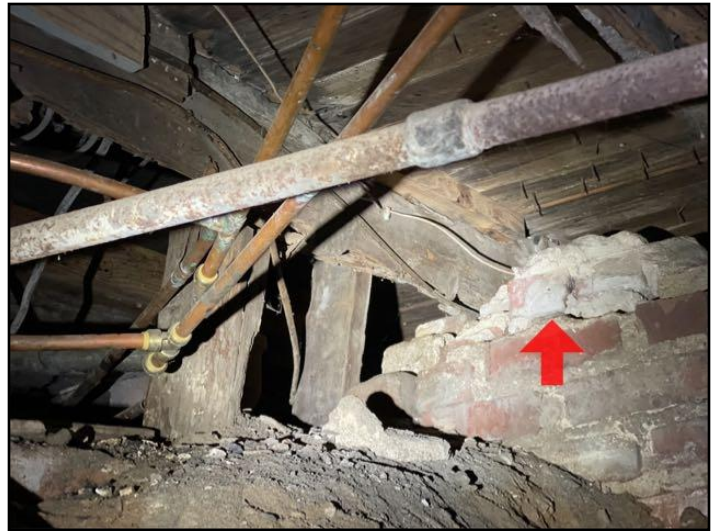
- Multiple piers and columns were in close proximity to the dug-out portion of the crawlspace and their integrity may be compromised as a result.
- Masonry columns were damaged potentially compromising their integrity.

58. Damaged column

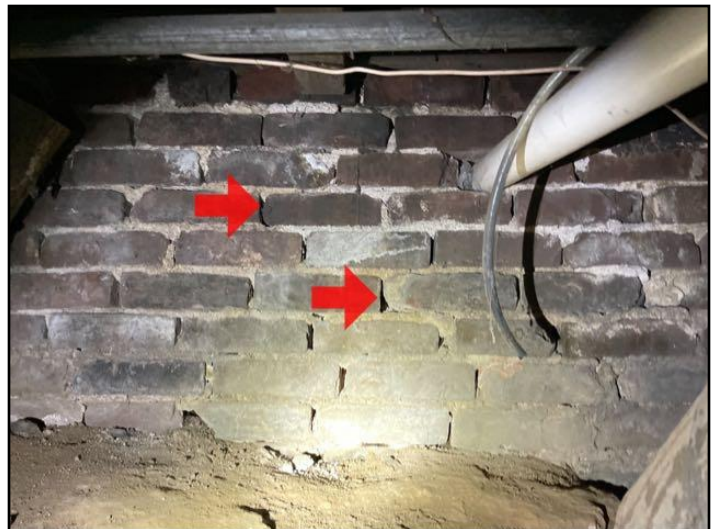
60. Mortar deterioration

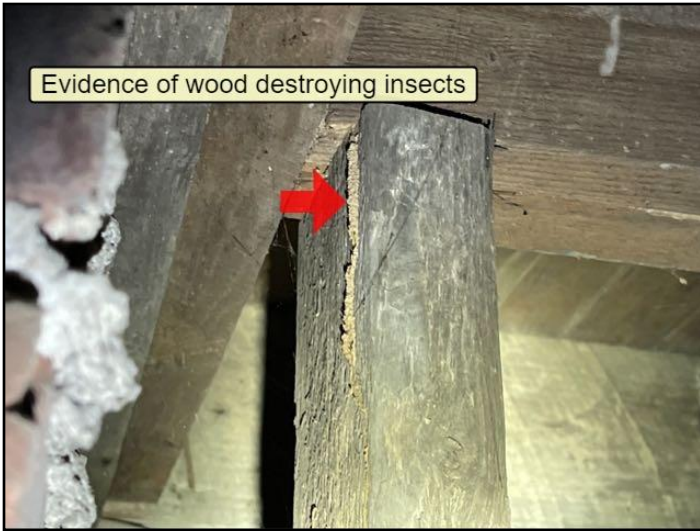
61. Evidence of wood destroying insects

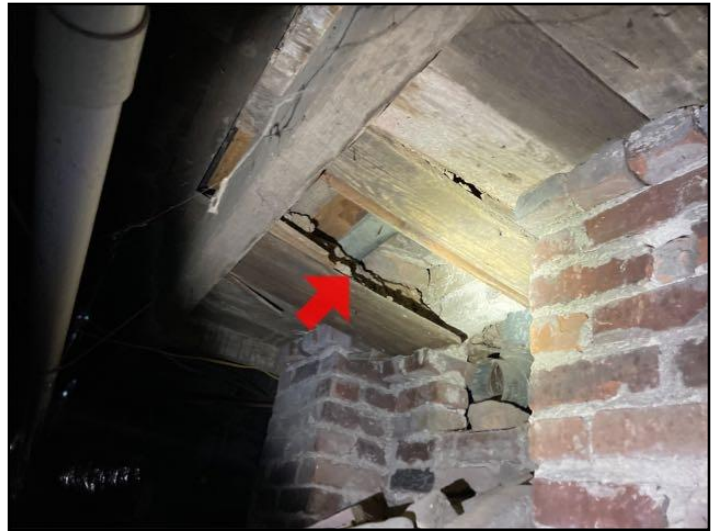
62. Subfloor damaged

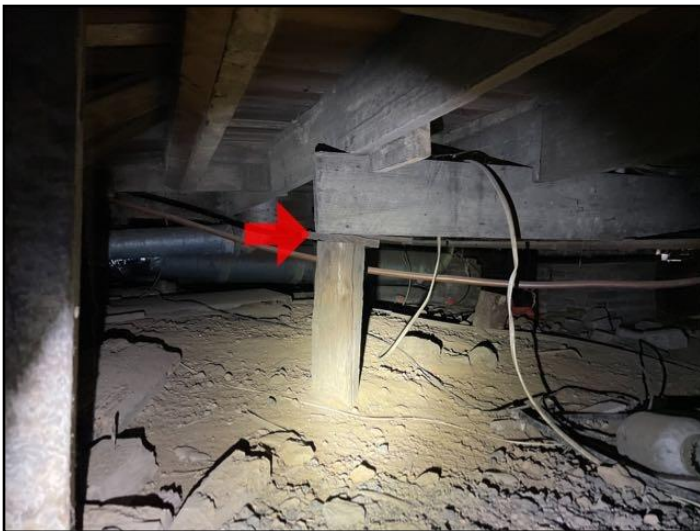
- Non-standard construction framing practices were present throughout the floor system.
- Heavy microbial growth was found in various locations within the crawlspace.

63. Non-standard support

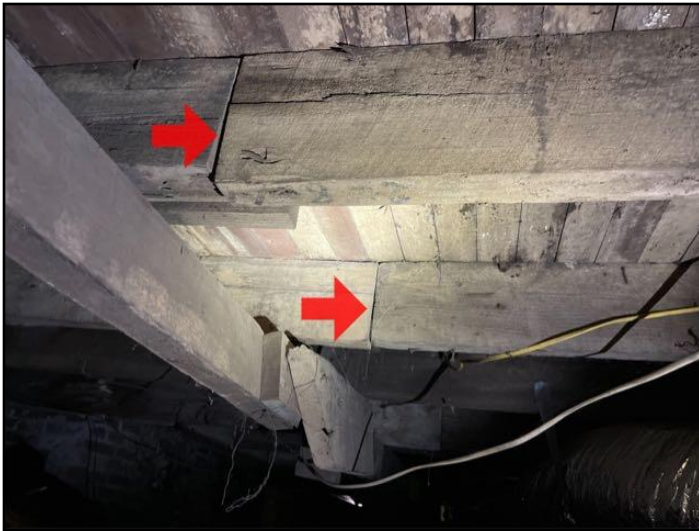
65. Improperly supported joints in framing

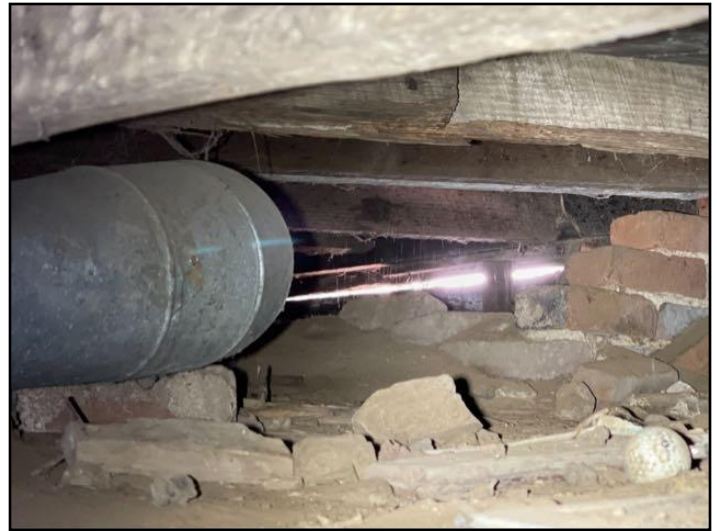
66. light visible through foundation wall

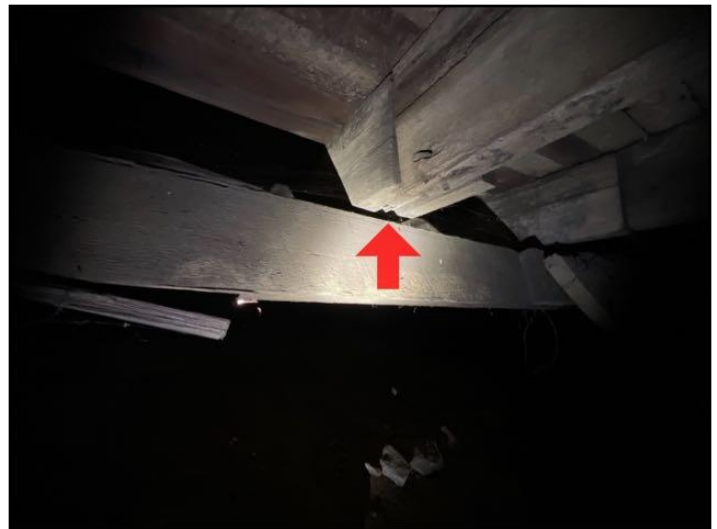
68. Beam not contacting joists

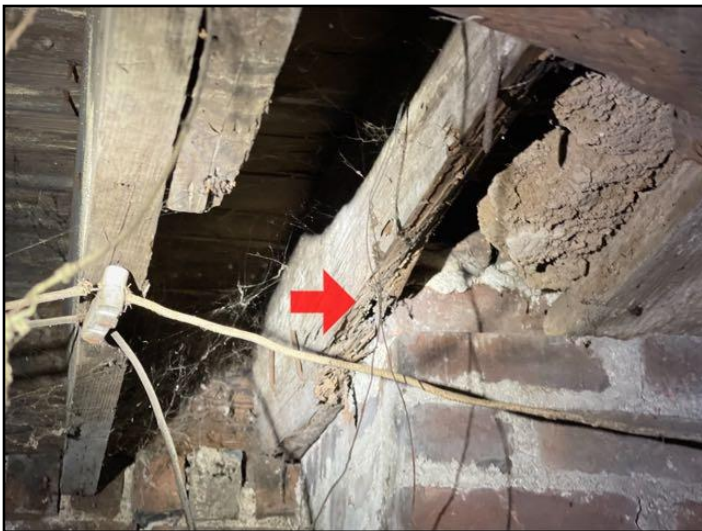
69. Excessive insect damage

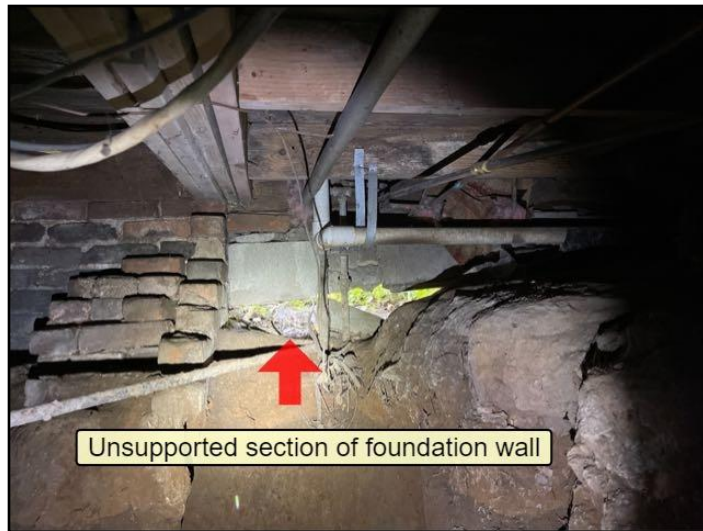
70. Poor support

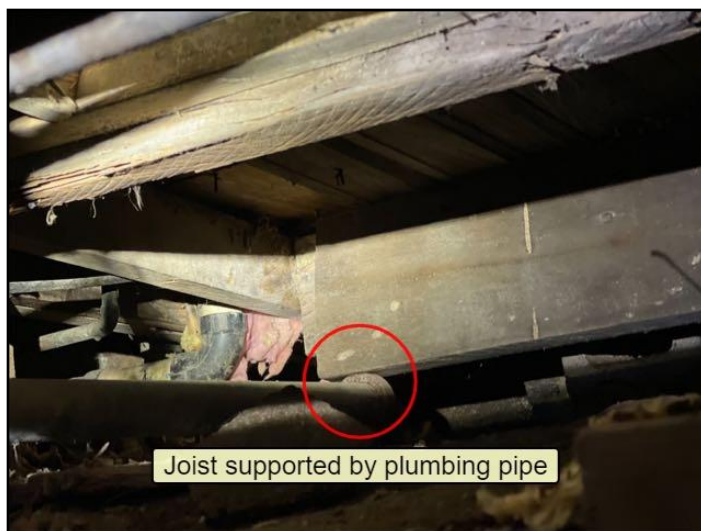
71. Improper joist support

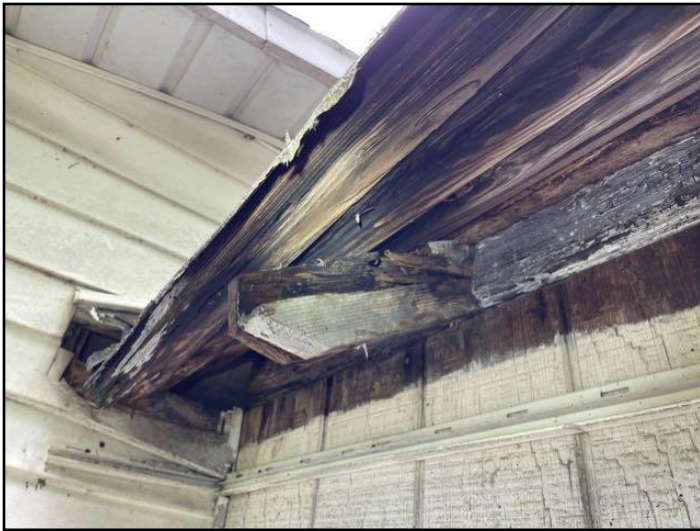
Condition: • Rot/deterioration, active moisture, and damage was found in accessible portions of the roof framing throughout the home. Due to the severity of the deterioration, the attic was not entered for safety concerns. Repair or replacement of all damaged roof framing materials by a licensed and qualified contractor under the guidance of a licensed and qualified structural engineer is recommended. Further damage is likely to be found during repairs.

72. Rafter tails and sheathing deteriorated

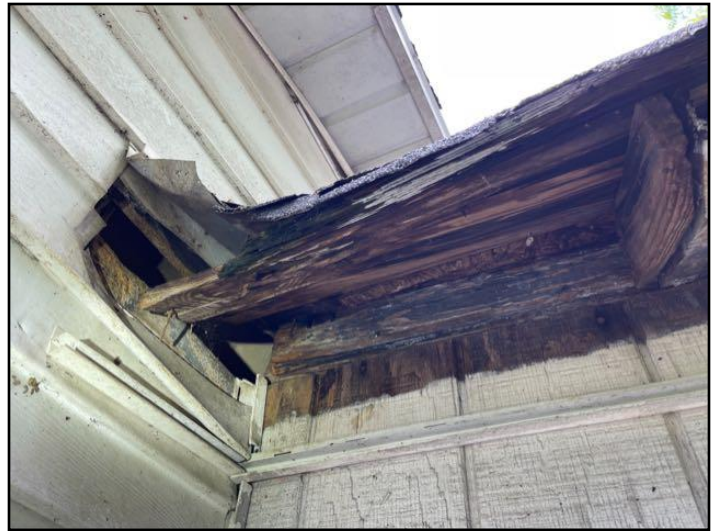
73. Rafter tails and sheathing deteriorated

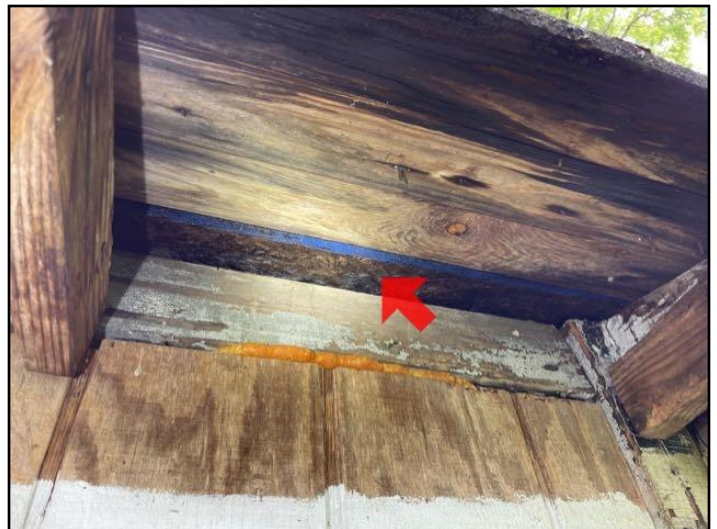
75. Active moisture in sheathing

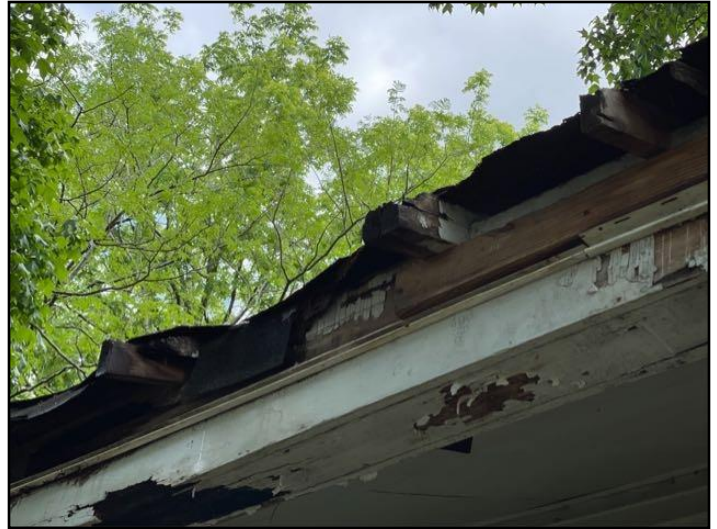
77. Deteriorated sheathing and rafter tails

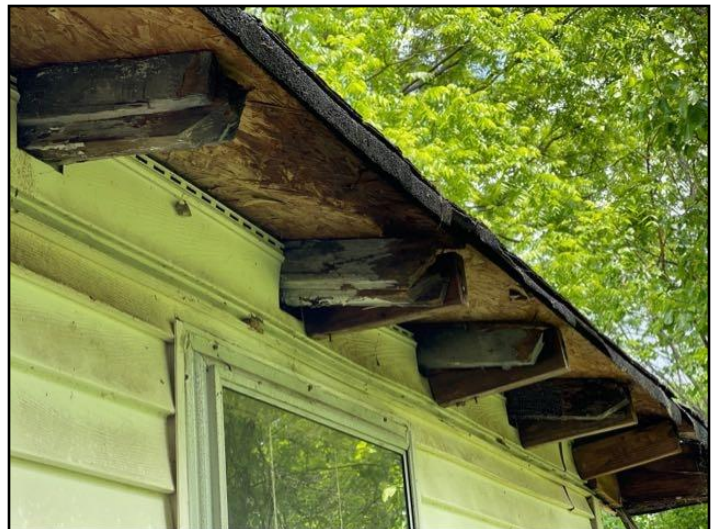
79. Active moisture on rafter tails and sheathing

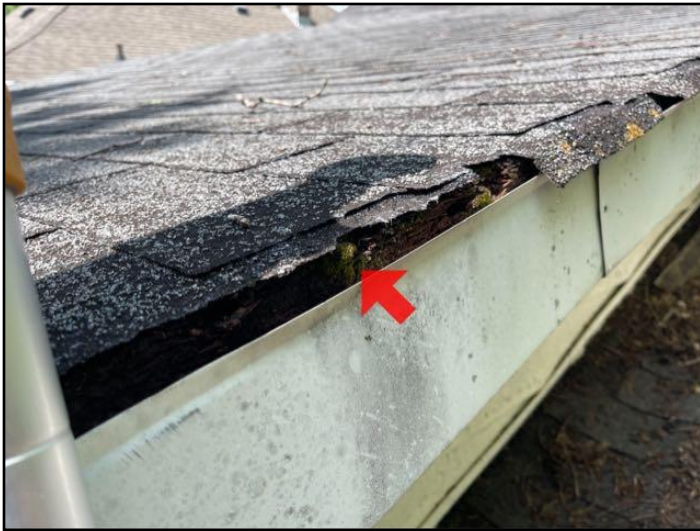
80. Rot in sheathing

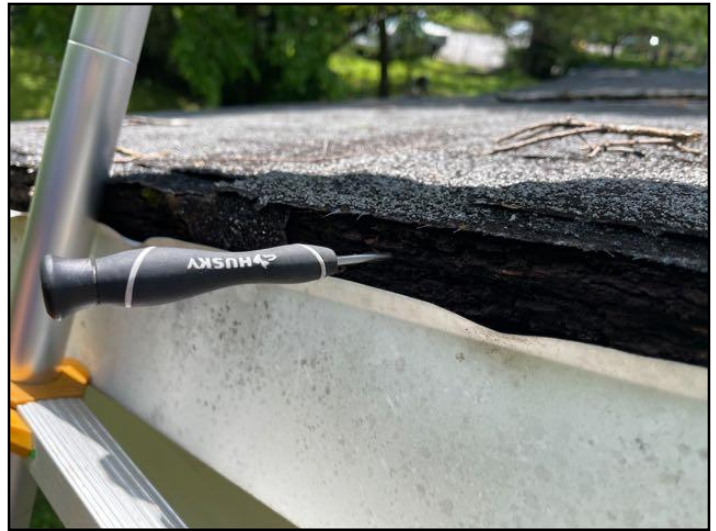
81. Rot in sheathing

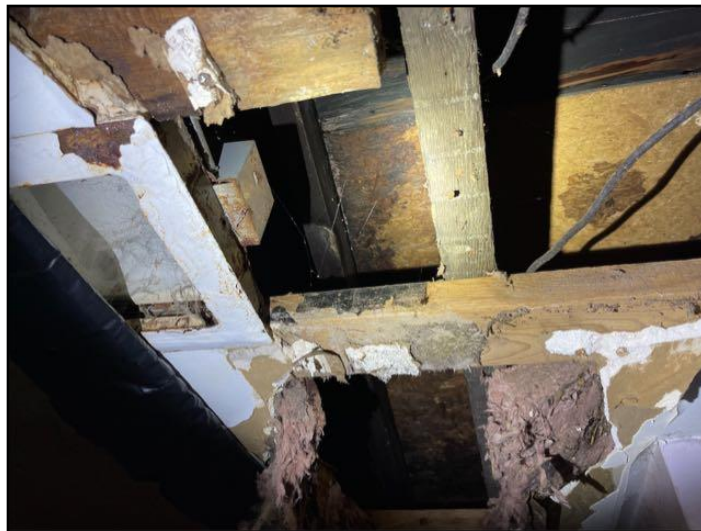
82. Active moisture in sheathing - inside home

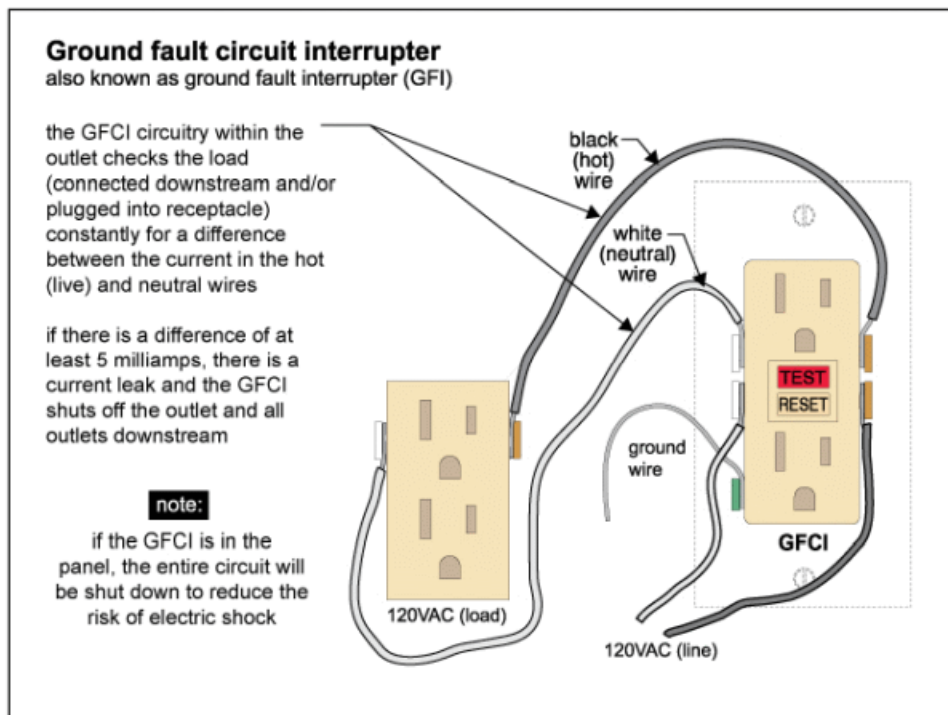
Condition: • [No GFCI/GFI \(Ground Fault Circuit Interrupter\)](#)

89. No GFCI/GFI (Ground Fault Circuit...

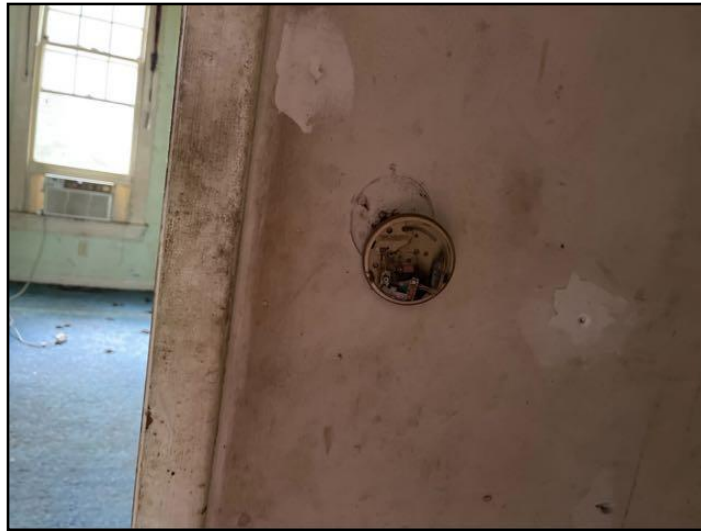
94. Service Furnace

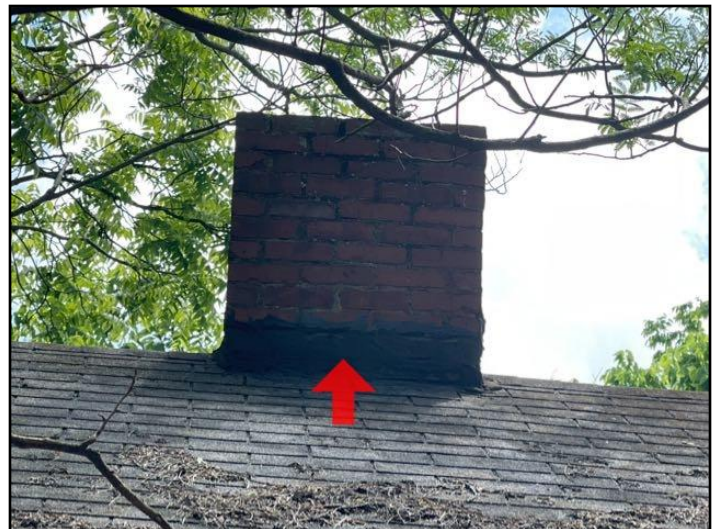
96. Deteriorated/poor flashing

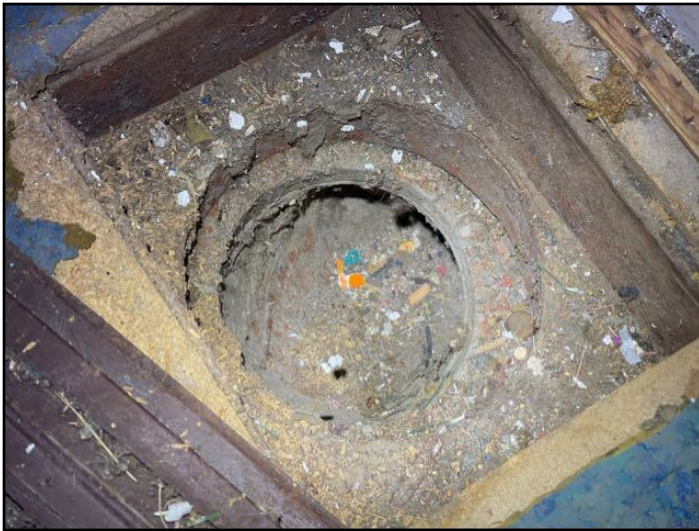
99. Dirty

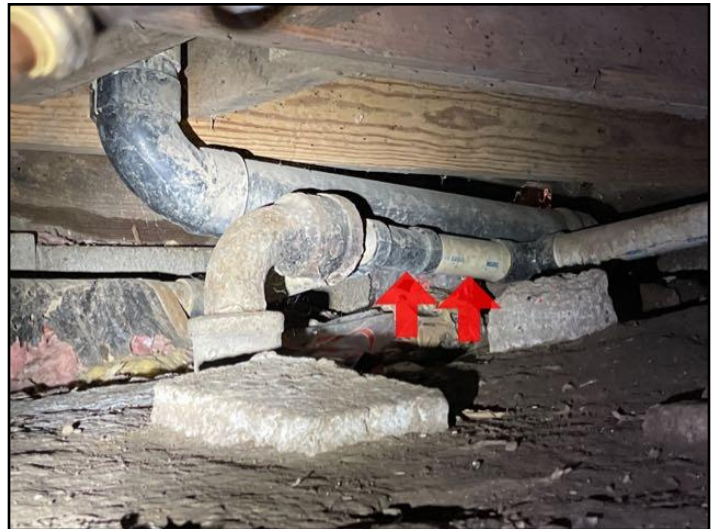
104. *possible abs to pvc connections*

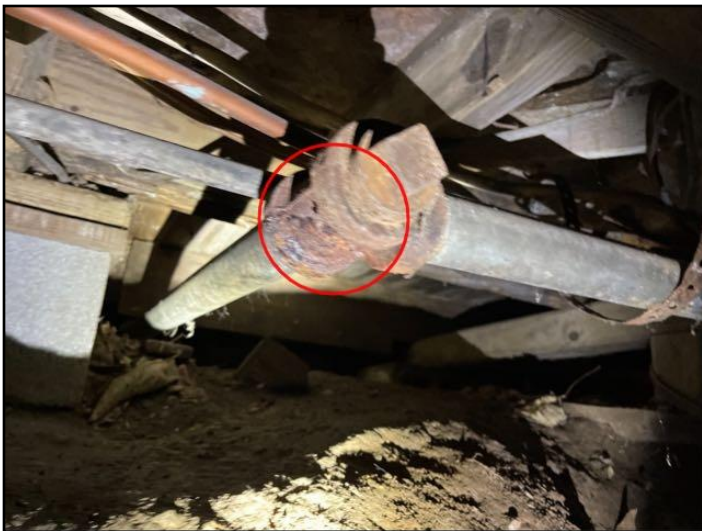
105. rust on cast iron

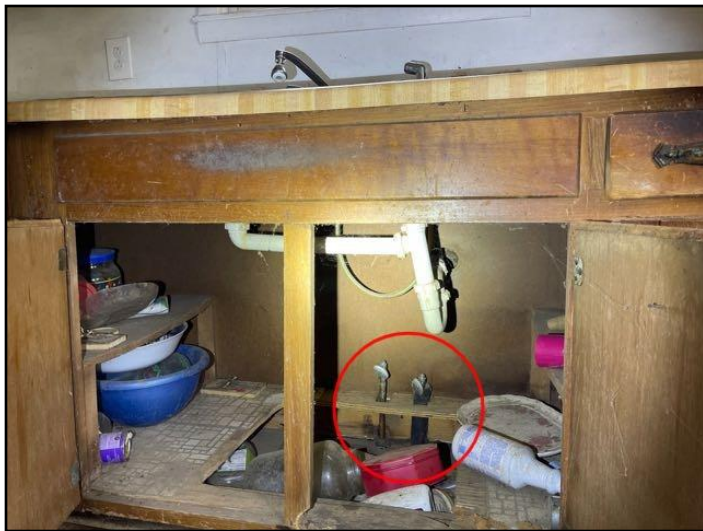
106. not connected
