STAFF RECOMMENDATION
1702 Forrest Avenue
July 21, 2021

Application: Demolition: Economic Hardship
District: Lockeland Springs Historic Conservation Zoning Overlay
Council District: 06
Base Zoning: R6
Map and Parcel Number: 08310029700
Applicant: Nicole Piersiak
Project Lead: Joseph Rose joseph.rose@nashville.gov

<p>Description of Project: The applicant requests demolition of a contributing building due to extreme disrepair, arguing for economic hardship and demolition of a non-contributing outbuilding.</p> <p>Recommendation Summary: Staff recommends approval of full demolition of all structures at 1702 Forrest, finding that demolition meets section III.B (2) (b) as the necessary demolition required to repair the primary building will result in a non-contributing building and the outbuilding is a non-contributing building and the project meets section III.B (2) (a) as repairs are not possible in a manner that retain the historic building.</p>	<p>Attachments</p> <ul style="list-style-type: none">A: PhotographsB: Engineer Report-FieldsC: Engineer Report-Engineered Solutions and Thunder River ConstructionD: Diligent Home InspectionE: Purchase DocumentationF: Tax HistoryG: Appraisal H

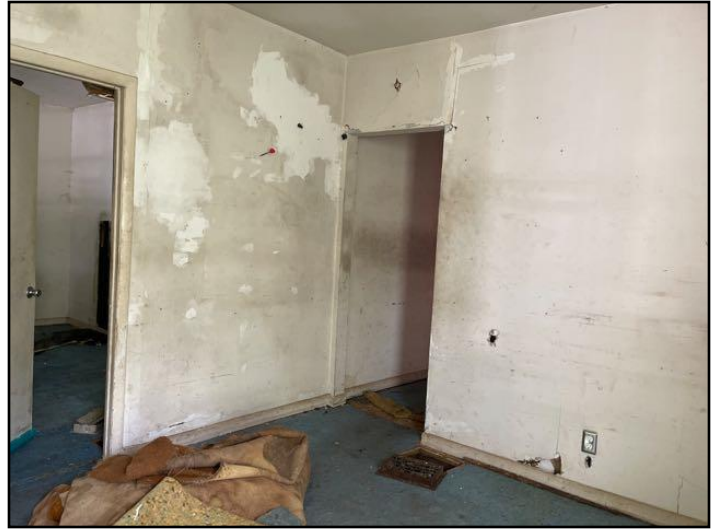
108. Generally poor condition

Repair of these issues by a licensed and qualified contractor is recommended. Further damage will likely be found during repairs.

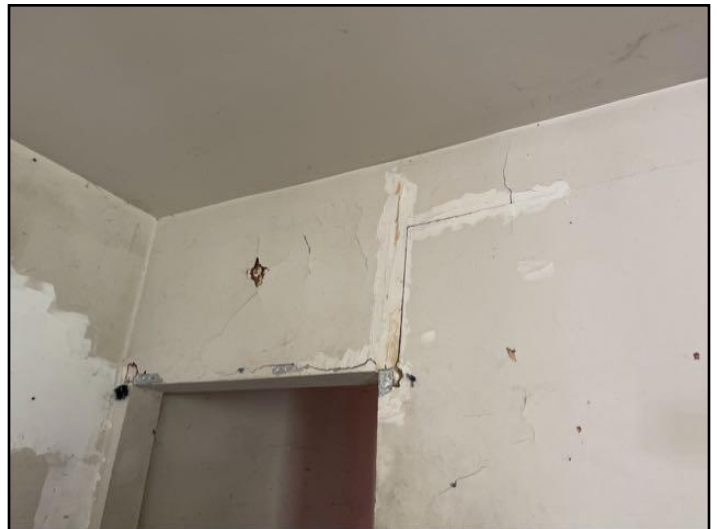
110. Cracks

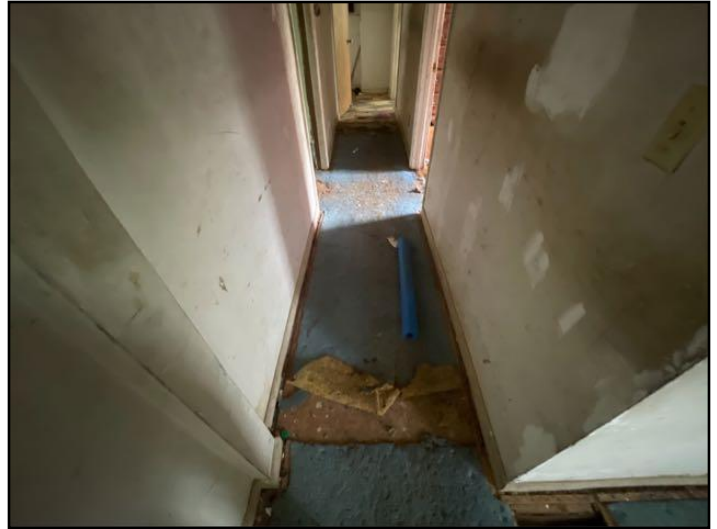
112. Damaged floors

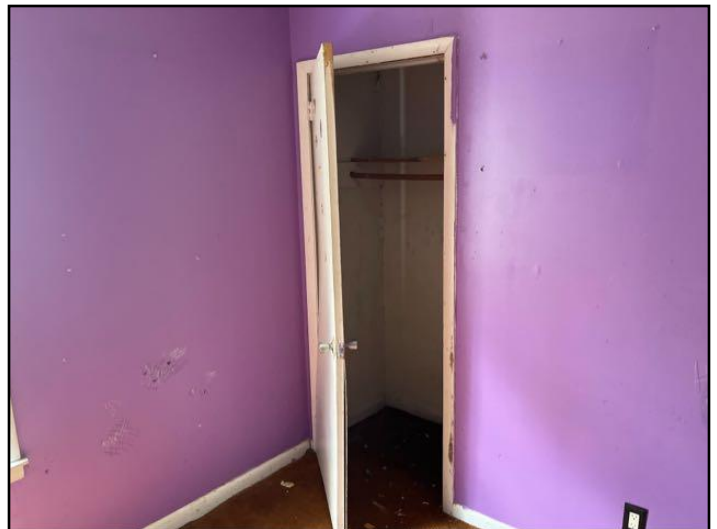
114. Damaged door

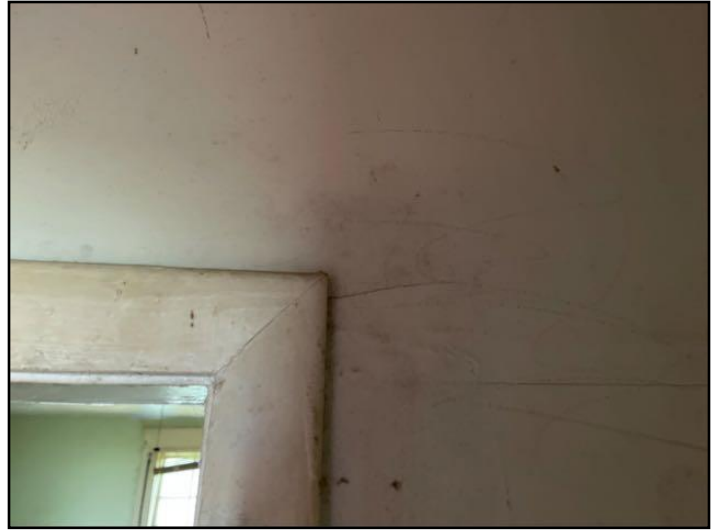
116. Cracked

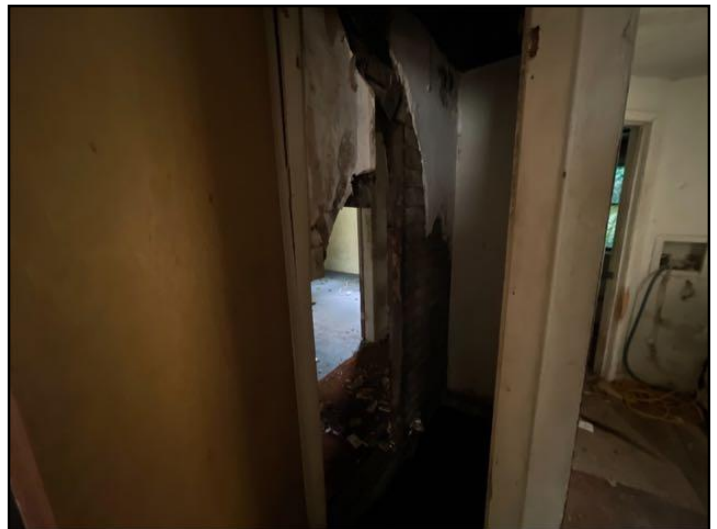
118. Hole through wall framing

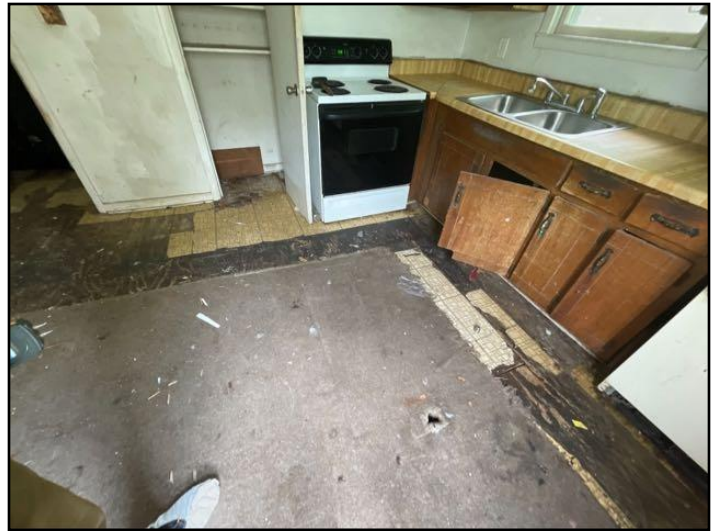
120. General poor condition

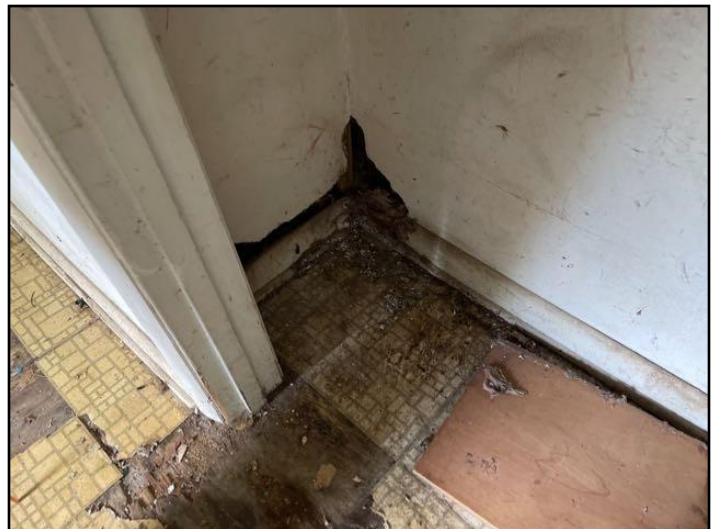
122. Damage to wall

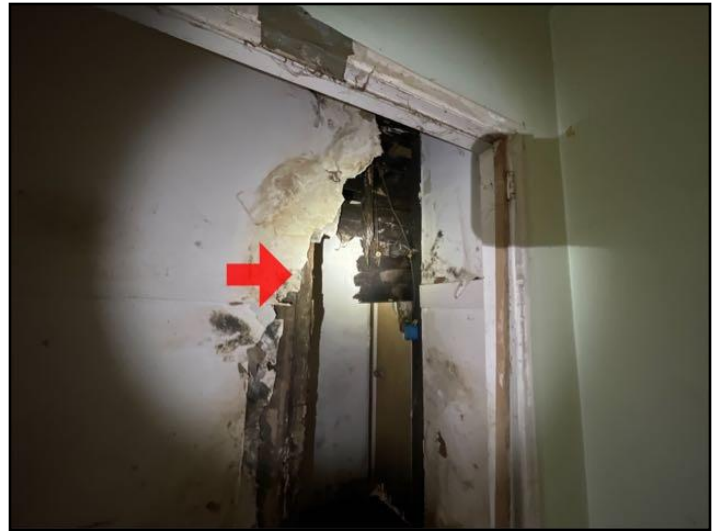
124. Wall damaged

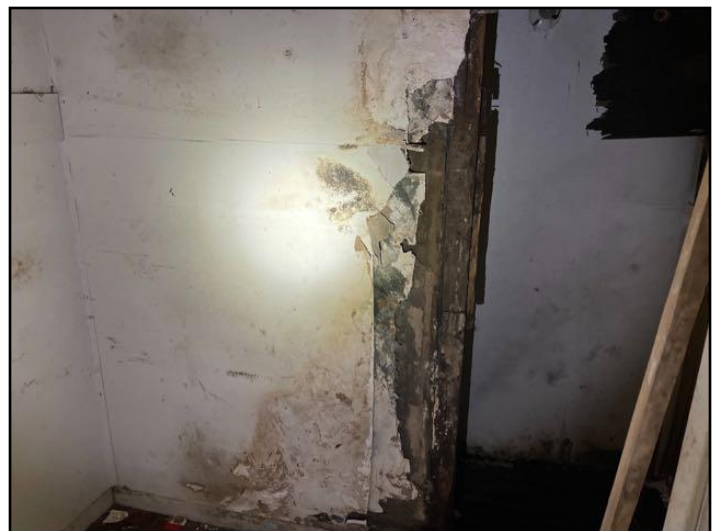
126. Damage/active moisture

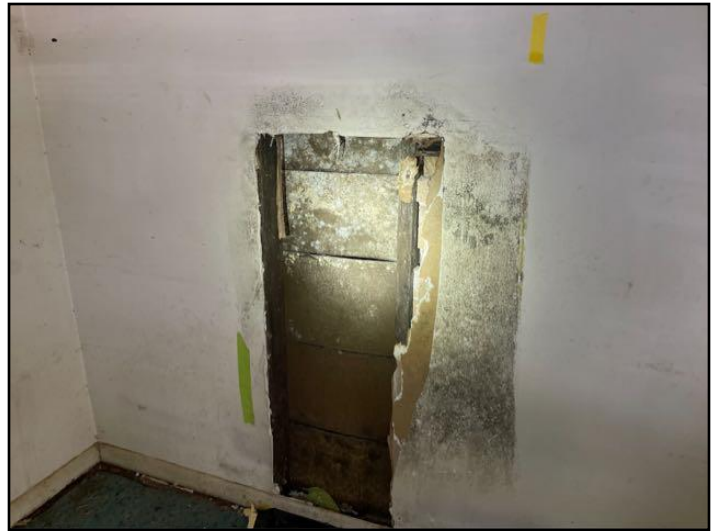
128. Damage to wall

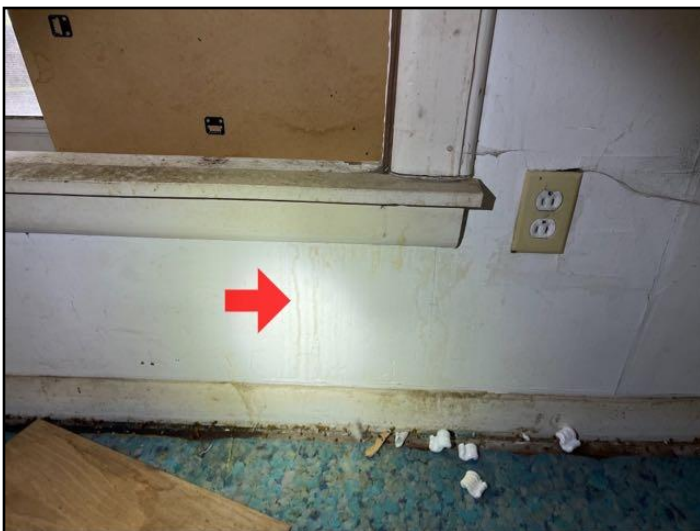
129. Moisture stains

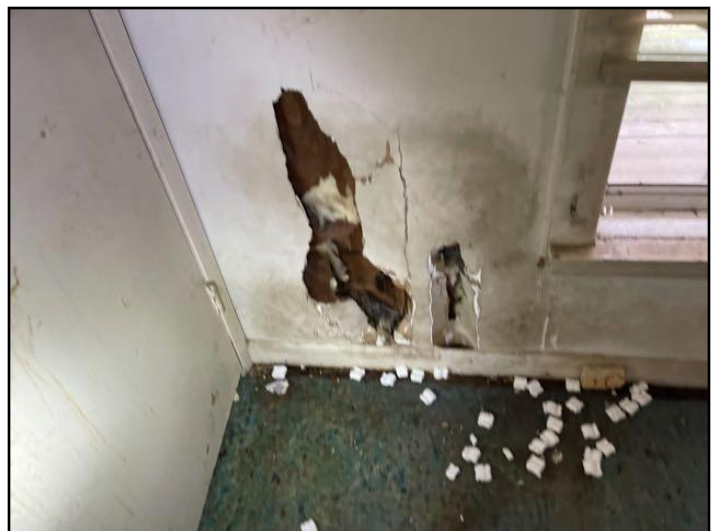
130. Wall damage
