METROPOLITAN GOVERNMENT OF NASHVILLE AND DAVIDSON COUNTY

STAFF RECOMMENDATION 949 Russell Street July 21, 2021

Application: Demolition
District: Edgefield Historic preservation Zoning Overlay
Council District: 06
Base Zoning: R8
Map and Parcel Number: 082120038300
Applicant: Troy Harper
Project Lead: Robin Zeigler, robin.zeigler@nashville.gov

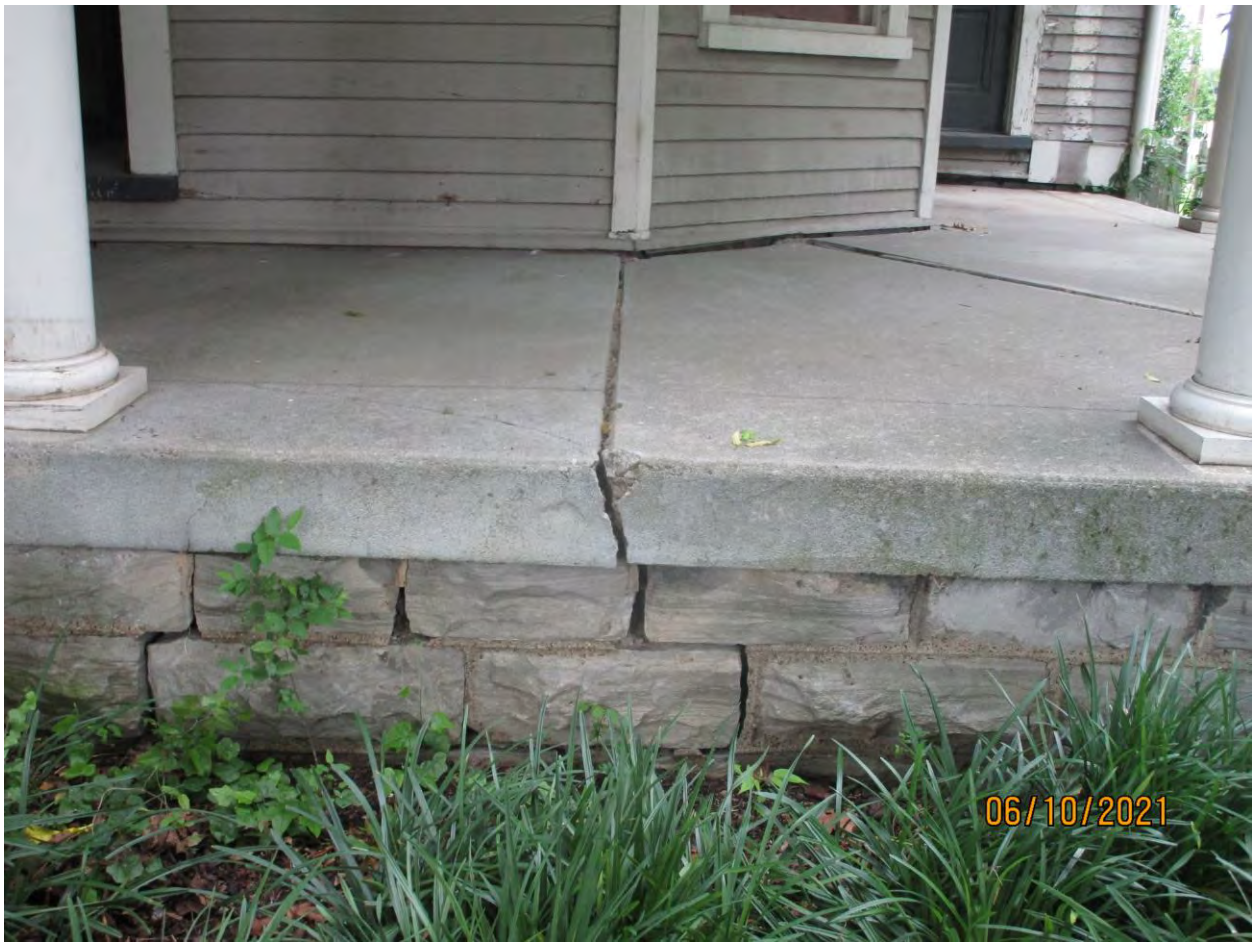
Photograph 14: Settlement of front porch foundation wall.

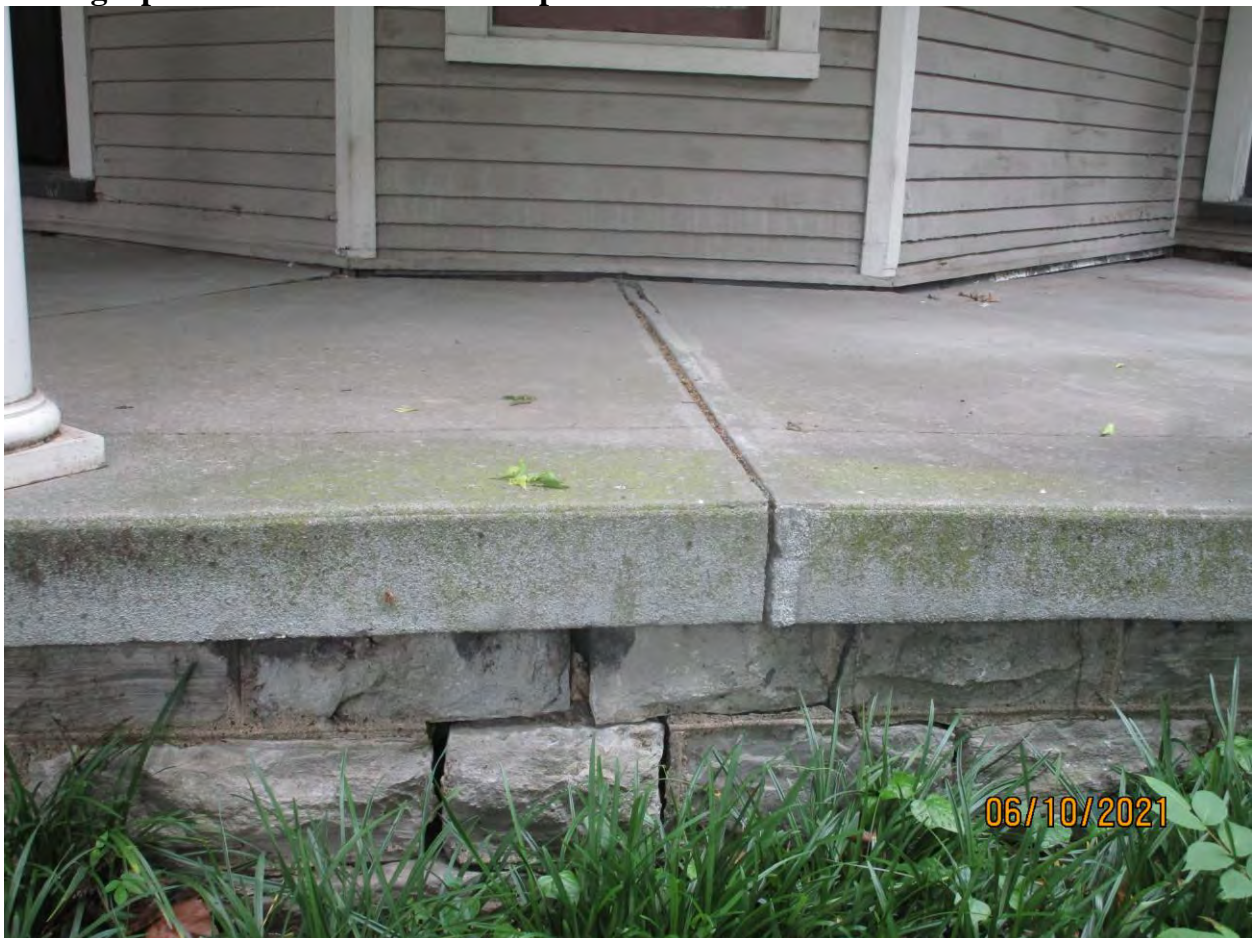
Photograph 15: Settlement of front porch foundation wall.

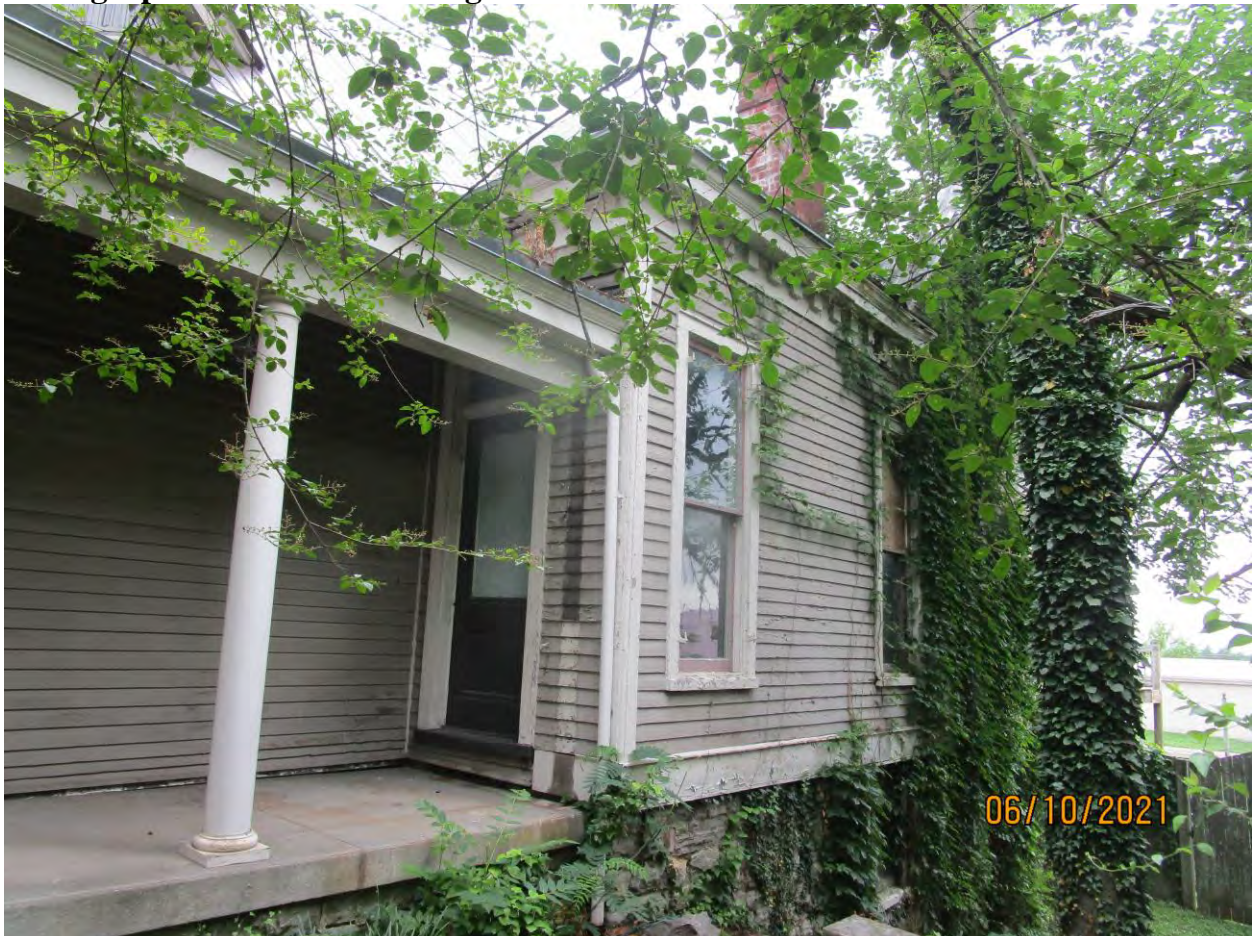
- I also observed that the band board located at the bottom face of the home appears to have been subjected to moisture as is evident by the deteriorated wood (photograph 17).

Photograph 17: Rotten band board at right side.

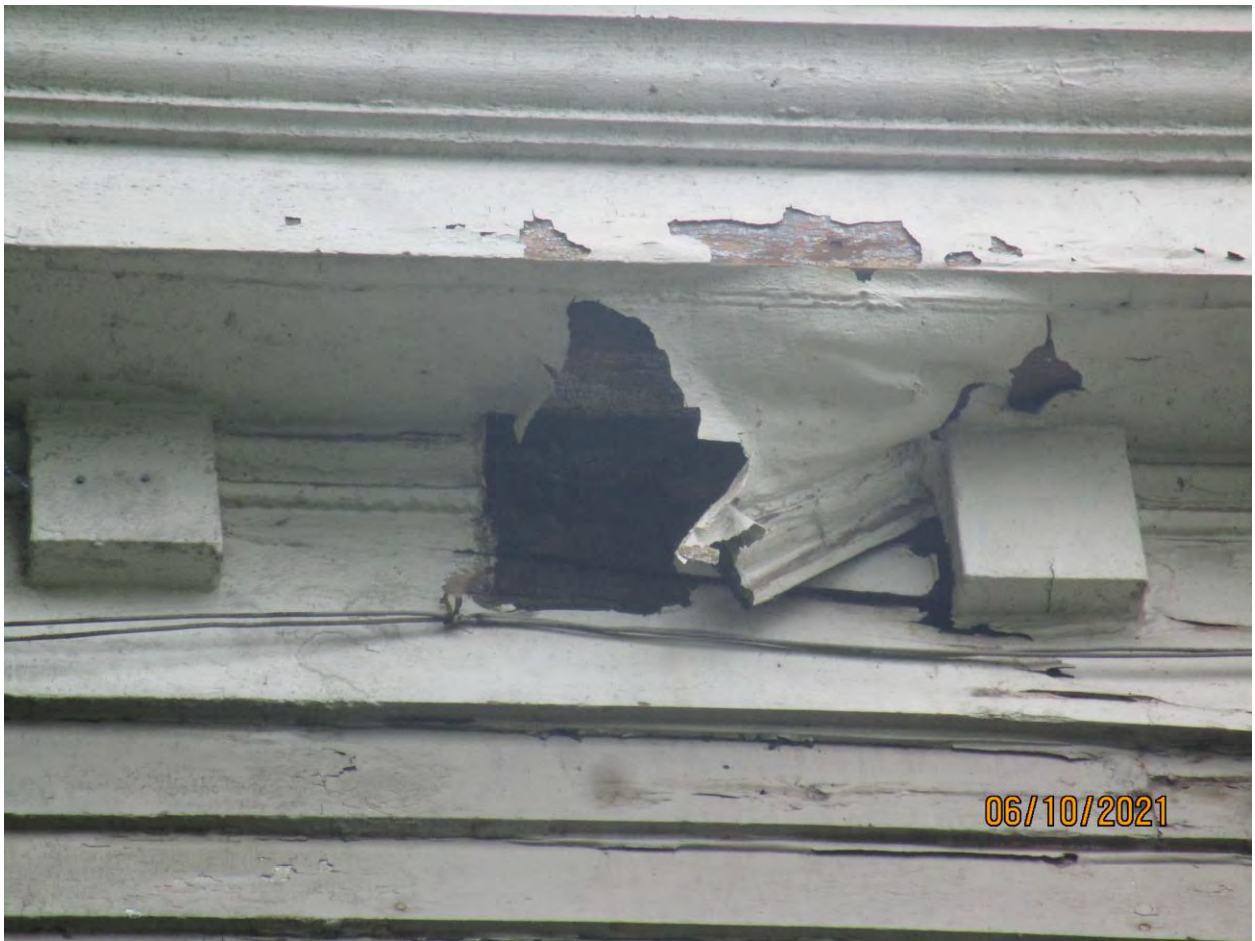
- From reviewing the right side of the home, which is sheathed in 1x lap siding, the interior Queen Anne gutters appear to have leaked, which is common with these types of structures, and has damaged the soffit of the home (photograph 19).

Photograph 19: Rotten soffit at right rear corner.

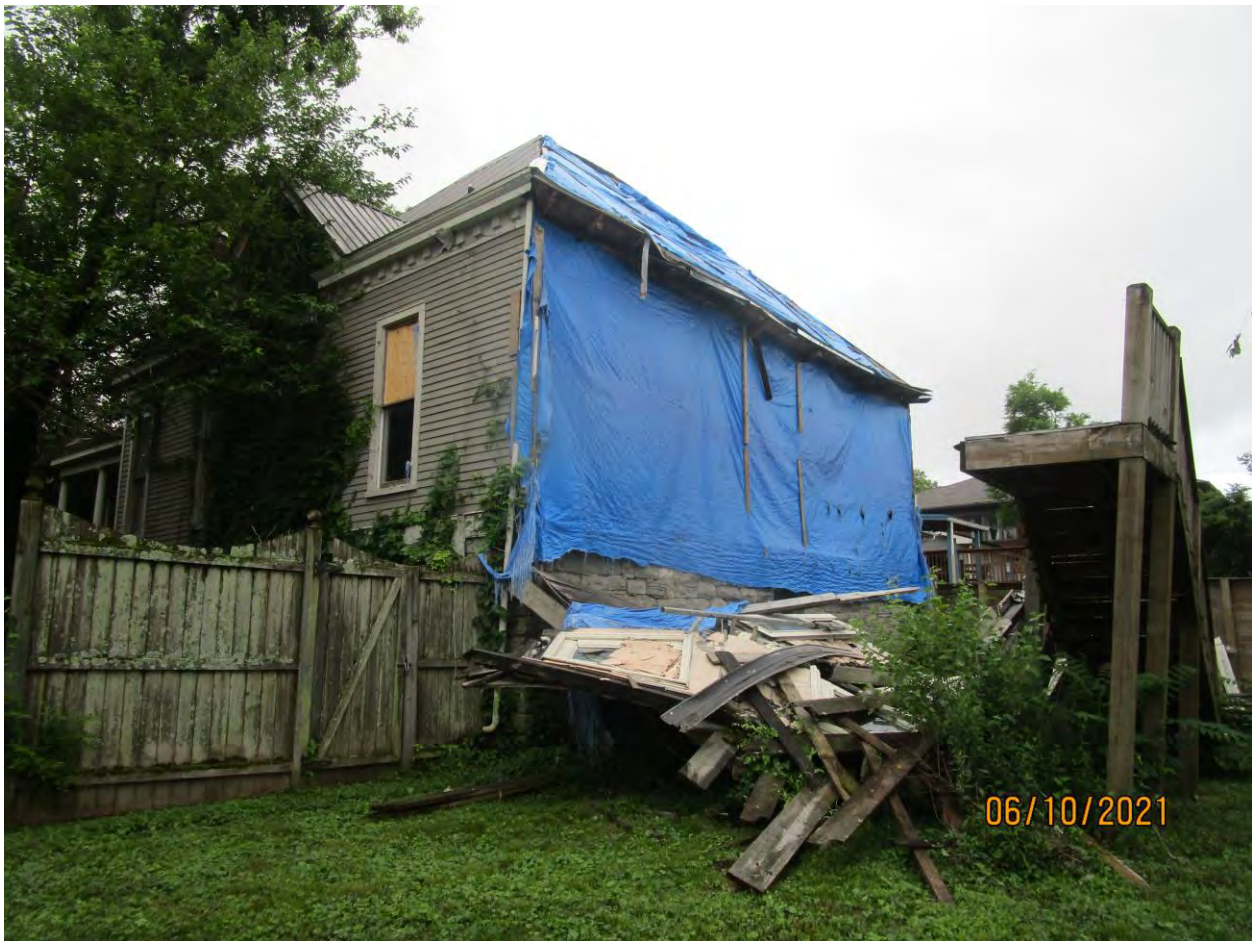
- Due to the effects of the high winds, the entire rear wall of the home was displaced as well as the rear porch (photographs 21 and 22).
- The left side of the home was observed, and the same deterioration common to the interior gutter has created rotten wood common to the soffit and, most likely, common to the interior wall cavity. Examples of the rotten soffits on the left sidewall can be observed in photographs 24, 25, 26, and 28.

Photograph 21: Rear elevation.

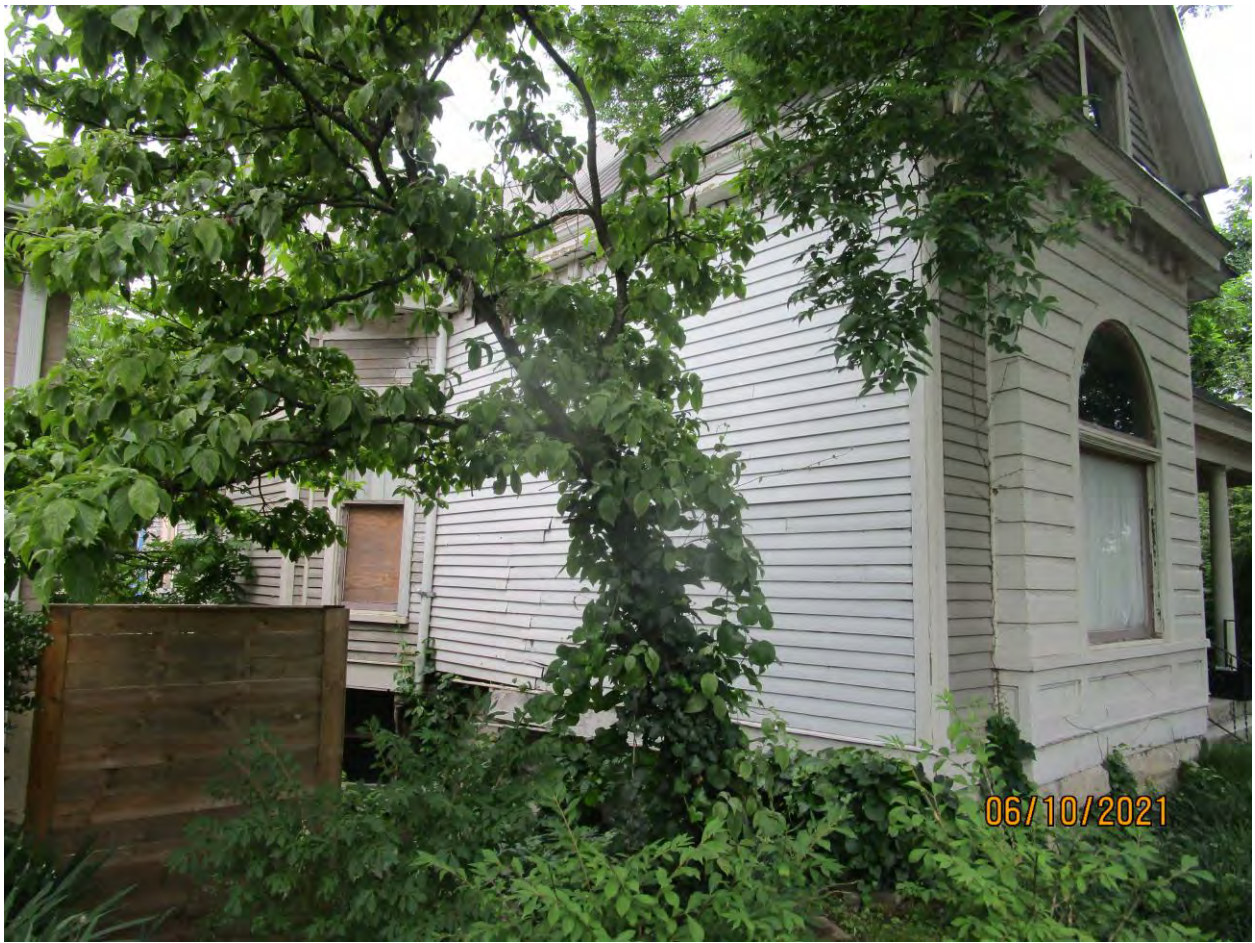
- Due to the high tornadic wind forces, the left sidewall of the home was displaced vertically by approximately four inches at the base of the wall (overview in photographs 31 and 32; interior photograph 69). As can be seen in photograph 33, the wood siding common to this area has been replaced in the past as is evident by the joint.

Photograph 31: Close-up of left sidewall at front of house.

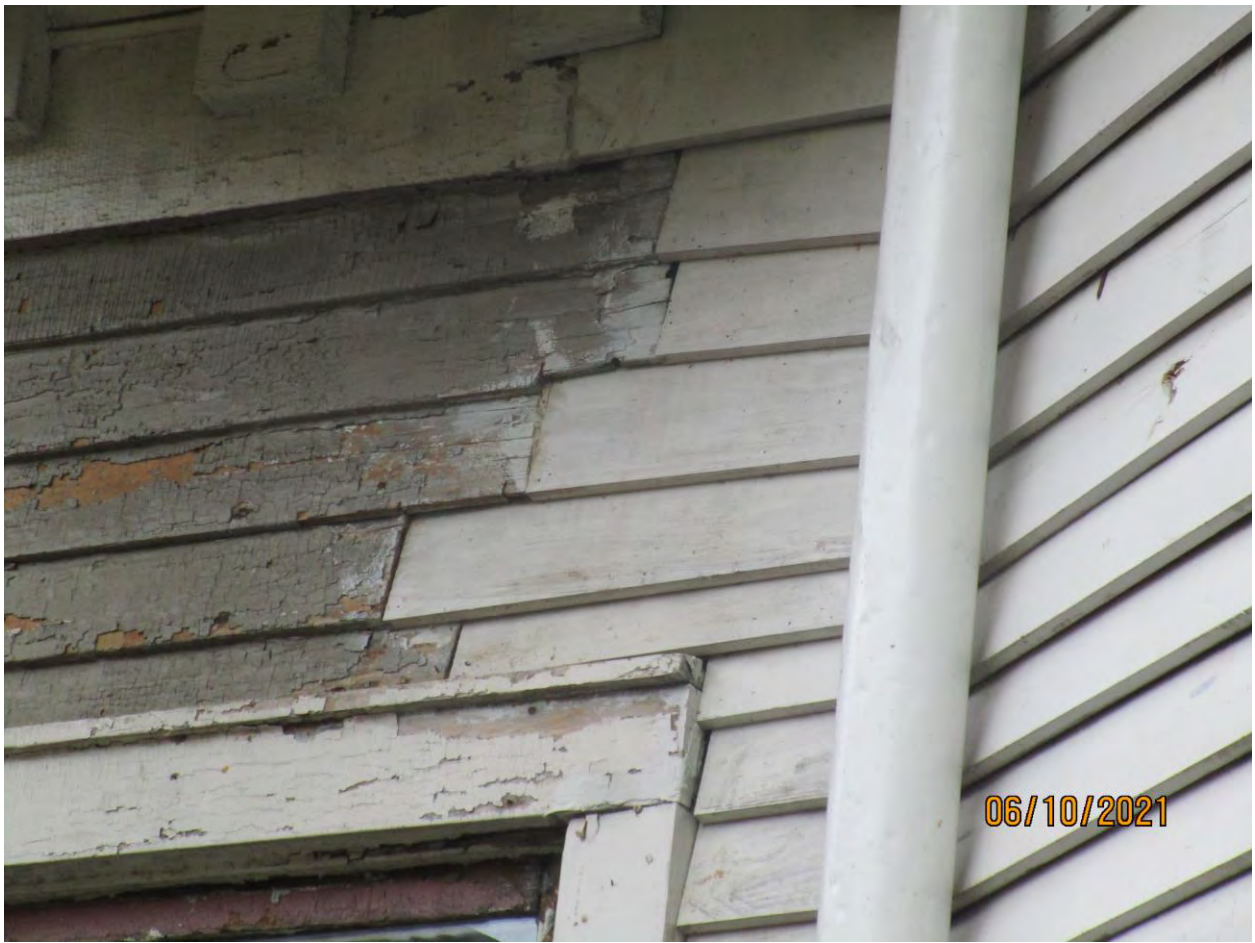
Photograph 33: Previously replaced wood siding.

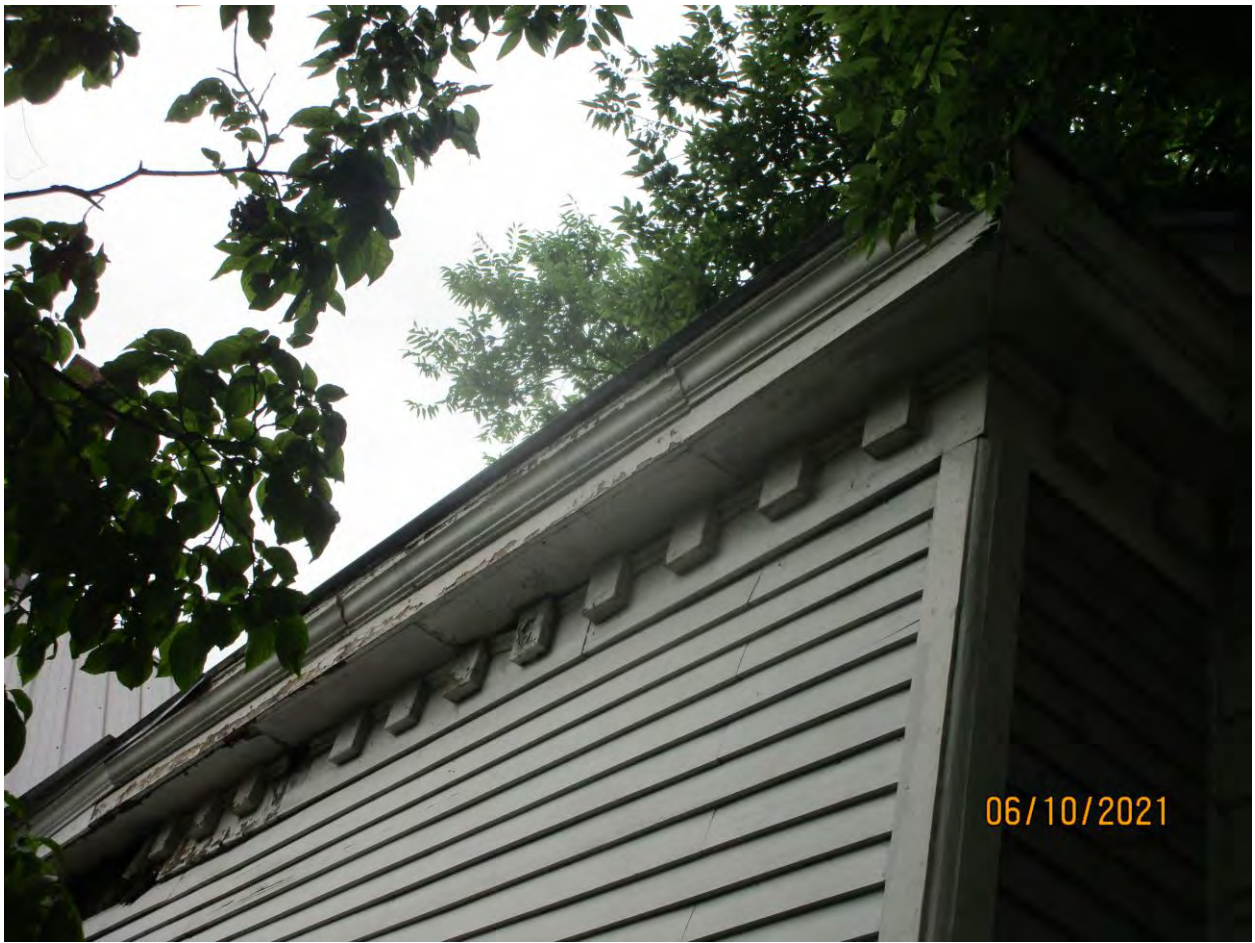
Photograph 35: Previously repaired interior gutter.

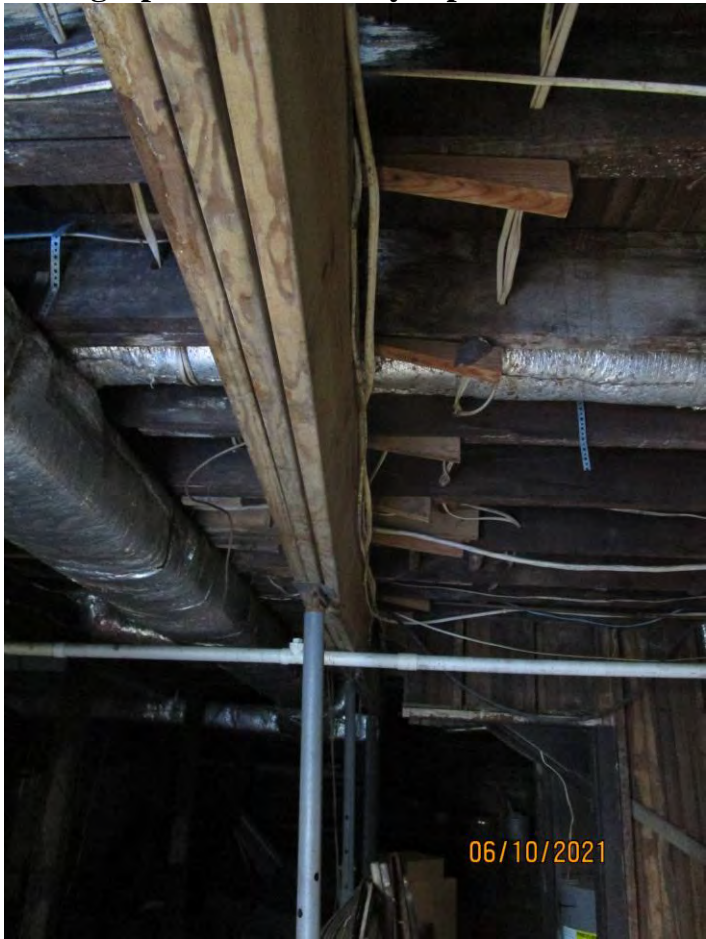
Photograph 39: Previously replaced wood beam (inadequate).

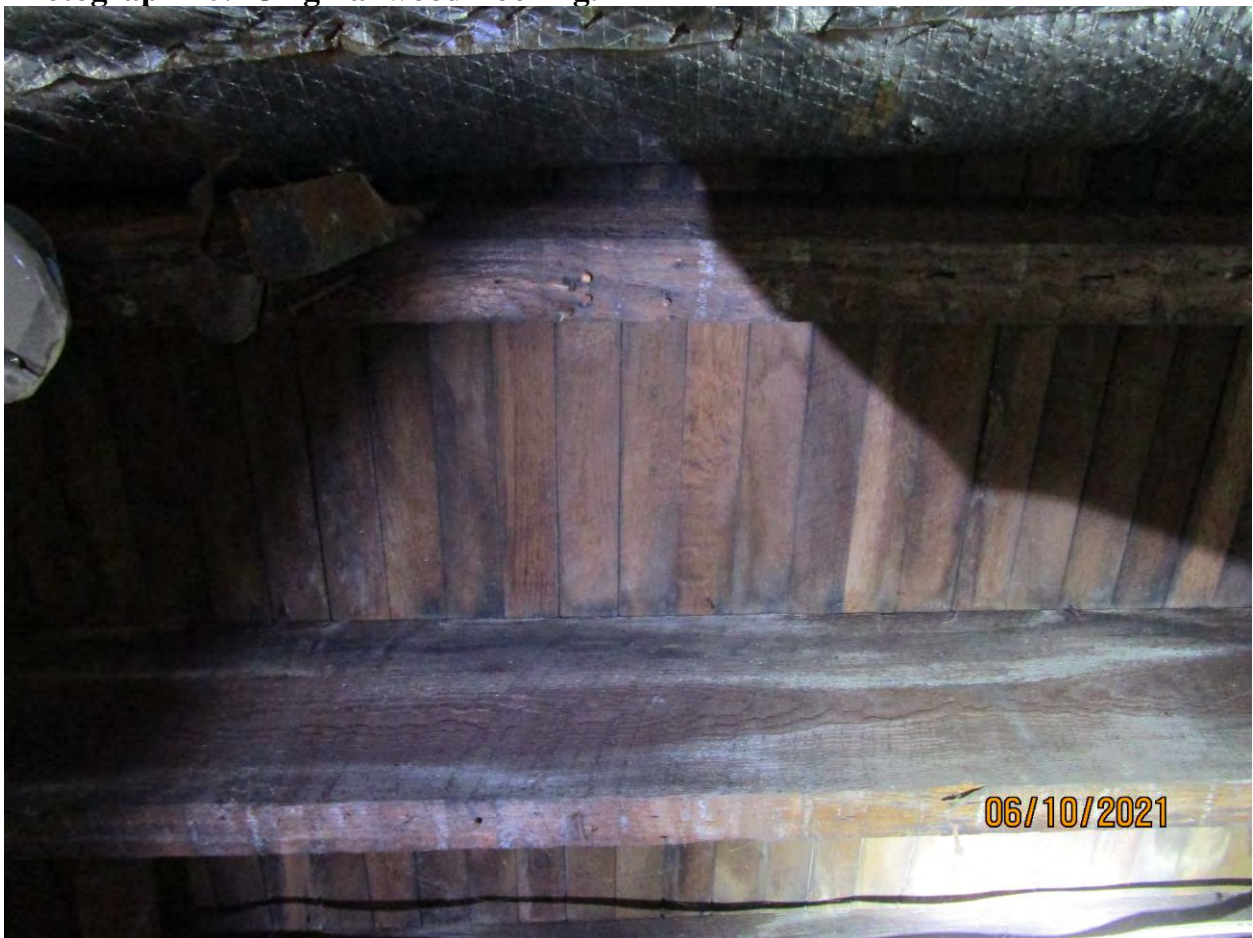
Photograph 41: Original wood beam (inadequate).

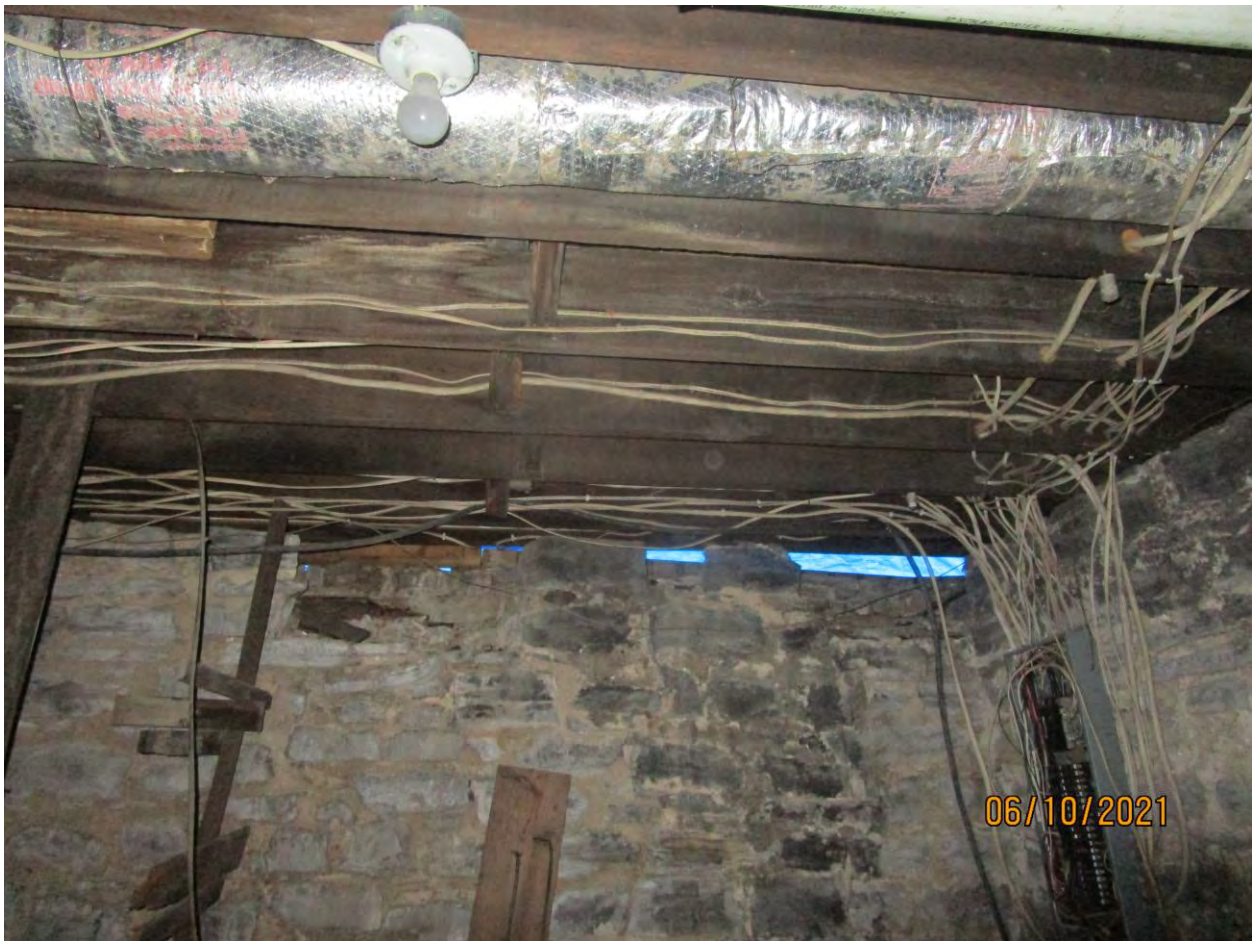
Photograph 44: Right sidewall foundation wall issues.

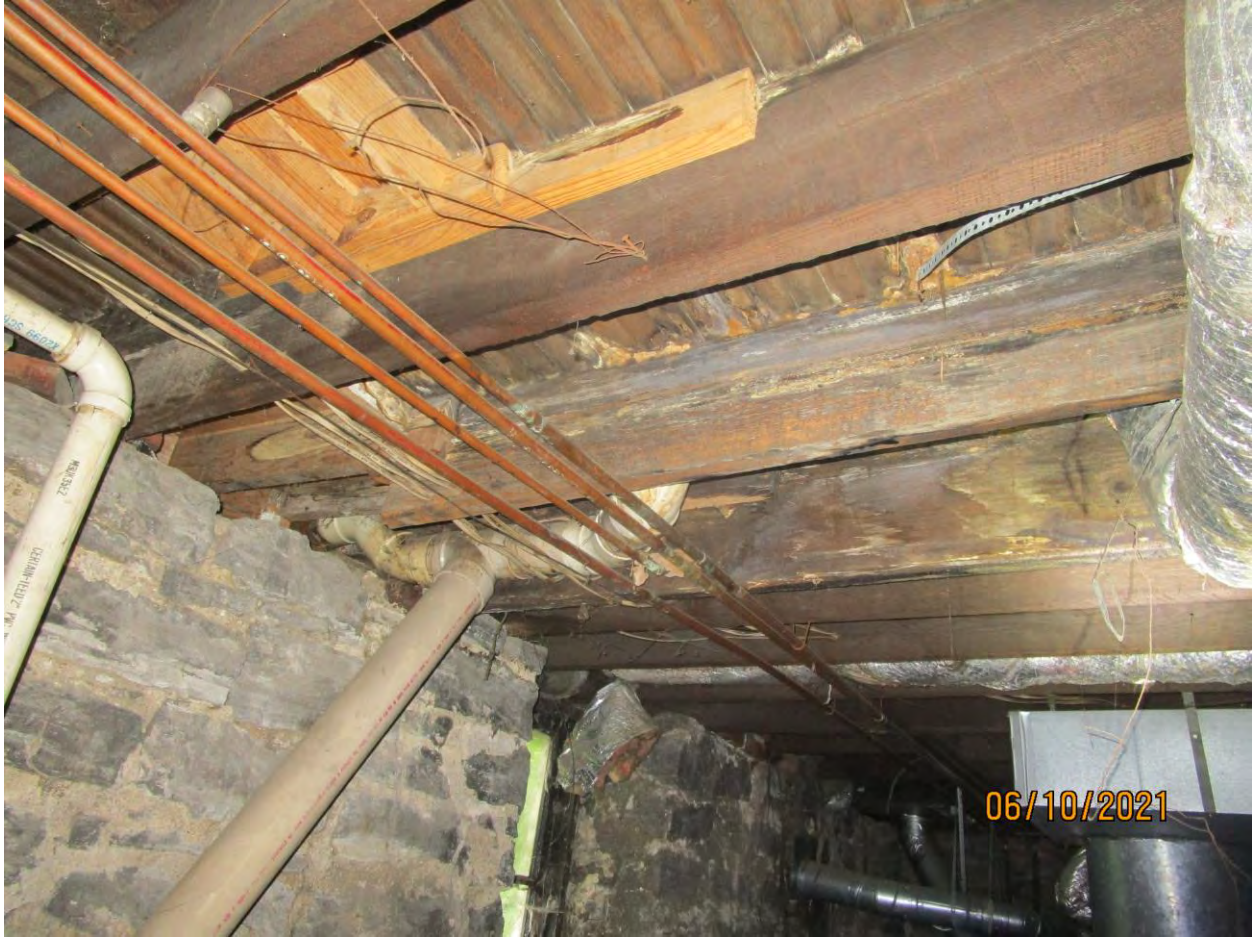
Photograph 45: Right sidewall foundation wall issues.

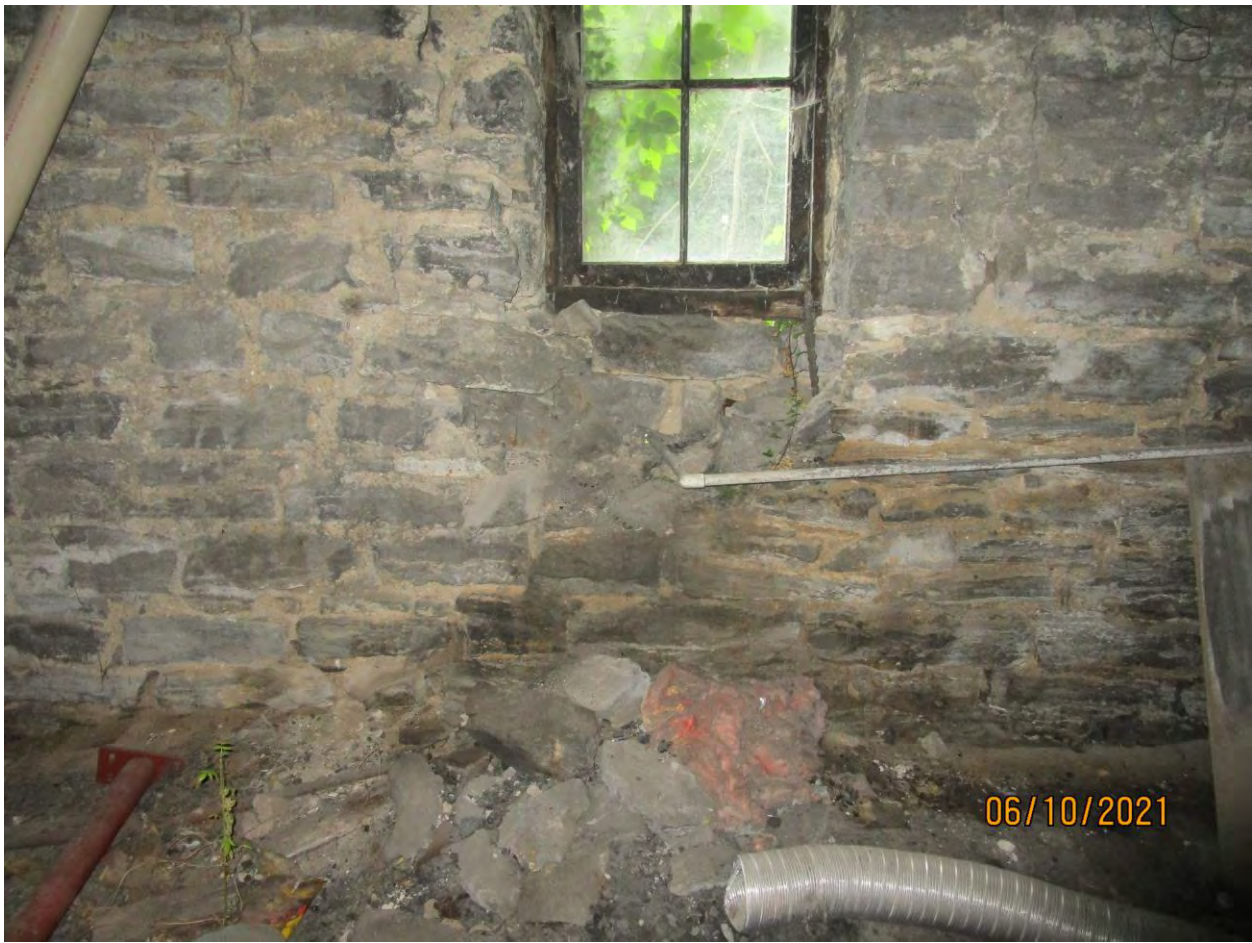
Photograph 46: Right sidewall foundation wall issues.

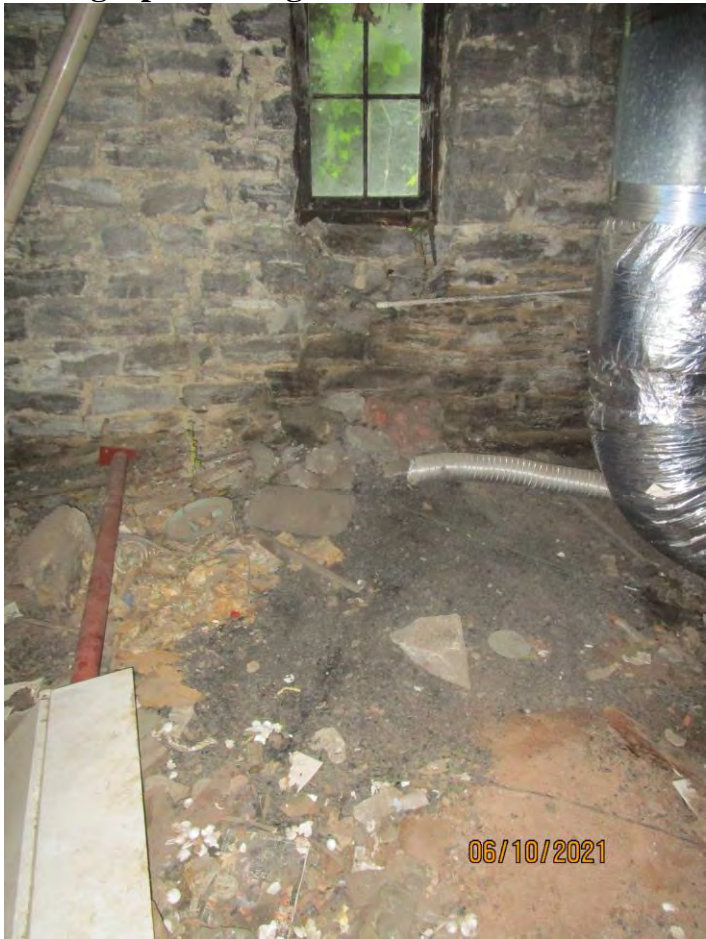
Photograph 47: Front wall foundation wall issues.

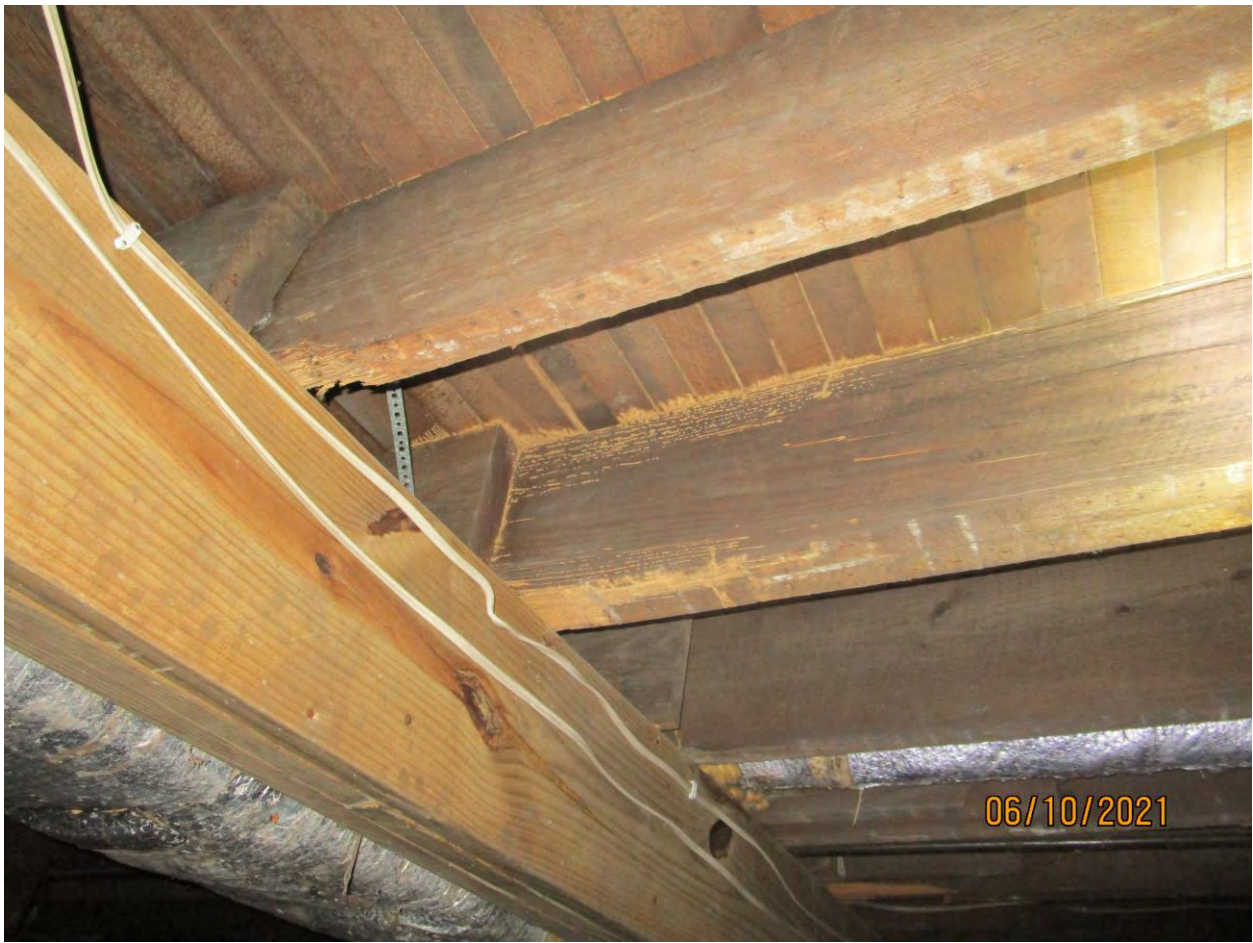
Photograph 51: Typical insect infestation of wood joists.

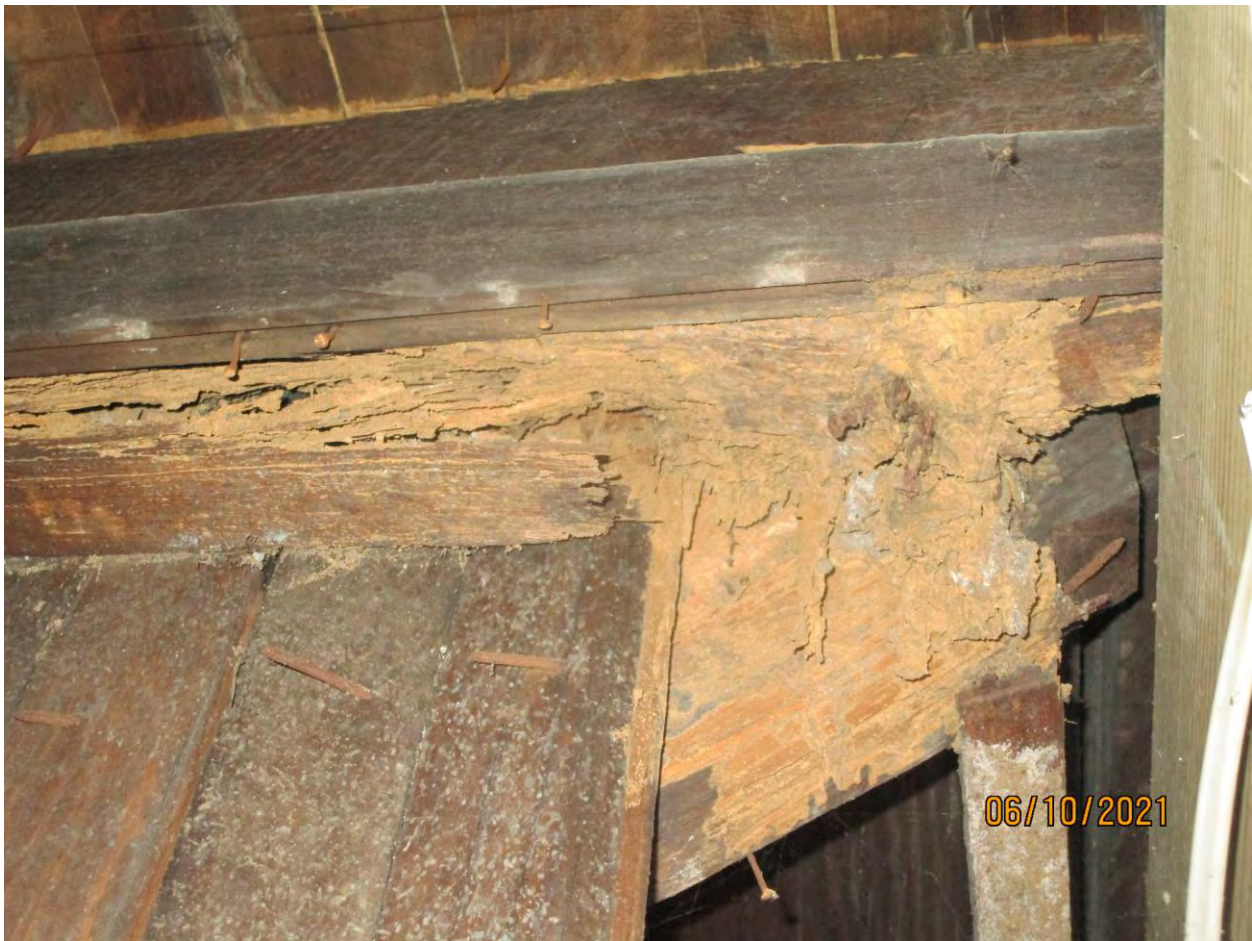
Photograph 53: Typical insect infestation issues with wood joists.

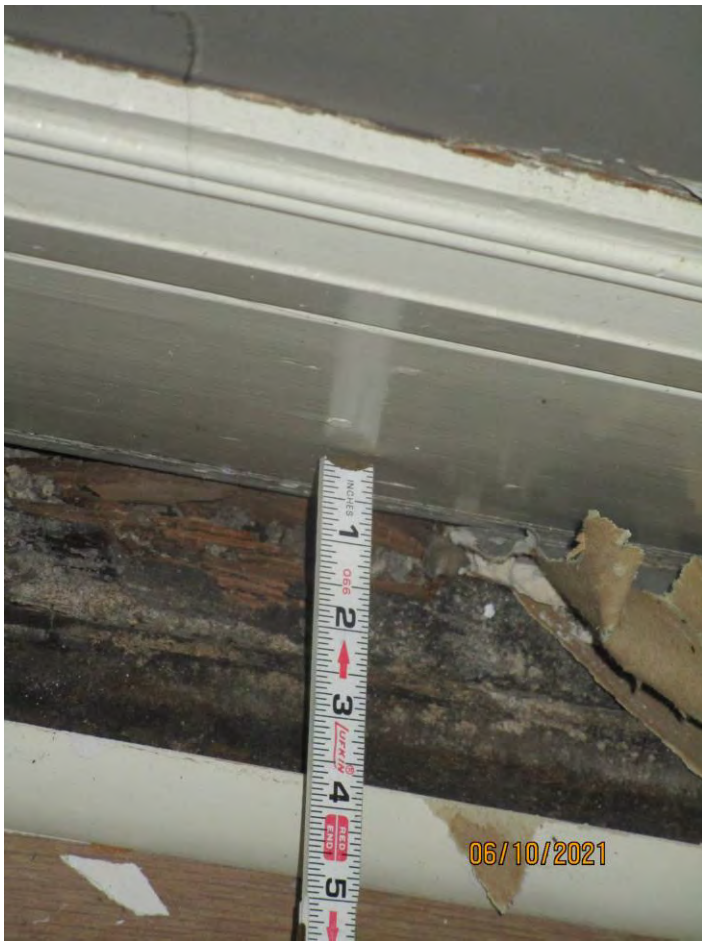
Photograph 69: Displaced left sidewall of formal living room.

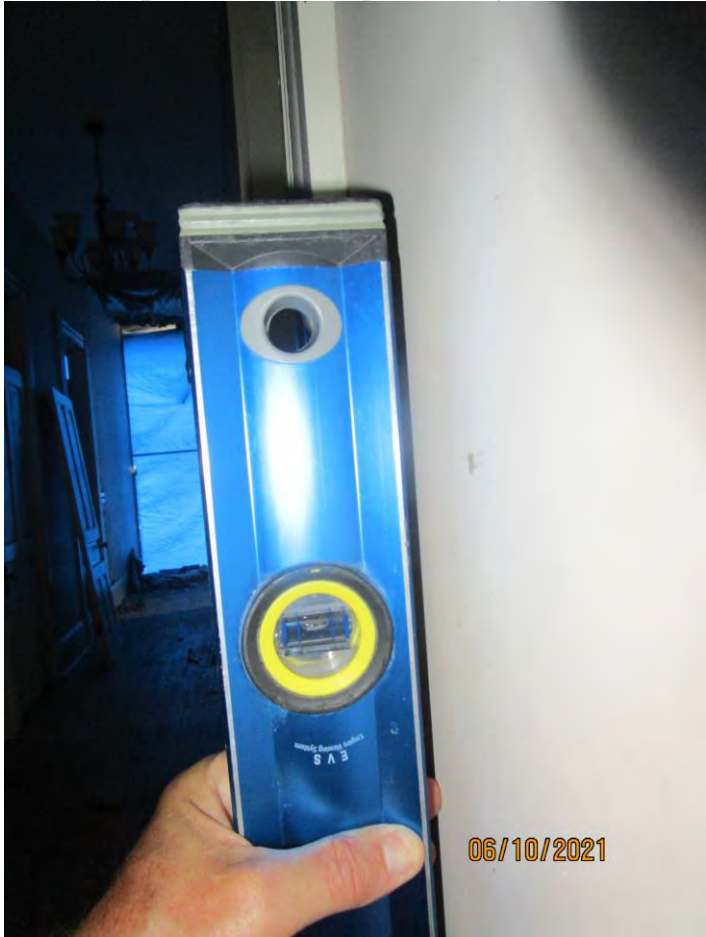
Photograph 75: Out-of-plumb right exterior wall.

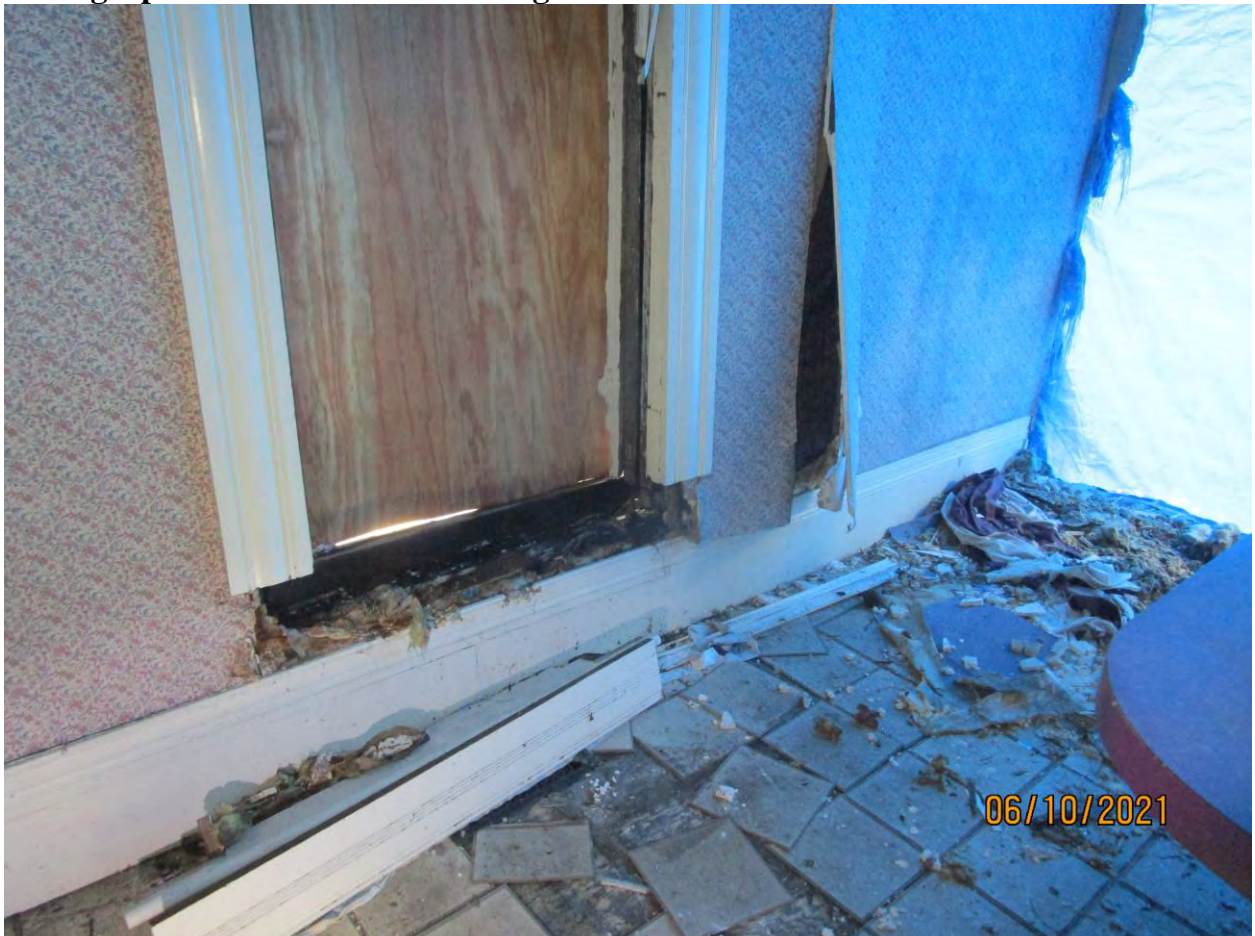
Photograph 89: Rotten wall framing in kitchen.

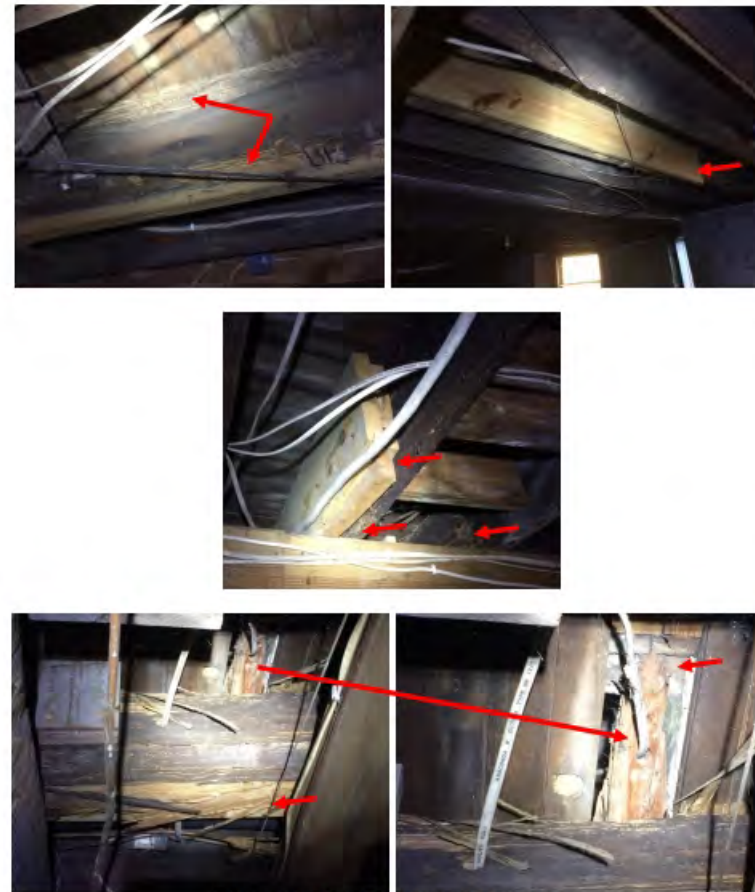
Undermined wall framing due to insect damaged floor
