STAFF RECOMMENDATION

308-310 Broadway

August 18, 2021

Application: Alteration—Windows, Lighting, and Signage

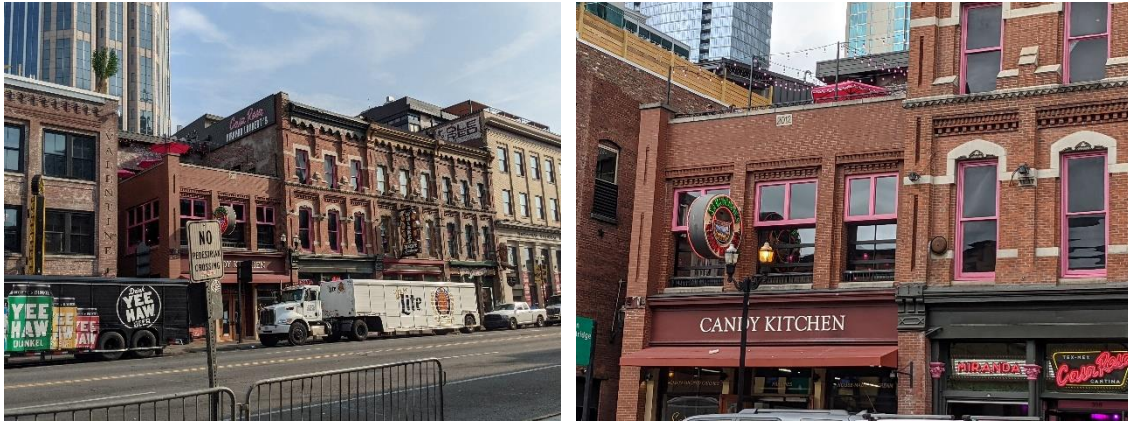
Figures 1 and 2 show the front façade of 308-310 Broadway.

Windows: Windows were installed on the second-level of the front façade without a permit and include fixed and roll up windows. (See Figures 2 and 3). According to Section II.A.4, replacement windows should be should have single-light or multiple-light clear-glass panes to match the style and period of the building. In this case, a single or double hung window would be appropriate for the style of the building (Figure 4). Roll up doors on upper levels are not seen in the district historically, and the Commission has not approved such windows for upper levels, or for Broadway facing elevations, in the past.

Recommendation Summary: Staff recommends disapproval of the windows and lighting, finding that they do not meet Section II and Section III. of the design guidelines for Rehabilitation. Staff recommends that the unpermitted windows and lighting with the associated poles be removed and the menu signs changed to not exceed a total of five square feet (5 sq. ft.) within 60 days of the Commission’s decision.

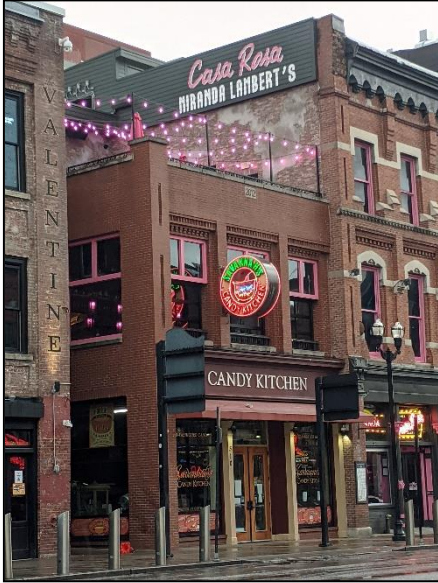
Figure 3. Completed work.

Lighting: All proposed lighting should be simple and unobtrusive in both material and appearance. The new string lights, which were also installed without a permit, are located in a highly visible location on the rooftop addition (Figure). While they are made from a dark material as the guidelines suggest, they are overall not appropriate due to their location. The lighting and associated poles also do not comply with the guidelines for Additions, III.A.2 as they are located in the thirty-foot (30') stepback area where there should be no construction in order to lessen the visual impact of the rooftop addition.

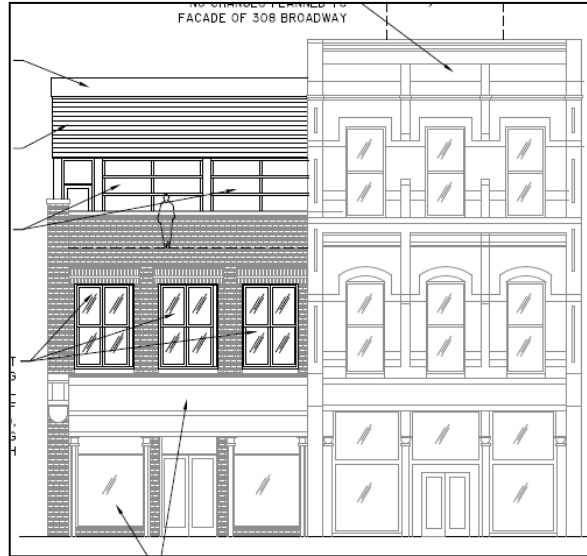
Figure 4. Front elevation approved by MHZC in July 2015.

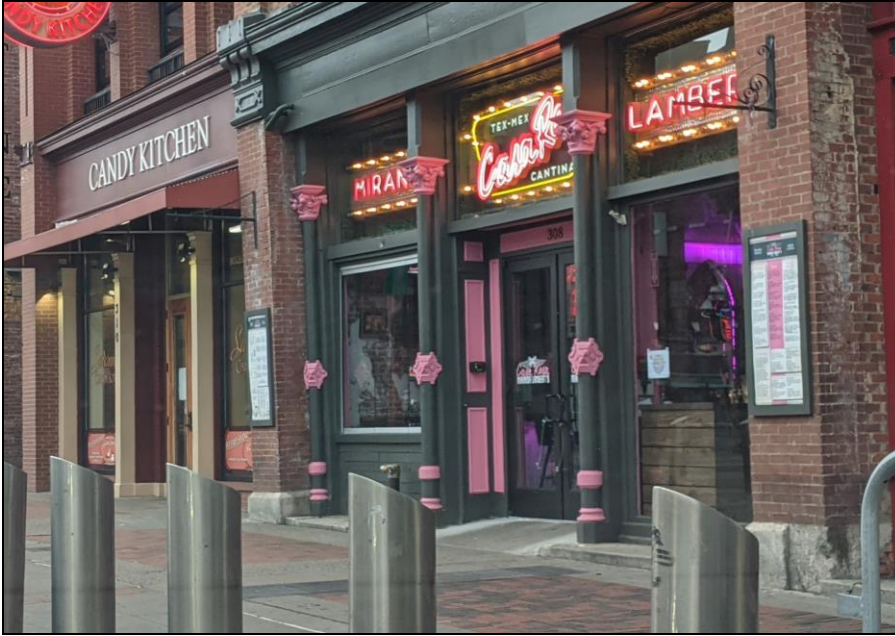
Menu Signs: Two menu boards, each measuring twenty-four inches by fifty inches (24" x 50"), or approximately eight square feet (8 sq. ft.), have been added to the storefront on the ground-level (Figure 5). For this type of signage, the Commission has allowed for a maximum of five square feet (5 sq. ft.) without the menu signs counting toward the signage allotment. The total area of menu signs installed is approximately sixteen square feet (16 sq. ft.). Staff recommends that the menu sign not exceed a total of five square feet (5 sq. ft.).

Figure 5. Menu signs
