METROPOLITAN GOVERNMENT OF NASHVILLE AND DAVIDSON COUNTY

Metropolitan Historic Zoning Commission
Sunnyside in Sevier Park
3000 Granny White Pike
Nashville, Tennessee 37204
Telephone: (615) 862-7970

STAFF RECOMMENDATION
308-310 Broadway
July 21, 2021

Application: Alteration—Windows, Lighting, and Signage
District: Broadway Historic Preservation Zoning Overlay
Council District: 19
Base Zoning: DTC
Map and Parcel Number: 09306202600
Applicant: 306 Broadway, LLC, property owner
Project Lead: Melissa Sajid, melissa.sajid@nashville.gov

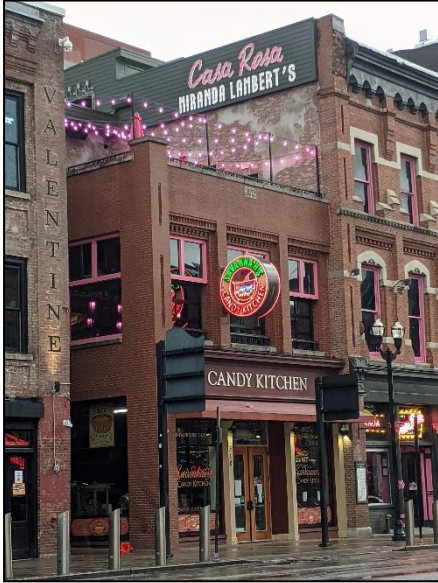
Windows: Windows were installed on the second-level of the front façade without a permit and include fixed and roll up windows. (See Figures 2 and 3). According to Section II.A.4, replacement windows should be should have single-light or multiple-light clear-glass panes to match the style and period of the building. In this case, a single or double hung window would be appropriate for the style of the building (Figure 4). Roll up doors on upper levels are not seen in the district historically, and the Commission has not approved such windows for upper levels, or for Broadway facing elevations, in the past.

Figure 3. Completed work.

Lighting: All proposed lighting should be simple and unobtrusive in both material and appearance. The new string lights, which were also installed without a permit, are located in a highly visible location on the rooftop addition (Figure). While they are made from a dark material as the guidelines suggest, they are overall not appropriate due to their location. The lighting and associated poles also do not comply with the guidelines for Additions, III.A.2 as they are located in the thirty-foot (30') stepback area where there should be no construction in order to lessen the visual impact of the rooftop addition.

Recommendation Summary: Staff recommends disapproval of the windows and lighting, finding that they do not meet Section II and Section III. of the design guidelines for Rehabilitation. Staff recommends that the unpermitted windows and lighting with the associated poles be removed and the menu signs changed to not exceed a total of five square feet (5 sq. ft.) within 60 days of the Commission's decision.

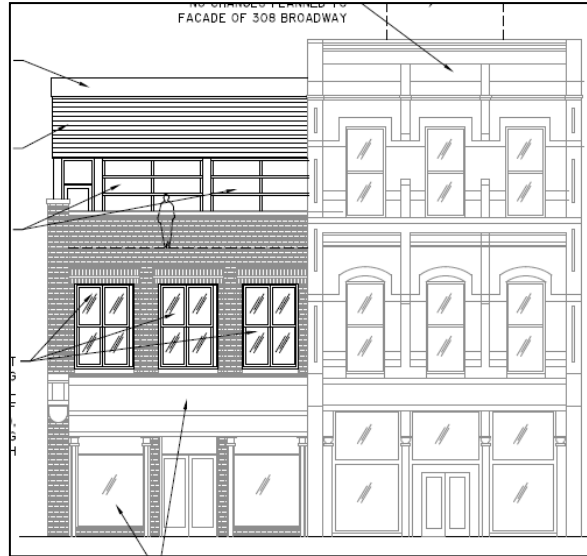
Figure 4. Front elevation approved by MHZC in July 2015.
