STAFF RECOMMENDATION

313 Broadway

May 19, 2021

Application: New Construction - Violation
District: Broadway Historic Preservation Zoning Overlay
Council District: 19
Base Zoning: DTC
Map and Parcel Number: 09306402300
Applicant: Troubadour Entertainment, LLC
Project Lead: Paul Hoffman; paul.hoffman@nashville.gov

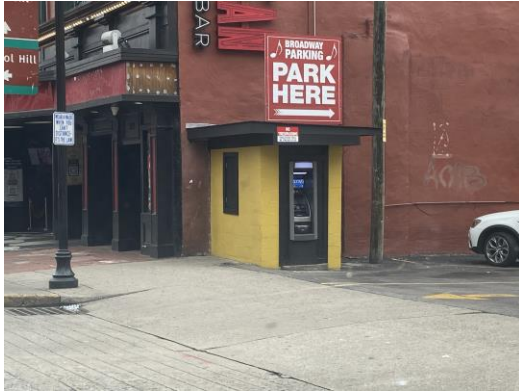
Figure 1: ATM in current location, relocated to side of structure, March 2021.

The ATM interpretation that the Commission decided upon in 2004 specifically allows for an ATM inside a building, where it would not be reviewed, or “in an alcove not on the primary facade.” The existing location does not meet the criteria of being inside the structure, nor in an alcove on a non-street facing façade. Installation of the ATM is not consistent with historic street-level facades and therefore does not meet section II for rehabilitation and III for New Construction.

Staff recommends disapproval of the ATM, finding that it does not meet Section II of the design guidelines for Rehabilitation, Section III of the design guidelines for New Construction or the intent of the Commission’s 2004 interpretation of ATMs. Staff recommends that the unpermitted ATM be removed from the site within 60 days from the Commission’s decision.

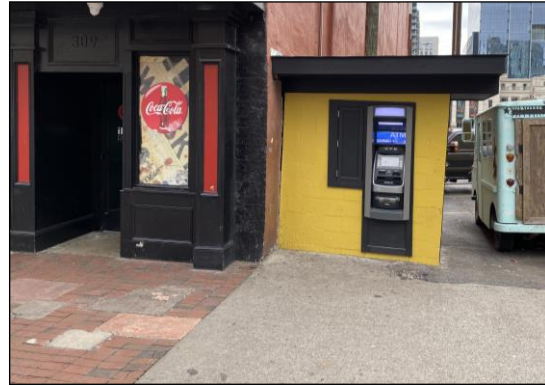
Background: 313 Broadway is a parking lot in the Broadway Historic Preservation Zoning Overlay. In November 2020, MHZC staff observed an ATM installed in the concrete block structure attached to the neighboring building. The date of construction for the structure itself is unknown, but it predates the overlay. Staff sent an abatement letter regarding the ATM on November 4th, 2020. On December 16, 2020, prior to the December MHZC meeting, the applicant informed staff that they would remove the ATM. This was not carried out, but rather in March 2021, staff observed that the ATM had been relocated to another side of the same structure.

Figure 2: ATM at 313 Broadway, November 2020.

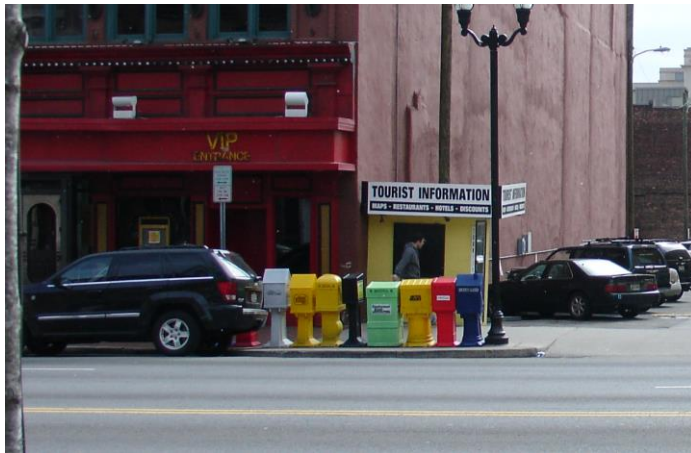
Figure 3: The subject structure in 2007.
