STAFF RECOMMENDATION
313 Broadway
December 16, 2020

Application: New Construction - Violation
District: Broadway Historic Preservation Zoning Overlay
Council District: 19
Base Zoning: DTC
Map and Parcel Number: 09306402300
Applicant: Troubadour Entertainment, LLC
Project Lead: Paul Hoffman; paul.hoffman@nashville.gov

<p>Description of Project: The applicant is seeking approval of construction that has already taken place without a Preservation Permit, the installation of an ATM on the Broadway façade.</p> <p>Recommendation Summary: Staff recommends disapproval of the ATM, finding that it does not meet Section II of the design guidelines for Rehabilitation, or Section III of the design guidelines for New Construction. Staff recommends that the unpermitted ATM be removed within 60 days of the Commission’s decision.</p>	<p>Attachments A: Photographs</p>
---	---

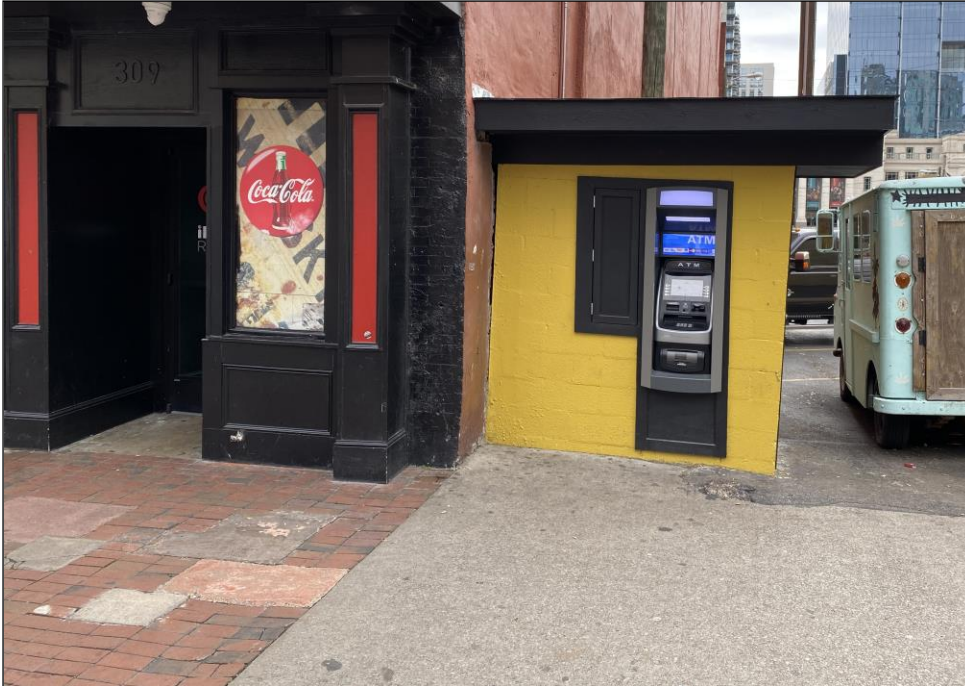
Figure 1: ATM at 313 Broadway.

Background: 313 Broadway is a parking lot in the Broadway Historic Preservation Zoning Overlay. In November 2020, MHZC staff observed an ATM installed in the concrete block structure attached to the neighboring building. The date of construction for the structure itself is unknown, but it predates the overlay. Staff sent an abatement letter regarding the ATM on November 4th, 2020.

Analysis and Findings: An ATM was installed on the Broadway façade in the existing non-contributing structure. No permits were applied for with MHZC or Metro Zoning.

Staff recommends disapproval of the ATM, finding that it does not meet Section II of the design guidelines for Rehabilitation, or Section III of the design guidelines for New Construction. Staff recommends that the unpermitted ATM be removed within 60 days from the Commission's decision.

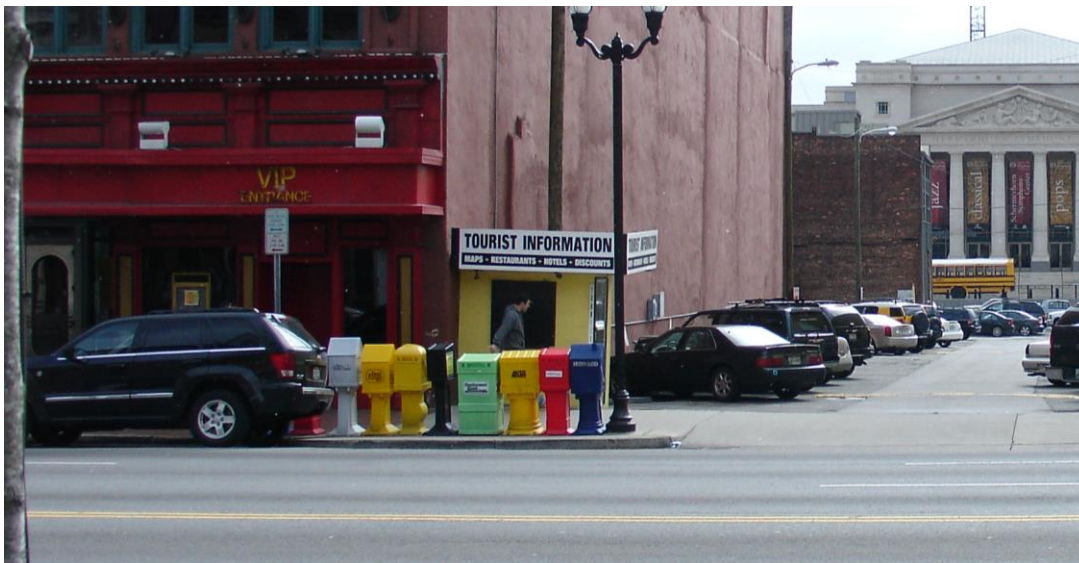
Figure 2: The subject structure in 2007.
