Operations Monitoring Report

Fourth Quarter FY24

**Thermal Engineering Group, Inc.
105 Hazel Path Court, Ste 2
Hendersonville, TN 37075**

July 31, 2024

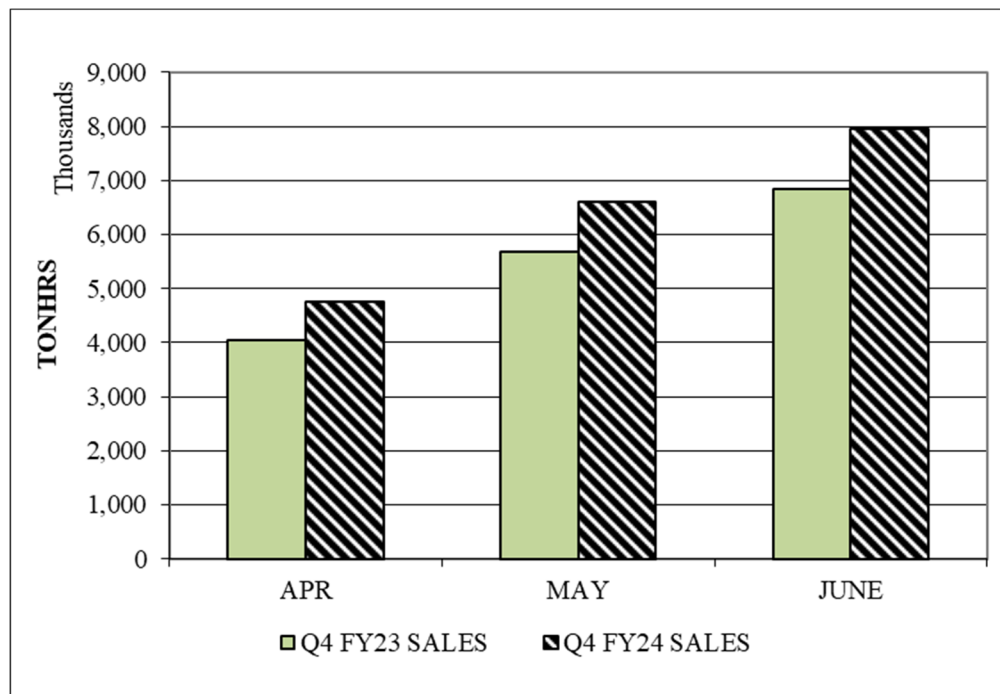
A comparison for the Fourth Quarter chilled water sales is shown in Figure 1. This data reflects a 16.6% increase in sales for the current quarter over the same quarter of the previous fiscal year. Sales likewise increased for FY24 compared to FY23 by 2.8%. These increases in chilled water sales follow an increase in the number of cooling degree days of 38.9% for the Fourth Quarter and 10.2% for the fiscal year.

Figure 1. Chilled Water Sales Comparison

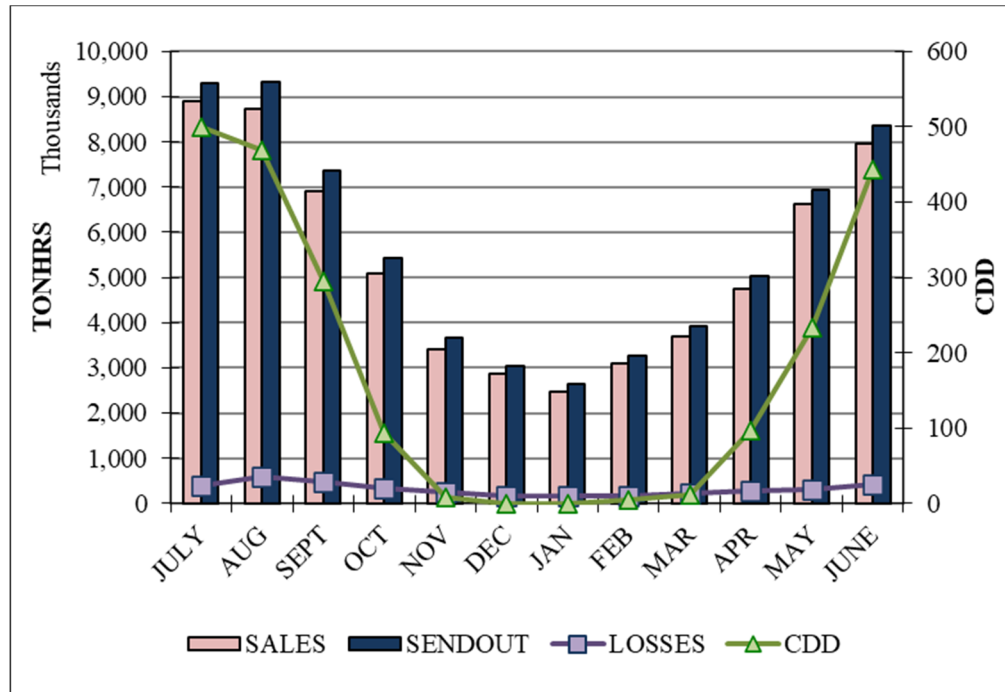
Figure 2 shows the chilled water sales, sendout and losses for the previous twelve months. The losses on this figure are defined as the difference in tonhrs per month

between the recorded sendout and sales values and represent the total energy loss for chilled water in the EDS.

Figure 2. Chilled Water Sales, Sendout, Losses and CDD for the Previous Twelve Months

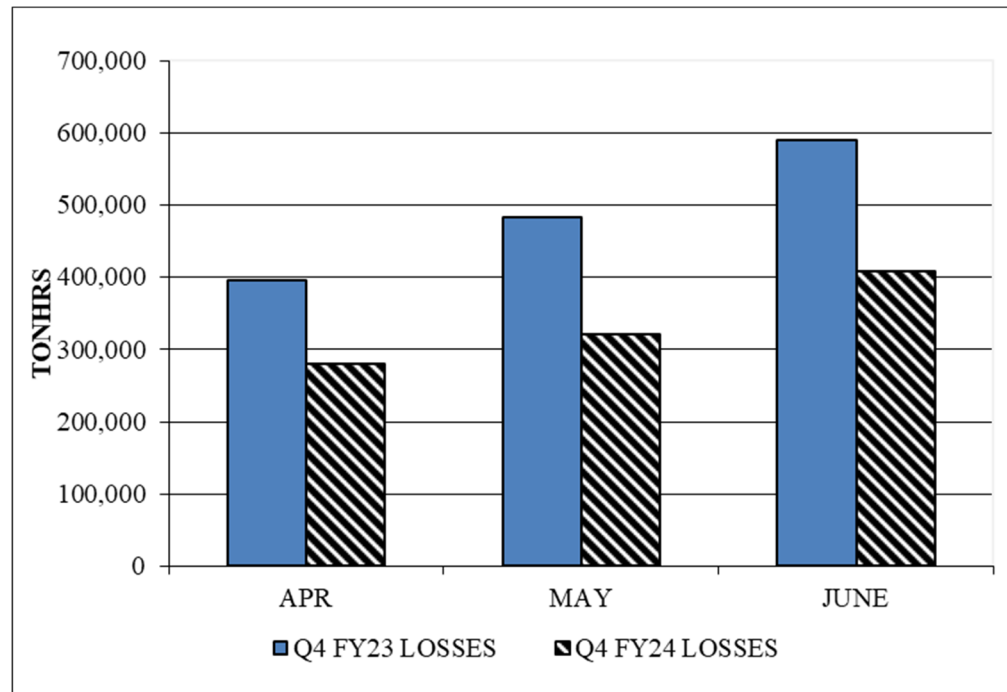
A comparison of the total chilled water energy losses in the EDS for the Fourth Quarter FY24 is shown in Figure 3. These losses are the difference in chilled water sendout and sales and may reflect differences in the meter accuracy between the EGF sendout meter and the customer meters. Losses are typically lower when chilled water sales are low. The losses decreased 31.2% over the previous Fourth Quarter due in part to a meter error at one of the customers in the Fourth Quarter FY23. For FY24, the total system losses decreased by 8.5%.

Figure 3. Chilled Water System Loss Comparison

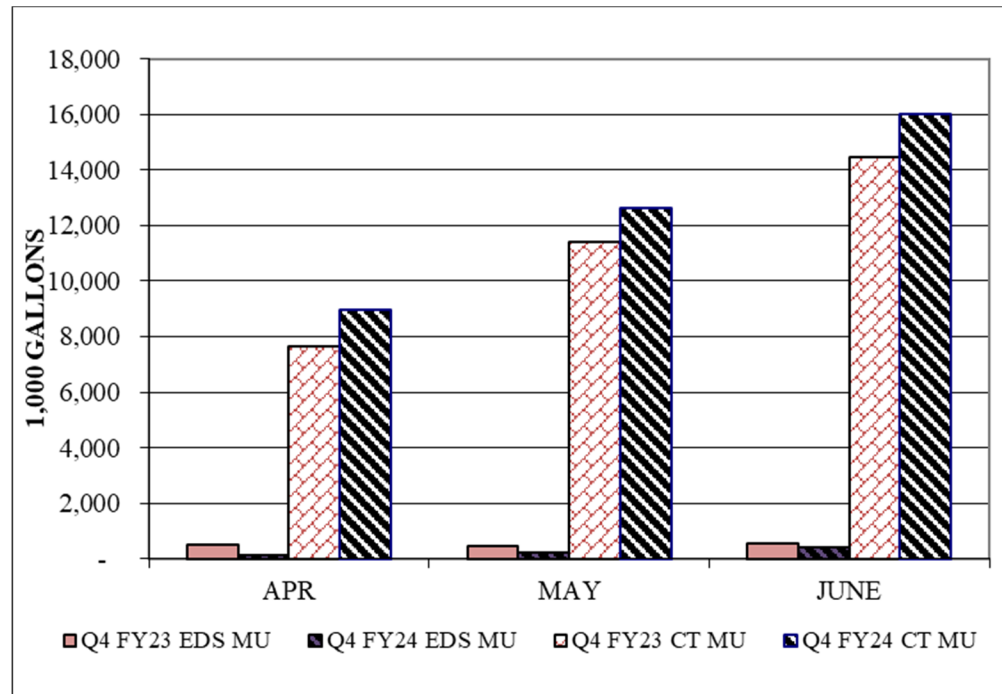
The make-up to the cooling towers increased 12.2% over the previous Fourth Quarter. The water usage in the cooling towers is typically proportional to the production of chilled water and should vary with chilled water sales. The total chiller plant water use increased 9.7% over the Fourth Quarter. The overall city water make-up comparison for the chilled water system Fourth Quarter is shown in Figure 4.

Figure 4. Chilled Water System City Water Usage Comparison

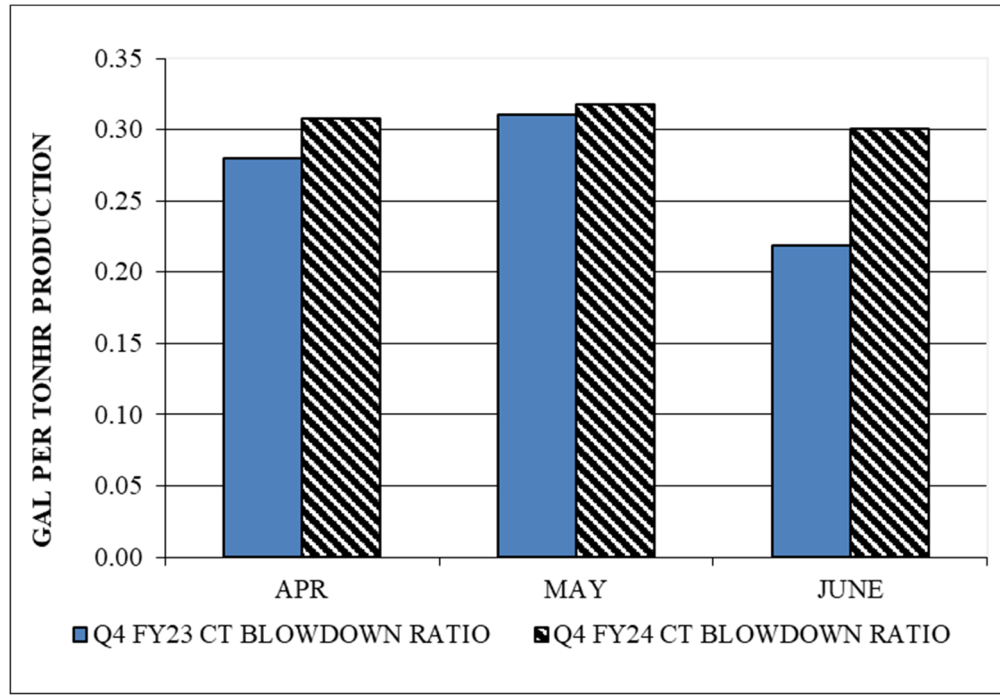
plant water usage. The data shown in Figure 5 indicates a more consistent ratio in the Fourth Quarter. However, Figure 7 shows the chilled water-water metric for June was not met.

Figure 5. Cooling Tower Blowdown Ratio Comparison

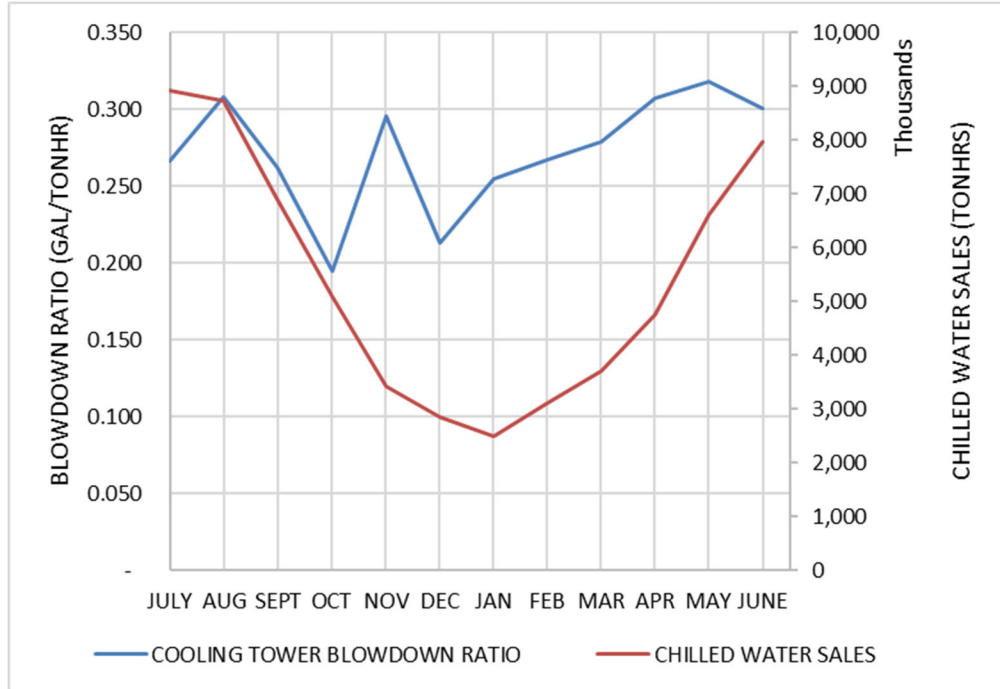
For FY24, the metric decreased 2.5%. In addition, the amount of cooling tower blowdown decreased 1.4%. Figure 5A provides a graphical representation of the metric and chilled water sales for the fiscal year. A correlation between these two values should exist revealing some level of proportionality between the sales and the metric. Except for the potential anomaly in November, the blowdown ratio appears to qualitatively track the chilled water sales although a consistent proportionality is not defined. TEG and CES will continue to monitor this metric through FY25.

Figure 5A. Cooling Tower Blowdown Ratio for FY24

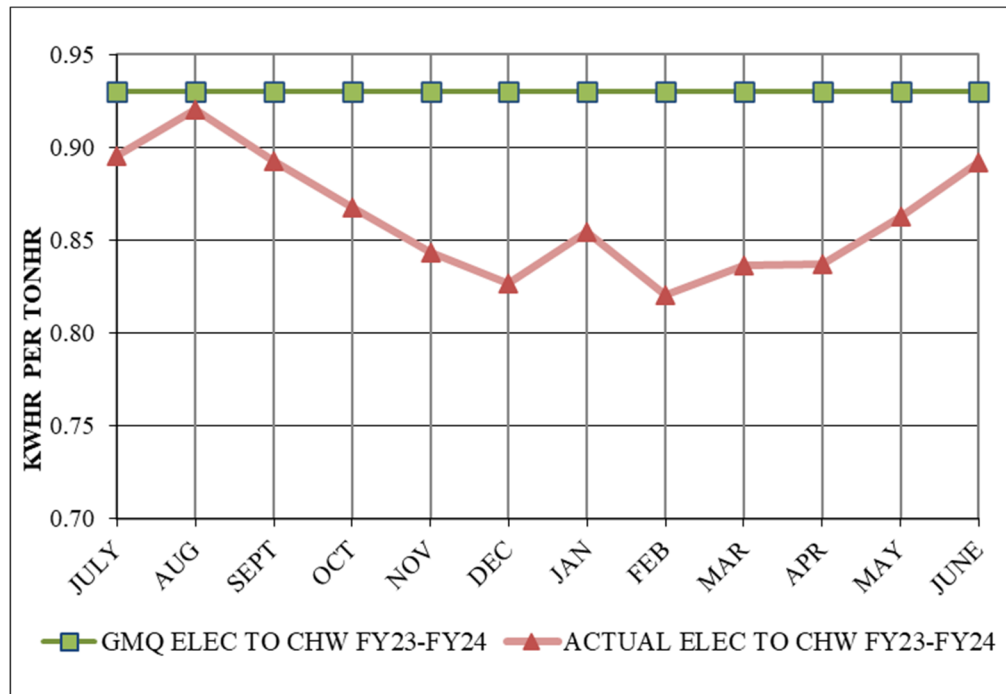
The performance of the chilled water portion of the EGF is presented in the following two charts, Figures 6 and 7, for the previous twelve months. The System Performance Guarantee levels as described in Amendment 2 of the ARMA were consistently achieved for the chilled water-electric, but they failed to meet the chilled water-water metric in June. The chilled water-electric guarantee has also been met for the previous twelve months. The chilled water-water guarantee was met each month during the quarter.

Figure 6. Chiller Plant Electric Performance Guarantee Comparison for the Previous Twelve Months

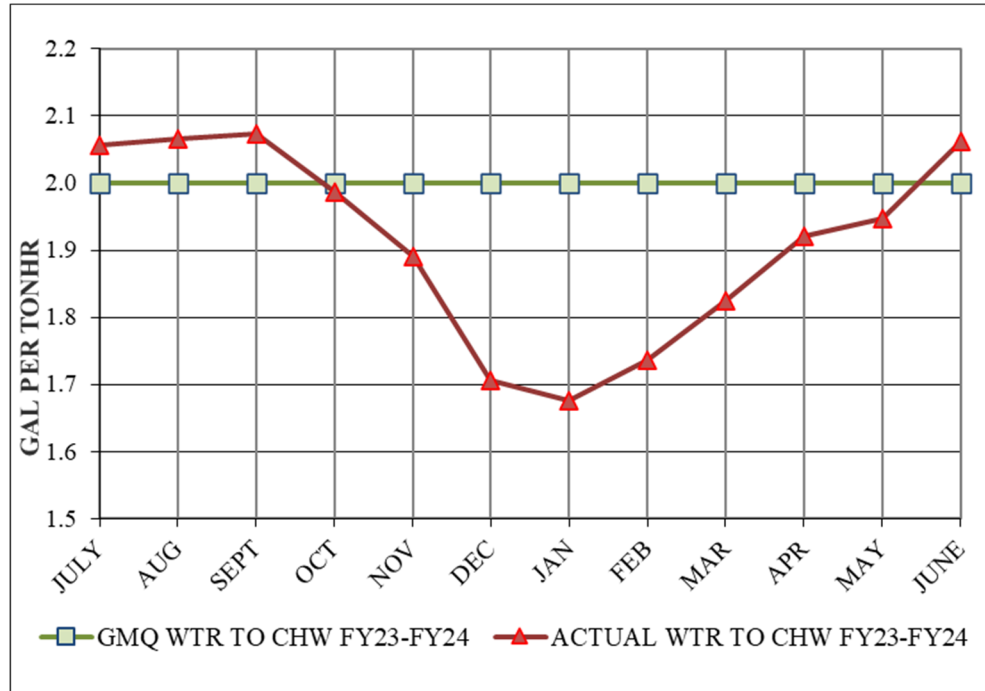
Figure 7. Chiller Plant Water Consumption Performance Guarantee Comparison for the Previous Twelve Months

Although the average value of the chilled water-water metric decreased 4.7% from FY23 to FY24, reflecting an increased efficiency, Figure 7 indicates an inability to meet the value during the summer months. This phenomenon may be caused by the variation in cooling tower blowdown noted in Figure 5A. The remaining influences in the water usage are cooling tower evaporation and EDS make-up. The EDS make-up has been consistently low for the fiscal year, and the cooling tower evaporation should be proportional to the chilled water sales. Additional investigation into this issue is warranted.

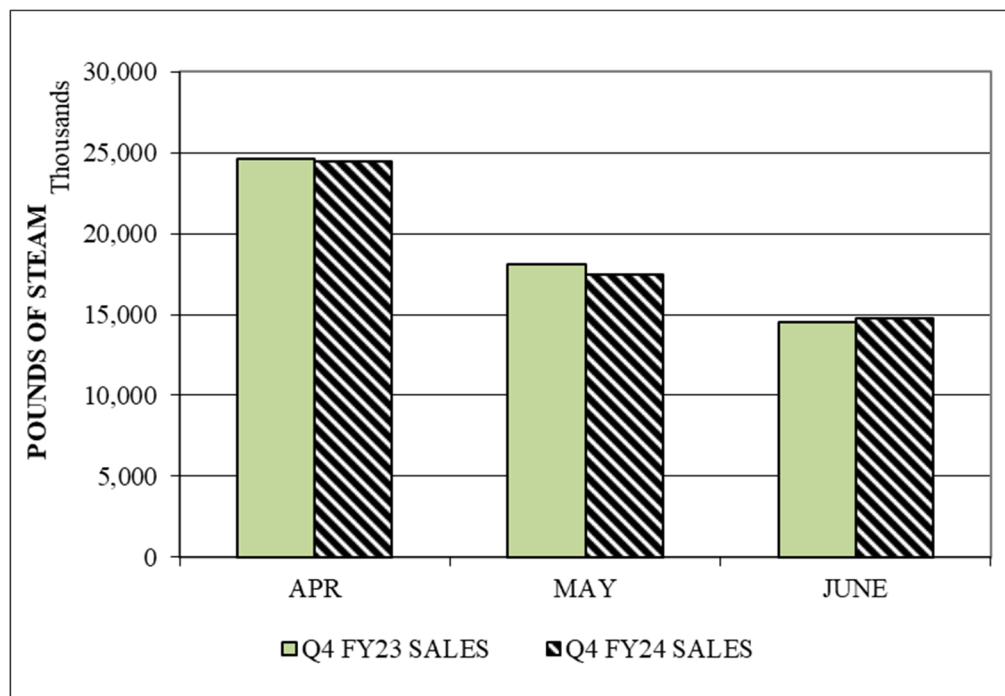
The steam sendout decreased 1.7% over the previous Fourth Quarter (FY23), and the decreased marginally. However, the heating degree days during the quarter decreased 8.8% due largely to a milder than normal quarter. The steam system losses increased 10.6% due largely to a decrease in sales. The relative amount of condensate return decreased 3.1% during the quarter. The peak steam demand for the current quarter was 85,937 pph, which reflects a 19.2% increase in the peak steam production over the previous Fourth Quarter. A comparison for the Fourth Quarter steam sales is shown in Figure 8.

Figure 8. Steam Sales Comparison

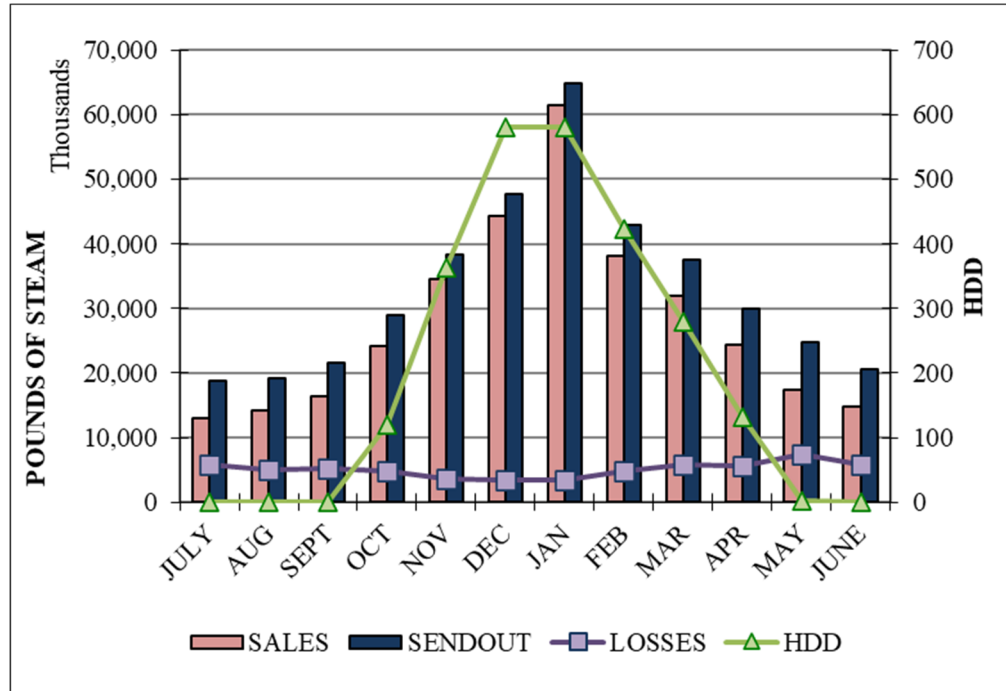
Figure 9 shows the steam sales, sendout and losses for the previous twelve months. The losses on this figure are defined as the difference in pounds per month between the recorded sendout and sales values and represent the total mass loss in the EDS between the EGF and the customer meters.

Figure 9. Steam Sales, Sendout, Losses and HDD for the Previous Twelve Months

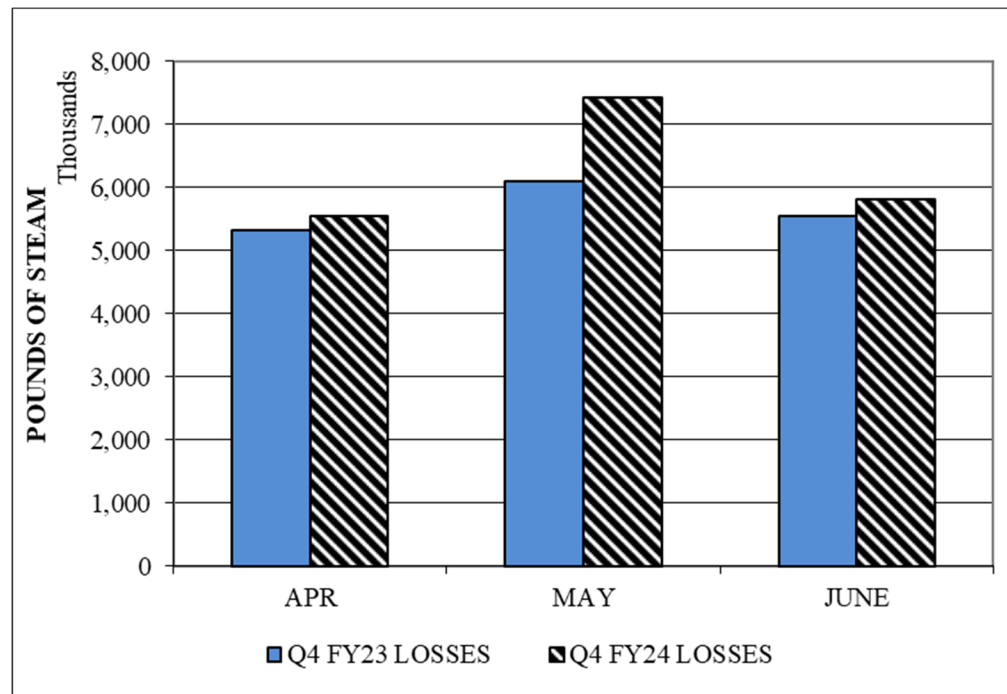
A comparison of the total steam mass losses in the EDS for the Fourth Quarter is shown in Figure 10. The mass loss is caused by the heat loss in the EDS between the EGF and the customer meters, resulting in a mass loss at steam traps. Faulty traps, steam leaks or meter error could also be a contributing cause of these losses. Whenever steam sales are low, steam losses are typically higher, which is reflected in the values in Figure 10.

The steam losses for FY24 were 8.0% higher than in FY23. This increase may be due to decrease in steam sales; however, the data for May (Figure 10) shows a significant increase in the losses compared to April and June. Further investigation into this phenomenon may be required.

Figure 10. Steam System Losses

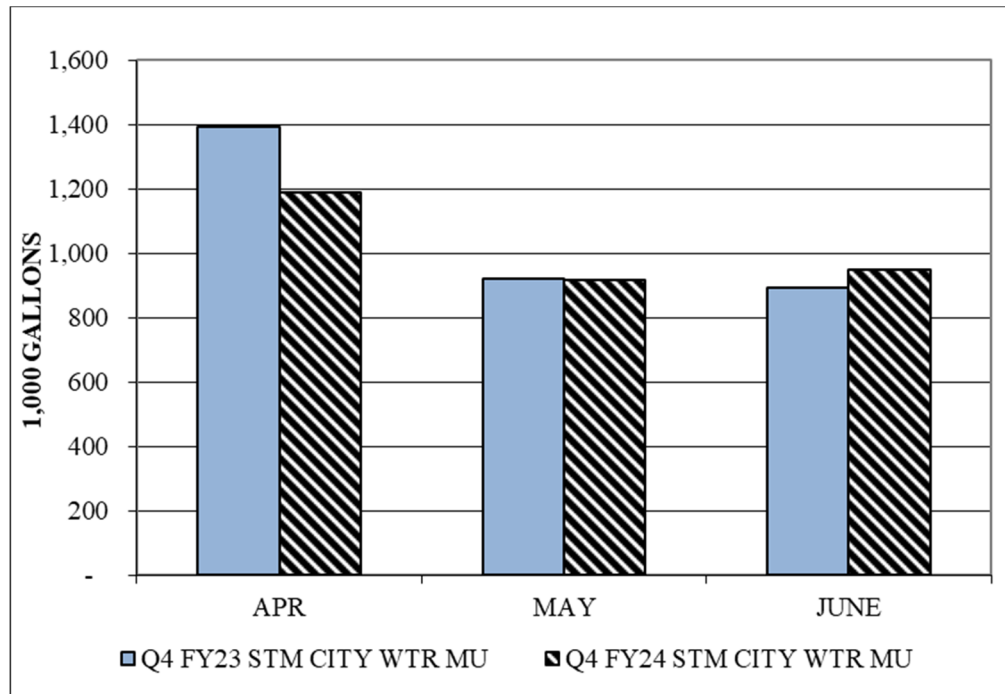
The amount of city water make-up (MU) to the steam system consists of the loss in mass between the EGF and the customers, in the condensate return from the customers to the EGF and losses at the EGF. The amount of make-up to the steam system decreased 4.6% over the Fourth Quarter FY23. The corresponding data for steam system make-up is shown in the comparison of Fourth Quarter data in Figure 11.

Figure 11. Steam System City Water Make-up Comparison

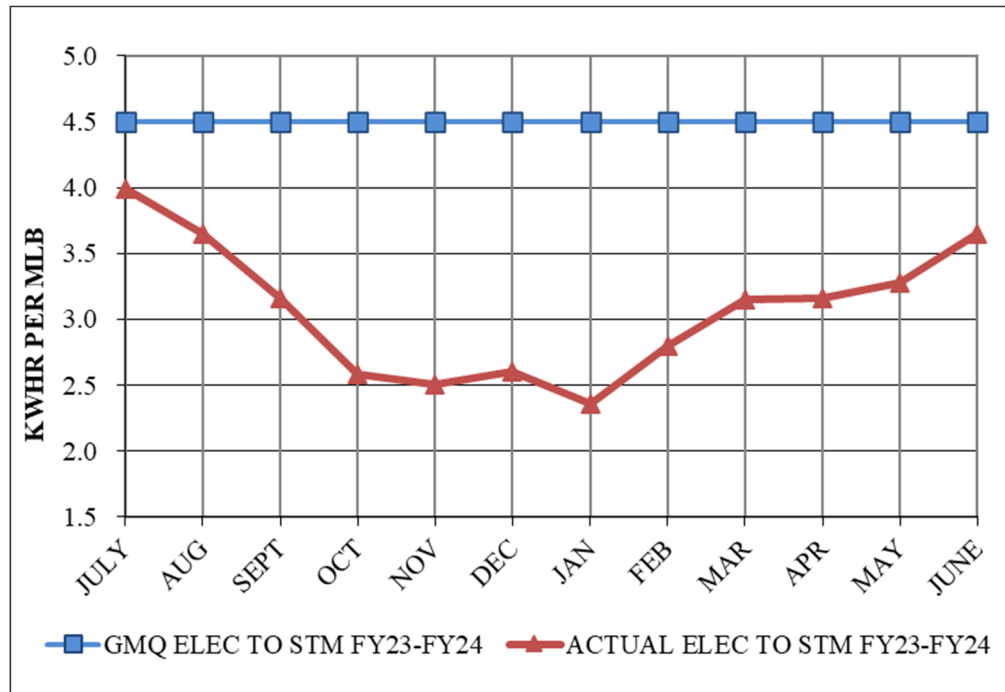
The performance of the steam system of the EGF is presented in the following three charts, Figures 12, 13 and 14. The steam electric conversion factor was met each month of the quarter. The steam plant electric consumption for the current quarter was 5.8% higher in FY24 than in FY23. The steam-electric metric increased 5.2% over the previous Fourth Quarter. The monthly steam-to-electric conversion factors, along with the guaranteed values, are shown in Figure 12.

Figure 12. Steam Plant Electric Performance Guarantee for the Previous Twelve Months

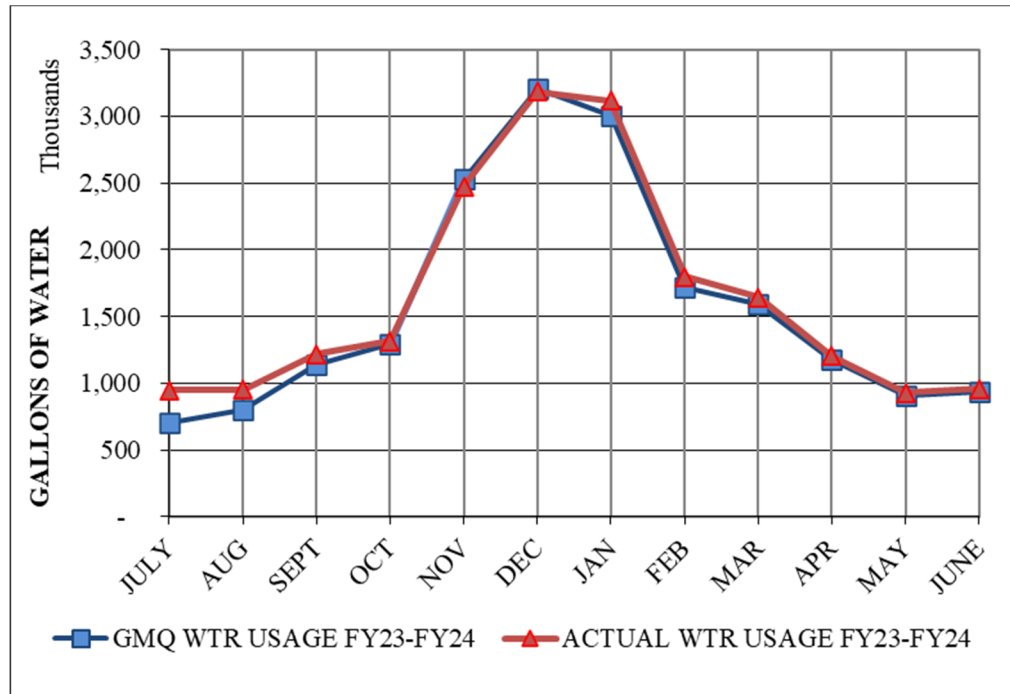
The steam water conversion factor exceeded the guaranteed values for each month during the quarter although the actual values were close in value to the actuals. CES and TEG continue to monitor the performance of the EGF as CES makes efforts to improve the DES performance. The guaranteed steam-water performance value is based on an equation which incorporates the amount of steam sendout and condensate return and did not change with the adoption of the new performance values in Amendment 2. CES has verified the accuracy of the meter readings and continues to review the operation. The steam water conversion factors are shown in Figure 13.

Figure 13. Steam Plant Water Performance Guarantee for the Previous Twelve Months

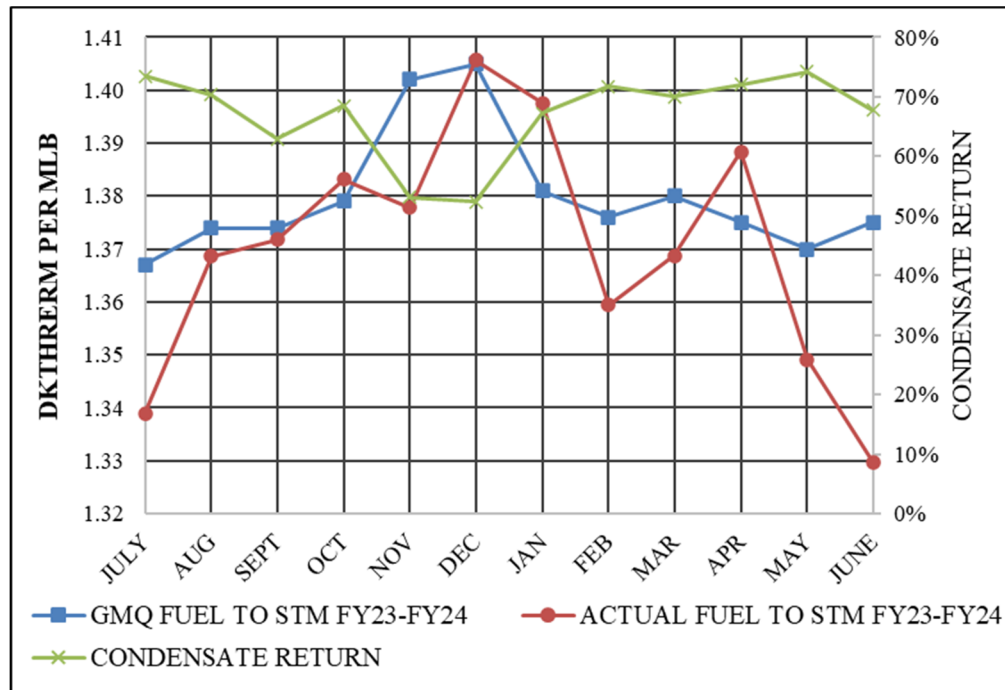
The steam fuel conversion factor met the guaranteed values for May and June. The fuel consumption per unit of steam sendout decreased marginally over the previous Fourth Quarter and have remained consistent for the fiscal year. The relative amount of condensate return is shown on this graph to reflect the influence that the condensate return has on the plant efficiency. Although the performance level for this metric changed with the adoption of Amendment 2, the equation used to calculate the value relies heavily on readings from the condensate return and steam sendout meters. Figure 14 shows the performance of the conversion factors for the previous twelve months.

Figure 14. Steam Plant Fuel Performance Guarantee for the Previous Twelve Months

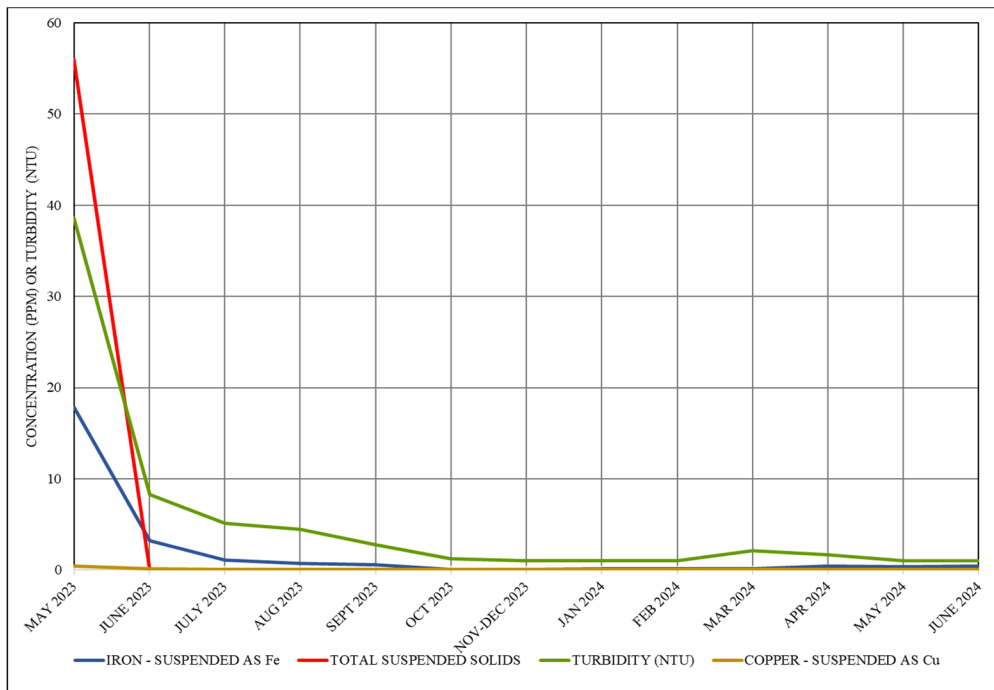
- Although the side stream filter has significantly reduced the amount of suspended solids in the chilled water and improved the turbidity of the system, the turbidity and iron levels have increased slightly in March and April. These results may be indicative of customers re-opening portions of their in-building systems which have been isolated during the winter months.

- Figure 15 shows the results of several measured metrics within the chilled water system which may be affected by the side stream filter.

Figure 15. Chilled Water Composition Downstream of Side Stream Filter
