**METROPOLITAN GOVERNMENT OF NASHVILLE AND DAVIDSON COUNTY**

**STAFF RECOMMENDATION**  
**170-176 Second Avenue North**  
**July 21, 2021**

**Application:** Demolition  
**District:** Second Avenue Historic Preservation Zoning Overlay  
**Council District:** 19  
**Base Zoning:** DTC  
**Map and Parcel Number:** 09306206600 and 09302401900  
**Applicant:** Callen Trust, property owner  
**Project Lead:** Robin Zeigler, robin.zeigler@nashville.gov

**Description of Project:** The property owner requests to demolish four historic buildings in the Second Avenue Historic Preservation Zoning Overlay, damaged in the 2020 Christmas morning explosion.

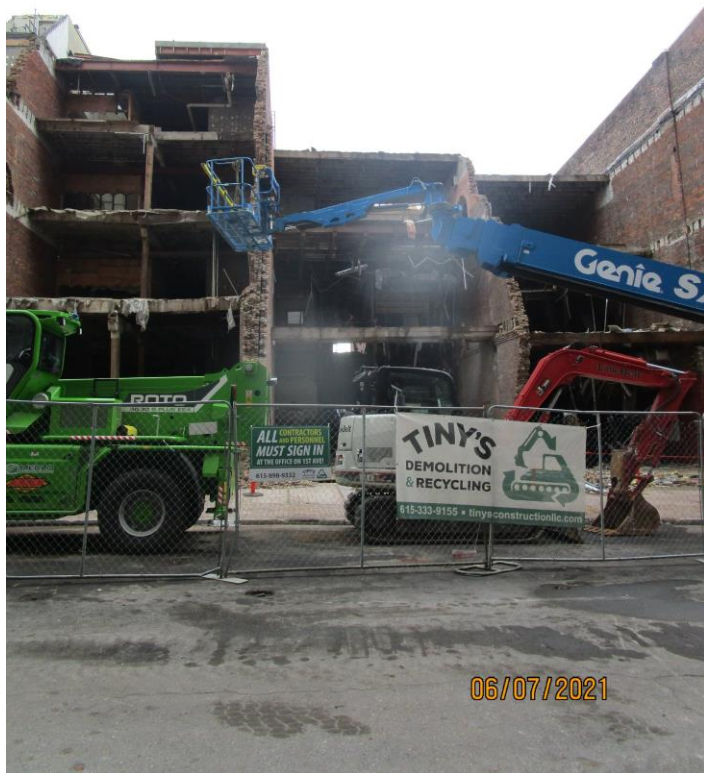
Building 172 is the short building that had the courtyard located at the rear of the building. An overview of the front of the building can be seen in Photographs June 7, 2021, photographs 3 and 8.

**Photograph 3: View of Building 172.**

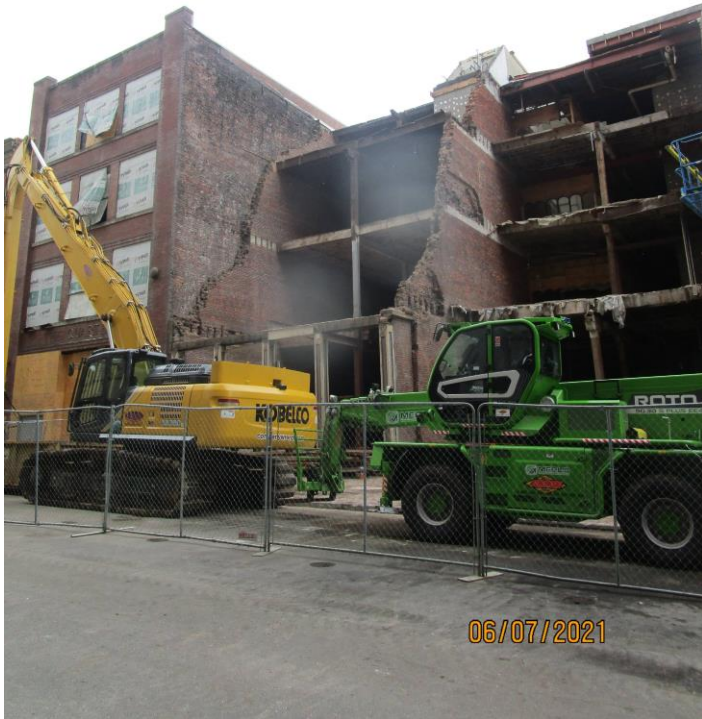
**Photograph 5: View of Building 176.**

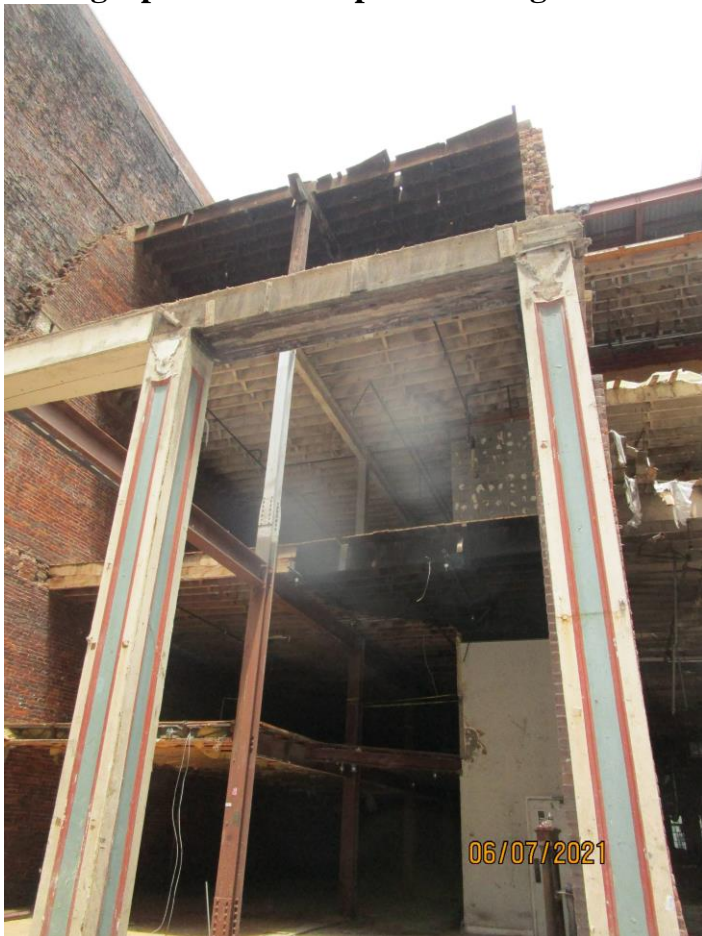
**Photograph 6: Close-up of Building 176.**

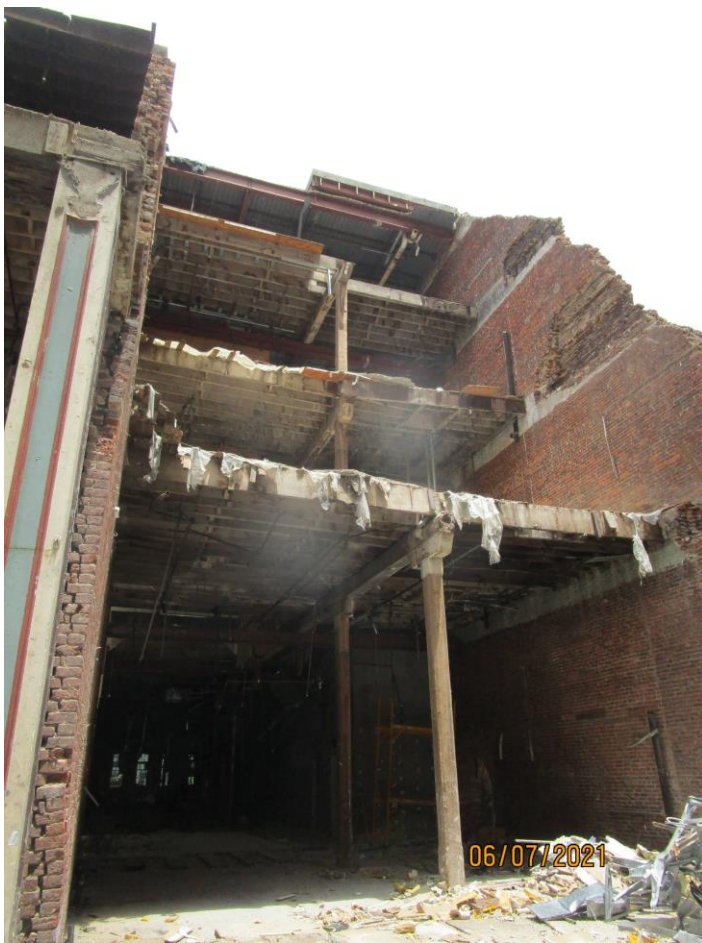
The front elevation of Building 174 can be observed in Photographs June 7, 2021, photographs 4 and 7.

**Photograph 7: Close-up of Building 174.**

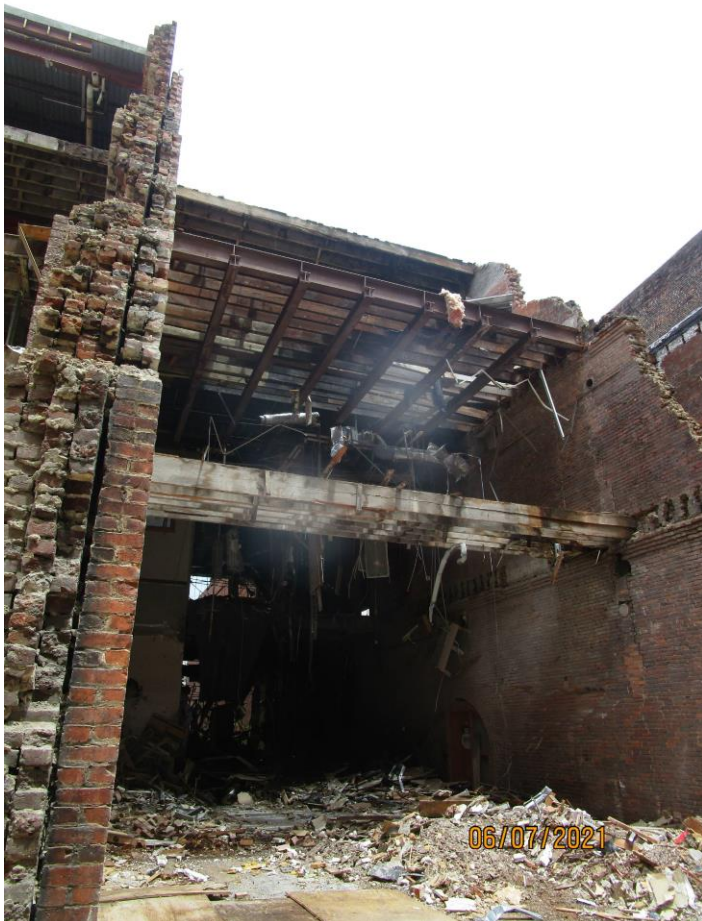
**Photograph 8: Close-up of Building 172.**

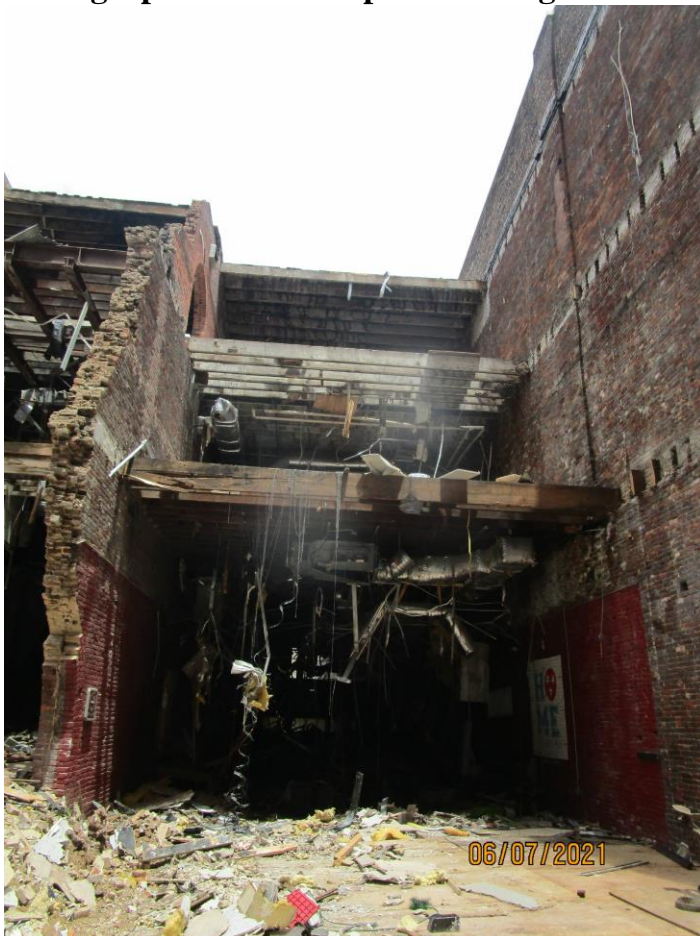
The front face of Building 170 from Second Avenue North can be observed in Photographs June 7, 2021, photographs 2 and 11. As can be seen in these photographs, the intensity of the blast caused the floor and roof framing to be stepped-back dramatically to remove all the broken and splintered wood members.

**Photograph 11: Close-up of Building 170.**

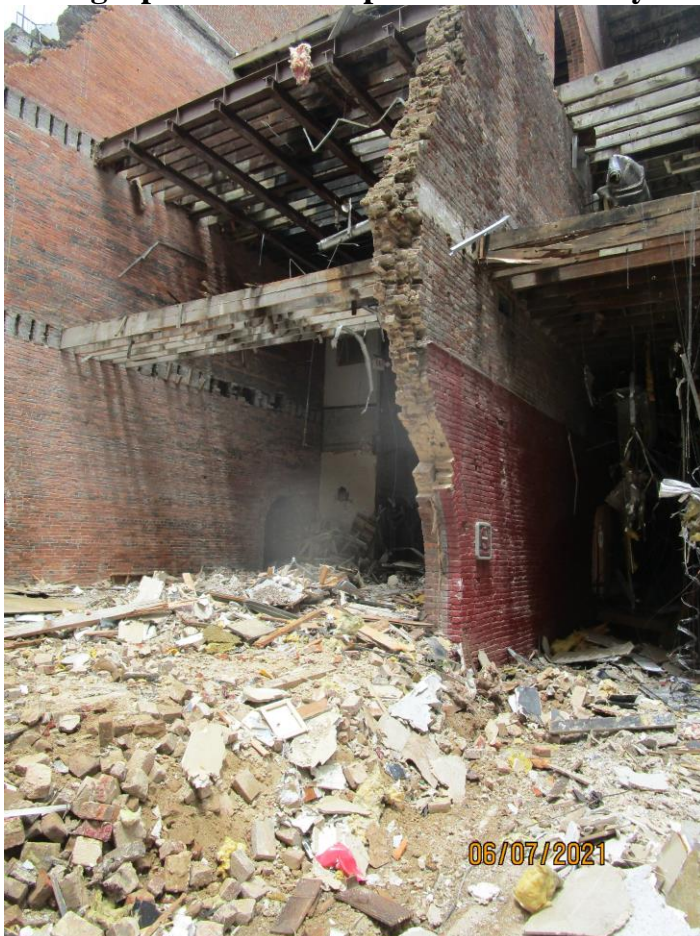
**Photograph 12: Close-up of failed masonry arch at Buildings 170/172.**

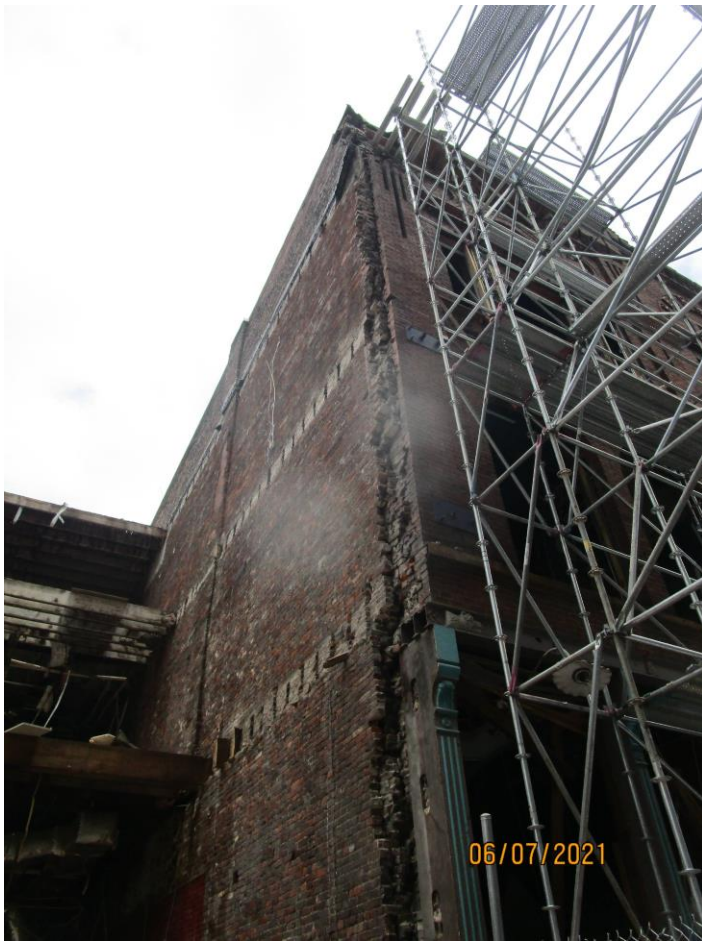
**Photograph 13: Close-up of wall at Buildings 168/170.**

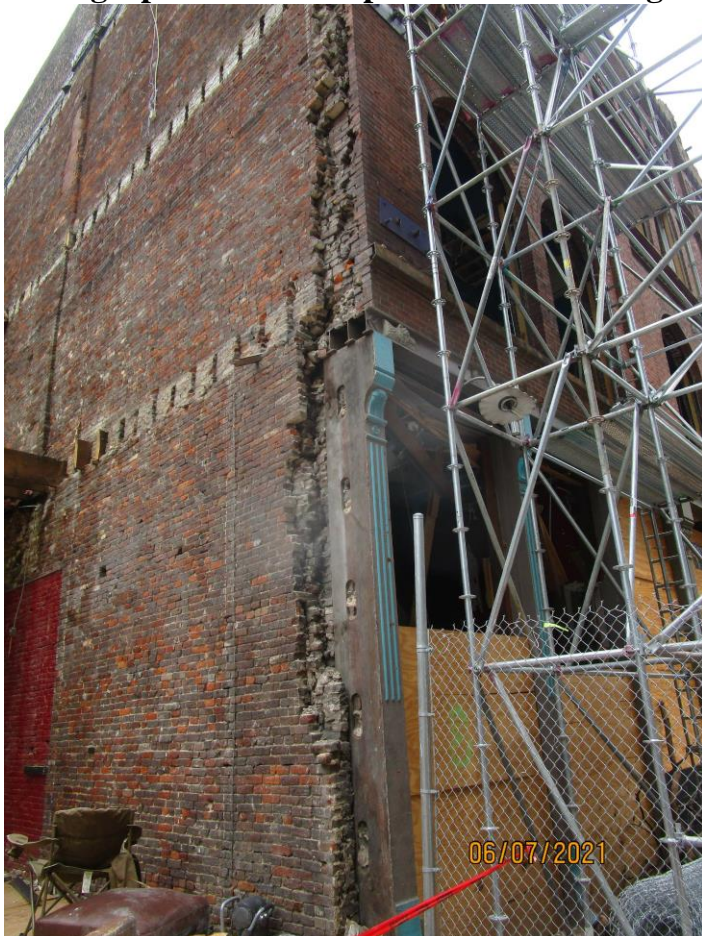
**Photograph 14: Close-up of wall at Buildings 168/170.**

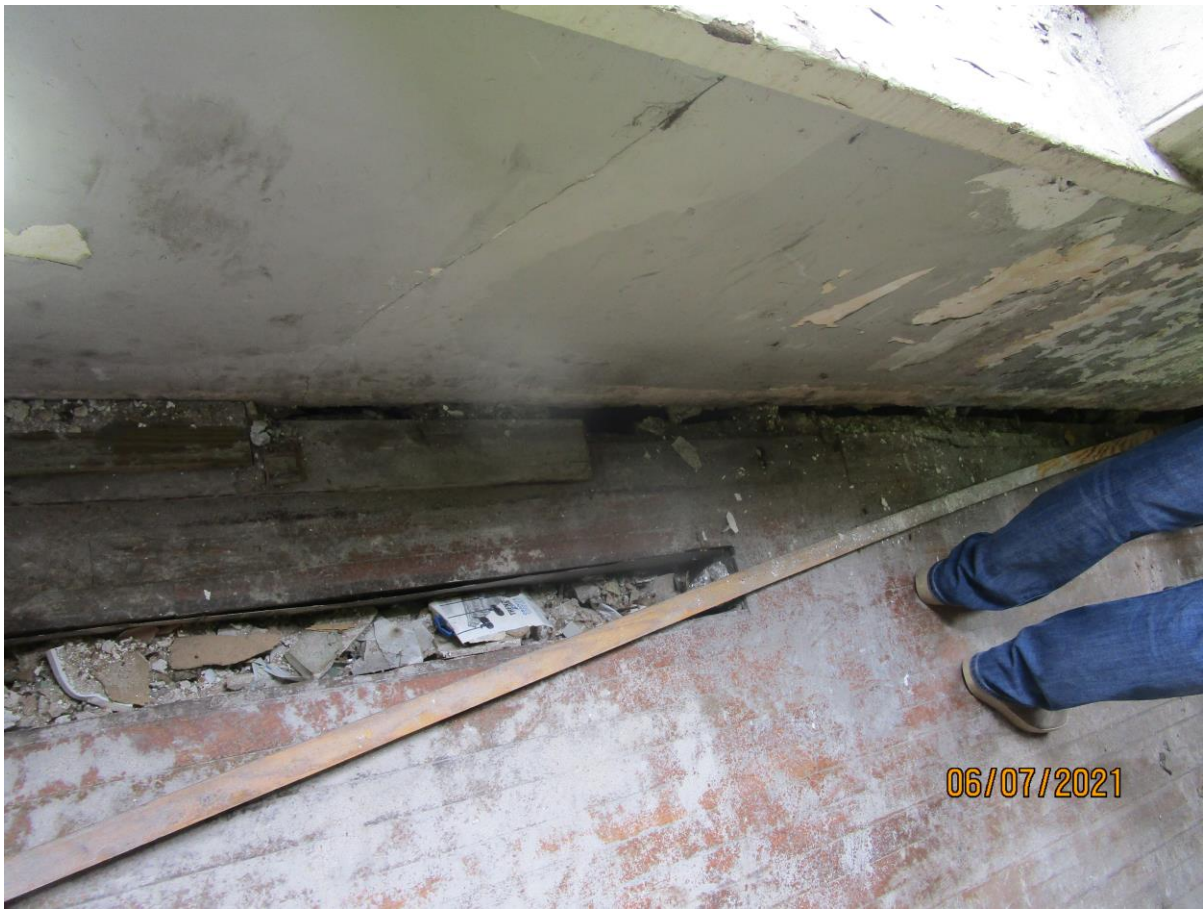
**Photograph 15: Rear wall at main floor of Building 176.**

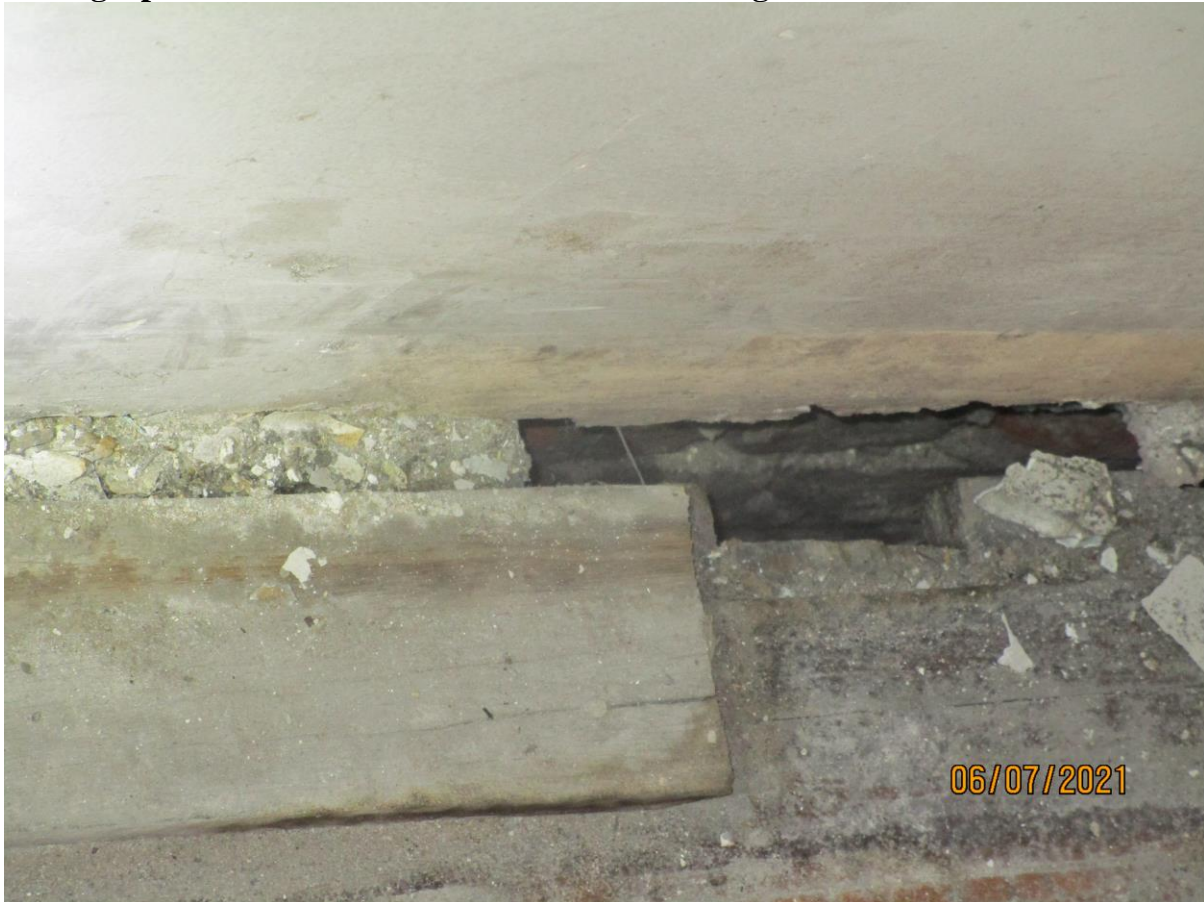
**Photograph 16: Rear wall at main floor of Building 176.**

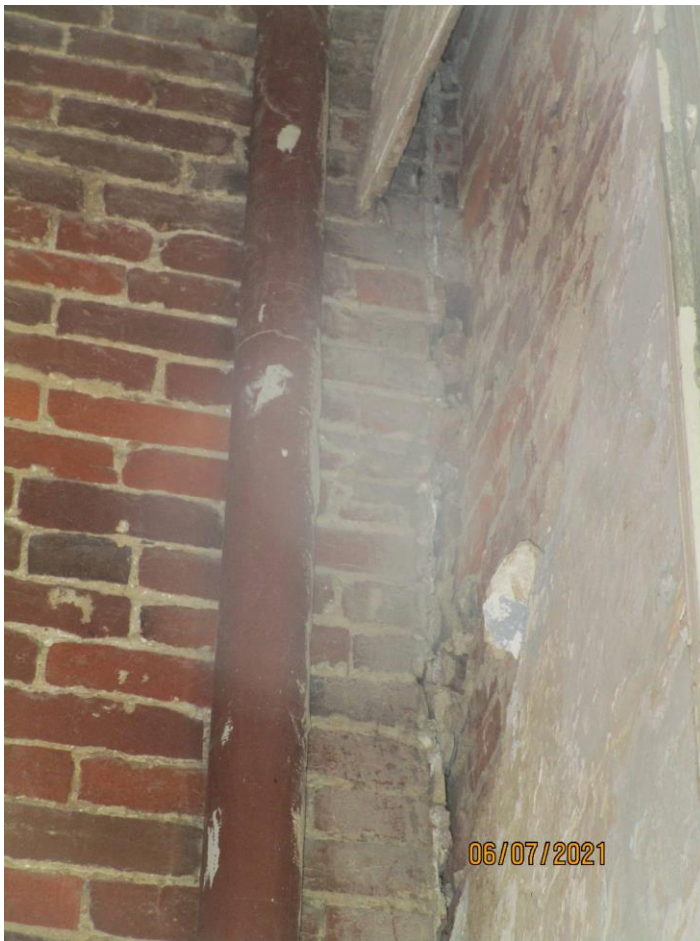
**Photograph 17: Intersection of rear wall and left-side wall of Building 176.**

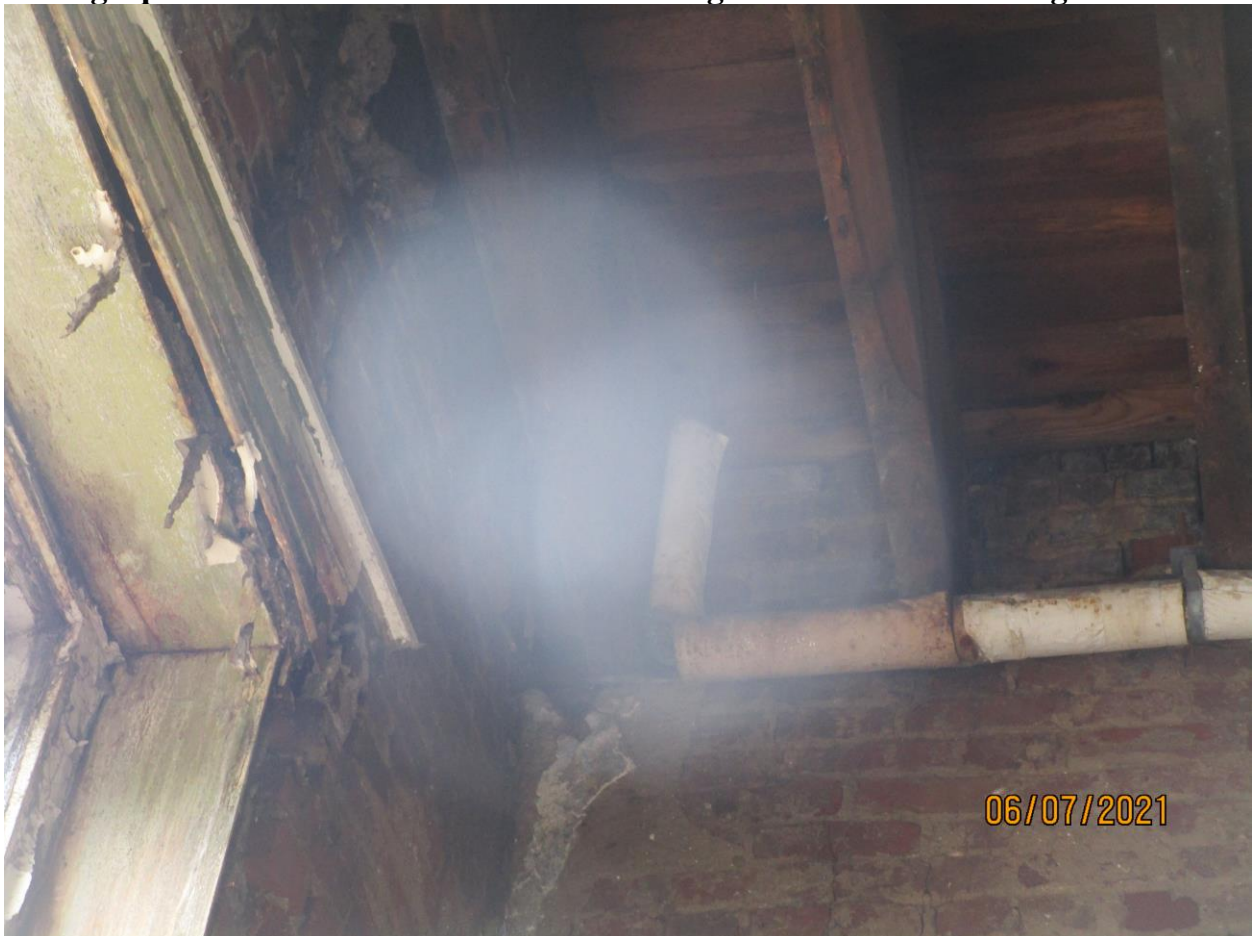
**Photograph 18: Intersection of rear wall and right-side wall of Building 176.**

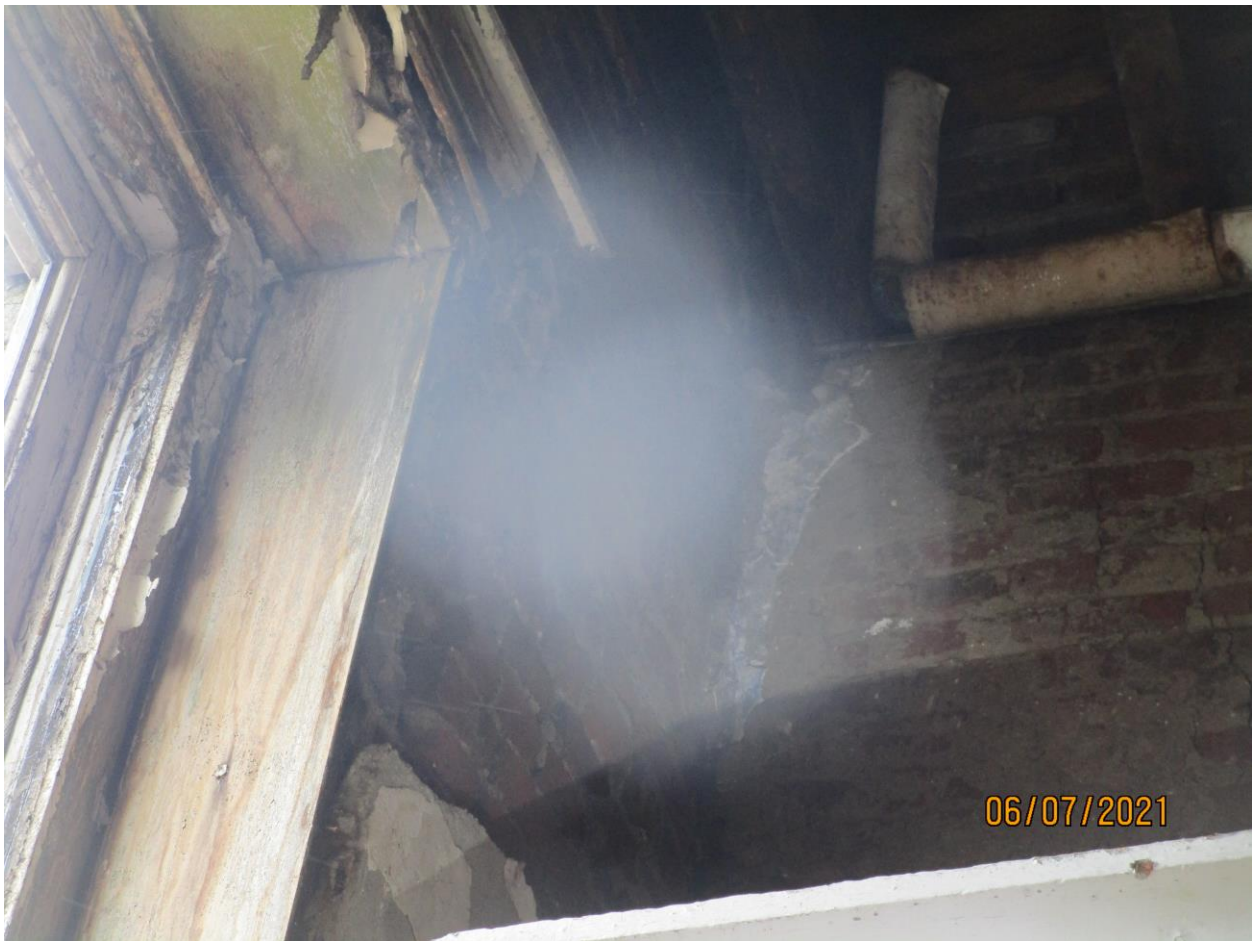
**Photograph 19: Intersection of rear wall and right-side wall of Building 176.**

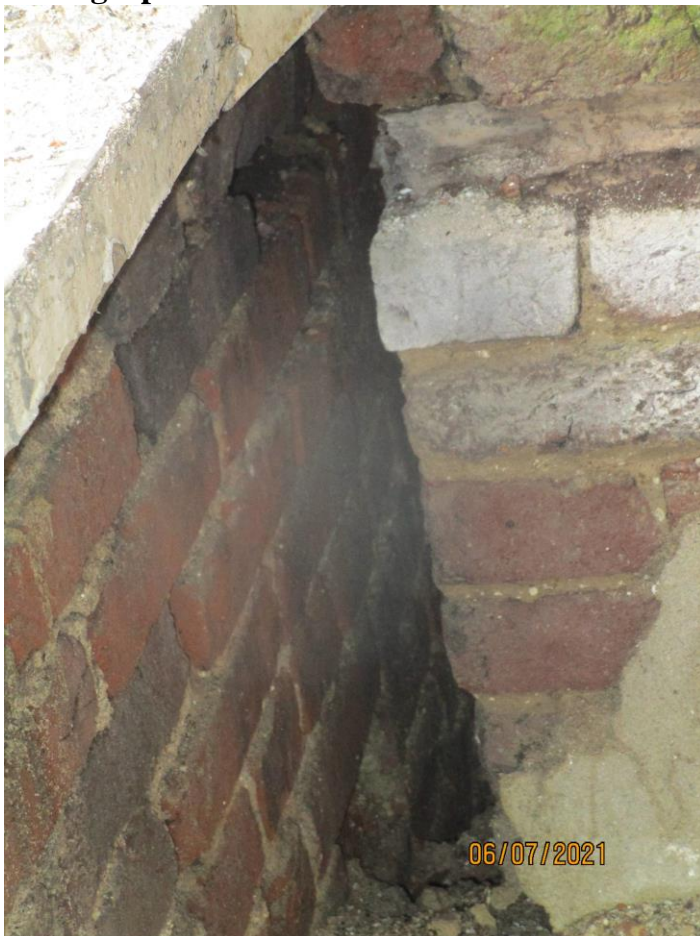
**Photograph 20: Intersection of rear wall and right-side wall of Building 176.**

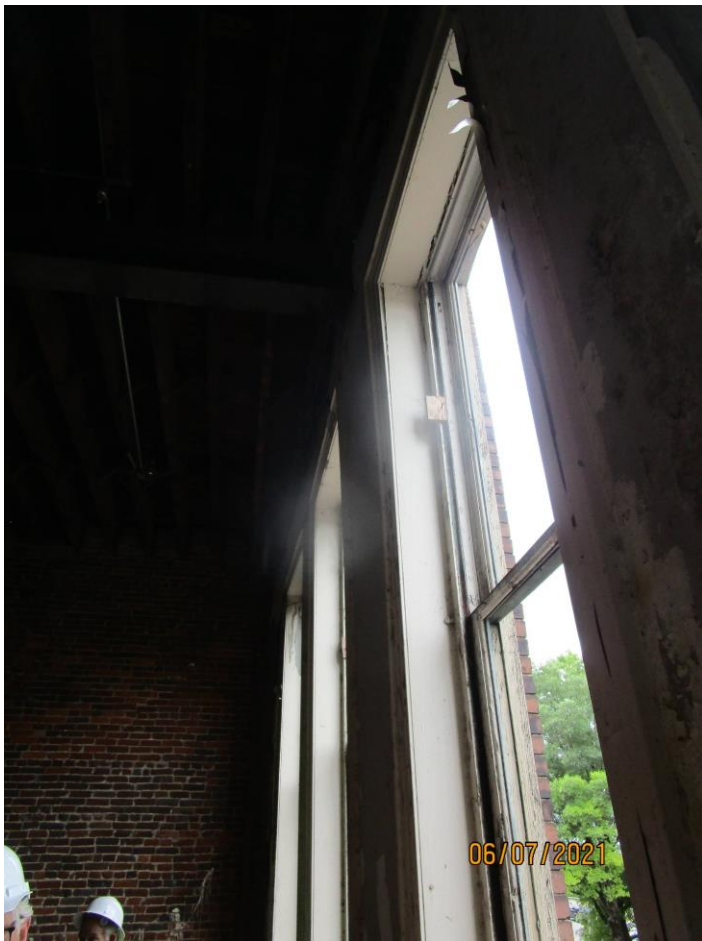
**Photograph 21: View of second floor/rear wall of Building 176.**

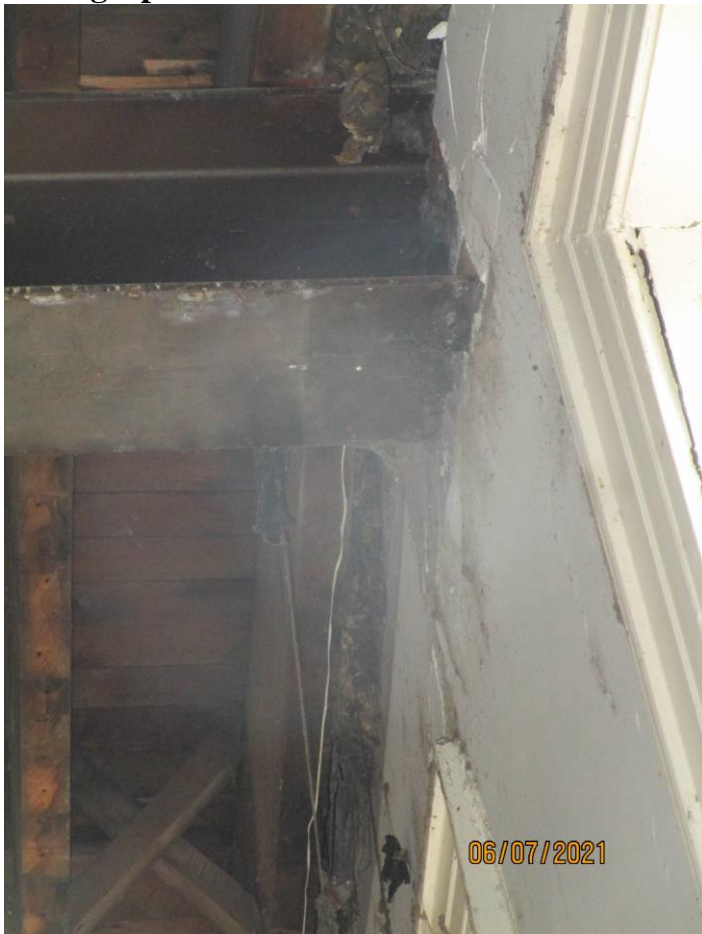
**Photograph 22: View of second floor/rear wall of Building 176.**

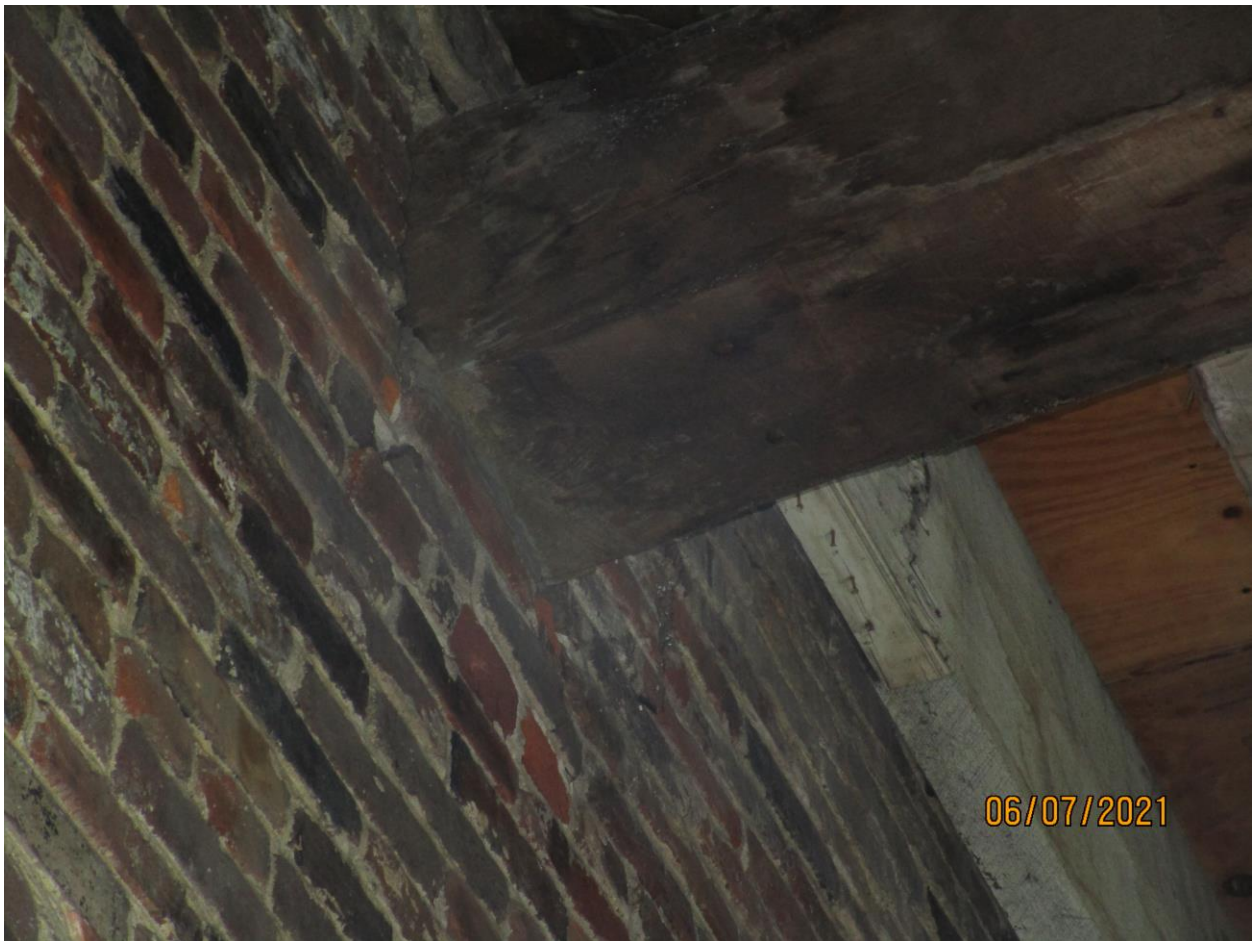
The front face of Building 176 can be seen in Photographs June 21, 2021, photographs 5 and 6. The rear wall of this building is extremely precarious. As I stated during the June 7 review, shoring should have immediately taken place to prevent collapse. This wall system has moved approximately 6" to 8" laterally. Open joints common to interior walls separating Building 176 from Building 174 can be seen in Photograph June 7, 2021 photograph 20, which shows its precarious condition. The floor joists patina located on the left and right sidewalls indicated that the building walls have moved (Photographs June 7, 2021, photographs 23, 24, and 25).

**Photograph 23: View of second floor/rear wall of Building 176.**

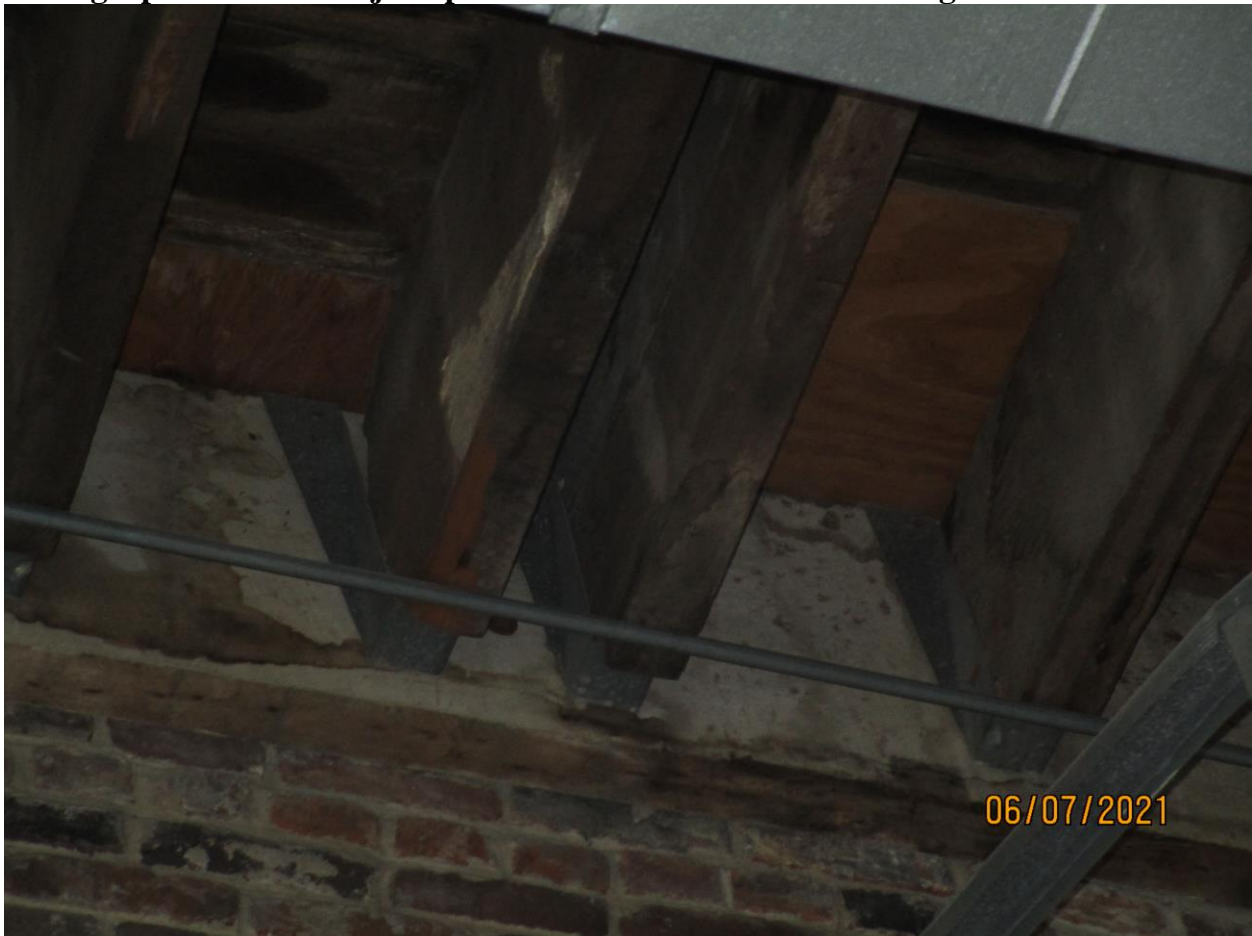
**Photograph 24: View of joist pockets at second floor of Building 176.**

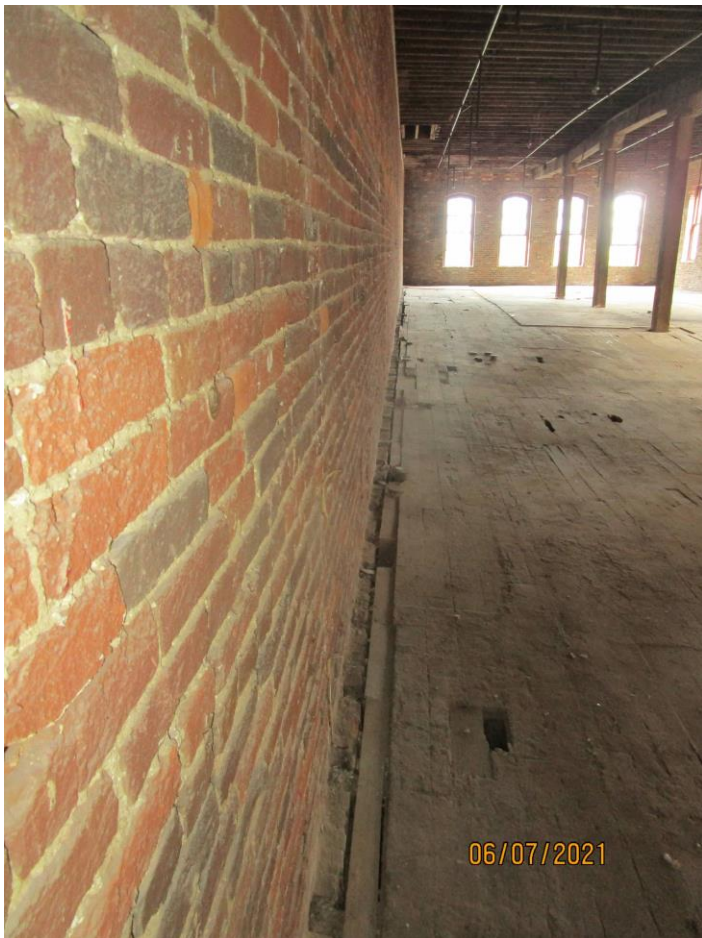
**Photograph 25: Left-side wall of main floor of Building 174.**

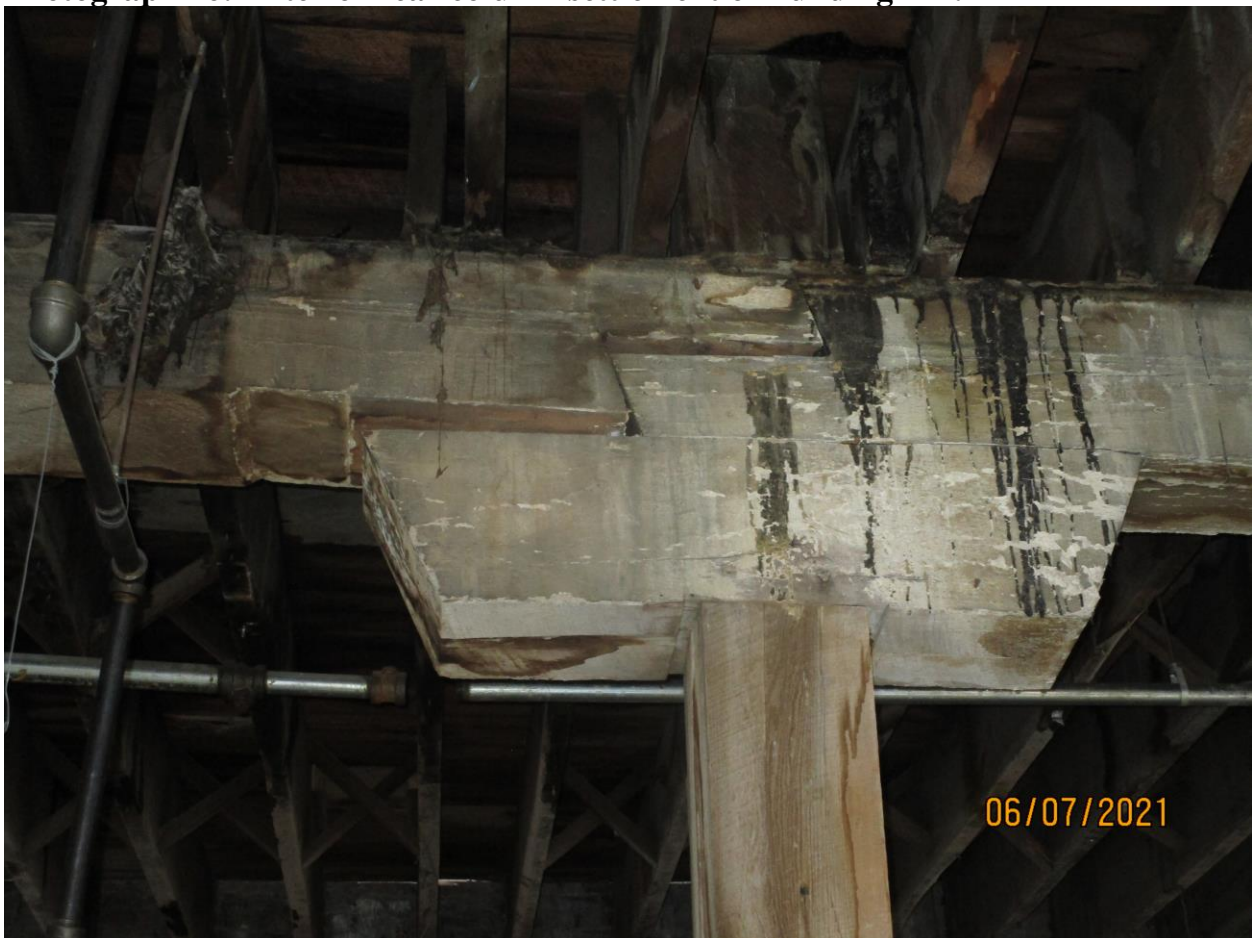
Building 174 was reviewed on June 7, 2021. It was found that approximately five of the columns located common to the rear of the building had experienced a significant settlement issue resulting in cracked floor beams and column capitals. An example of these cracked floor beams and column capitals can be observed in Photographs June 7, 2021, photographs 26, 34, 50, and 51.

**Photograph 26: Interior rear column settlement of Building 174.**

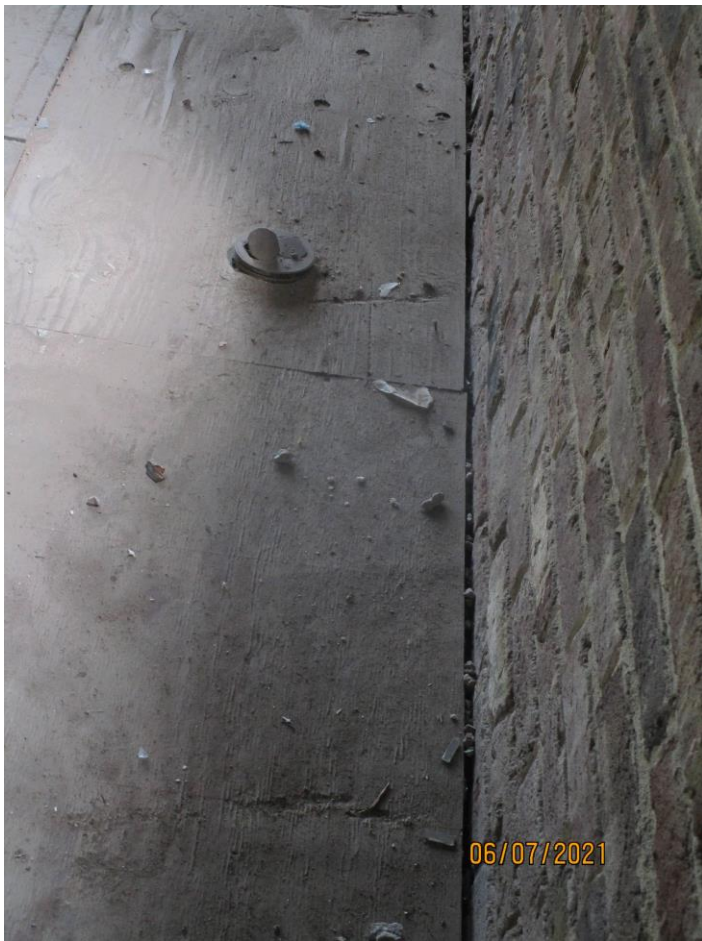
The right sidewall of Building 174 is also exposed to the courtyard. Once again, movement of the floor joists common to the right and left sides of this building were observed (Photographs June 7, 2021, photographs 27, 30, and 31).

**Photograph 27: Right-side wall of main floor of Building 174.**

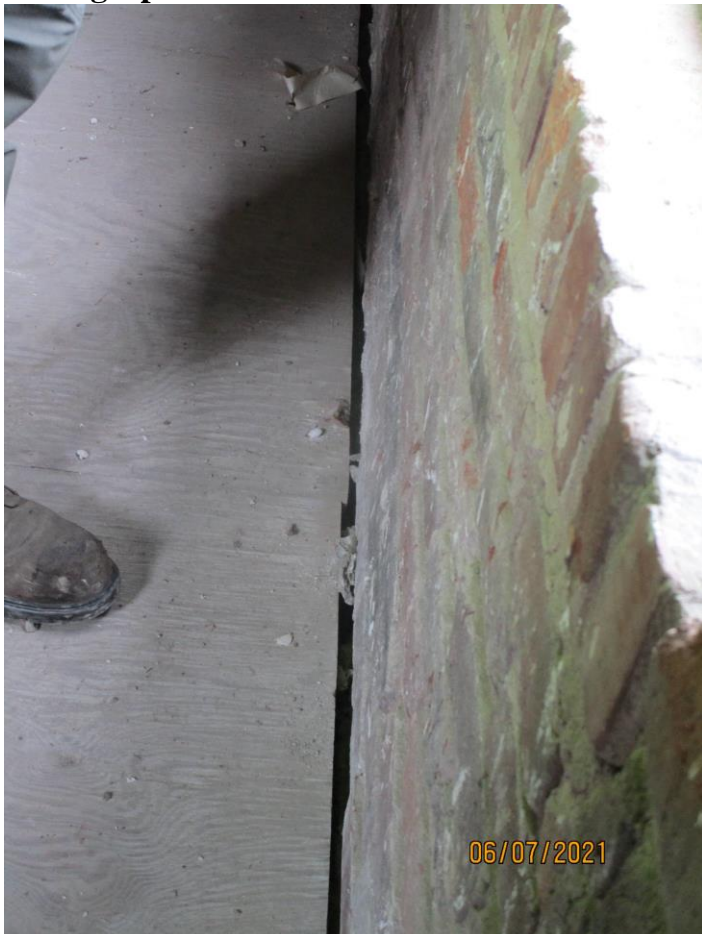
**Photograph 28: Rear wall of main floor of Building 174.**

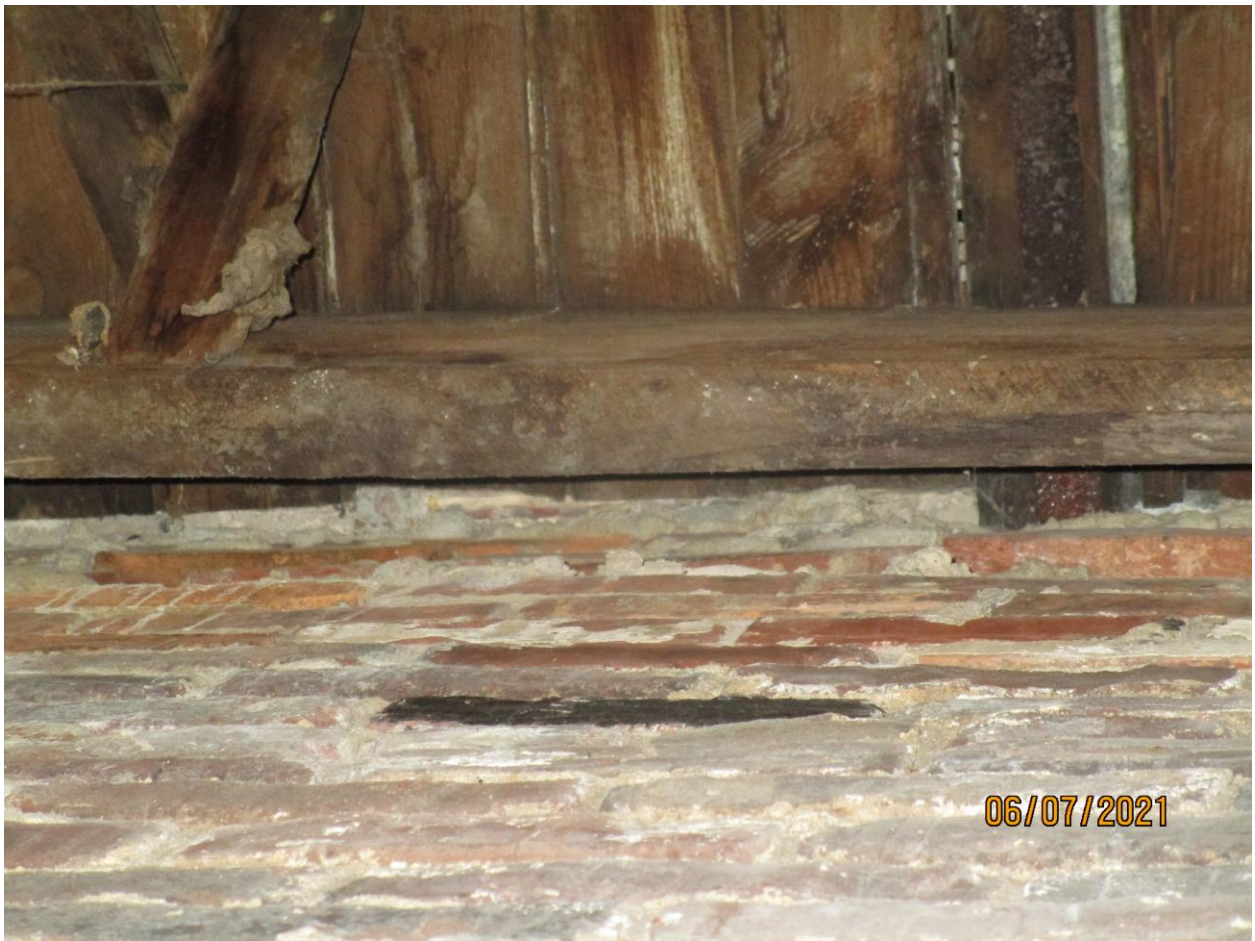
**Photograph 29: Rear wall of second floor of Building 174.**

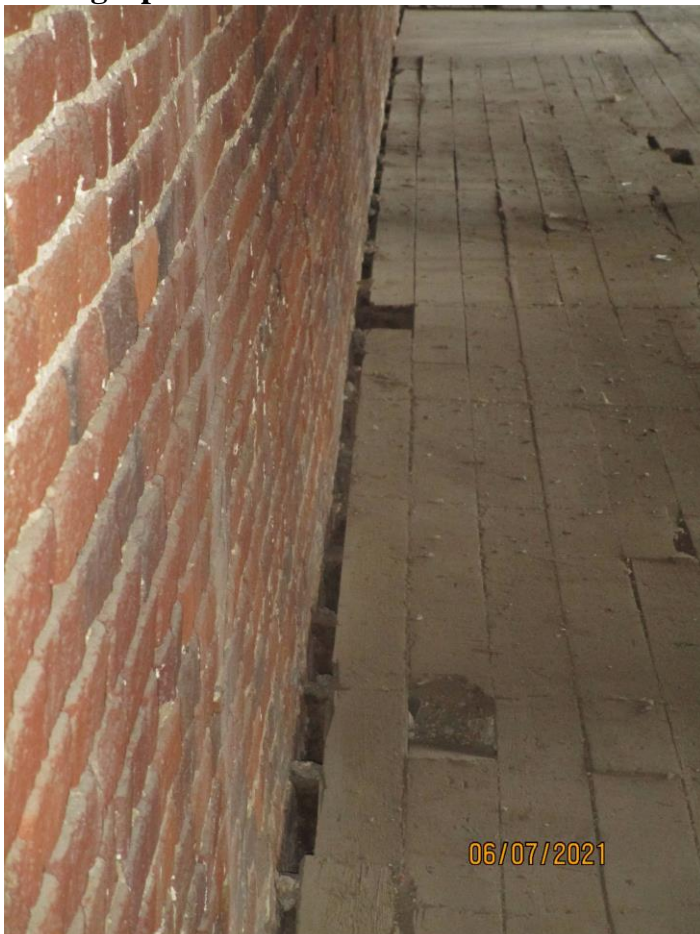
**Photograph 30: Left-side wall of second floor of Building 174.**

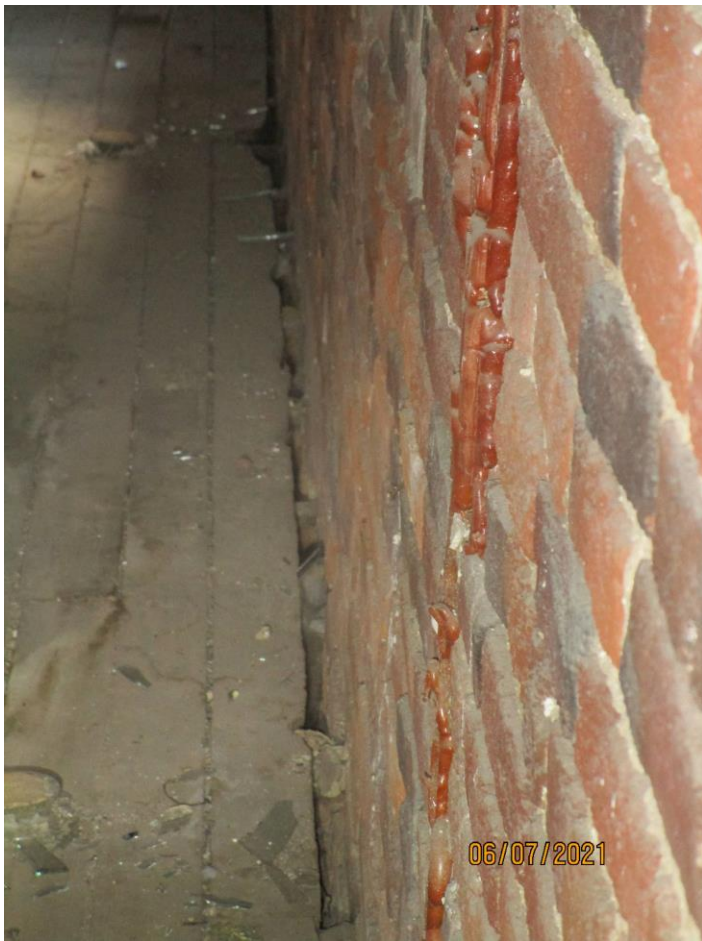
**Photograph 31: Right-side wall of second floor of Building 174.**

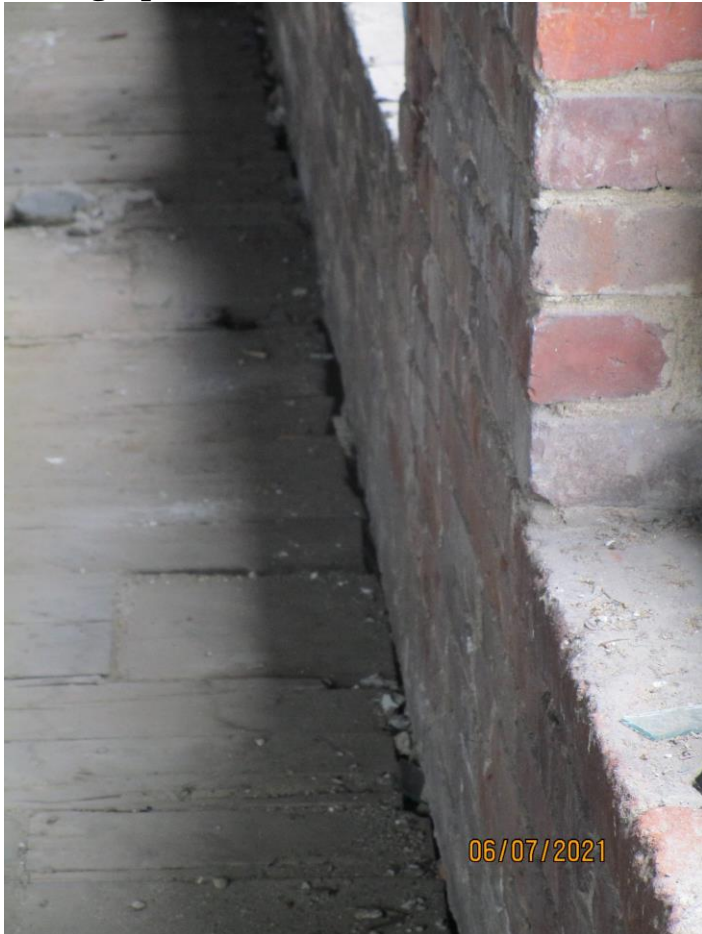
**Photograph 32: Rear wall of second floor of Building 174.**

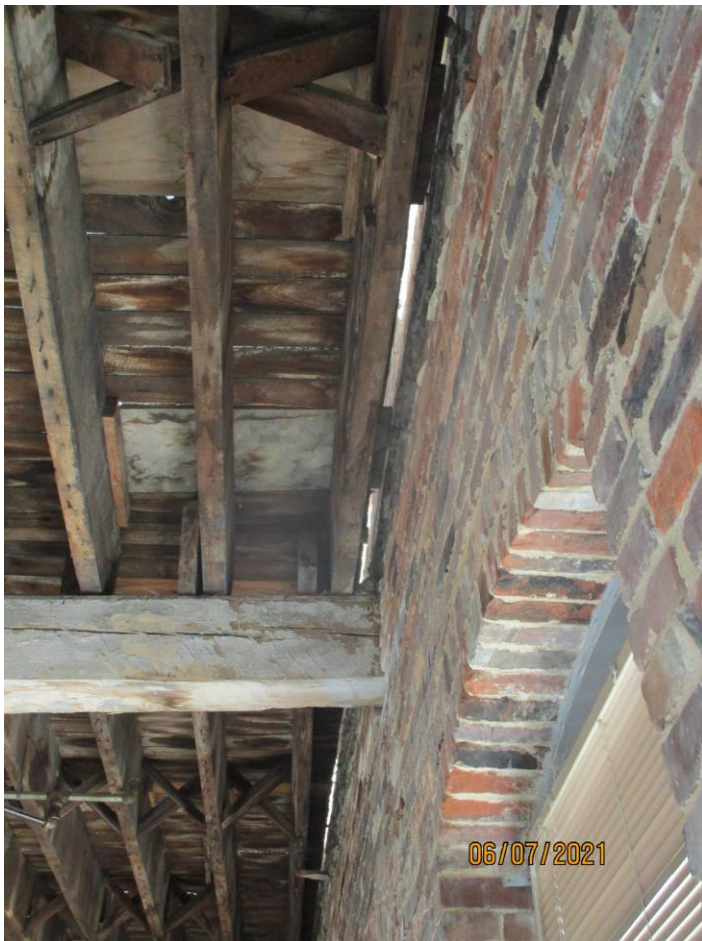
**Photograph 33: Third floor rear wall of Building 174.**
