**METROPOLITAN GOVERNMENT OF NASHVILLE AND DAVIDSON COUNTY**

**STAFF RECOMMENDATION**  
**170-176 Second Avenue North**  
**July 21, 2021**

**Application:** Demolition  
**District:** Second Avenue Historic Preservation Zoning Overlay  
**Council District:** 19  
**Base Zoning:** DTC  
**Map and Parcel Number:** 09306206600 and 09302401900  
**Applicant:** Callen Trust, property owner  
**Project Lead:** Robin Zeigler, robin.zeigler@nashville.gov

**Description of Project:** The property owner requests to demolish four historic buildings in the Second Avenue Historic Preservation Zoning Overlay, damaged in the 2020 Christmas morning explosion.

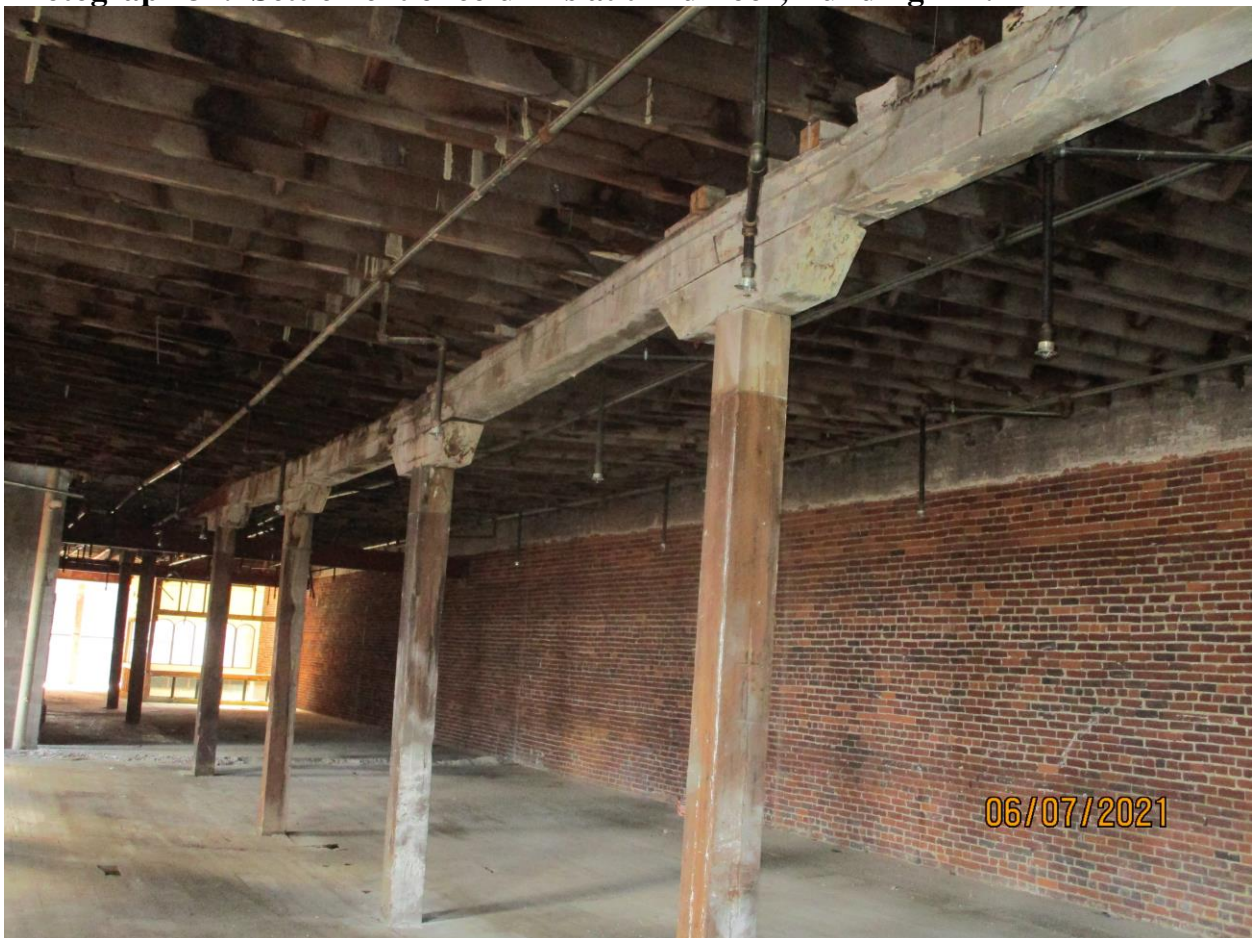
**Photograph 34: Settlement of columns at third floor, Building 174.**

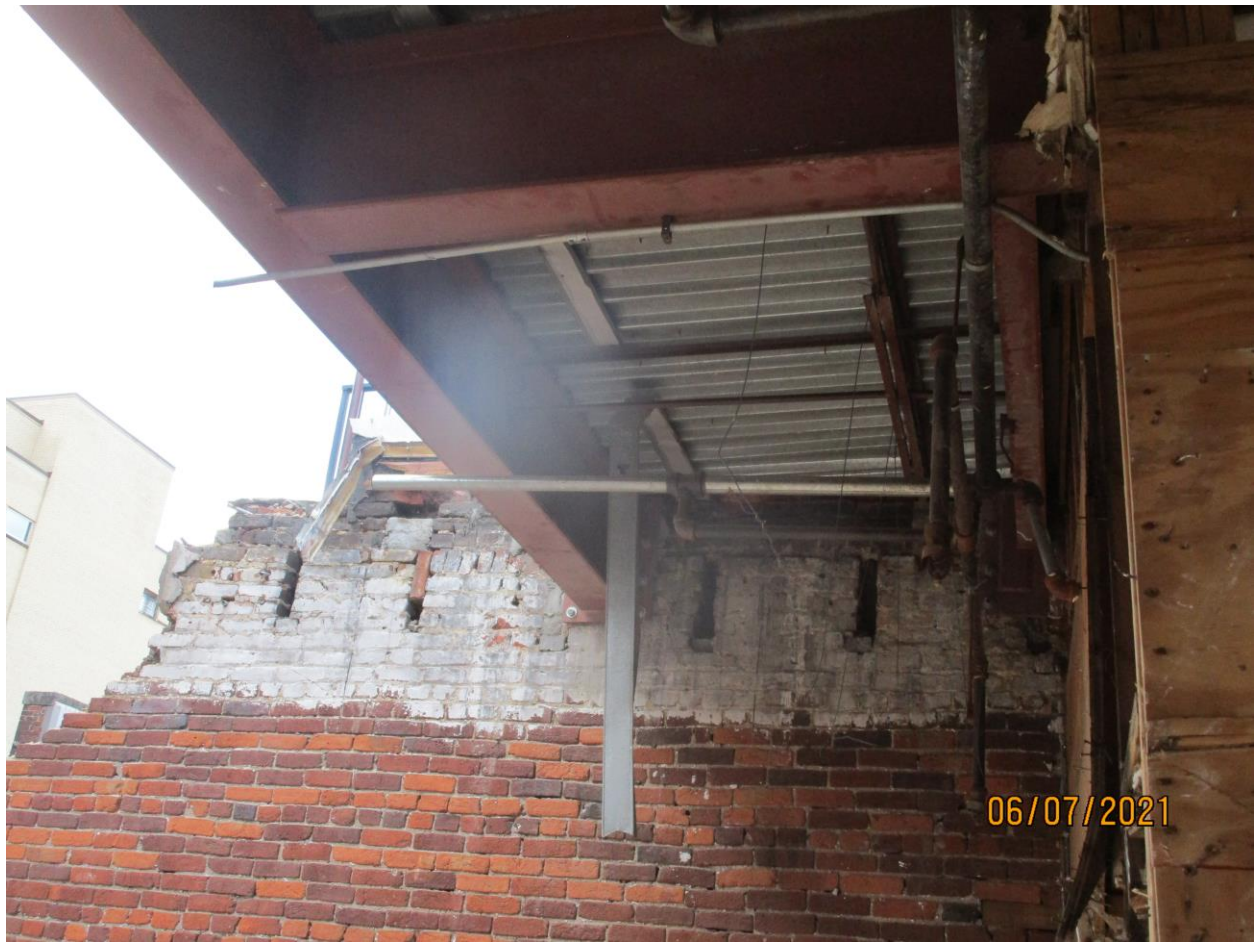
**Photograph 35: Close-up of roof framing of Building 174.**

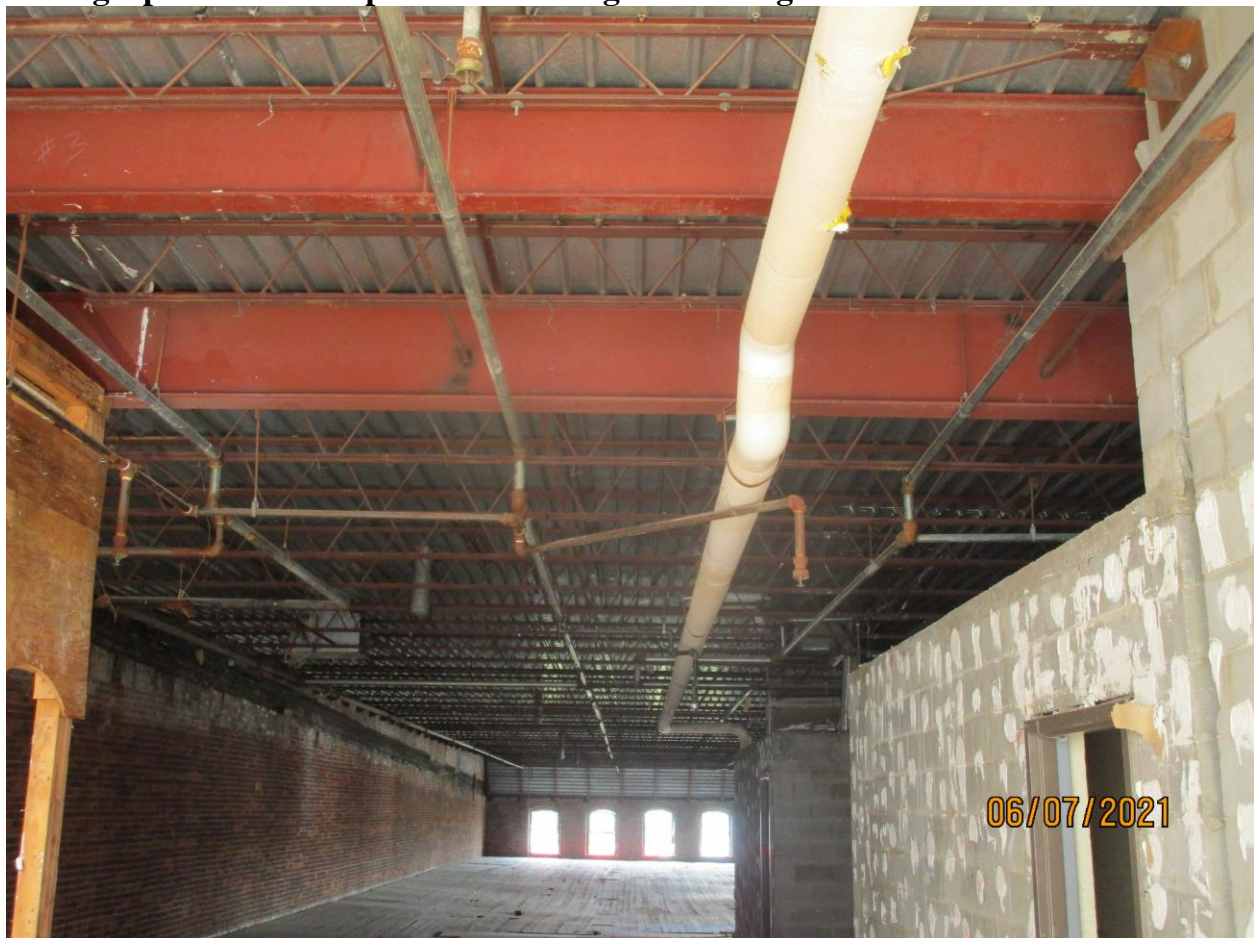
**Photograph 36: Close-up of roof framing of Building 174.**

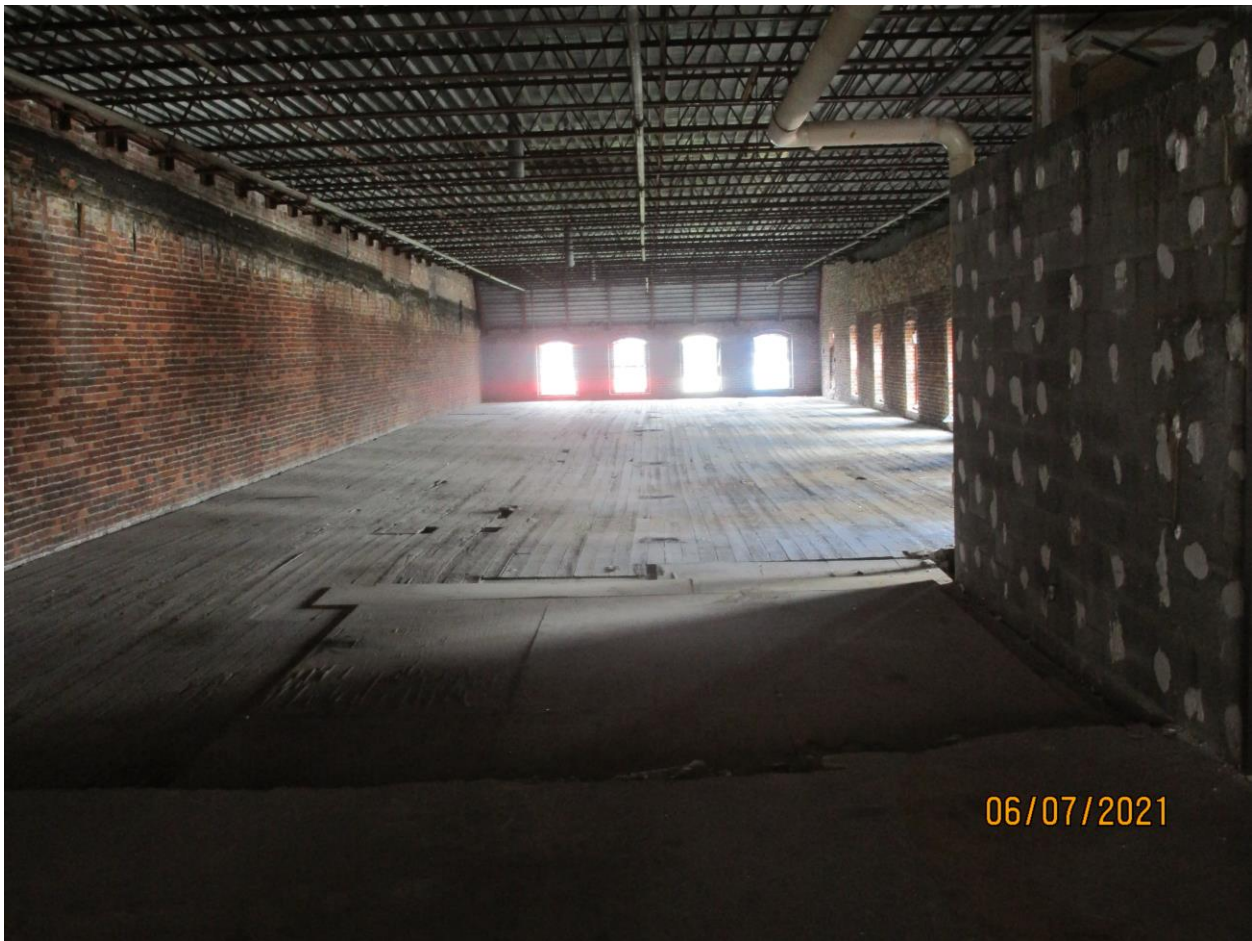
**Photograph 37: Overview of fourth floor of Building 174.**

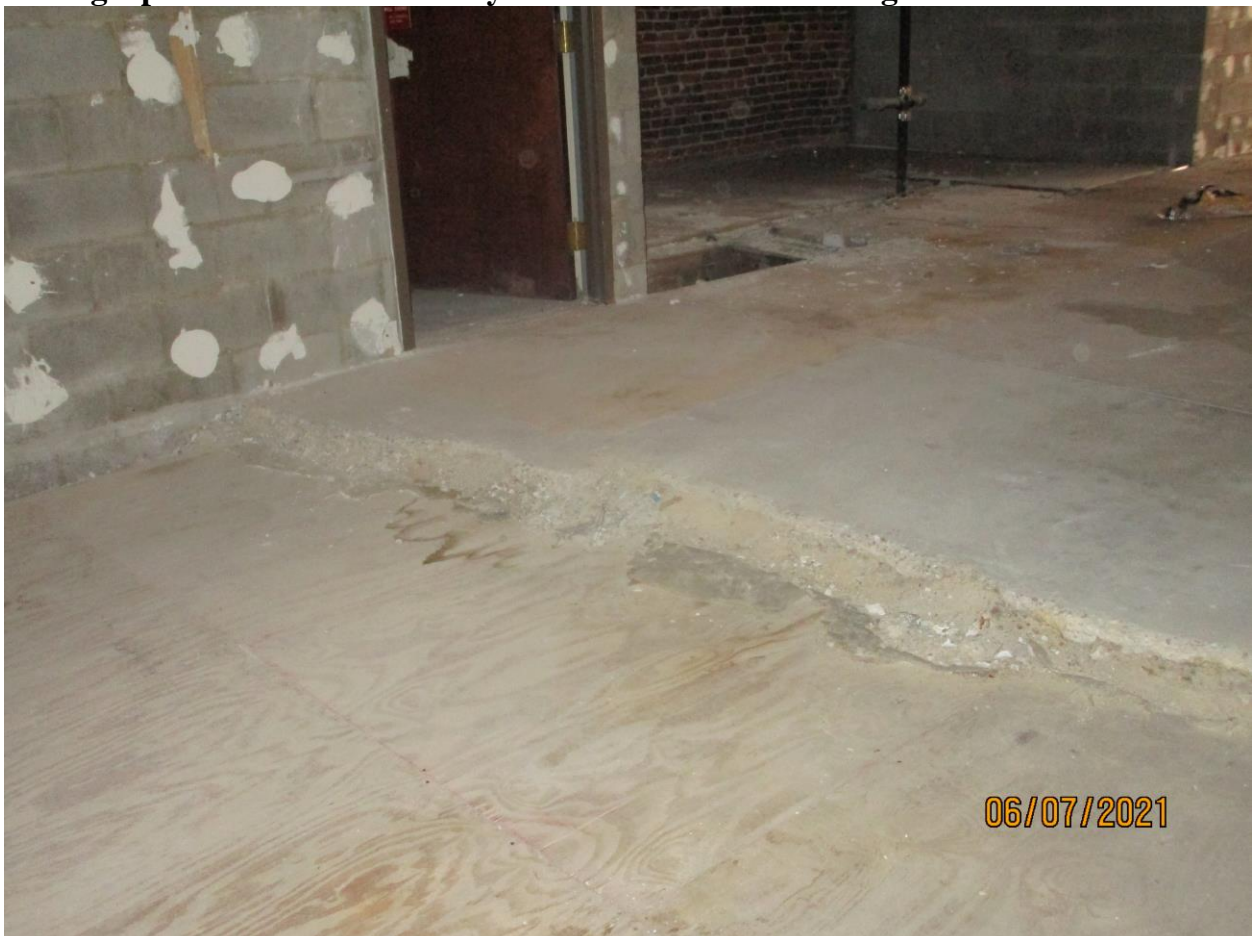
**Photograph 38: Concrete overlay at fourth floor of Building 174.**

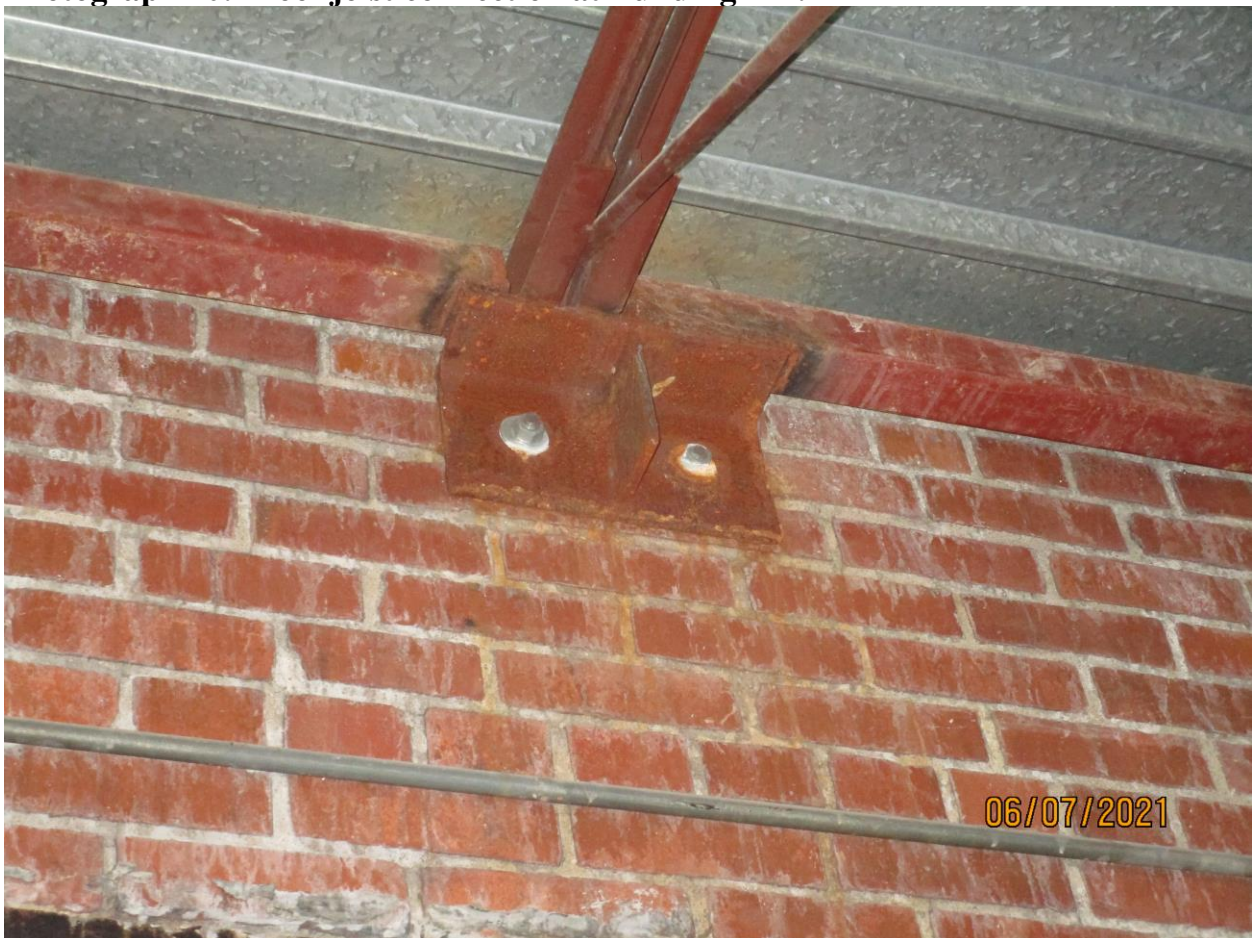
**Photograph 40: Roof joist connection at Building 174.**

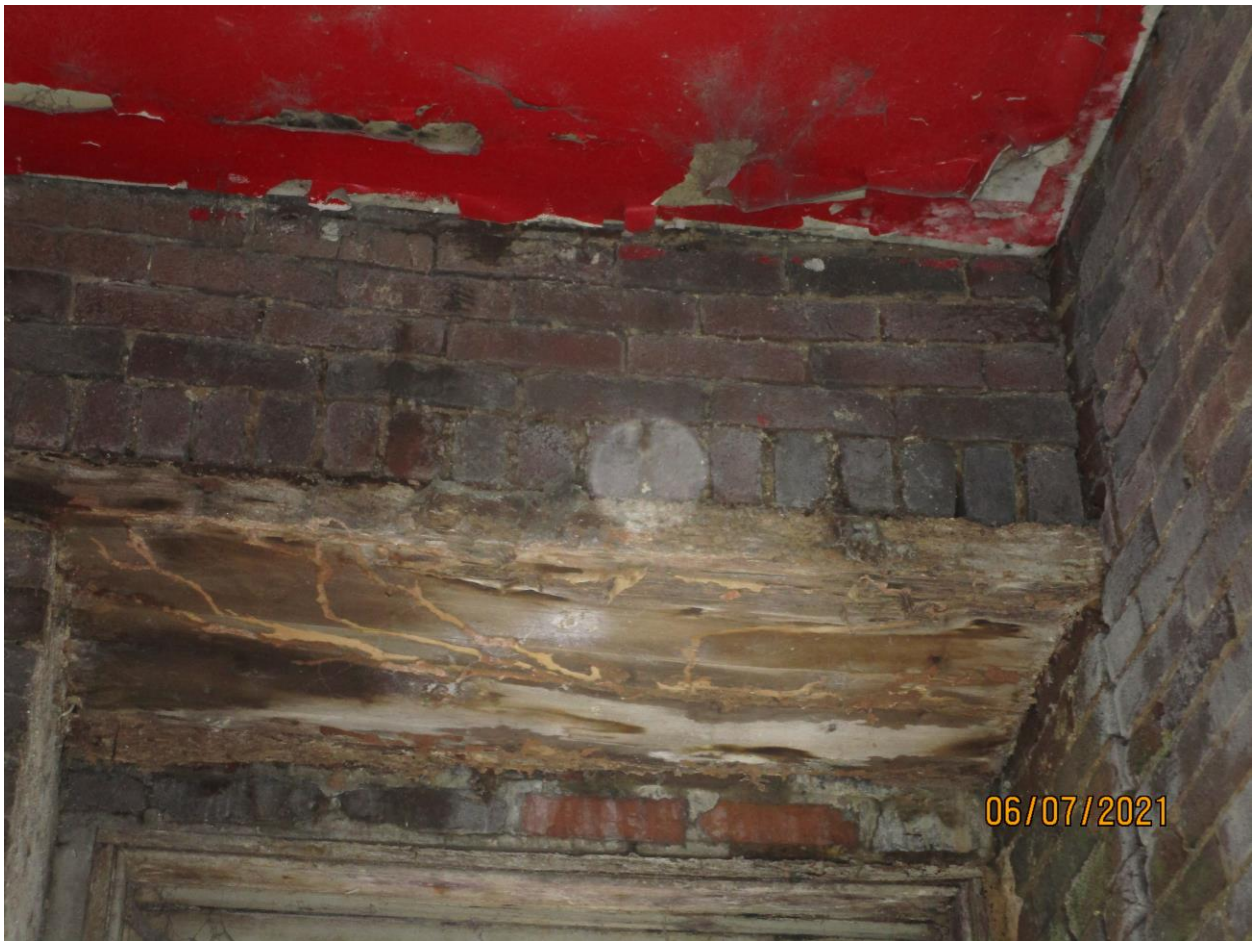
**Photograph 54: Typical joist pocket at Building 176.**

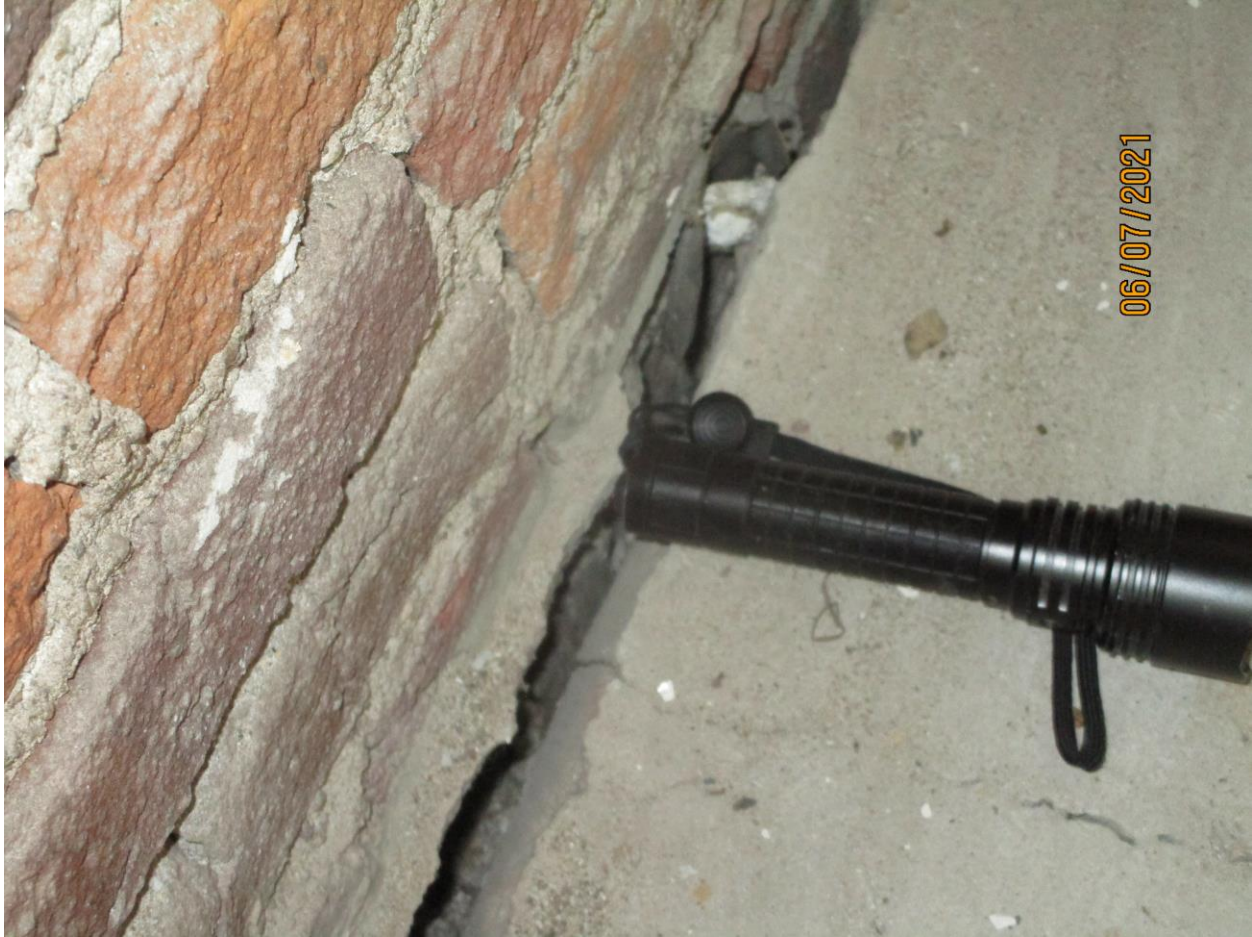
**Photograph 58: Rear wall second floor Building 176 (3/4" ± movement since concrete topping).**

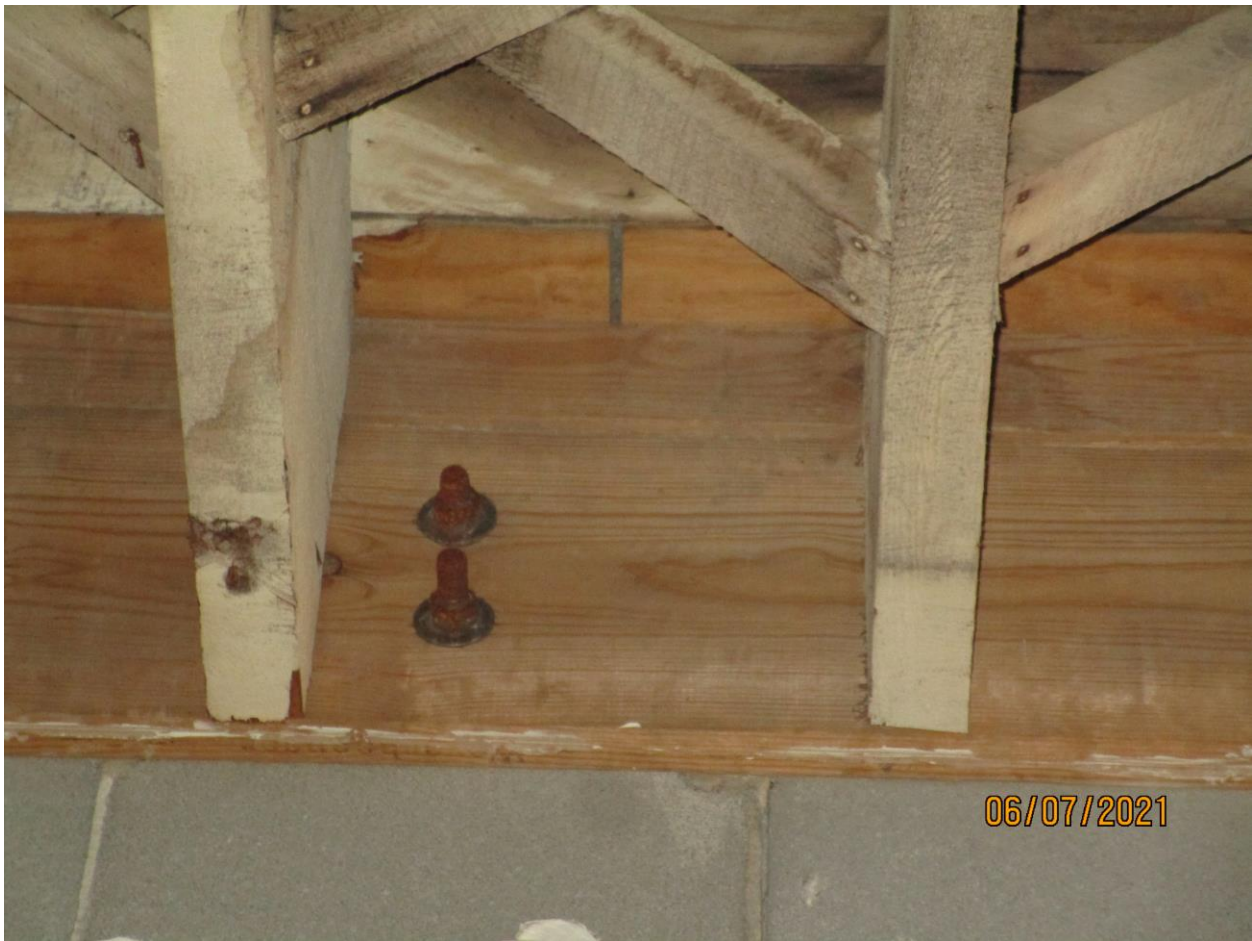
**Photograph 65: Bolted ledger board at right-side wall of third floor, Building 176.**

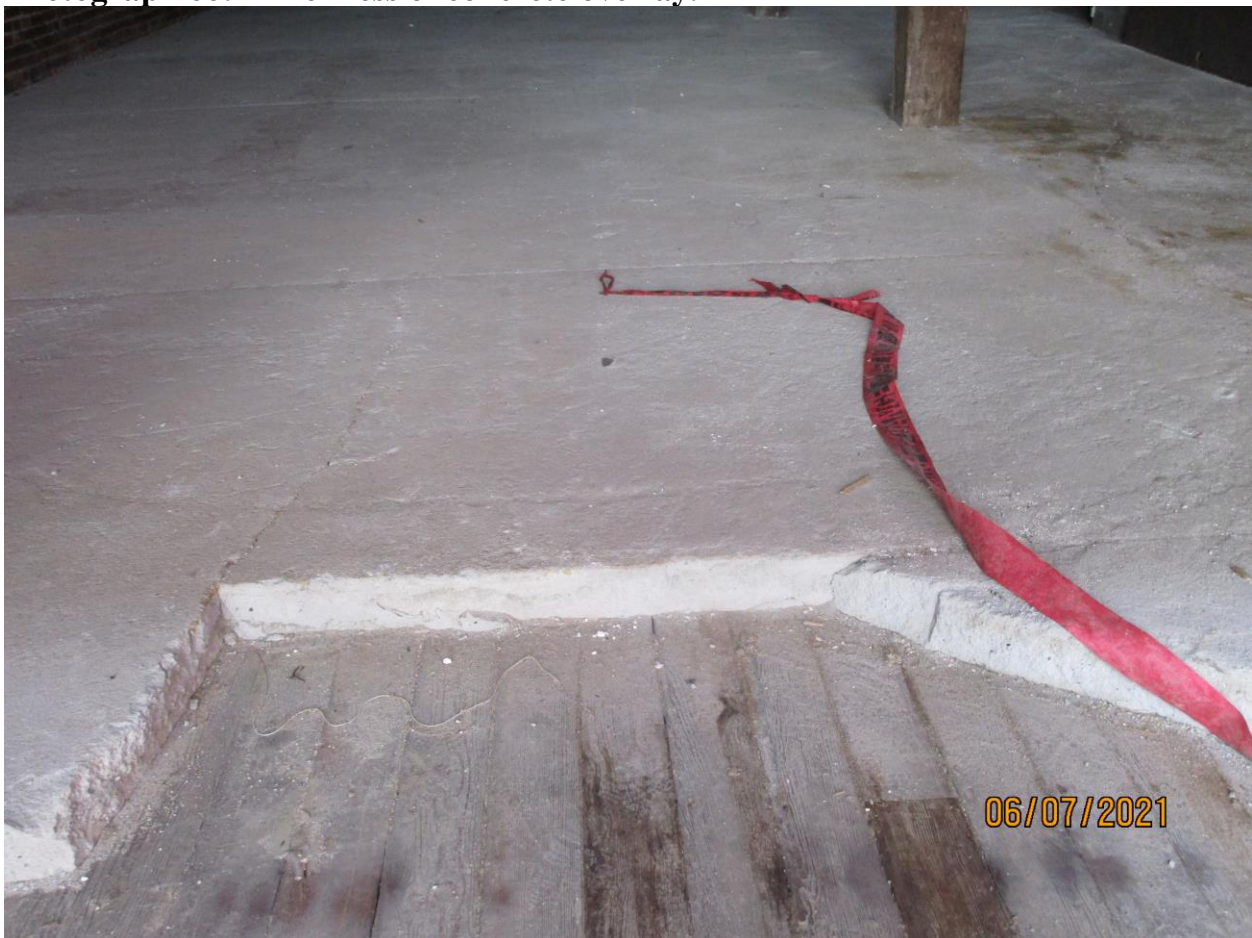
**Photograph 68: Thickness of concrete overlay.**

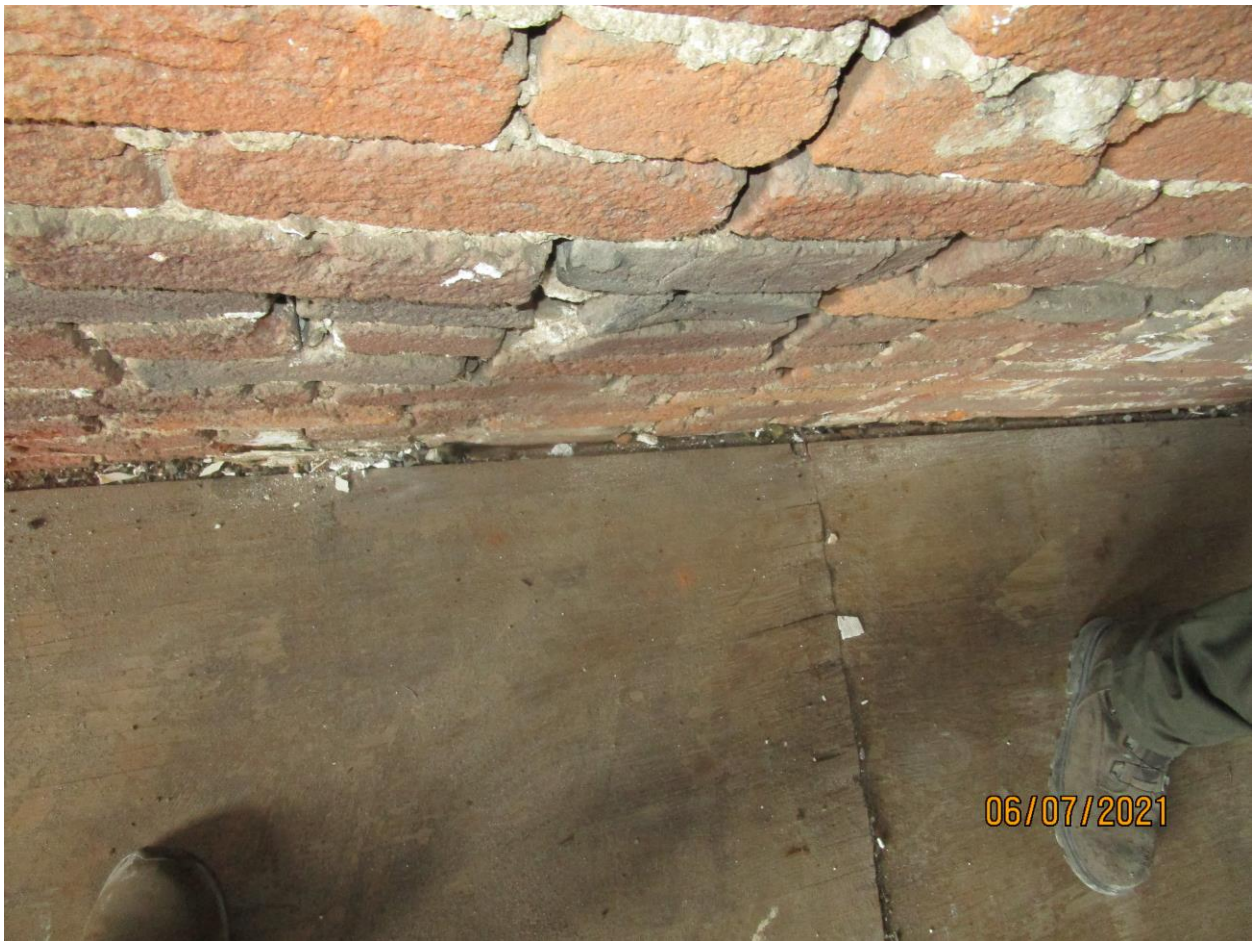
**Photograph 78: Right-side wall of fourth floor of Building 176**

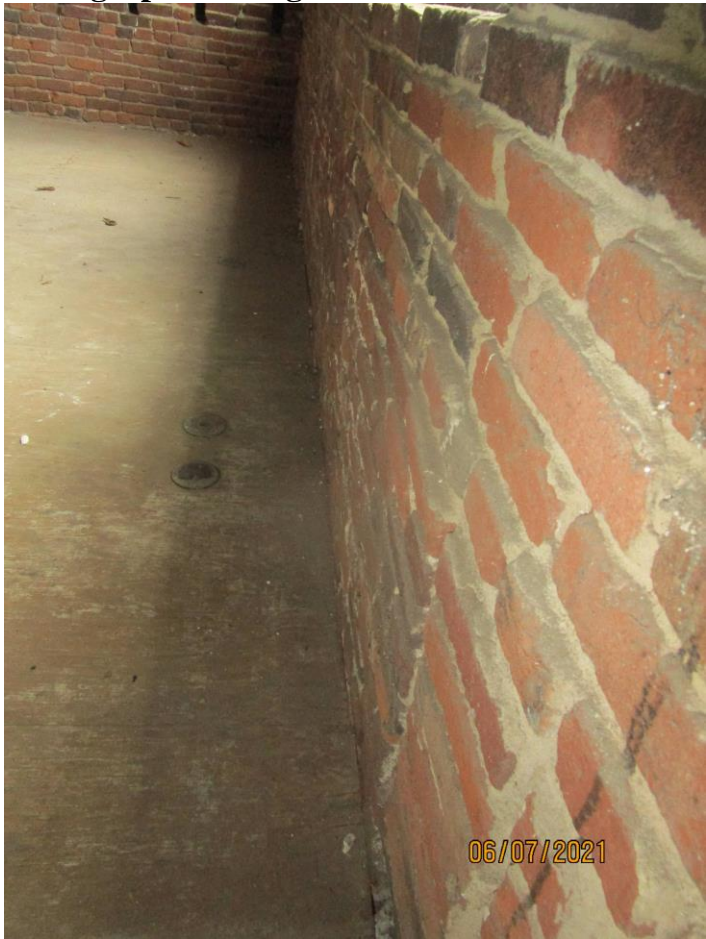
**Photograph 79: Overview of fourth floor of Building 176.**

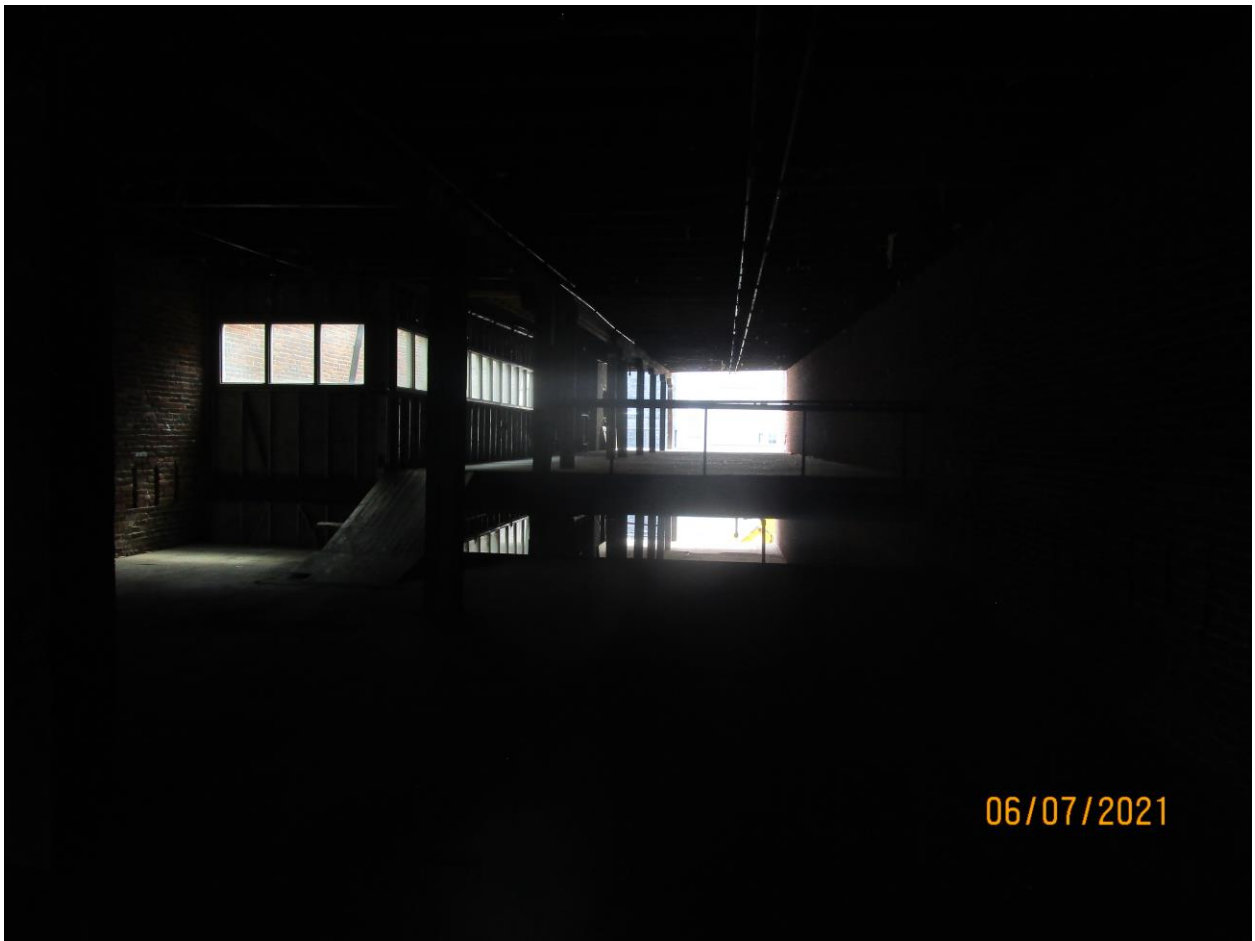
**Photograph 80: Overview of fourth floor of Building 176.**

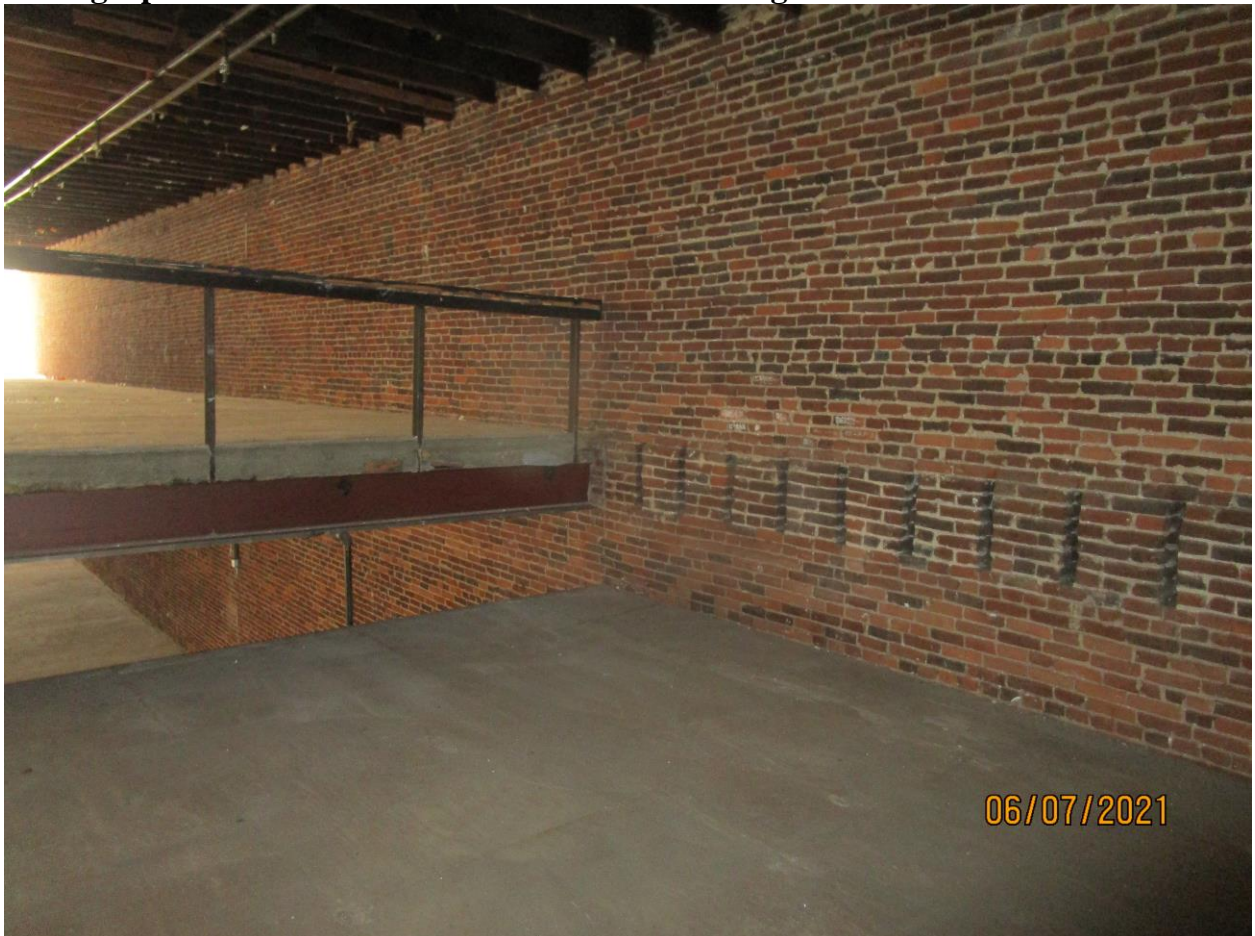
**Photograph 81: Right-side wall of fourth floor of Building 176.**

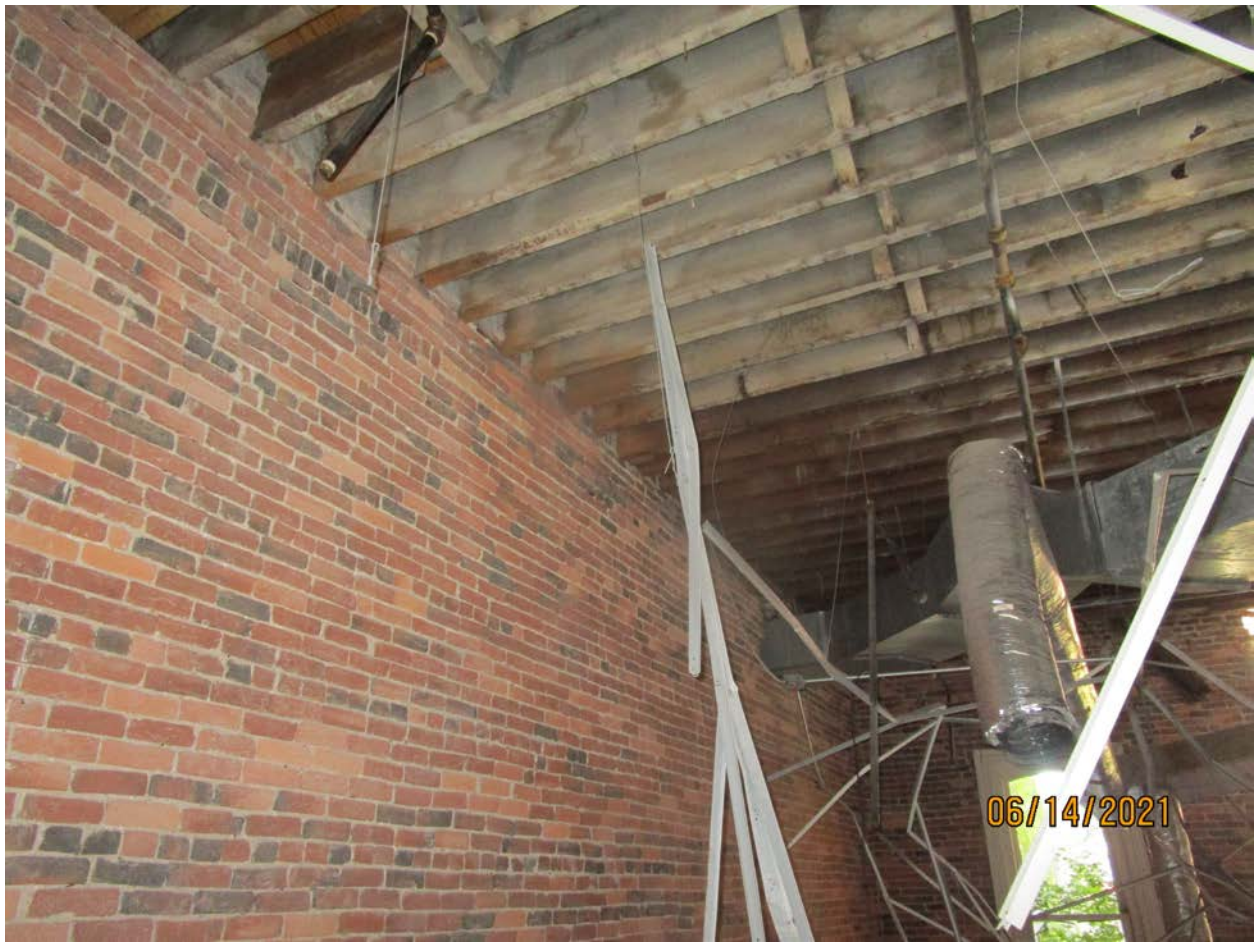
**Photograph 6: Joist pockets of Building 172.**

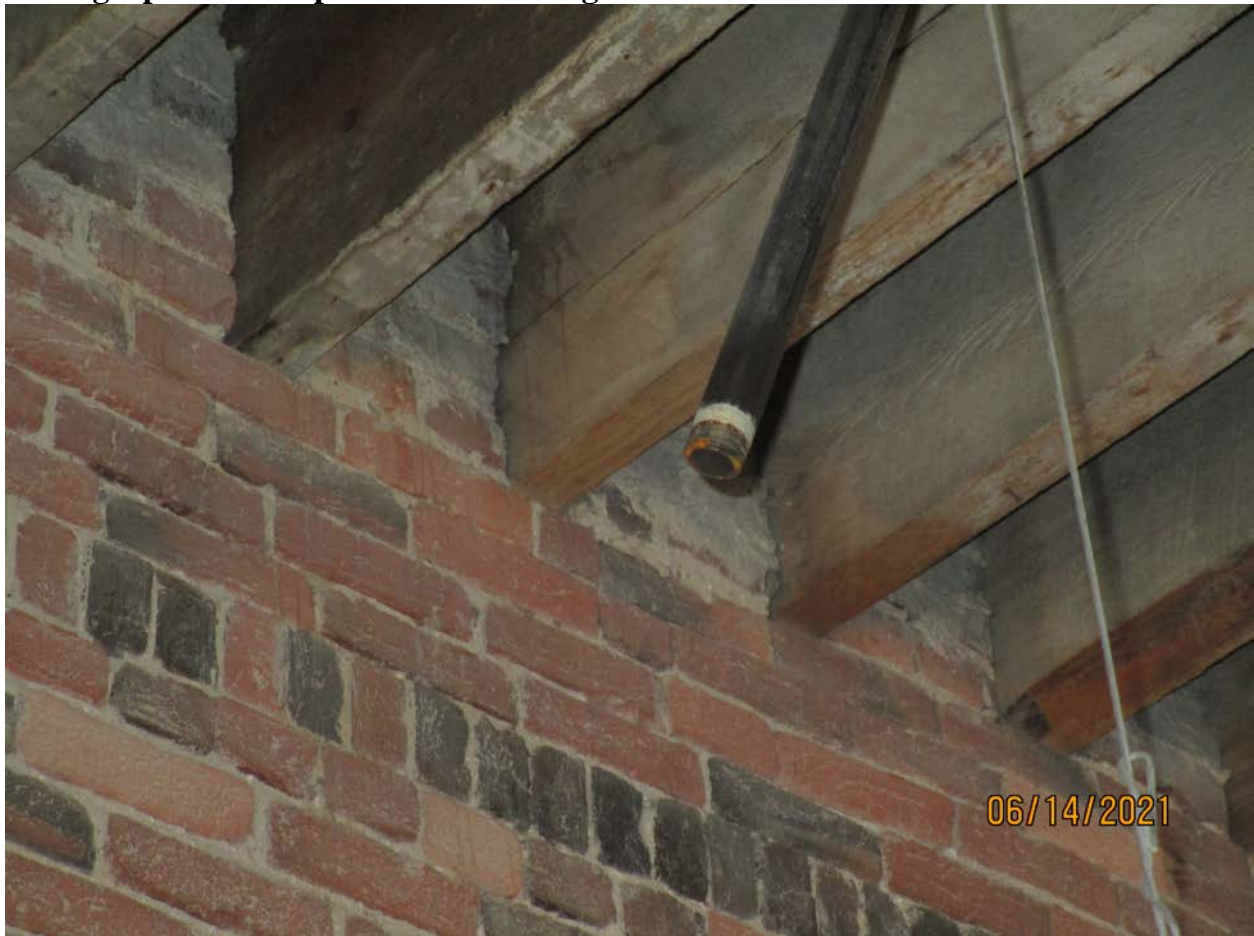
**Photograph 7: Joist pockets of Building 172.**

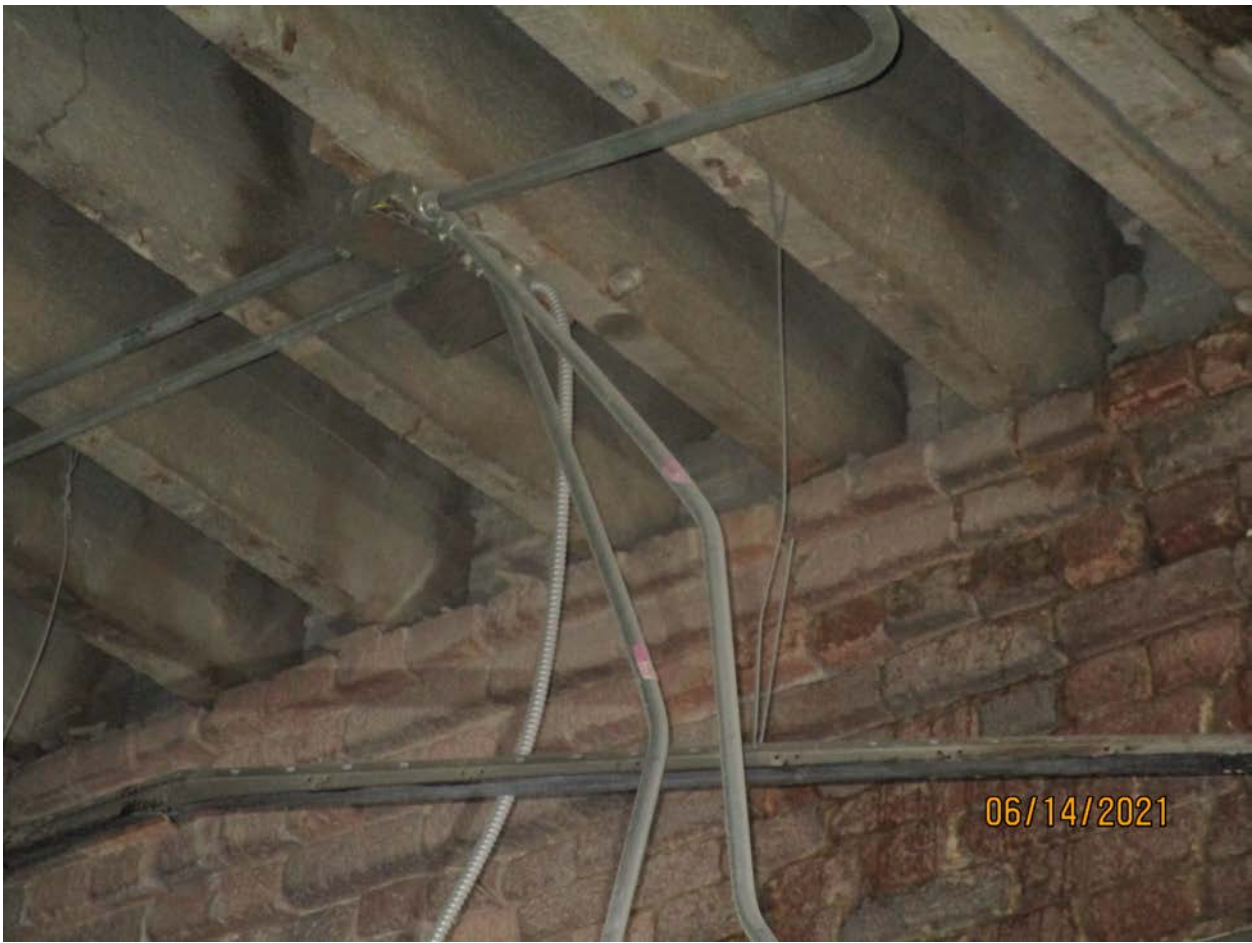
**Photograph 8: Joist pockets of Building 172.**

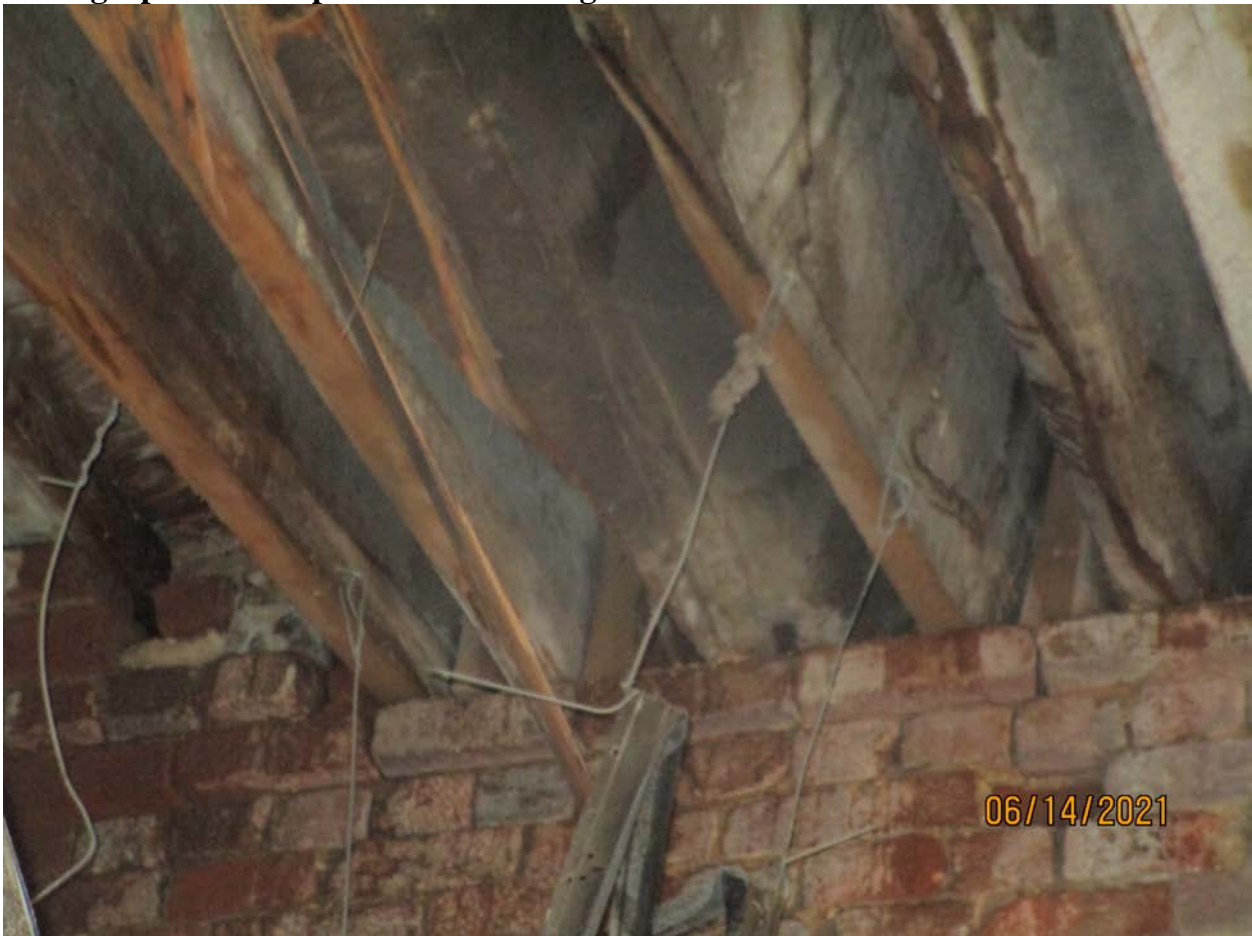
**Photograph 9: View of steel beams at Building 172.**

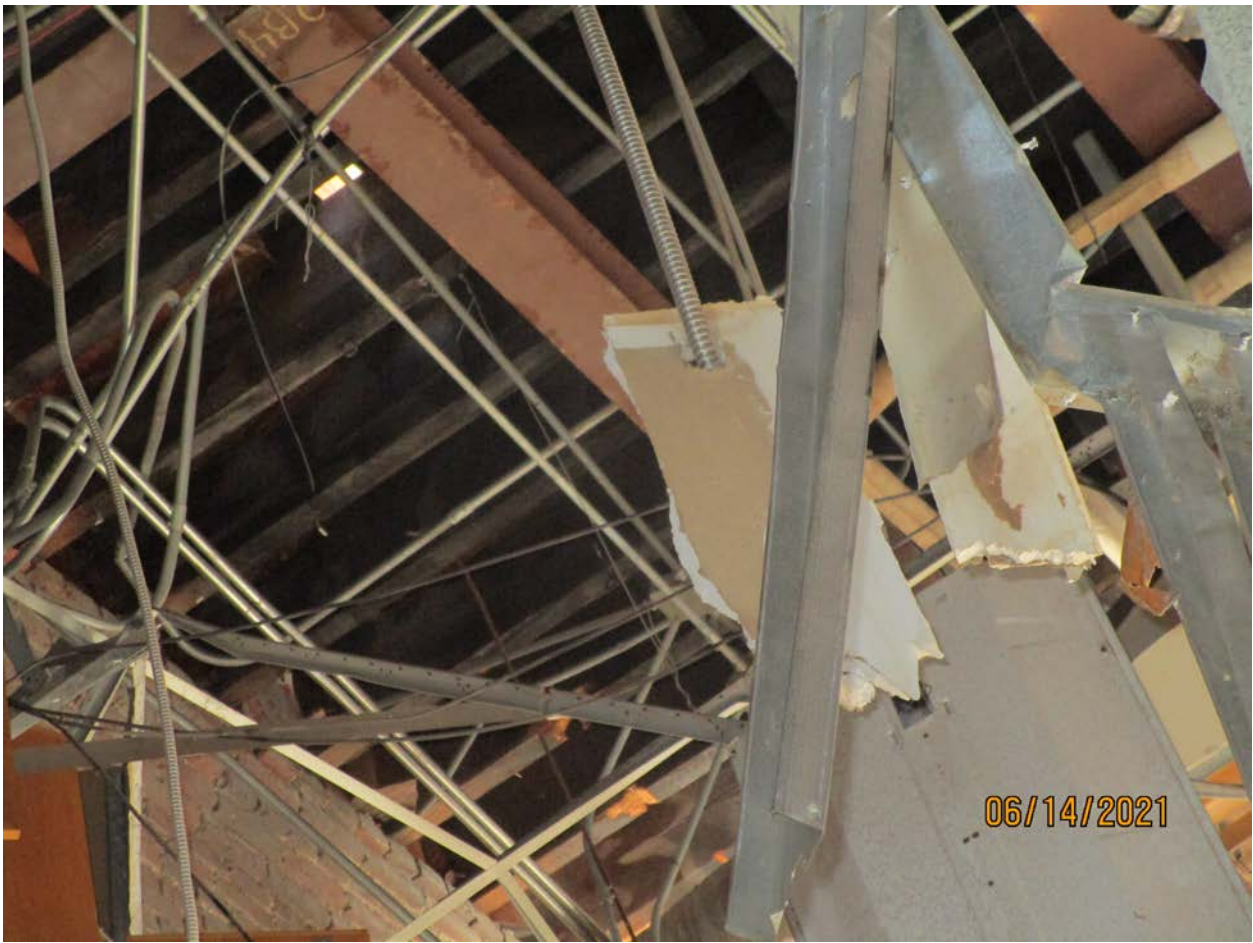
**Photograph 10: Forward view of Building 172.**
