**METROPOLITAN GOVERNMENT OF NASHVILLE AND DAVIDSON COUNTY**

**STAFF RECOMMENDATION**  
**170-176 Second Avenue North**  
**July 21, 2021**

**Application:** Demolition  
**District:** Second Avenue Historic Preservation Zoning Overlay  
**Council District:** 19  
**Base Zoning:** DTC  
**Map and Parcel Number:** 09306206600 and 09302401900  
**Applicant:** Callen Trust, property owner  
**Project Lead:** Robin Zeigler, robin.zeigler@nashville.gov

**Description of Project:** The property owner requests to demolish four historic buildings in the Second Avenue Historic Preservation Zoning Overlay, damaged in the 2020 Christmas morning explosion.

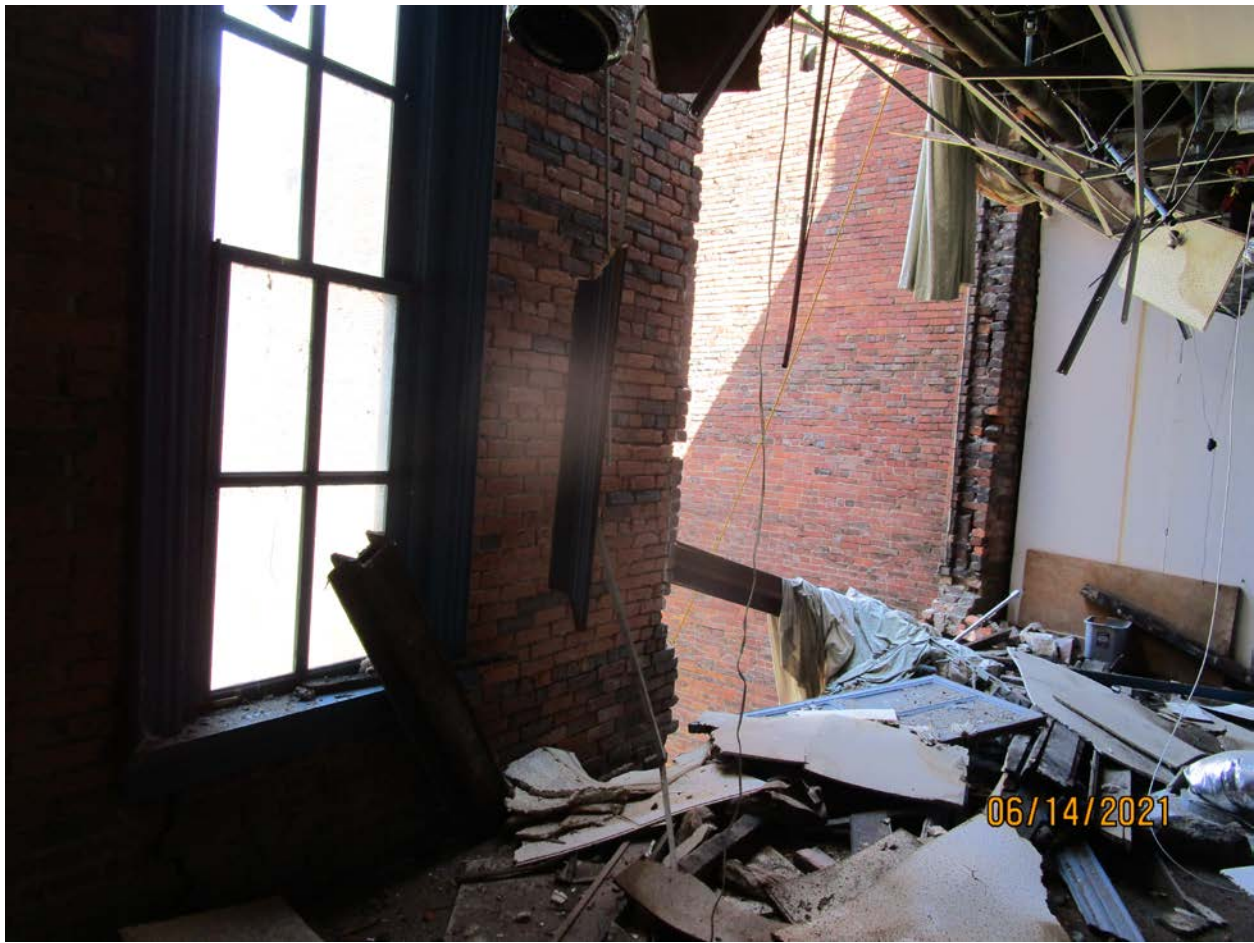
**Photograph 12: Rear wall of Building 172.**

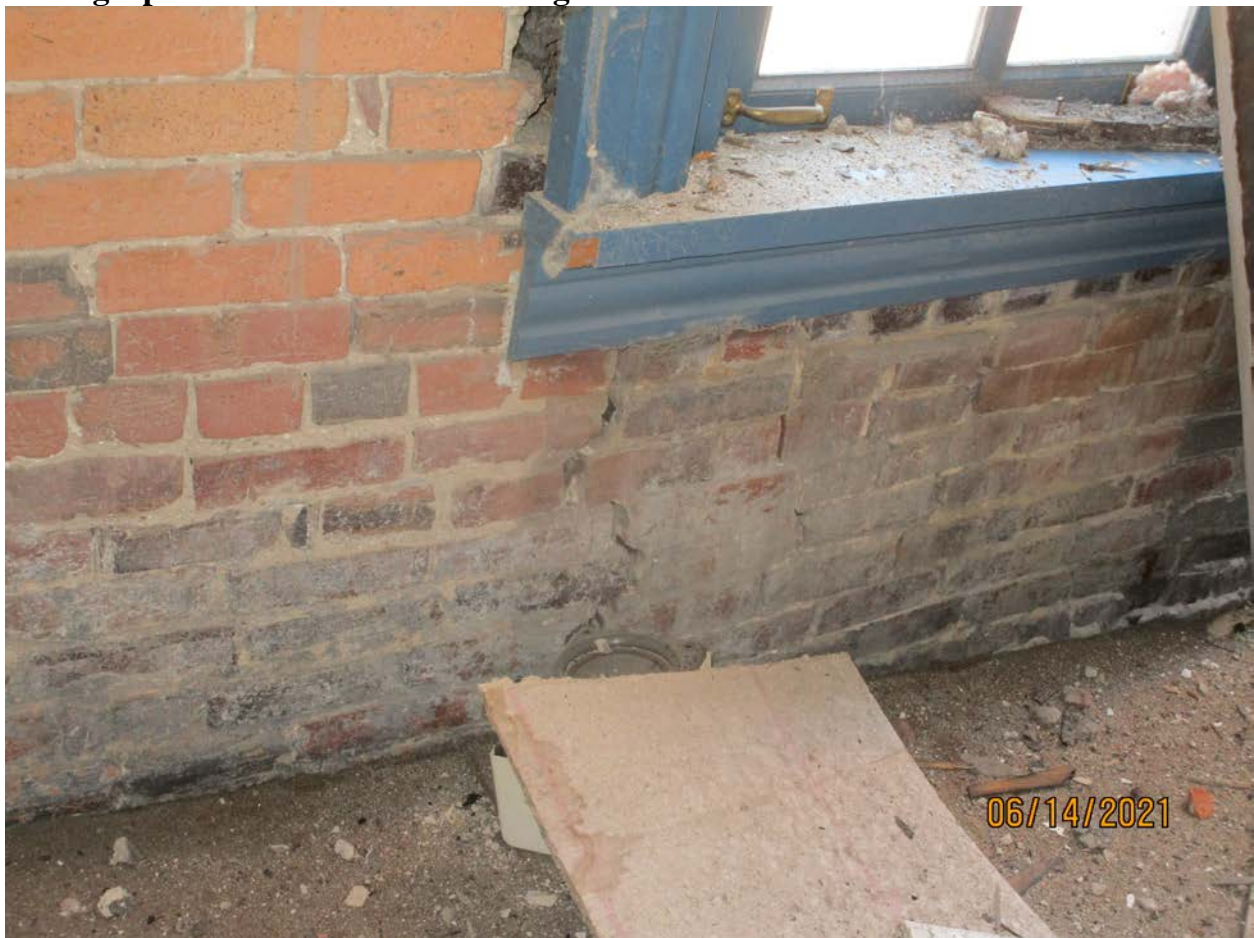
**Photograph 13: Rear wall of Building 172.**

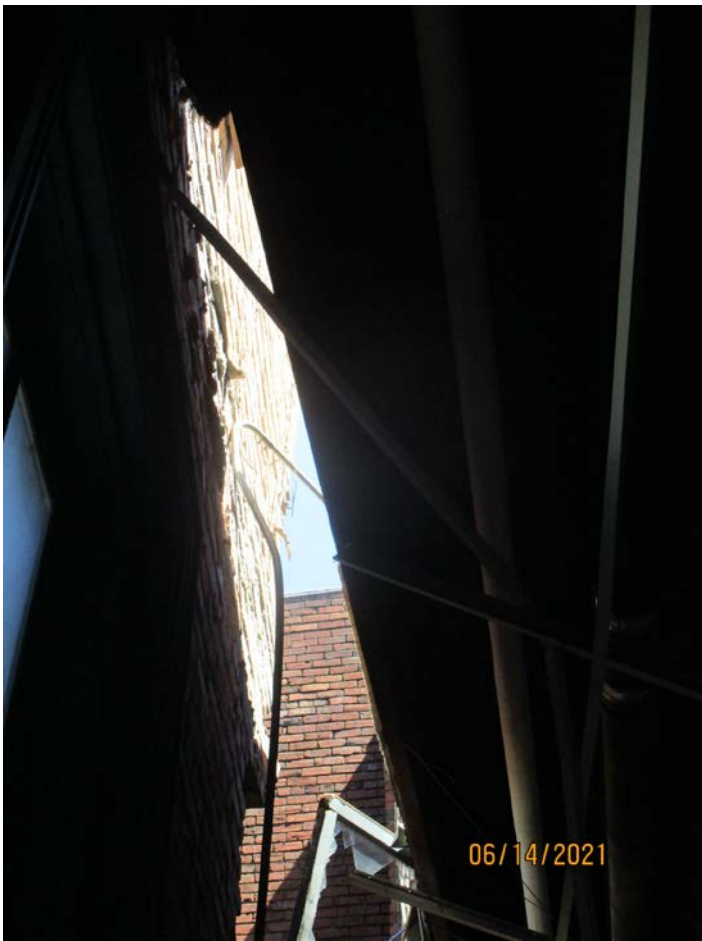
**Photograph 14: Rear wall of Building 172 .**

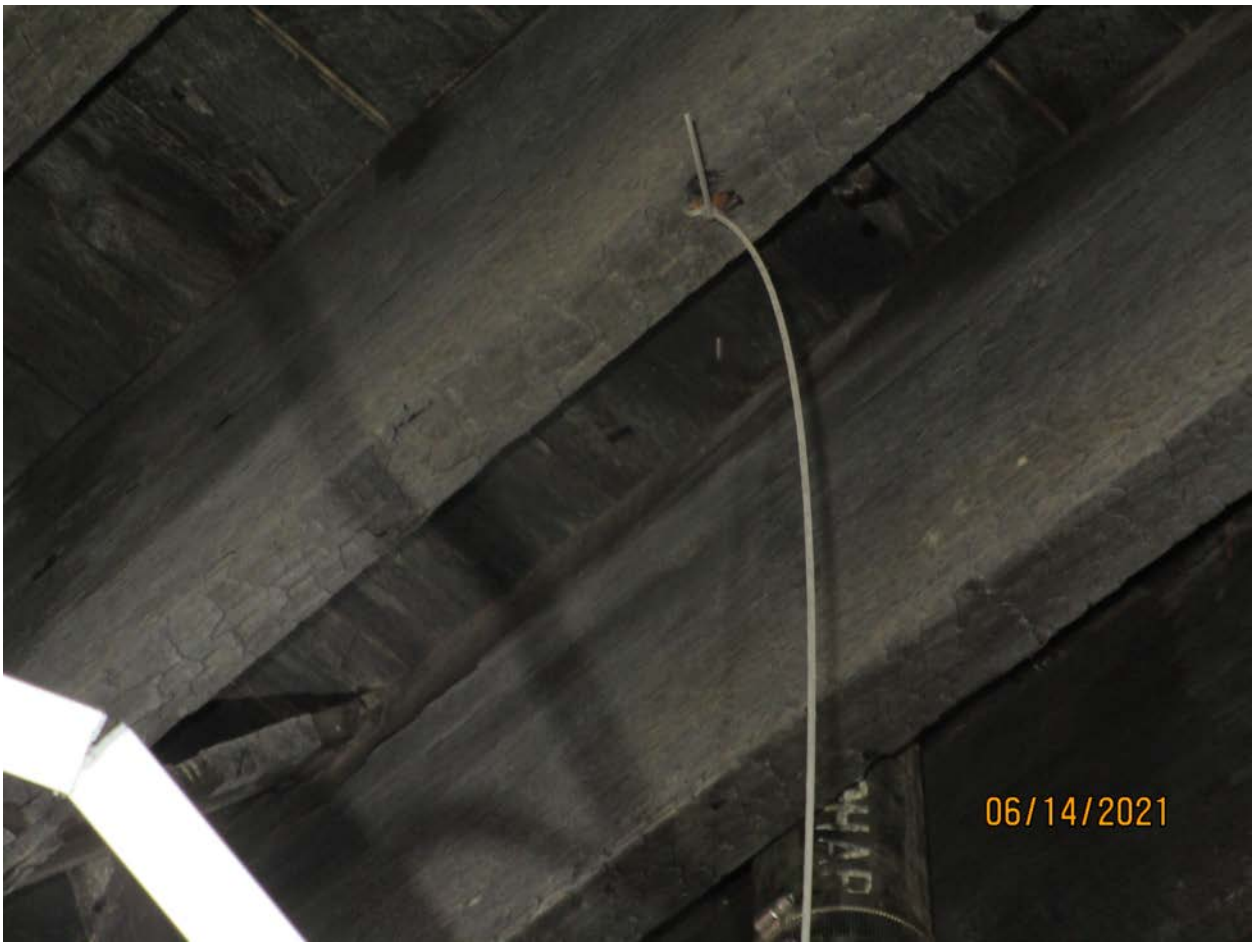
**Photograph 16: Common right-side wall of Building 172.**

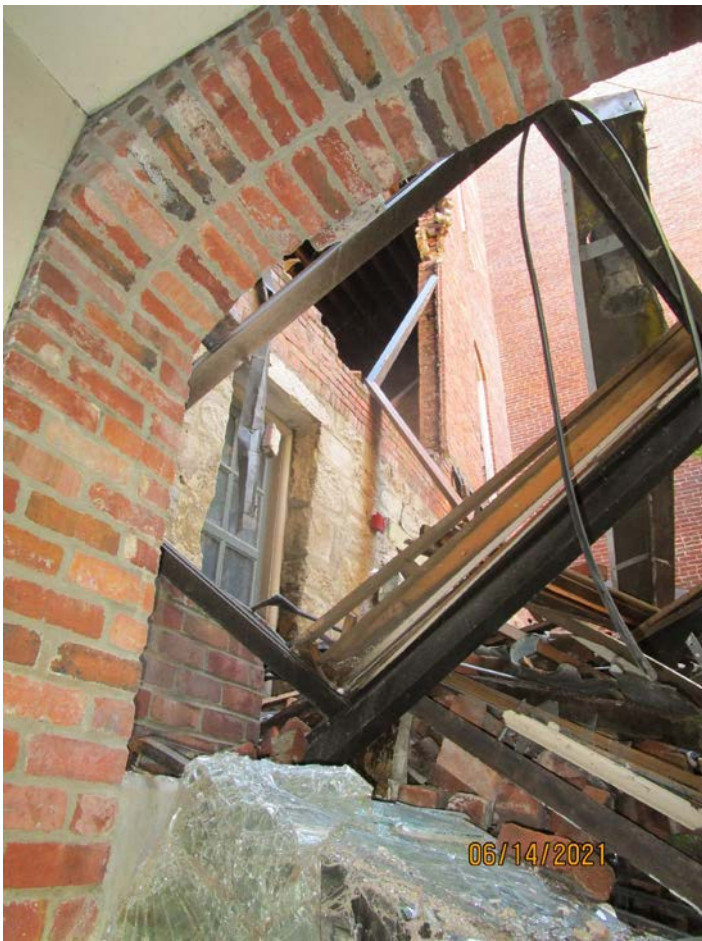
**Photograph 18: Basement level (front) of Building 170.**

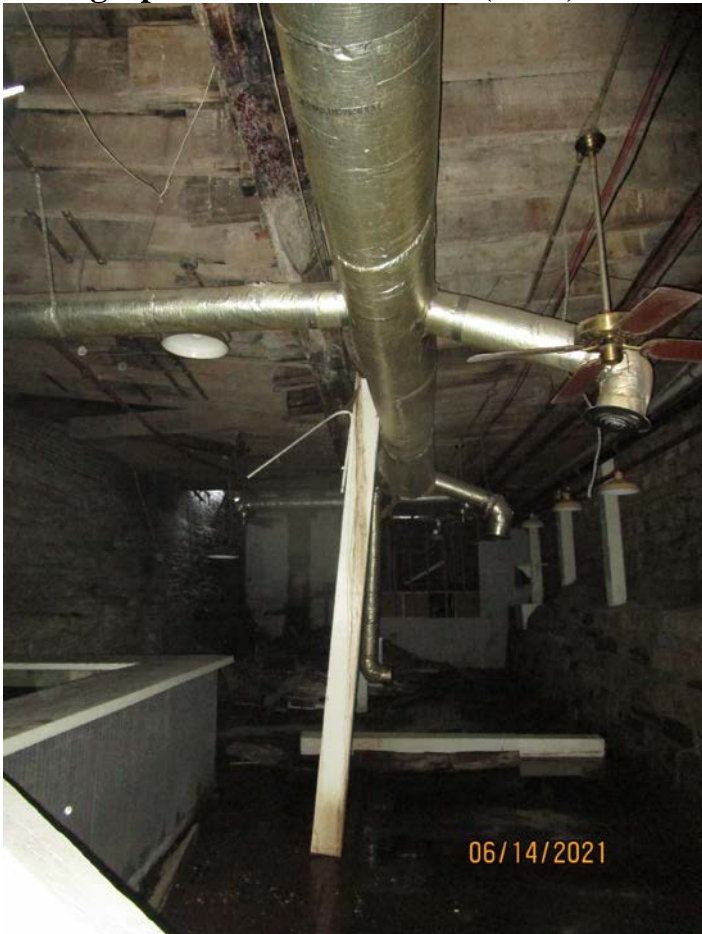
**Photograph 19: Basement level (front) of Building 170.**

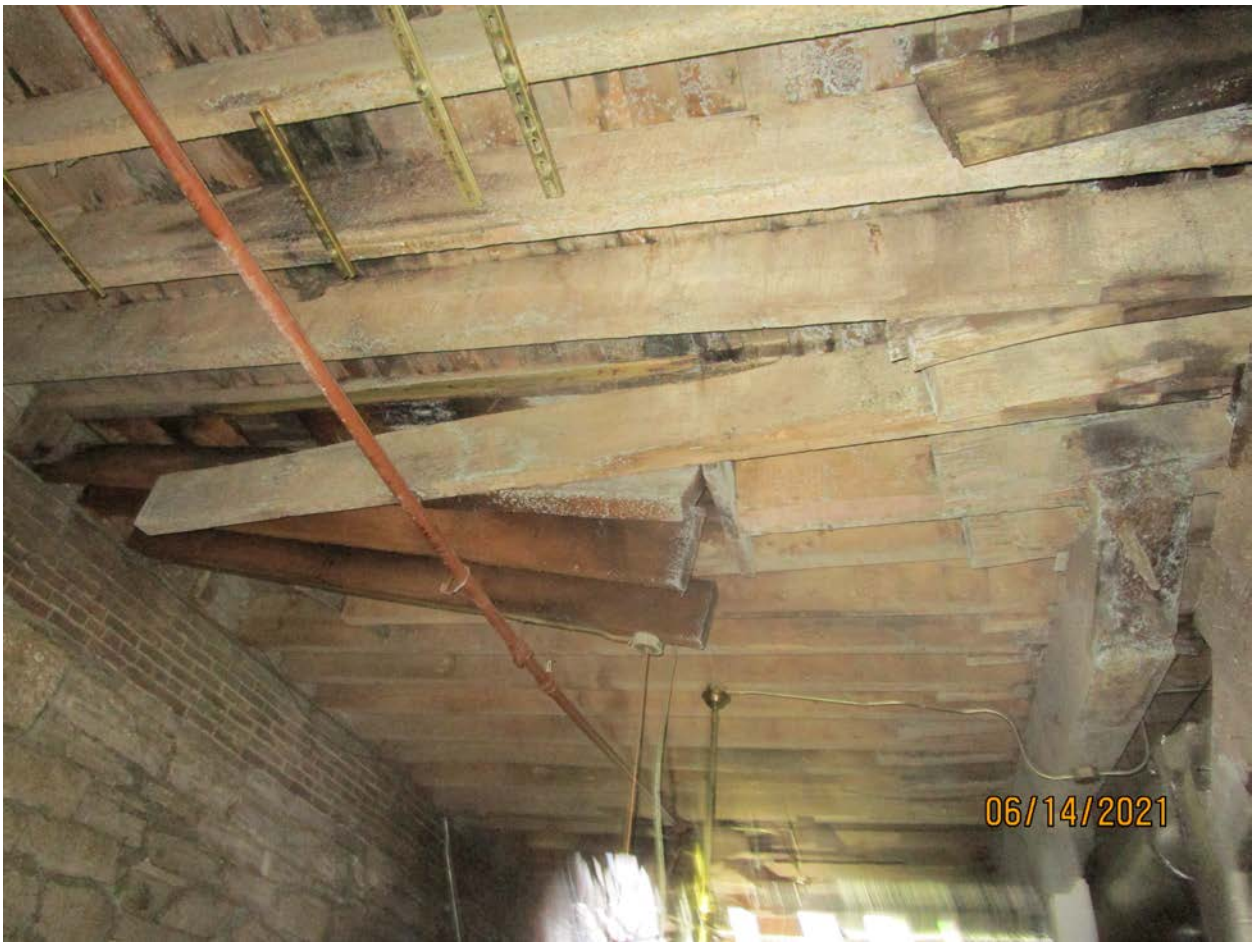
**Photograph 20: Basement level (front) of Building 170.**

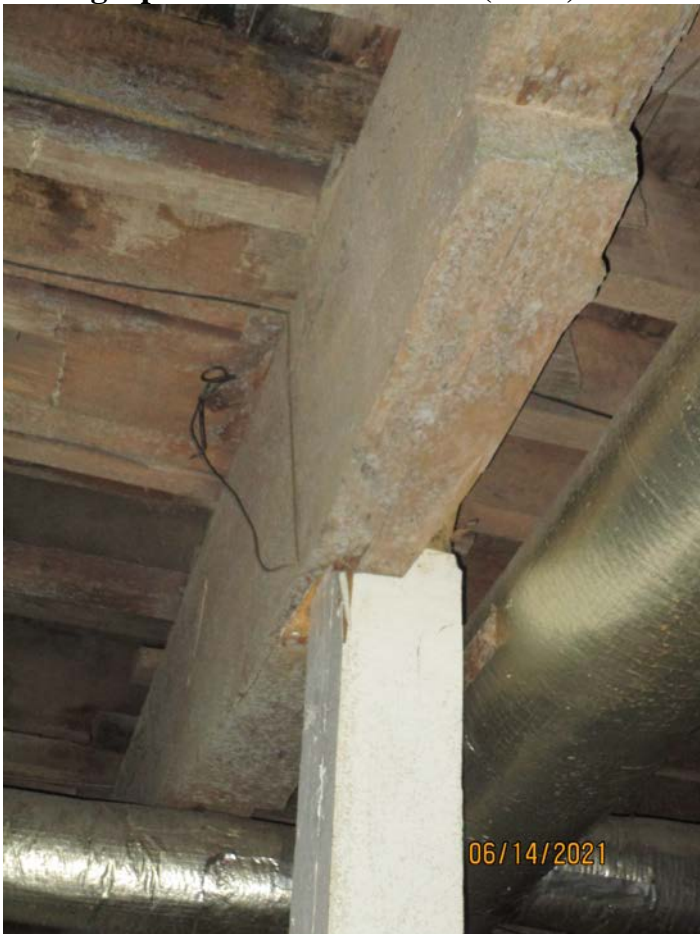
**Photograph 21: Basement level (front) of Building 170.**

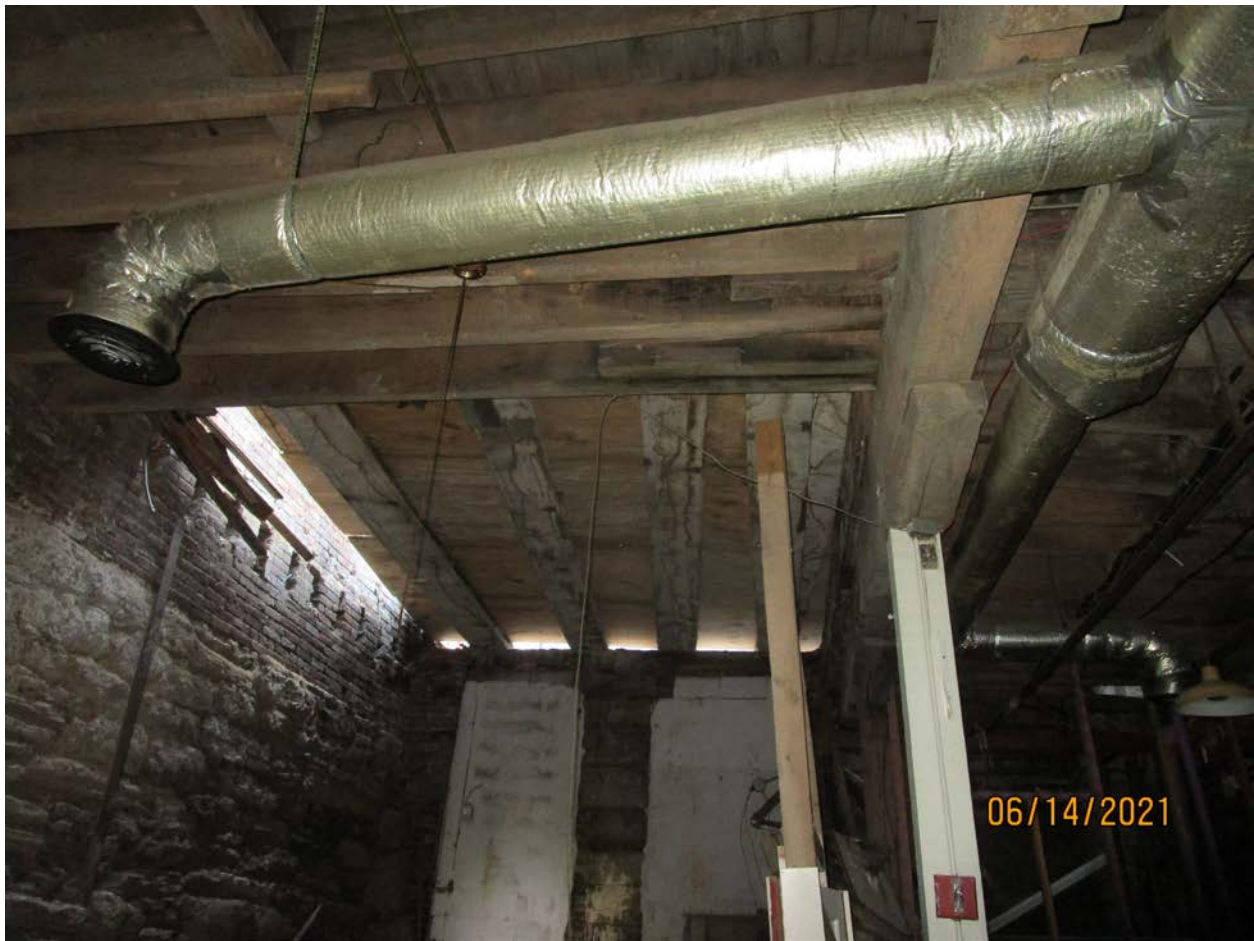
**Photograph 22: Left basement wall of building 170.**

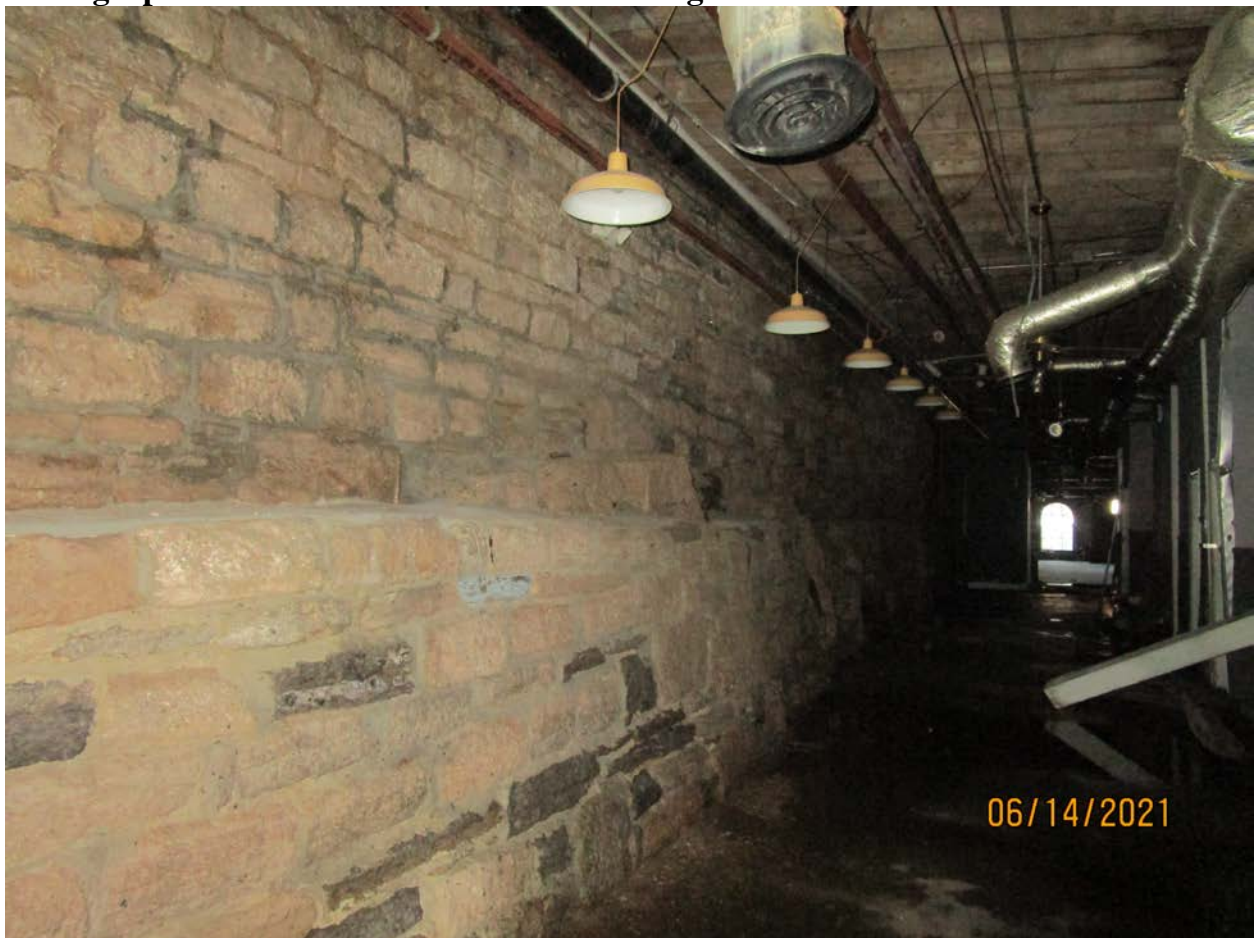
**Photograph 23: Basement level (front) of Building 170.**

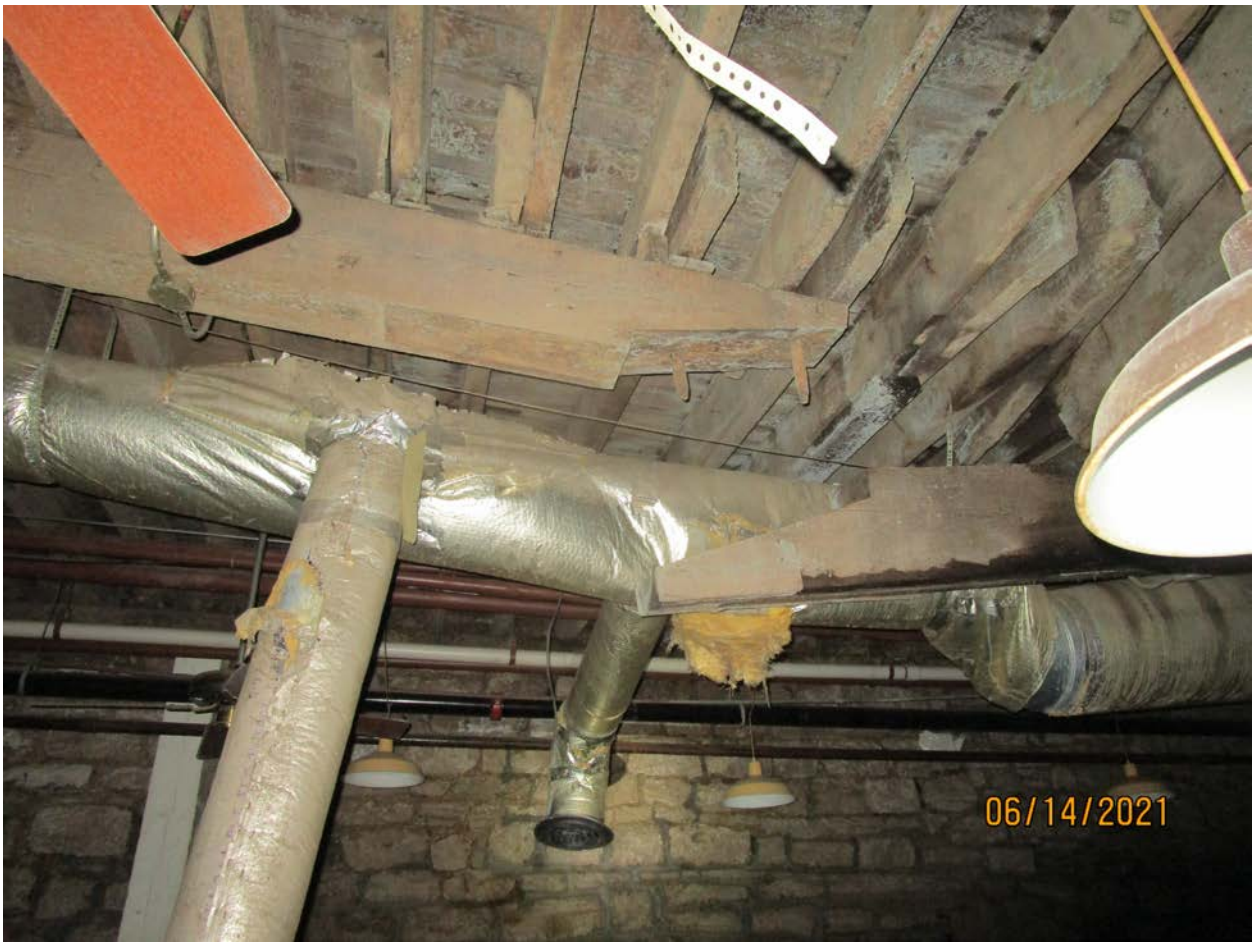
**Photograph 24: Basement level (front) of Building 170.**

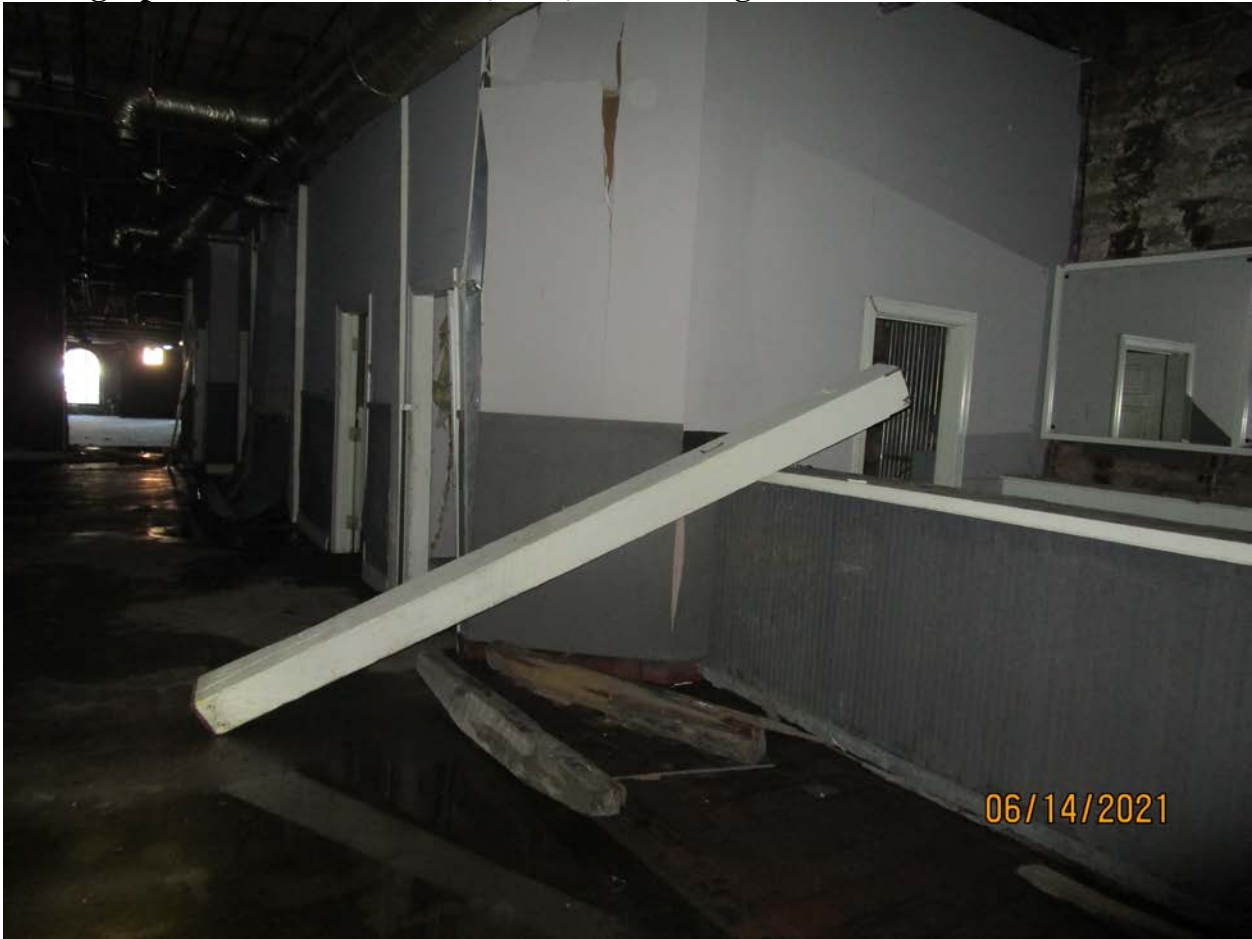
**Photograph 25: Left-side wall of Building 170 (rear of building).**

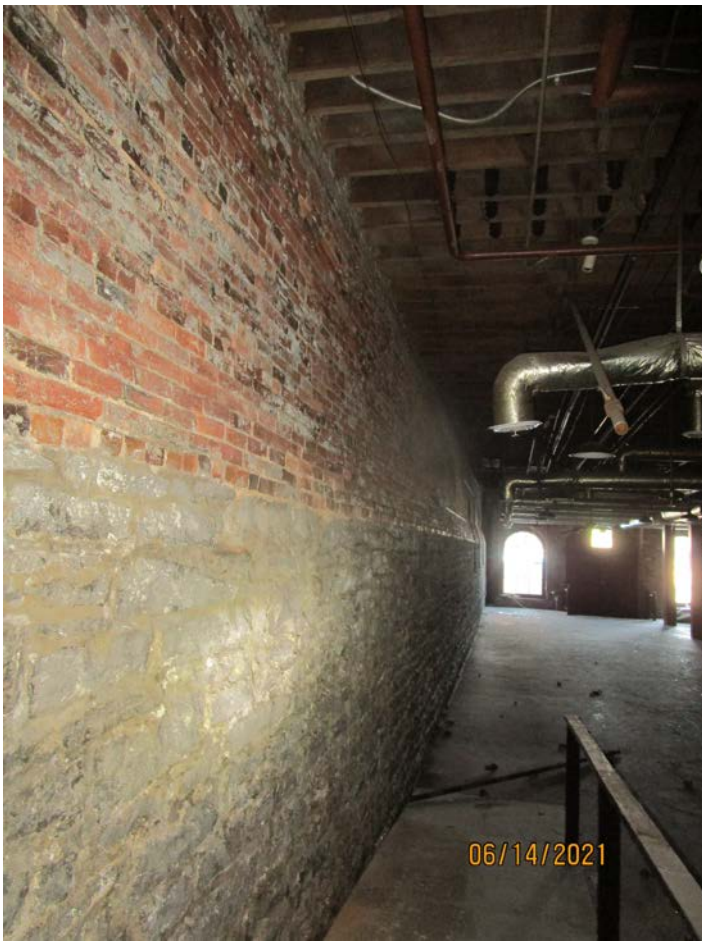
**Photograph 26: Overview of rear of Building 170 at basement.**

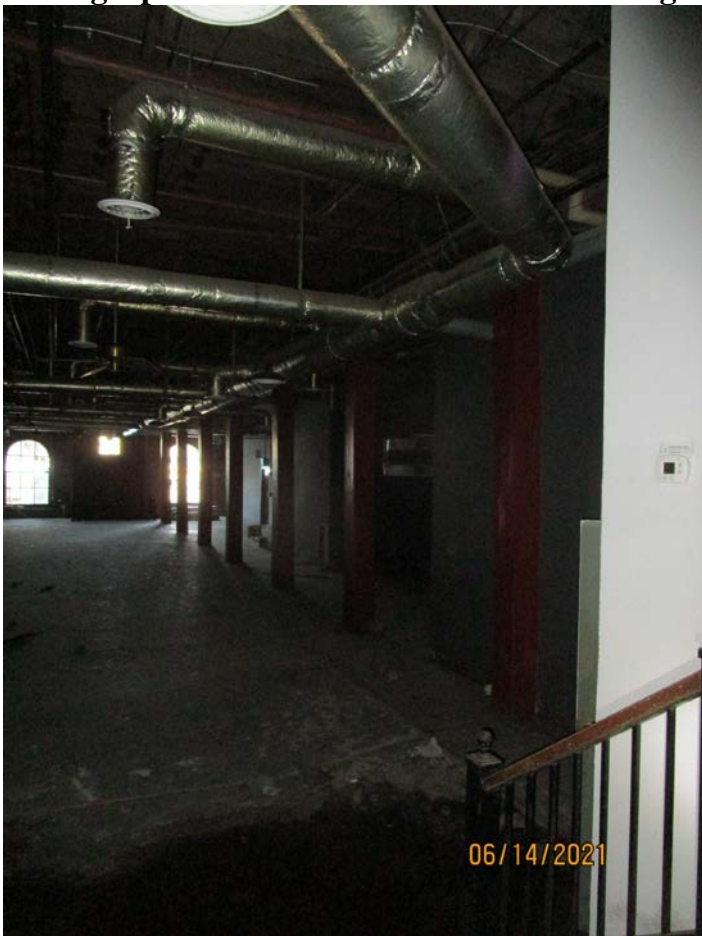
**Photograph 27: Overview of rear of Building 170 at basement.**

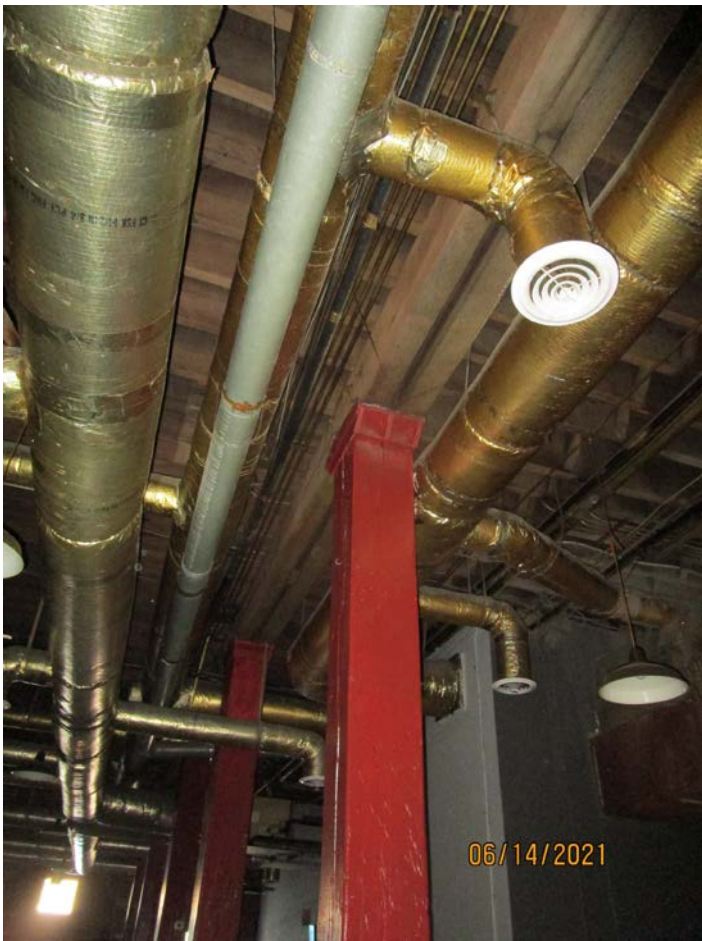
**Photograph 28: Overview of rear of Building 170 at basement.**

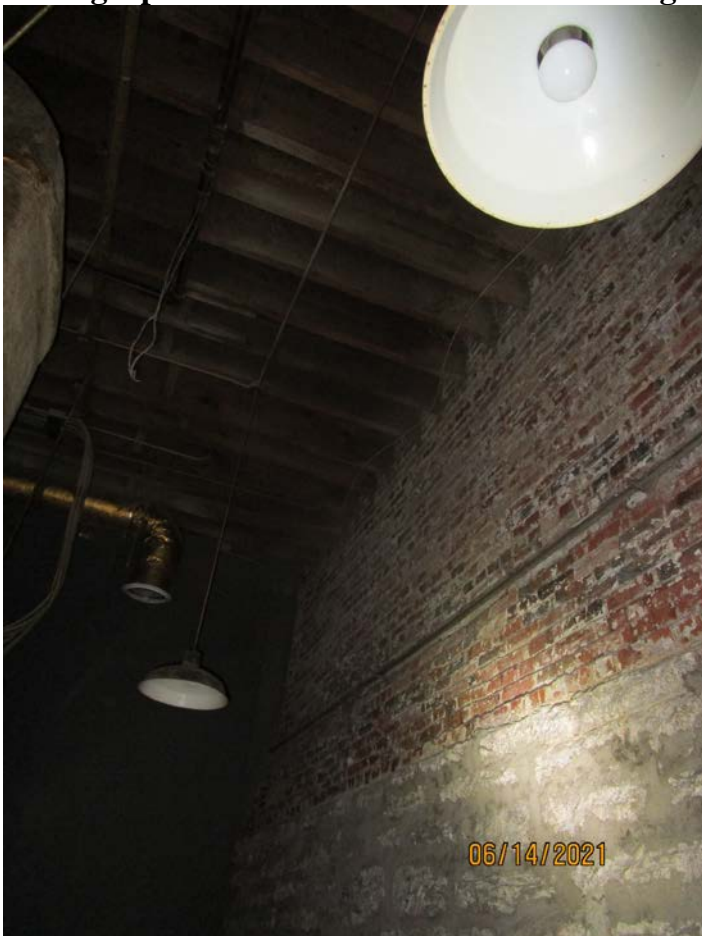
**Photograph 29: Floor joist attachment at rear wall of basement (Building 170).**

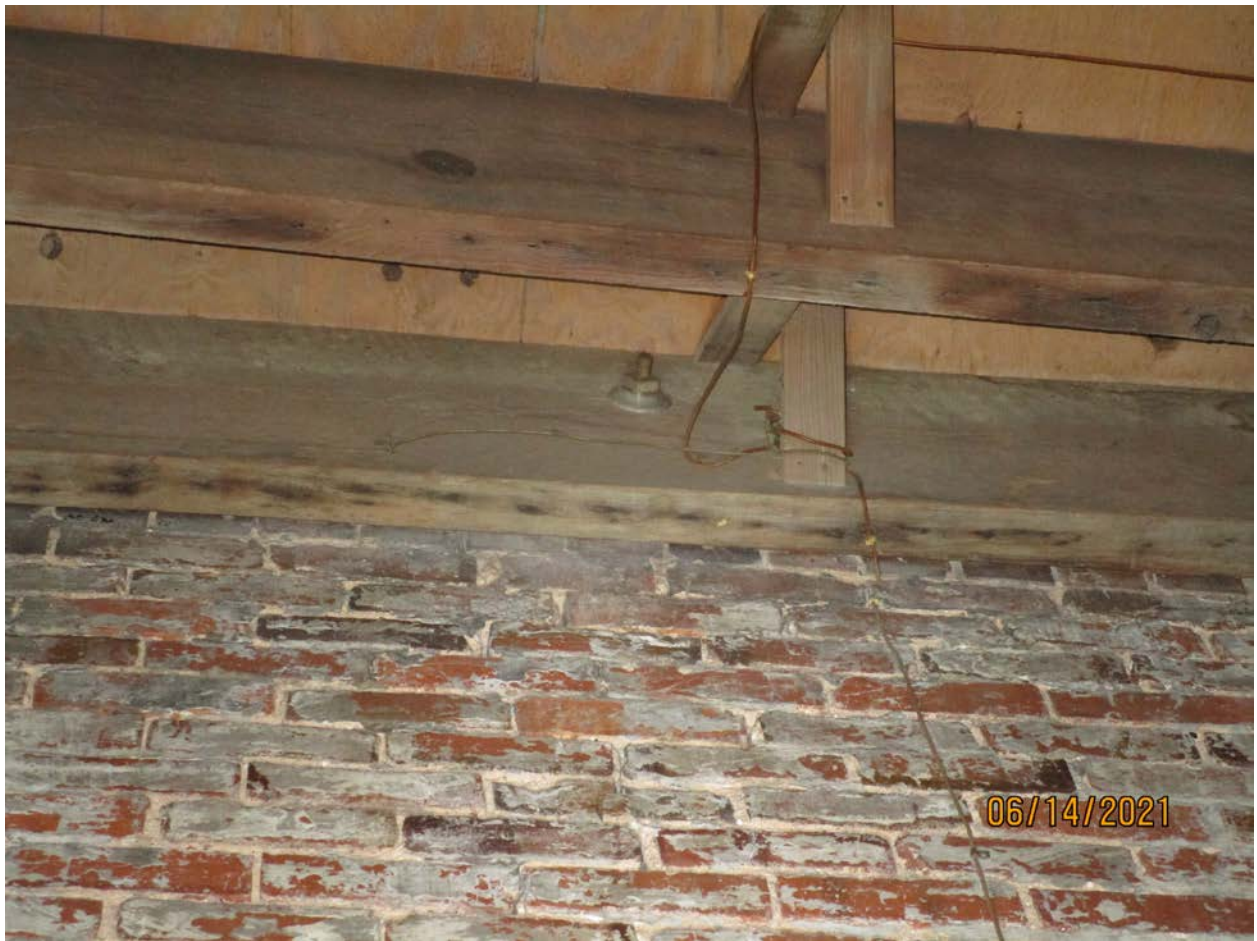
**Photograph 30: Floor joist attachment at rear wall of basement (Building 170).**

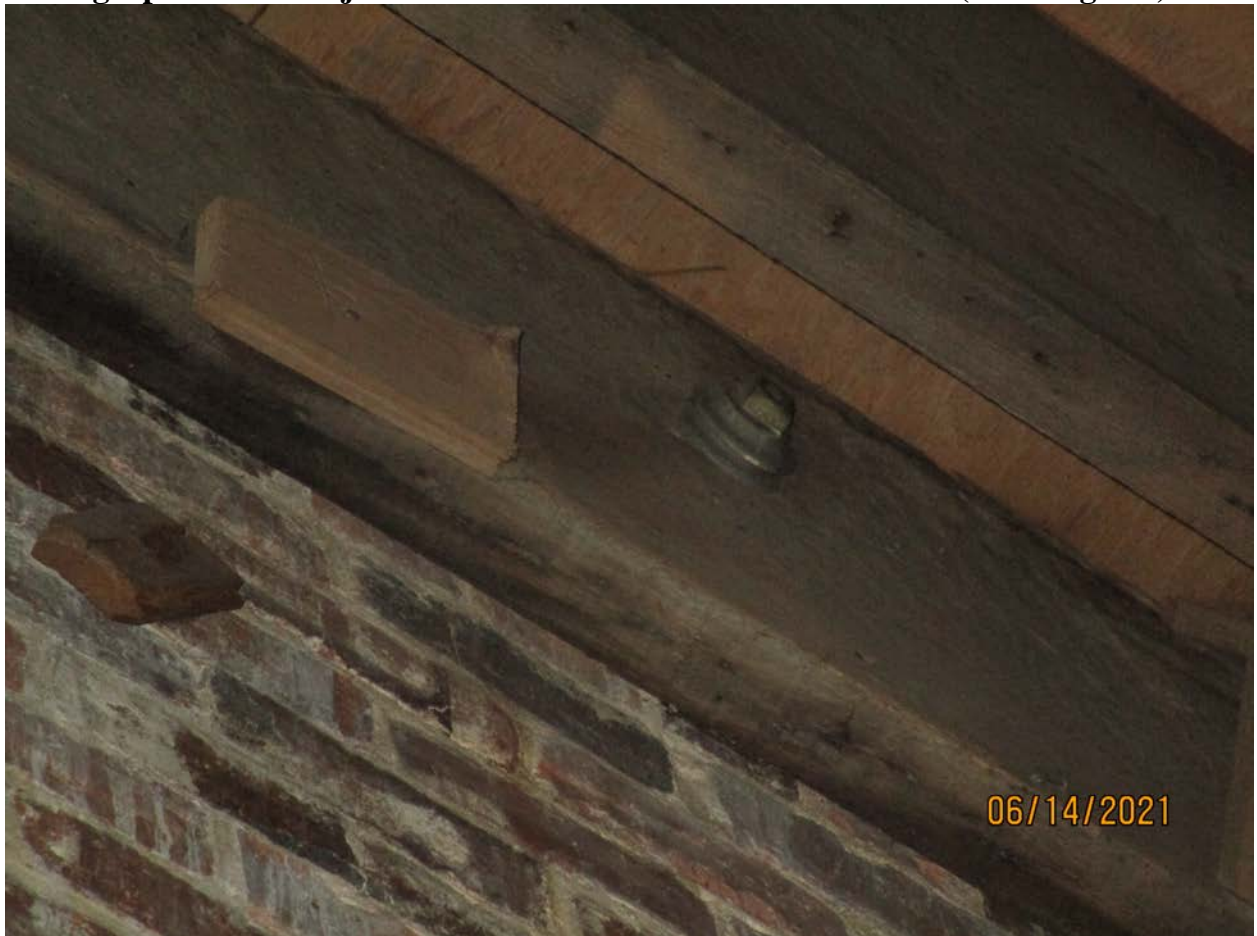
**Photograph 31: Right rear corner at basement level of Building 170.**

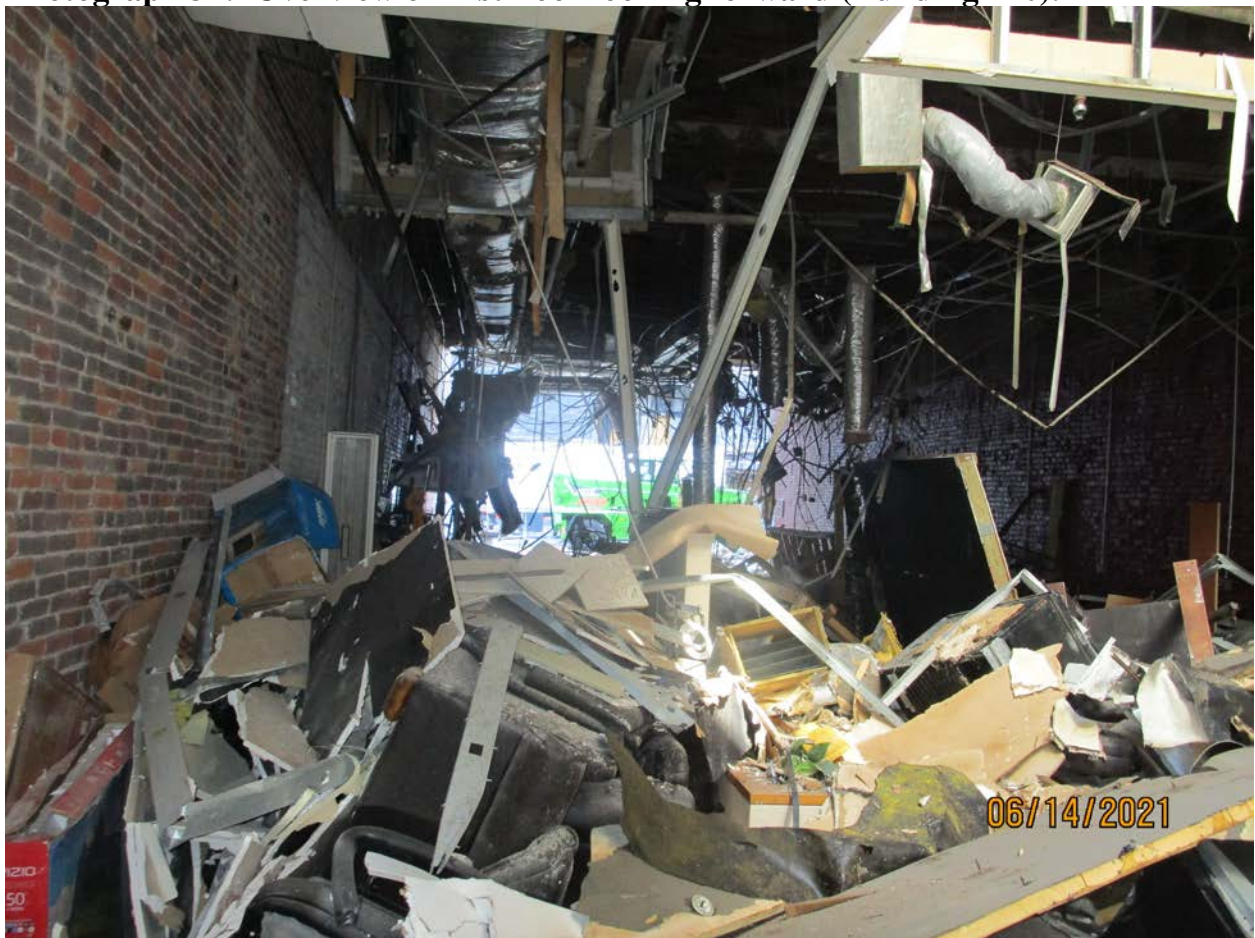
**Photograph 33: Overview of first floor looking rearward (Building 170).**

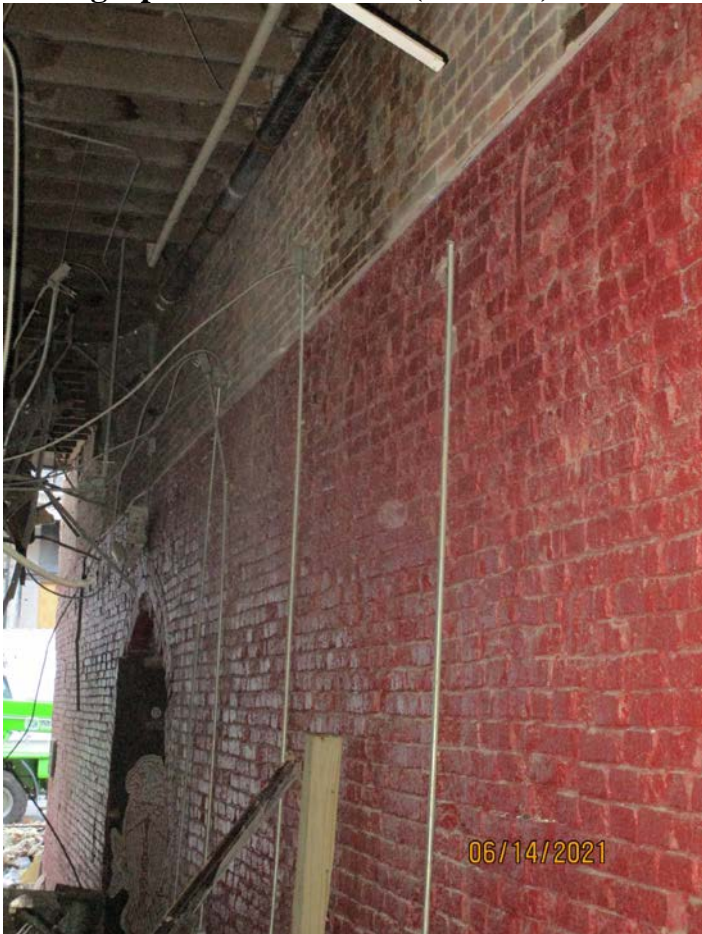
**Photograph 35: Second floor joist movement (left wall) of Building 170).**

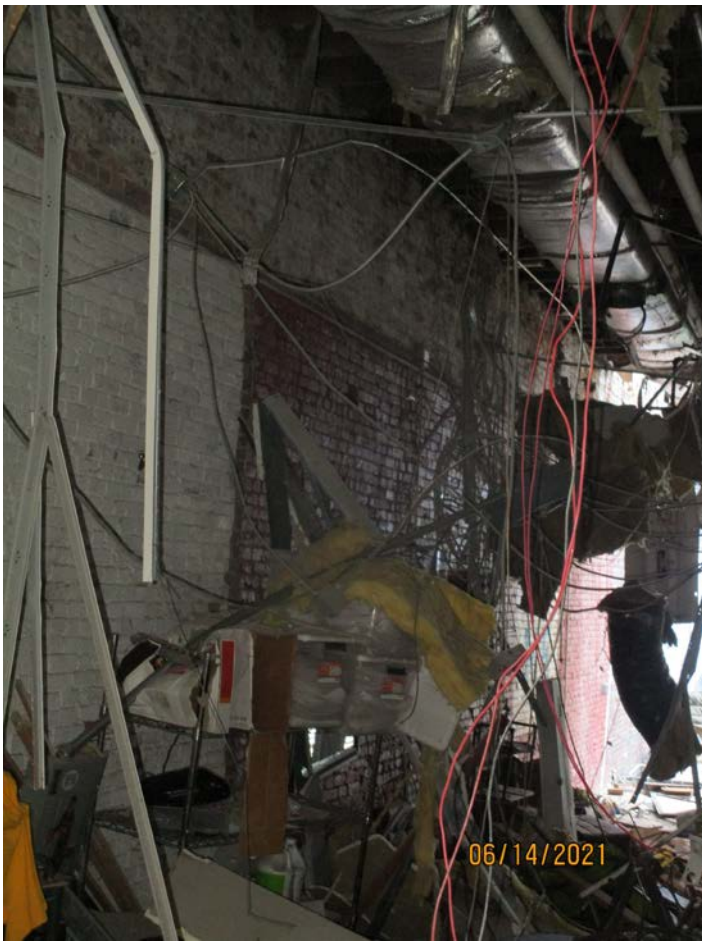
**Photograph 36: First floor (left wall) of Building 170.**

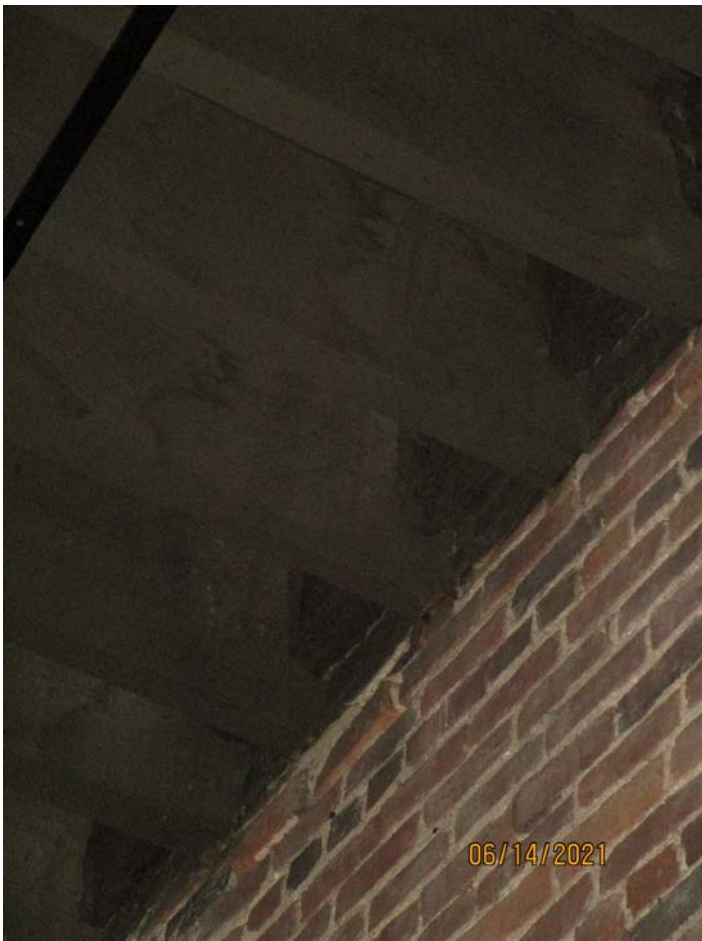
**Photograph 40: Typical floor framing at second floor (Building 170).**

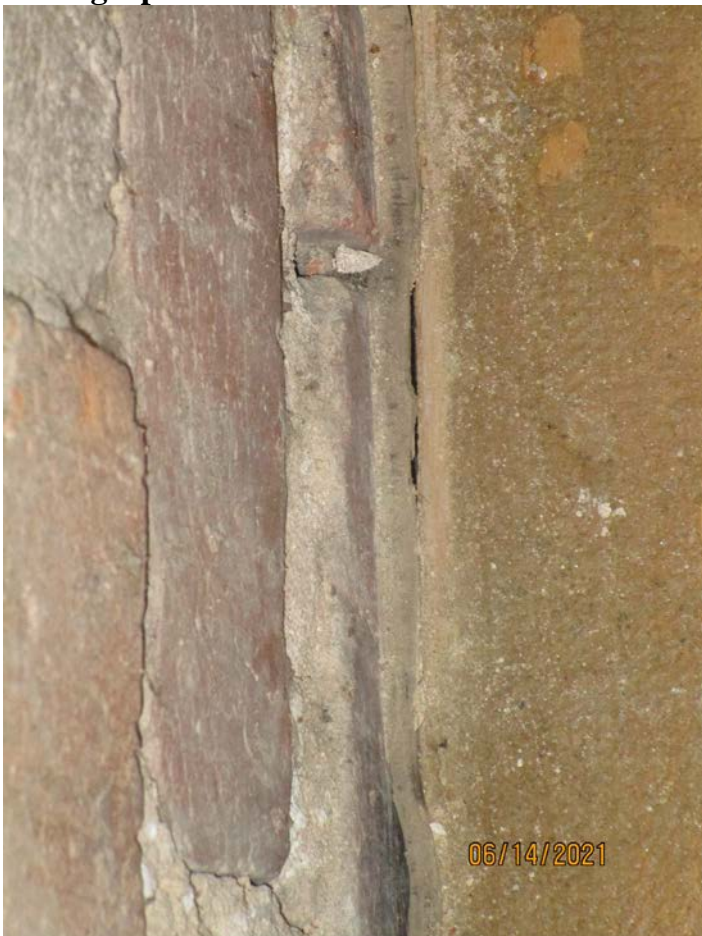
**Photograph 41: Right-side wall of second floor (Building 170).**

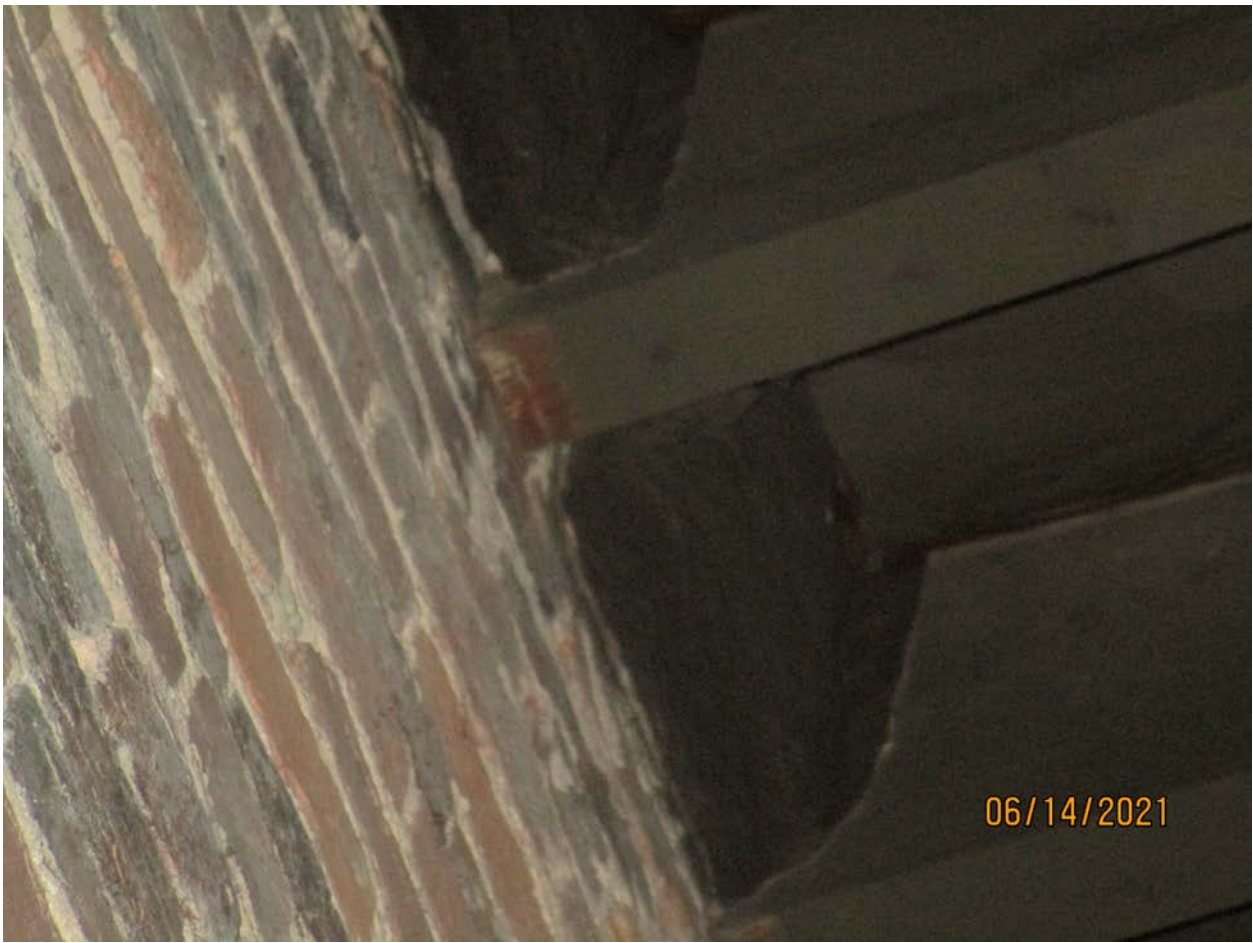
**Photograph 42: First floor movement at left-side wall (Building 170).**
