**METROPOLITAN GOVERNMENT OF NASHVILLE AND DAVIDSON COUNTY**

**STAFF RECOMMENDATION**  
**170-176 Second Avenue North**  
**July 21, 2021**

**Application:** Demolition  
**District:** Second Avenue Historic Preservation Zoning Overlay  
**Council District:** 19  
**Base Zoning:** DTC  
**Map and Parcel Number:** 09306206600 and 09302401900  
**Applicant:** Callen Trust, property owner  
**Project Lead:** Robin Zeigler, robin.zeigler@nashville.gov

**Description of Project:** The property owner requests to demolish four historic buildings in the Second Avenue Historic Preservation Zoning Overlay, damaged in the 2020 Christmas morning explosion.

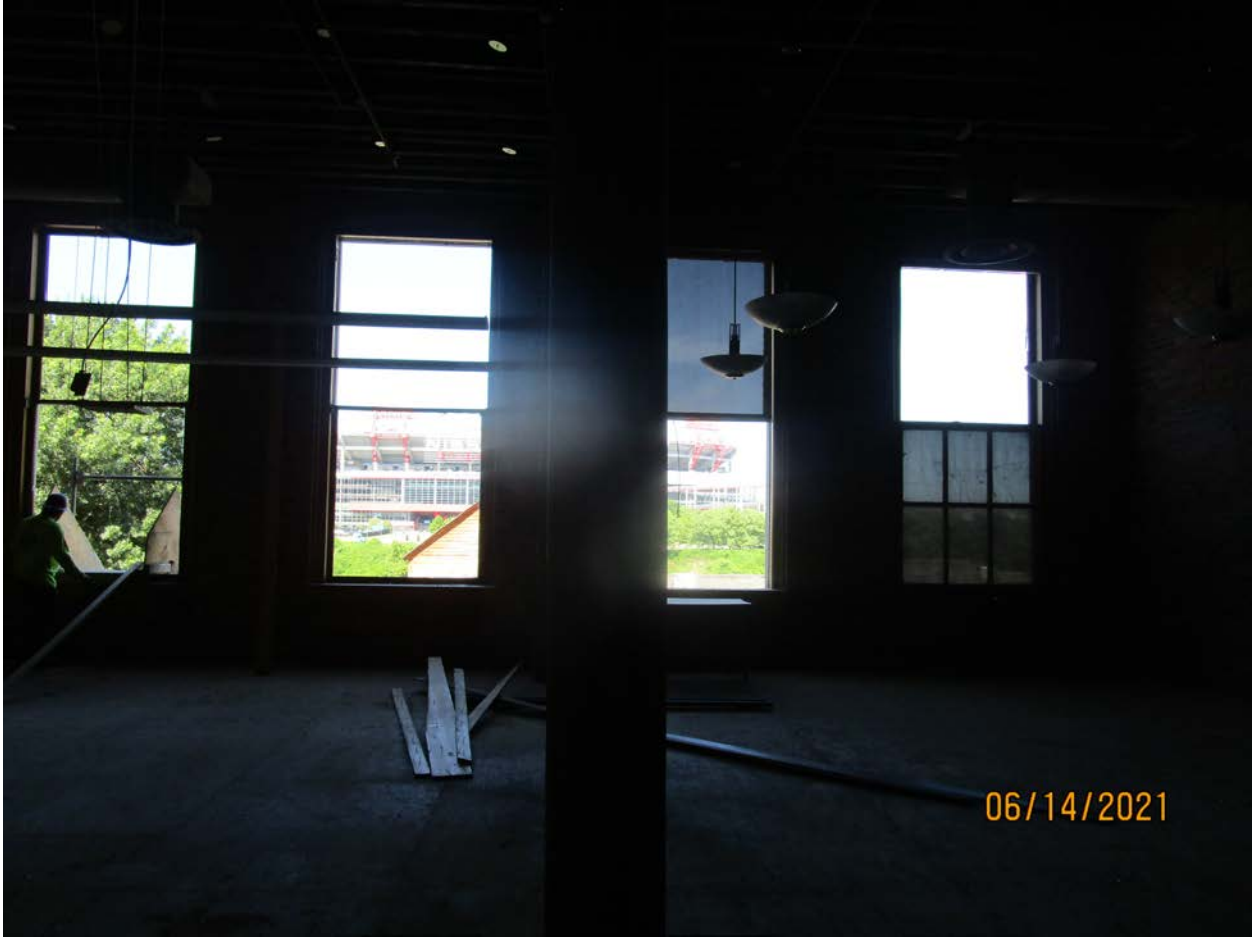
**Photograph 43: Second floor left-side wall movement (Building 170).**

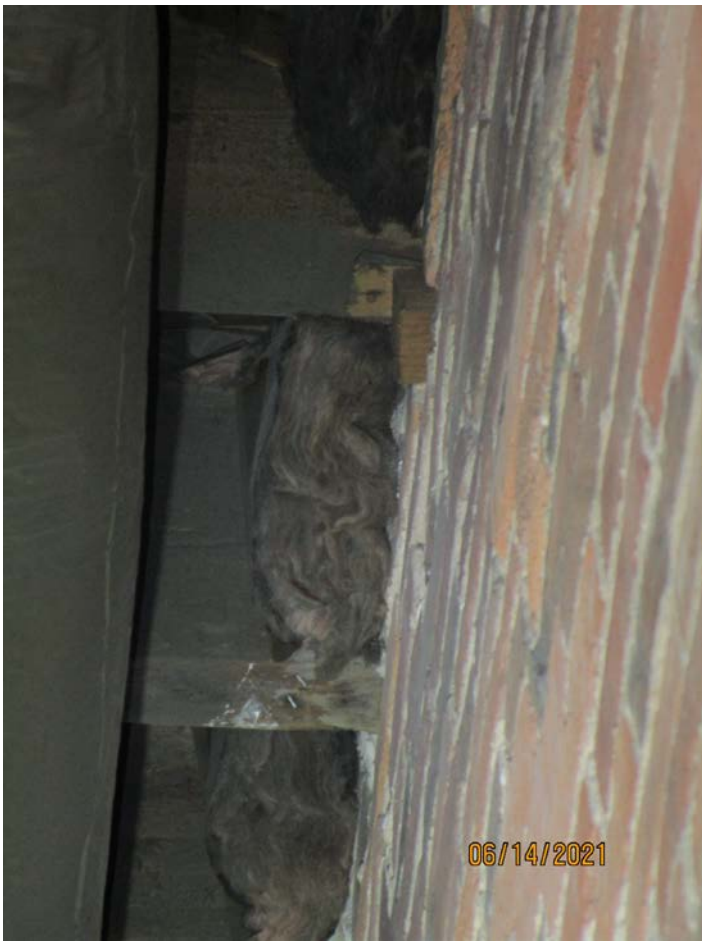
**Photograph 44: Rear wall of first floor (Building 170).**

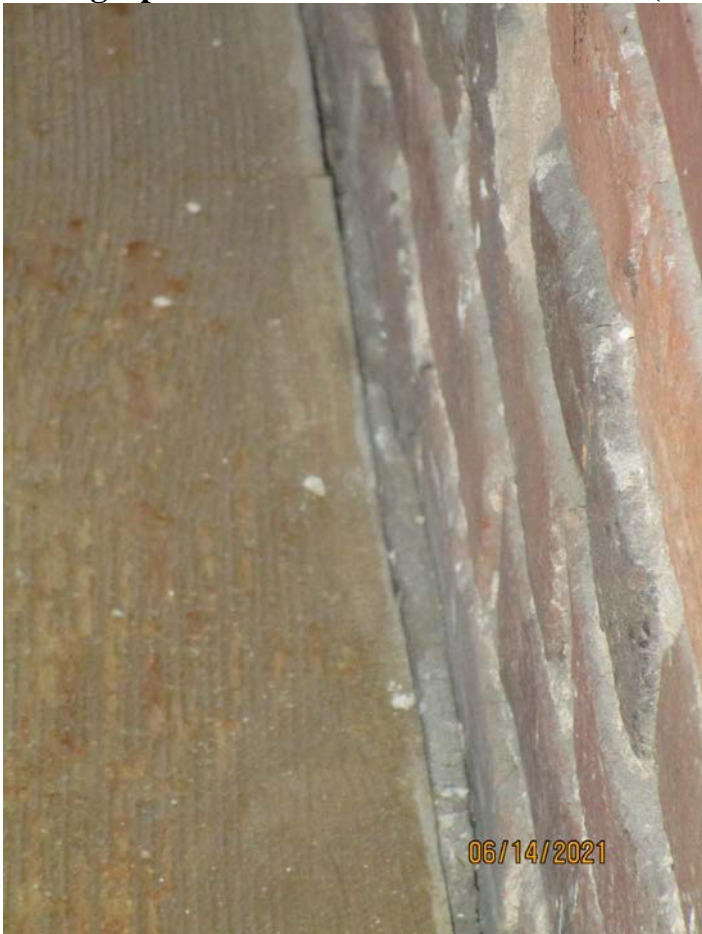
**Photograph 45: Right-side wall at second floor (Building 170).**

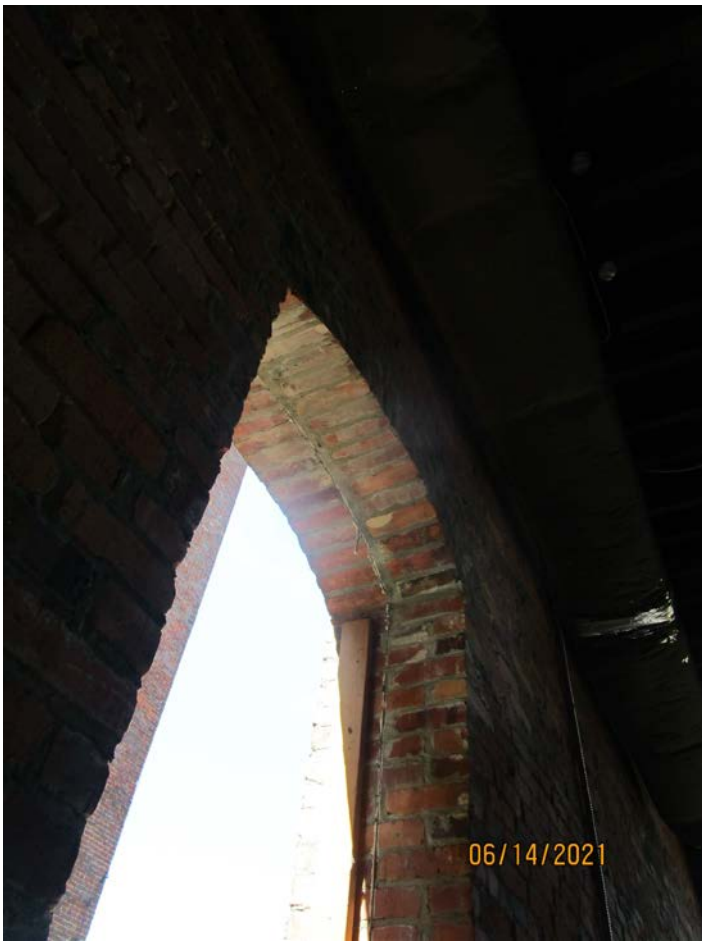
**Photograph 46: Left-side wall at first floor (Building 170).**

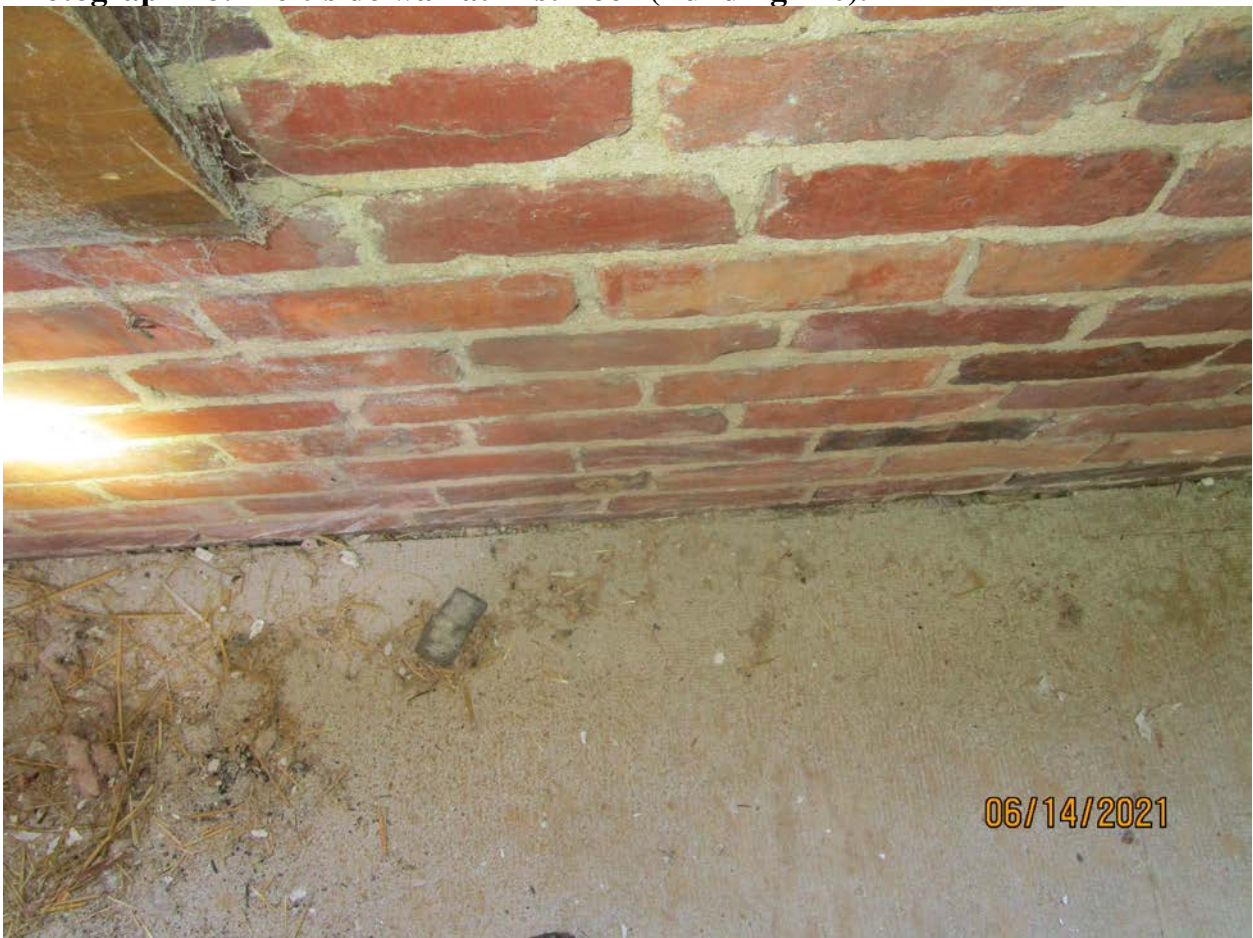
**Photograph 47: Left-side wall at first floor (Building 170).**

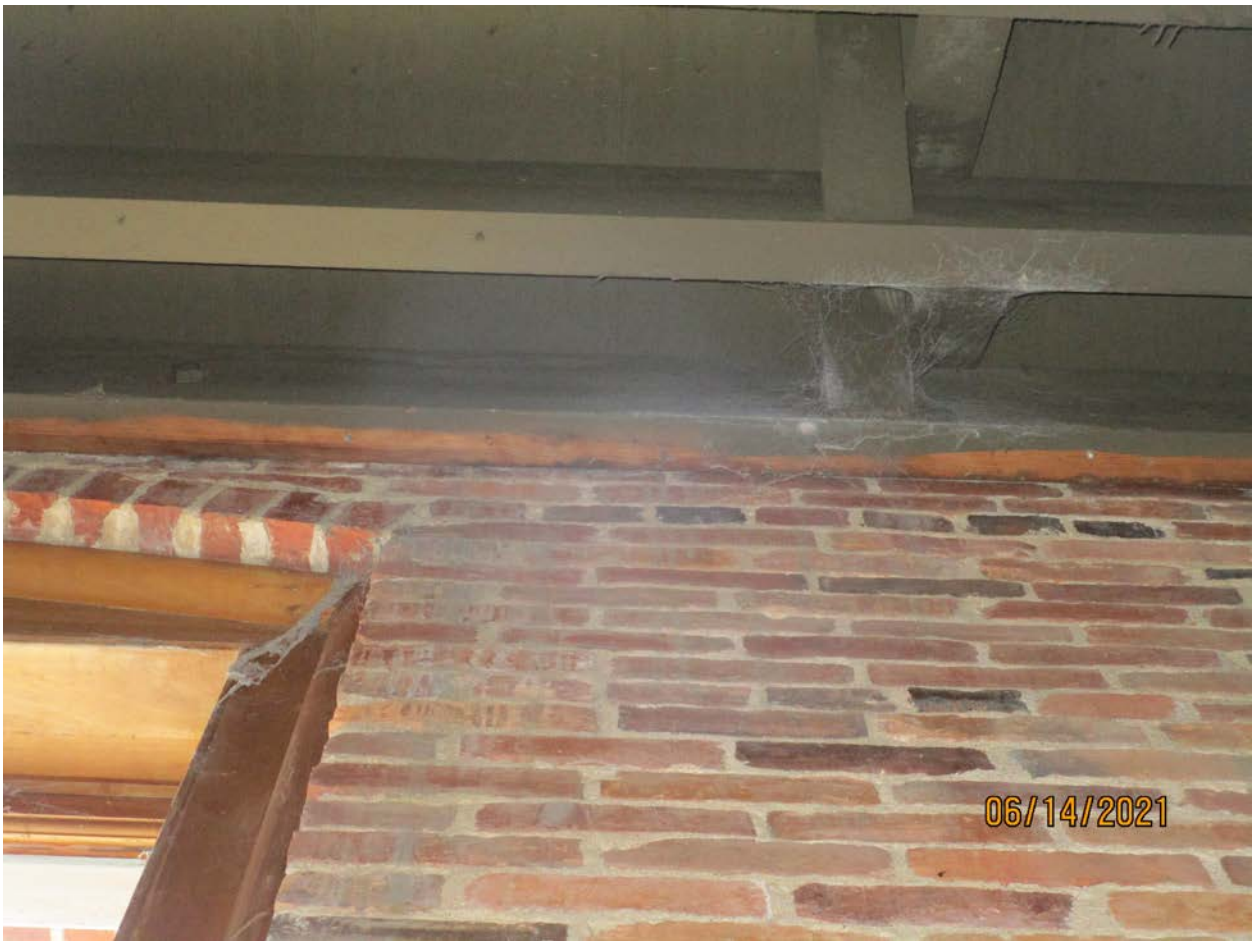
**Photograph 48: Left-side wall at first floor (Building 170).**

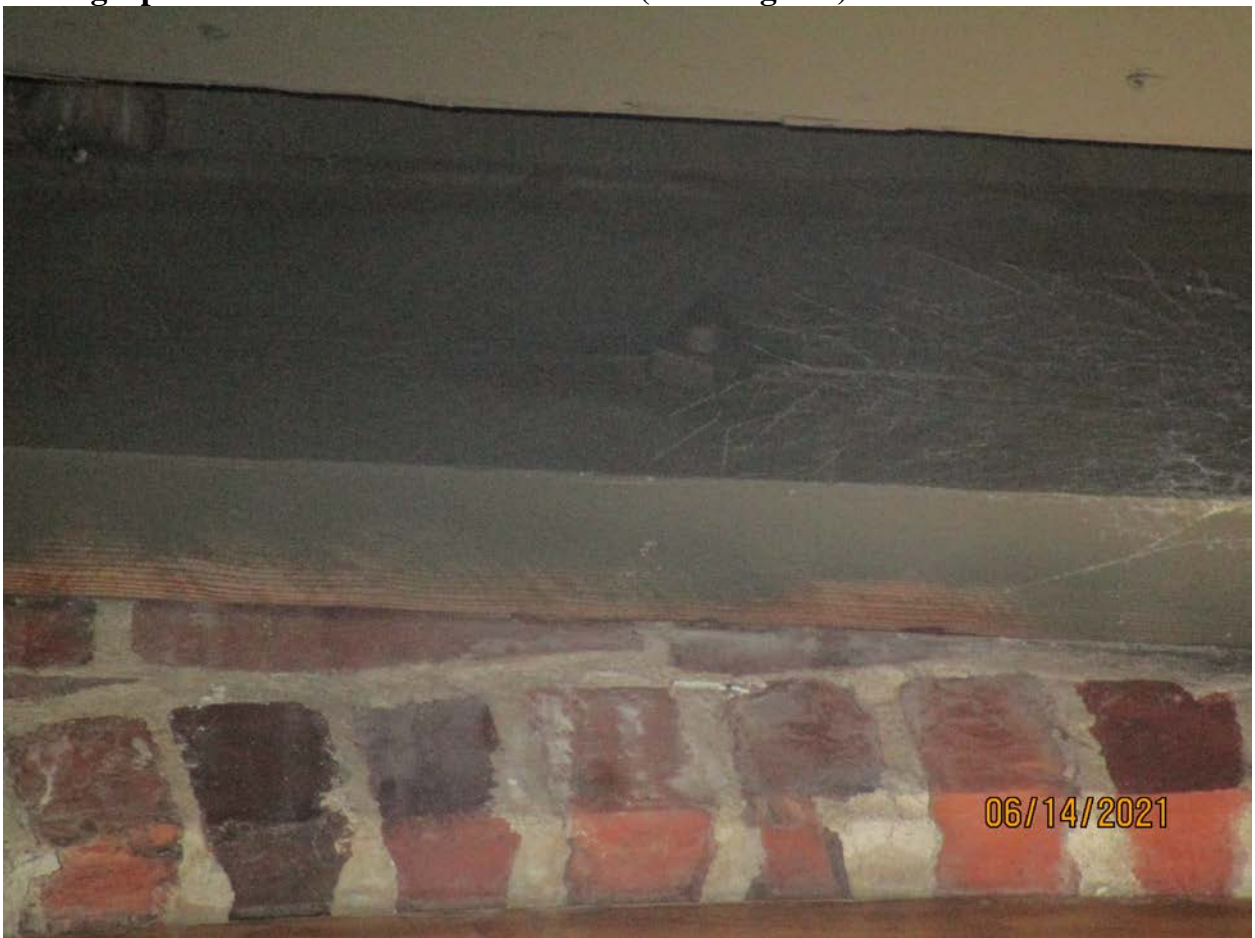
**Photograph 49: Rear wall at second floor (Building 170).**

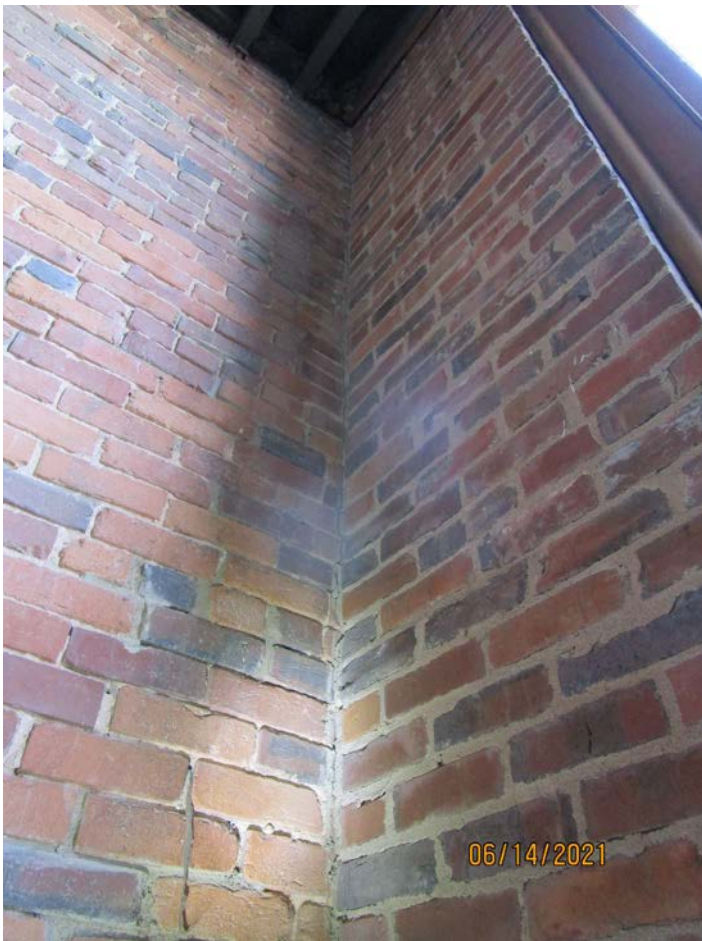
**Photograph 50: Rear wall at second floor (Building 170).**

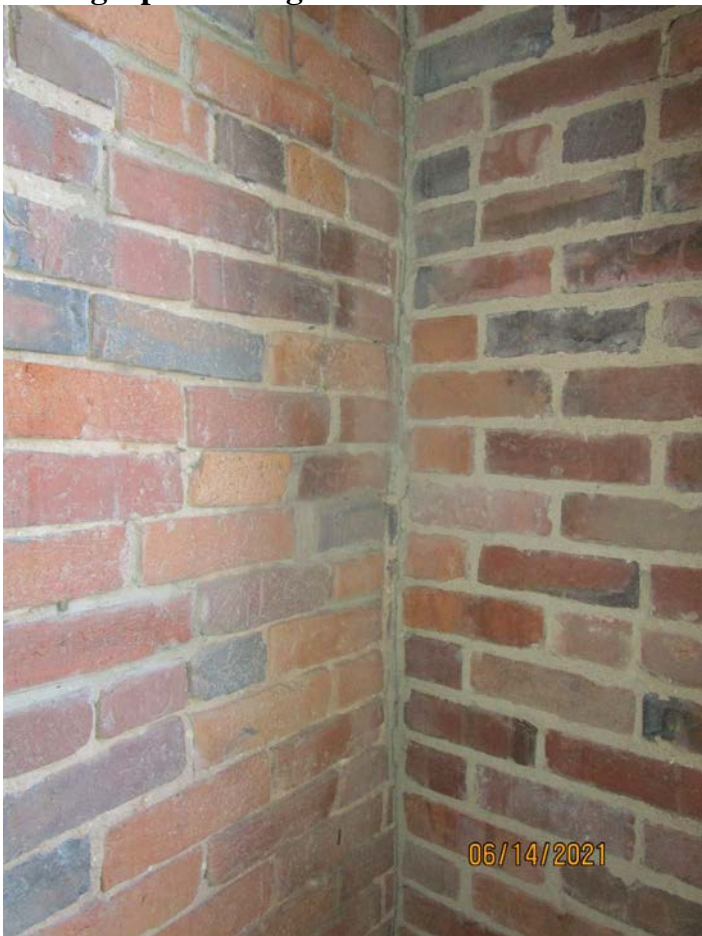
**Photograph 51: Left rear corner at first floor (Building 170).**

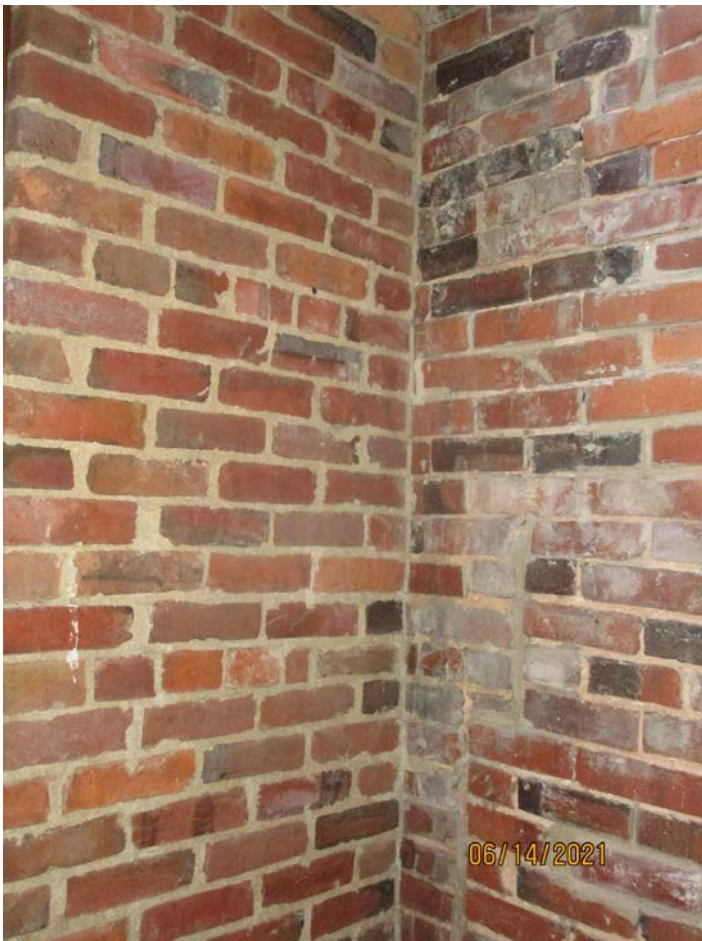
**Photograph 52: Right rear corner at first floor (Building 170).**

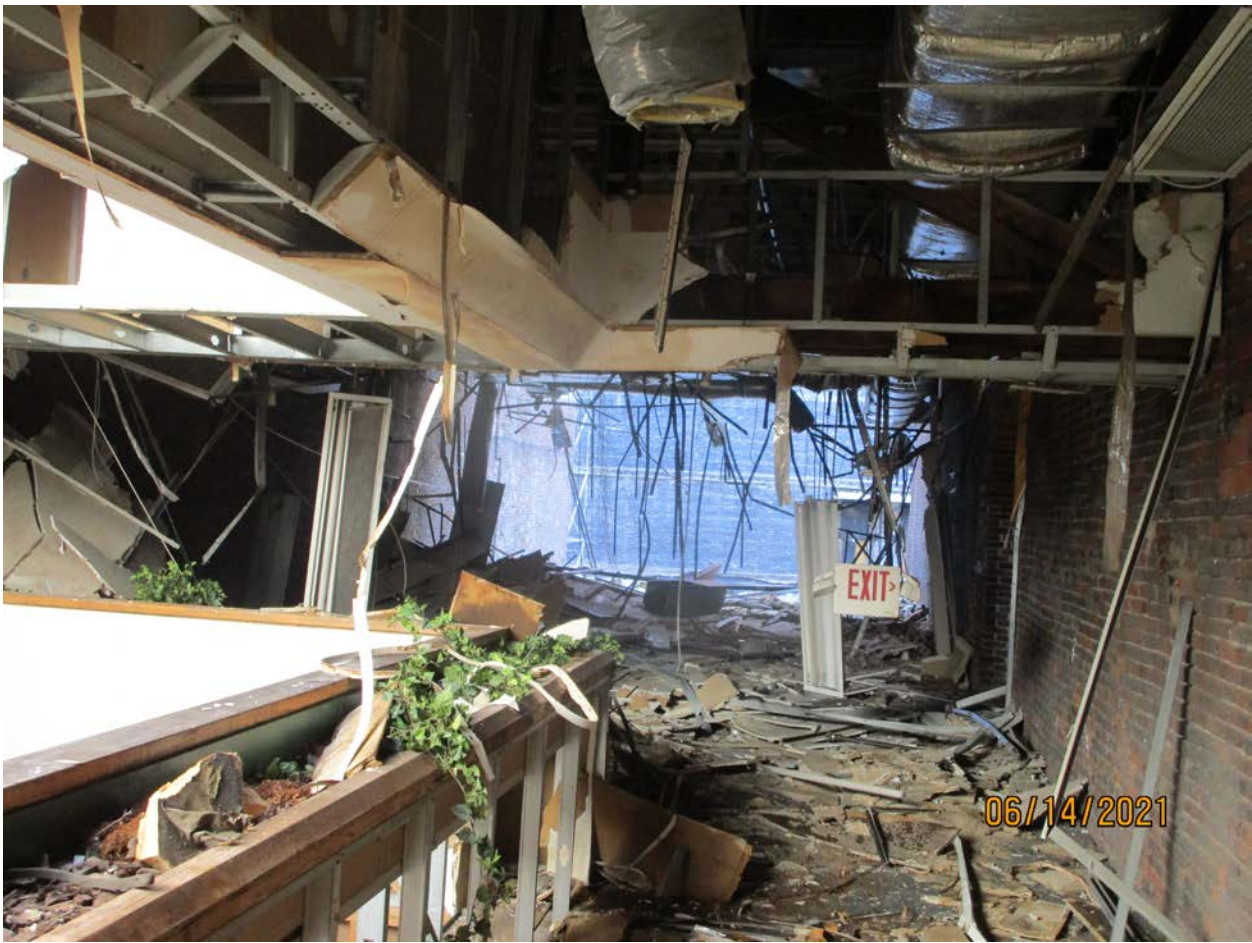
**Photograph 54: Second floor framing at rear (Building 170).**

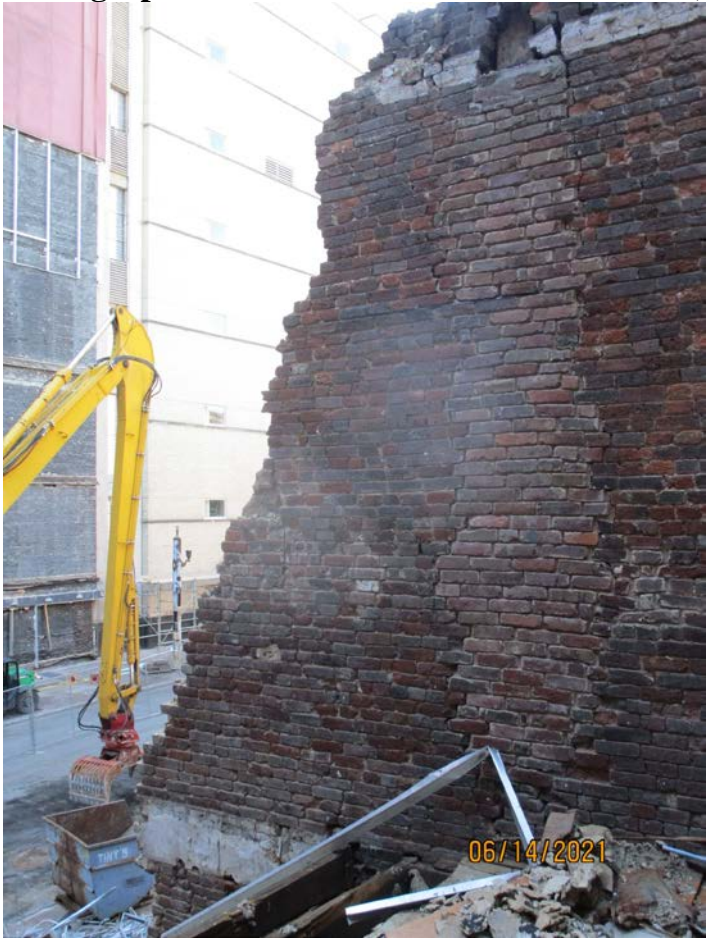
**Photograph 55: Front view of second floor (Building 170).**

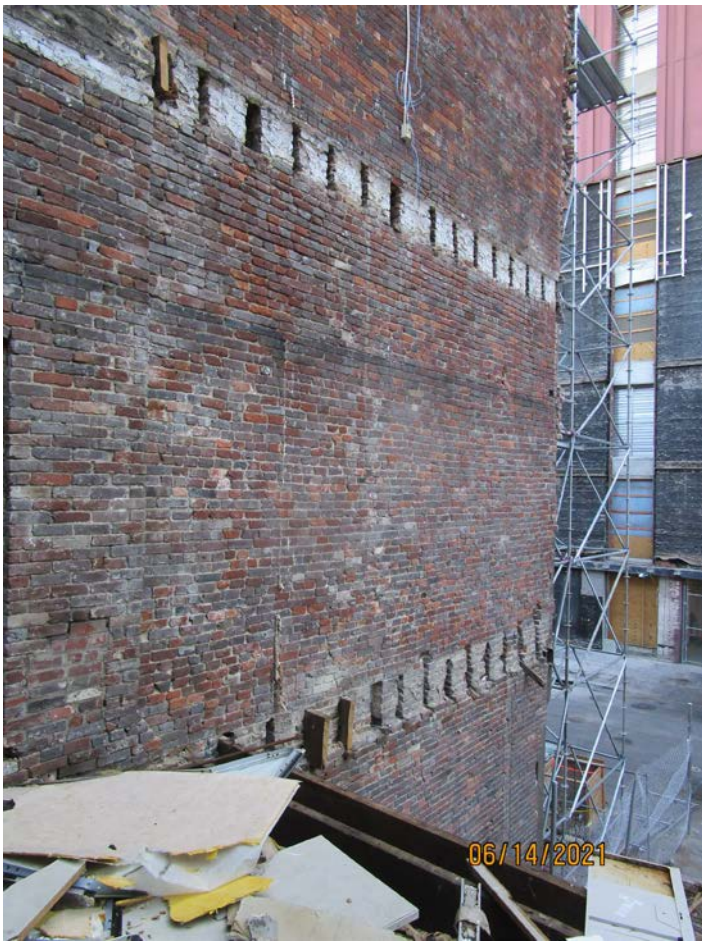
**Photograph 56: Left-side wall of second floor (Building 170).**

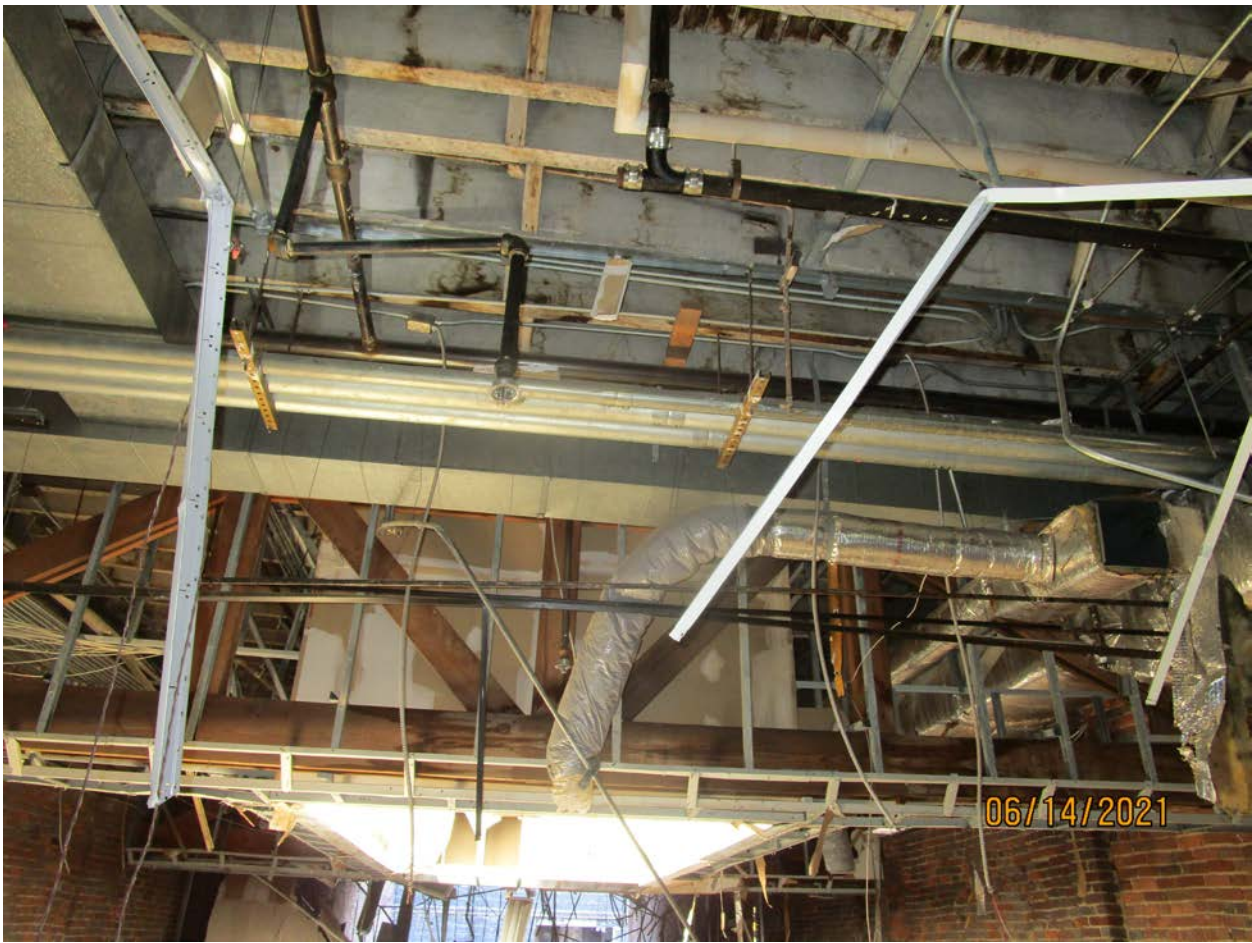
**Photograph 62: Third floor framing (Building 170).**

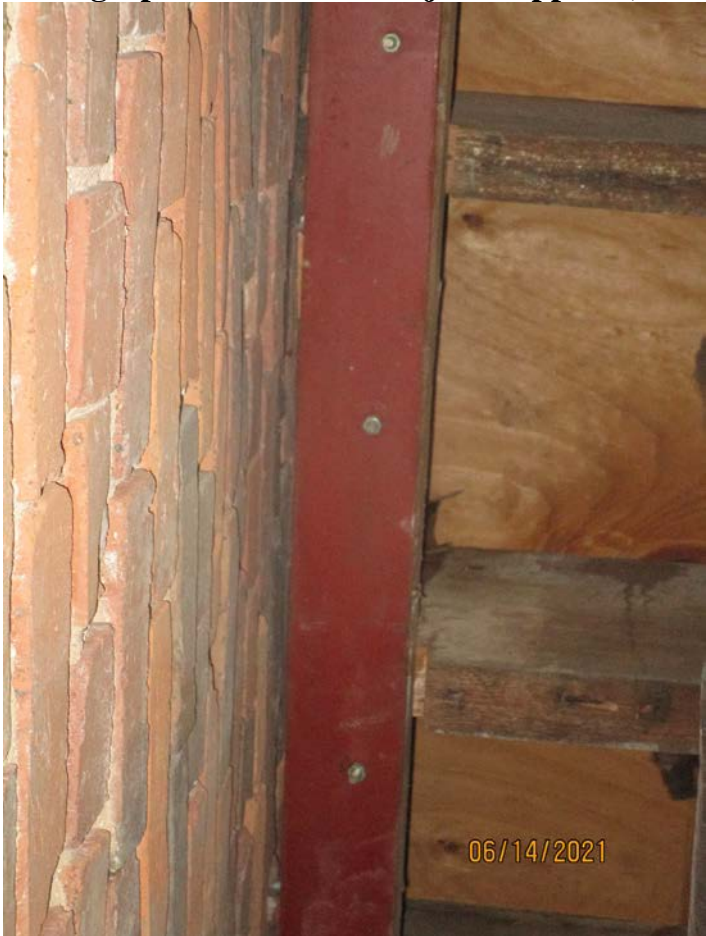
**Photograph 63: Wood truss at third floor (Building 170).**

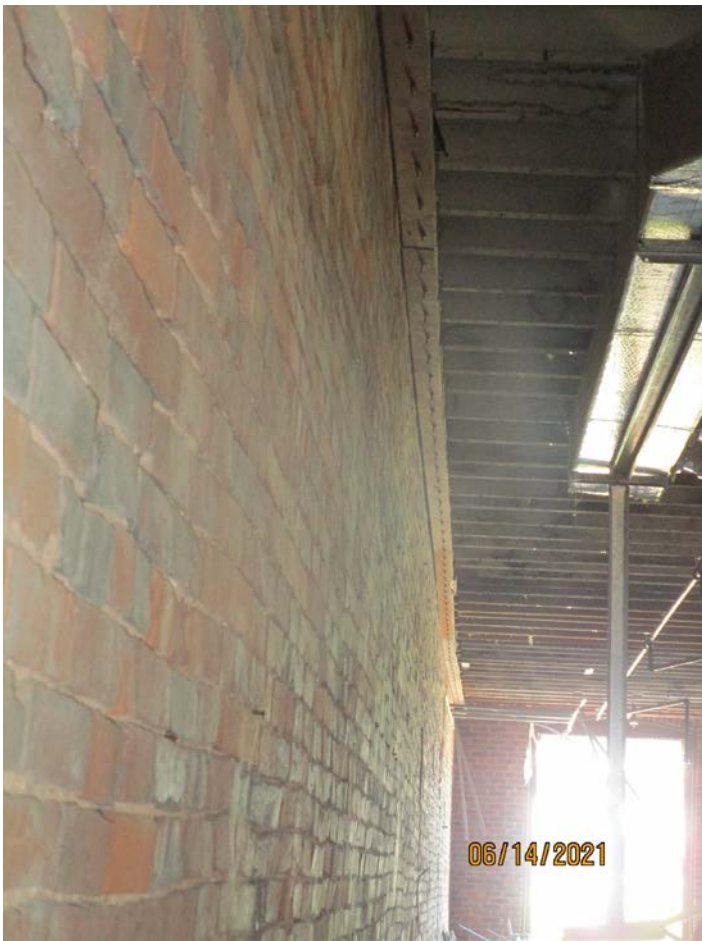
**Photograph 64: Third floor joist support (left-side wall) at Building 170).**

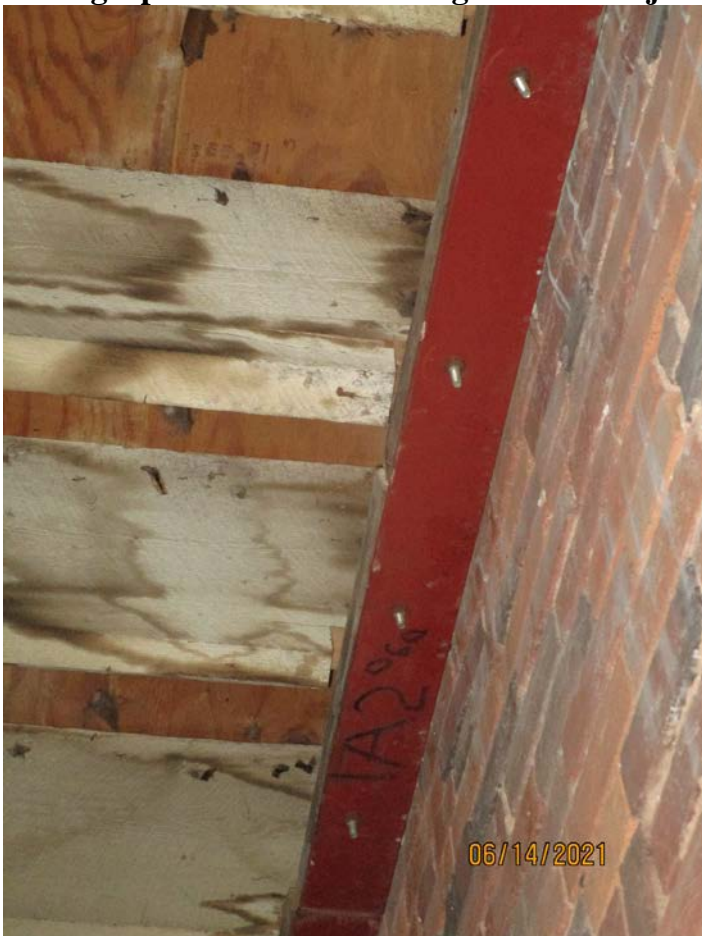
**Photograph 65: Overview of left-side wall of third floor (Building 170).**

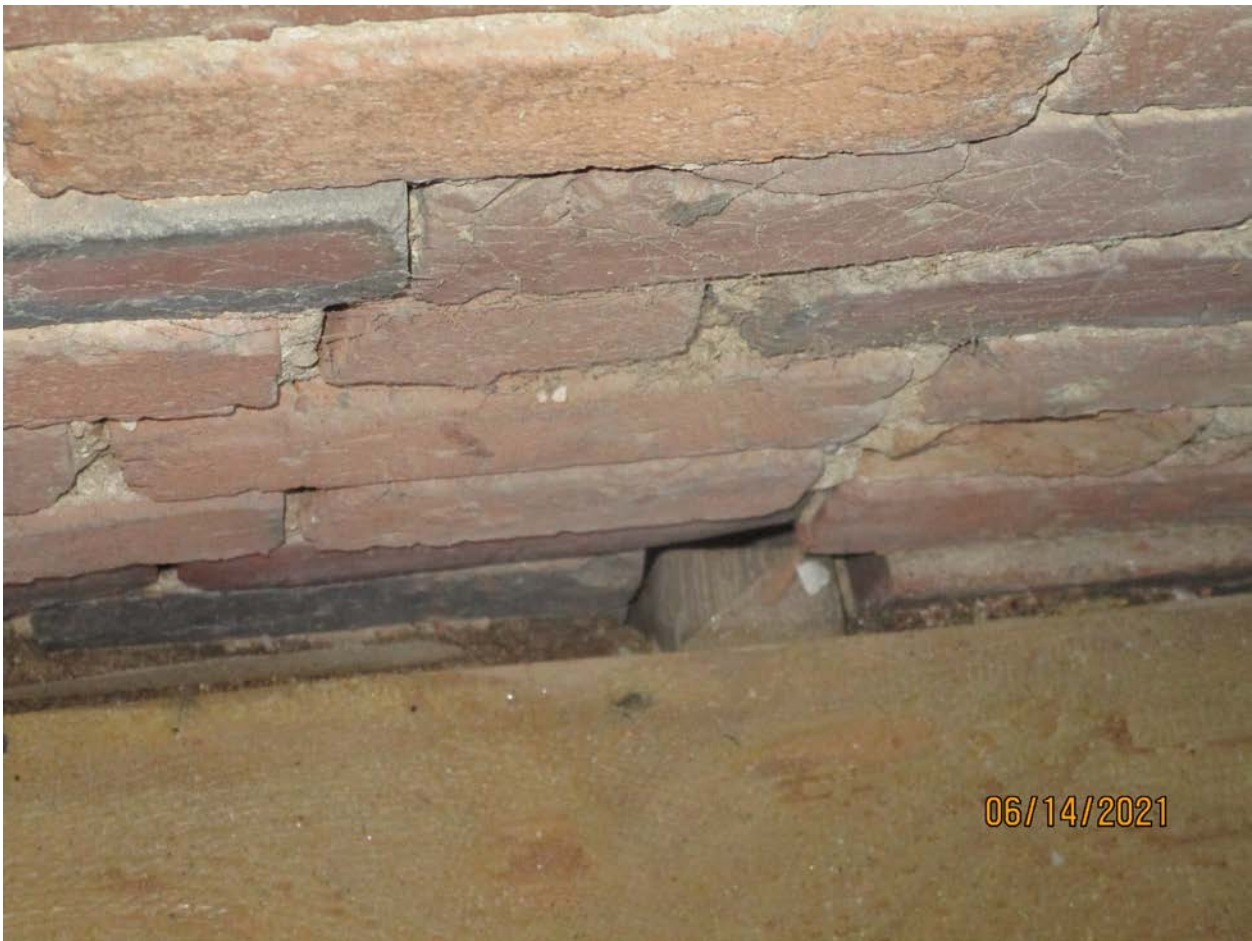
**Photograph 66: Third floor right-side wall joist support (Building 170).**

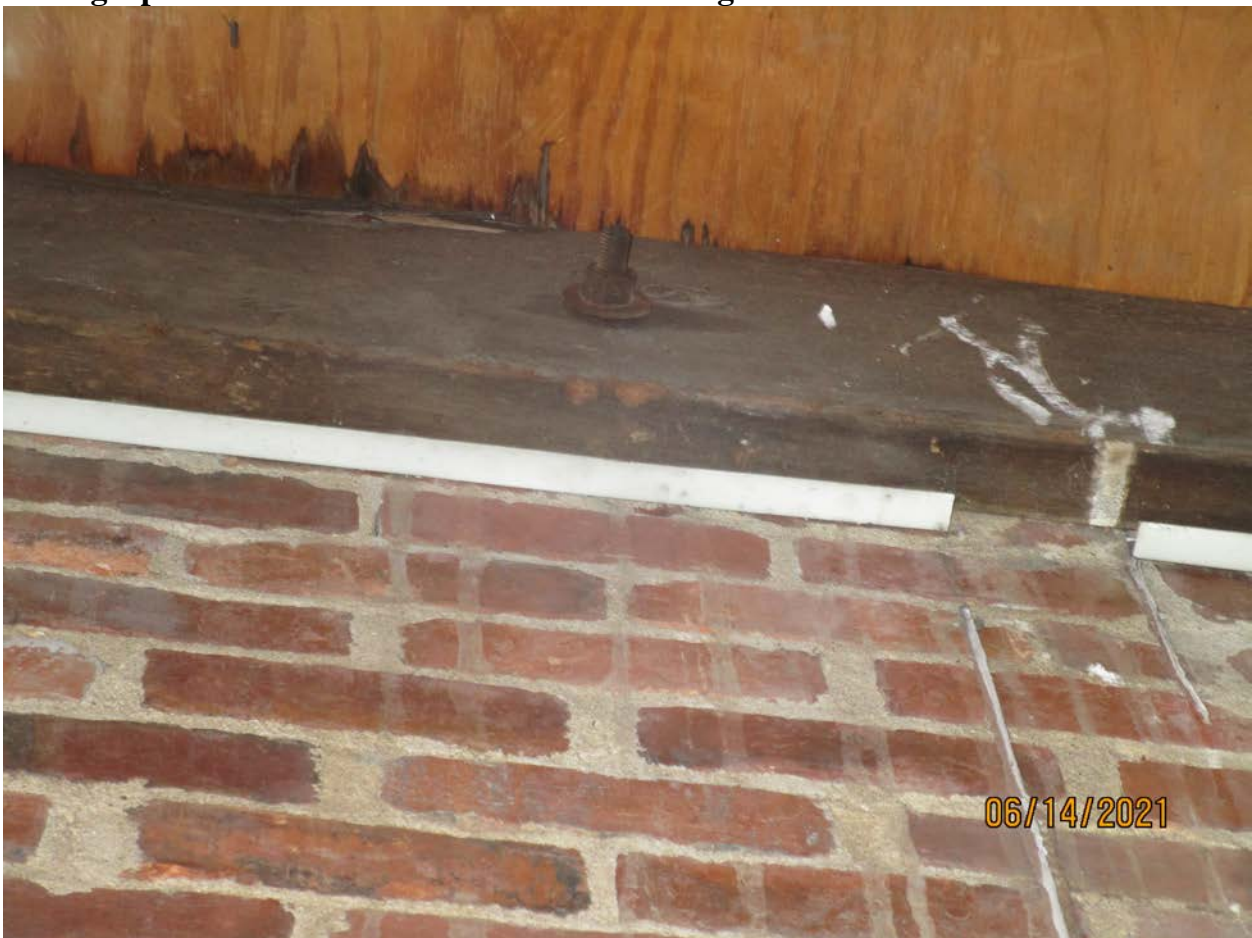
**Photograph 69: Second floor/rear wall of Building 170.**

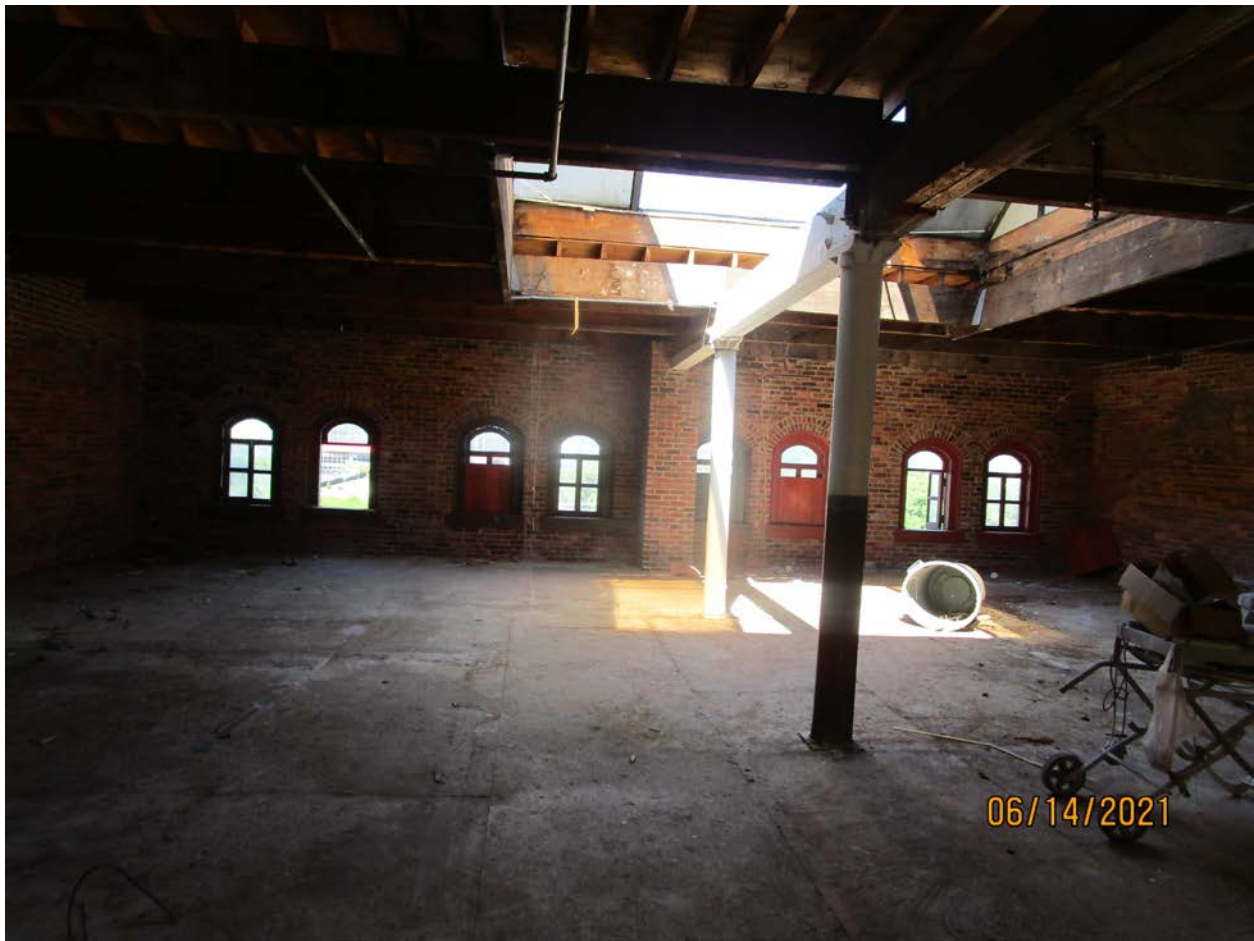
**Photograph 70: Third floor/rear wall of Building 170.**

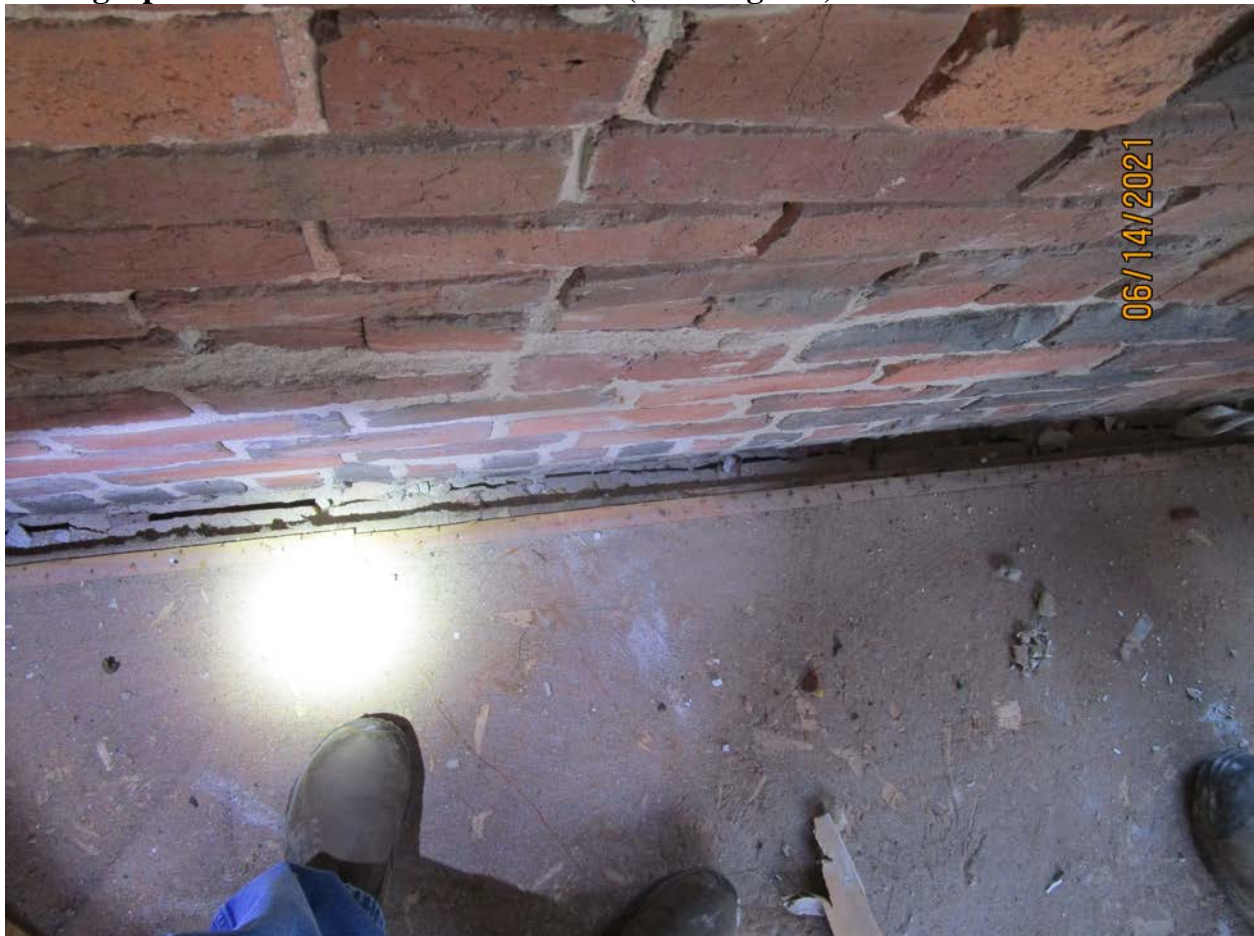
**Photograph 71: Overview of third floor rear wall (Building 170).**

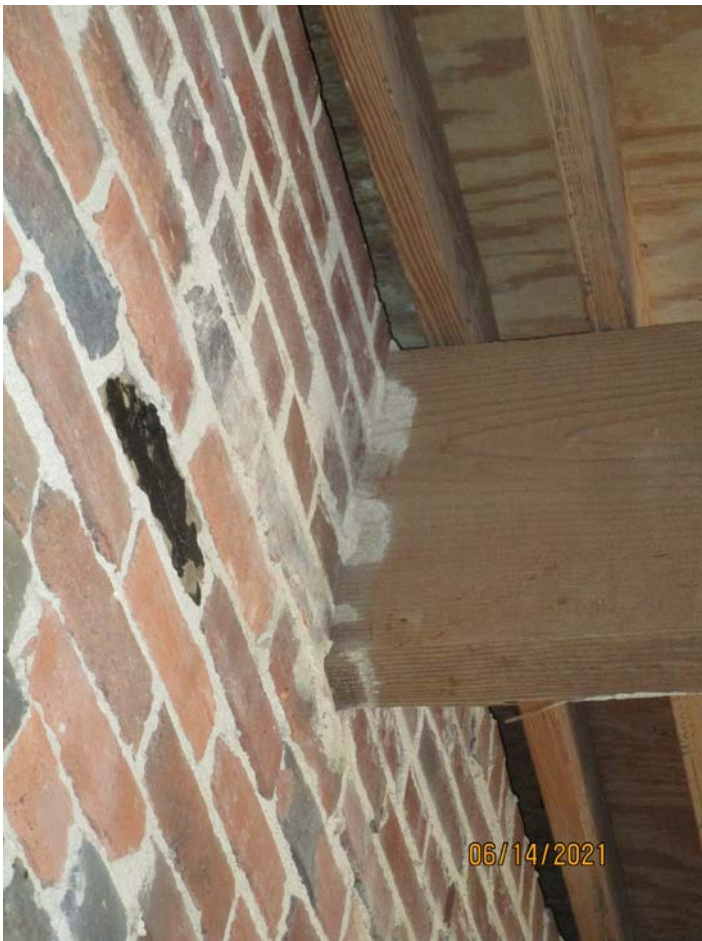
**Photograph 72: Third floor left-side wall (Building 170).**

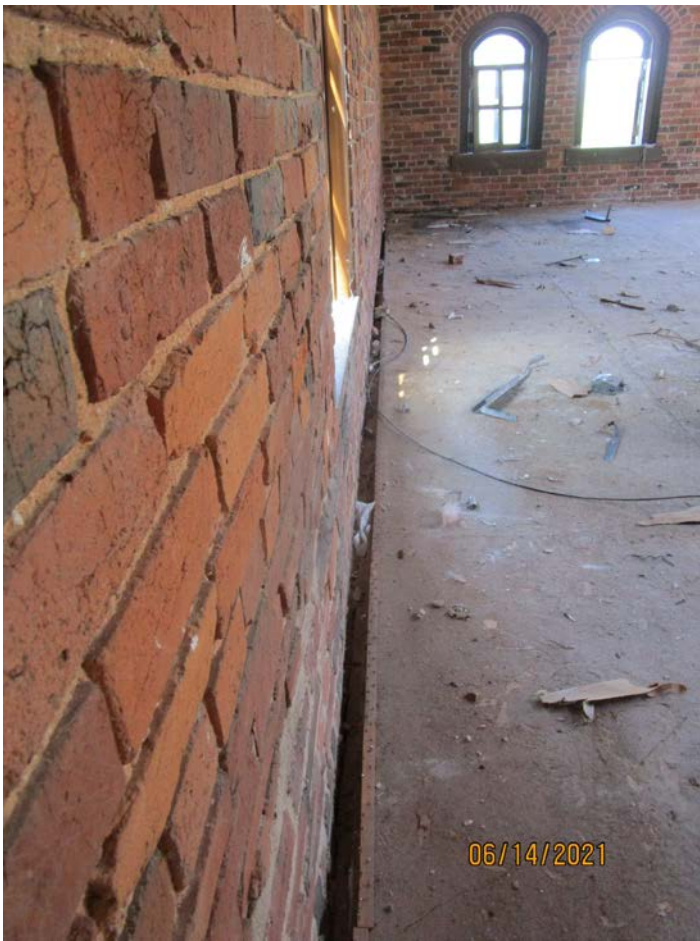
**Photograph 75: Third floor left-side wall movement (Building 170).**

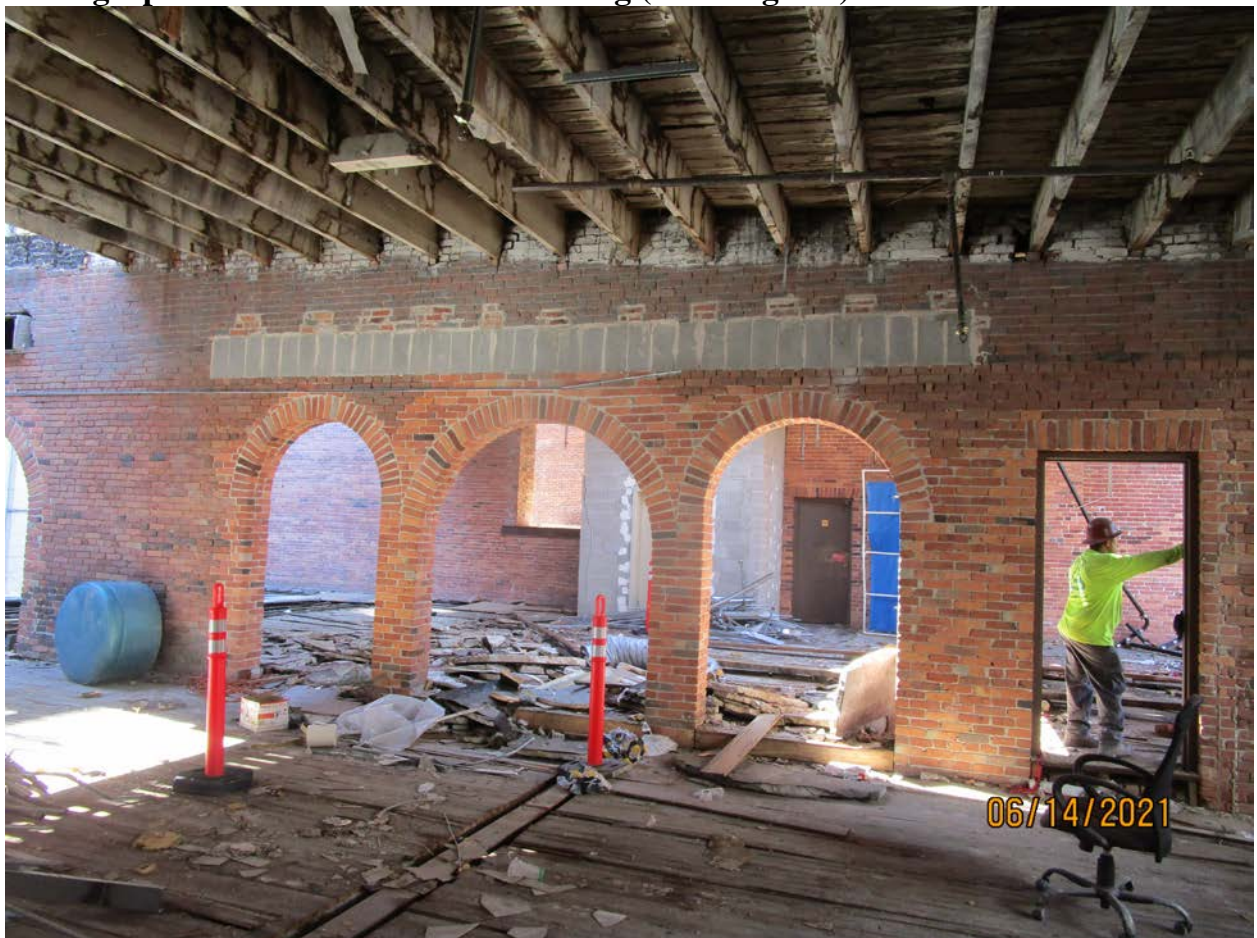
to this building can be observed in Photographs June 14, 2021, photographs 79 through 81. The joist pocket movement can be observed in Photographs June 14, 2021, photographs 82 and 83. The severity of the blast common to the more recently constructed masonry elevator shaft can be observed in Photographs June 14, 2021, photographs 84 and 85. The rear wall of Building 172 should be removed and rebuilt in its entirety. Once again, due to the severity of the blast racking the floor joists and roof rafters, extensive rework will also be required common to the interior wall of Building 172.

**Photograph 79: Rear wall of Building 172.**
