**METROPOLITAN GOVERNMENT OF NASHVILLE AND DAVIDSON COUNTY**

**STAFF RECOMMENDATION**  
**170-176 Second Avenue North**  
**July 21, 2021**

**Application:** Demolition  
**District:** Second Avenue Historic Preservation Zoning Overlay  
**Council District:** 19  
**Base Zoning:** DTC  
**Map and Parcel Number:** 09306206600 and 09302401900  
**Applicant:** Callen Trust, property owner  
**Project Lead:** Robin Zeigler, robin.zeigler@nashville.gov

**Description of Project:** The property owner requests to demolish four historic buildings in the Second Avenue Historic Preservation Zoning Overlay, damaged in the 2020 Christmas morning explosion.

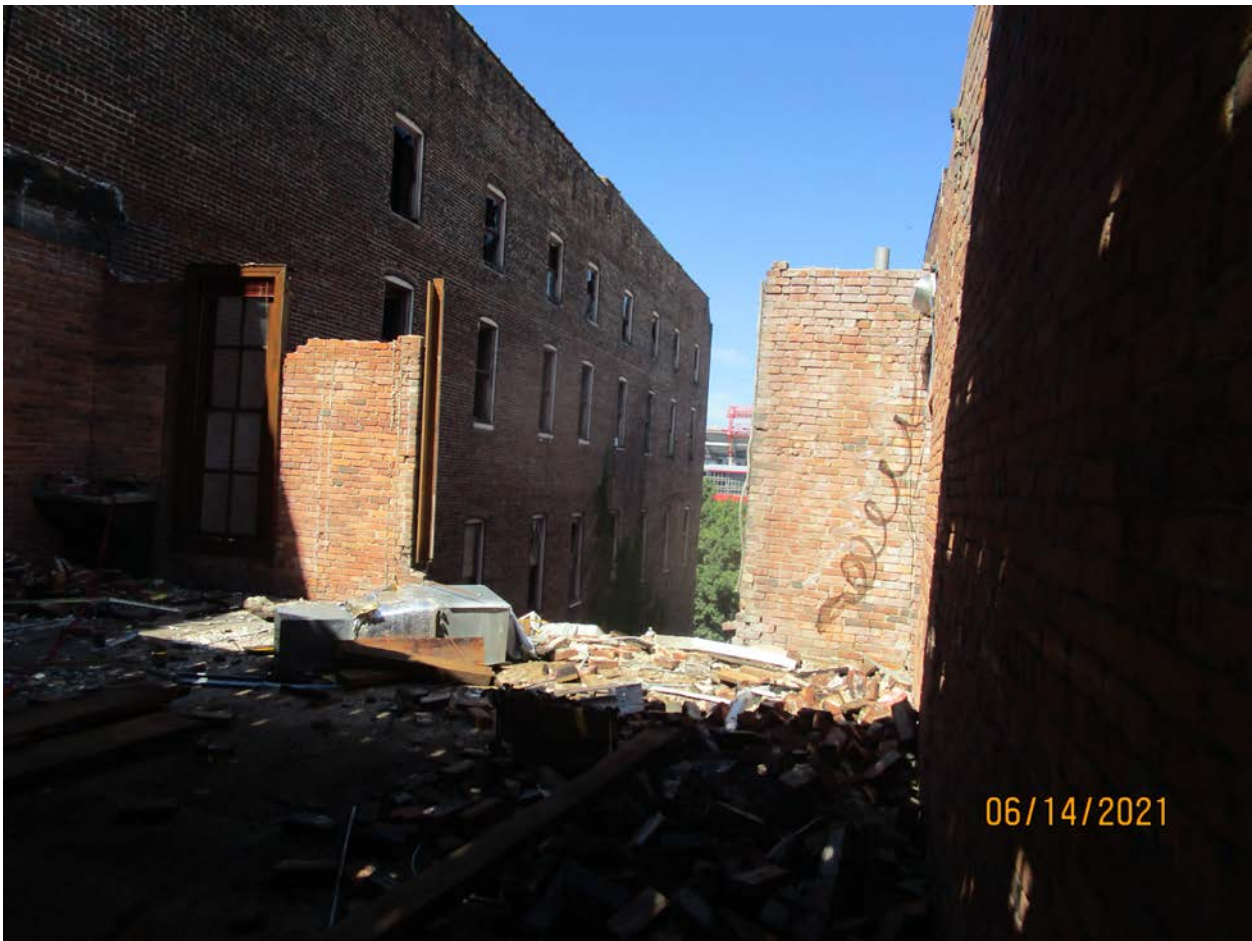
to this building can be observed in Photographs June 14, 2021, photographs 79 through 81. The joist pocket movement can be observed in Photographs June 14, 2021, photographs 82 and 83. The severity of the blast common to the more recently constructed masonry elevator shaft can be observed in Photographs June 14, 2021, photographs 84 and 85. The rear wall of Building 172 should be removed and rebuilt in its entirety. Once again, due to the severity of the blast racking the floor joists and roof rafters, extensive rework will also be required common to the interior wall of Building 172.

**Photograph 80: Rear wall of Building 172.**

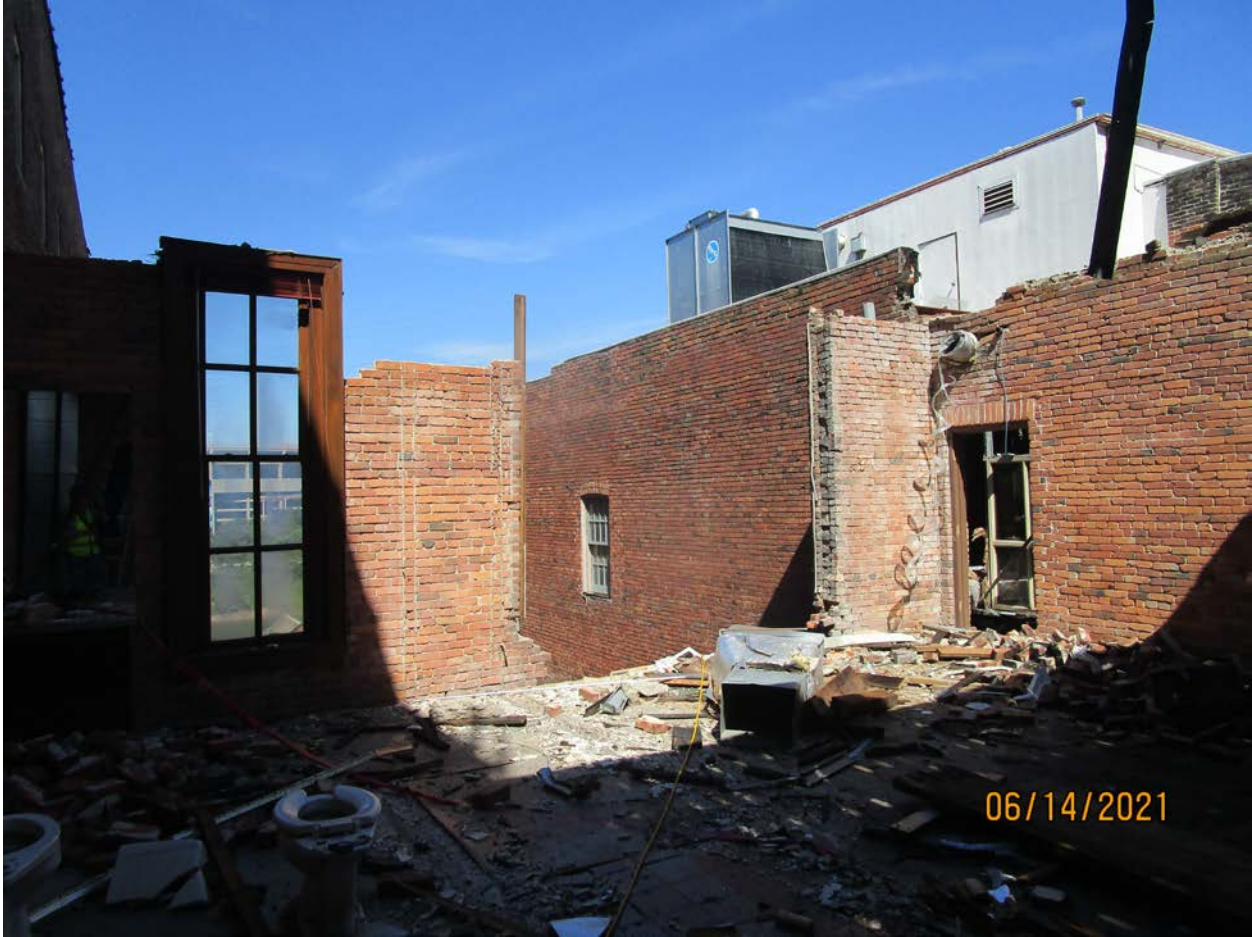
**Photograph 81: Left-side wall of Building 172.**

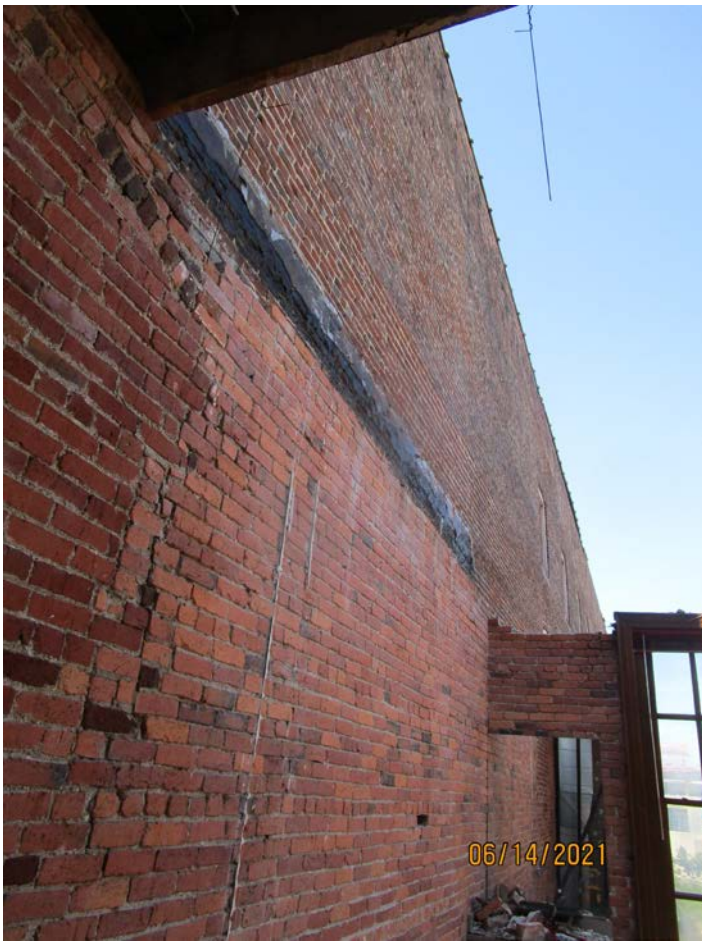
**Photograph 82: Roof joist movement of Building 172.**

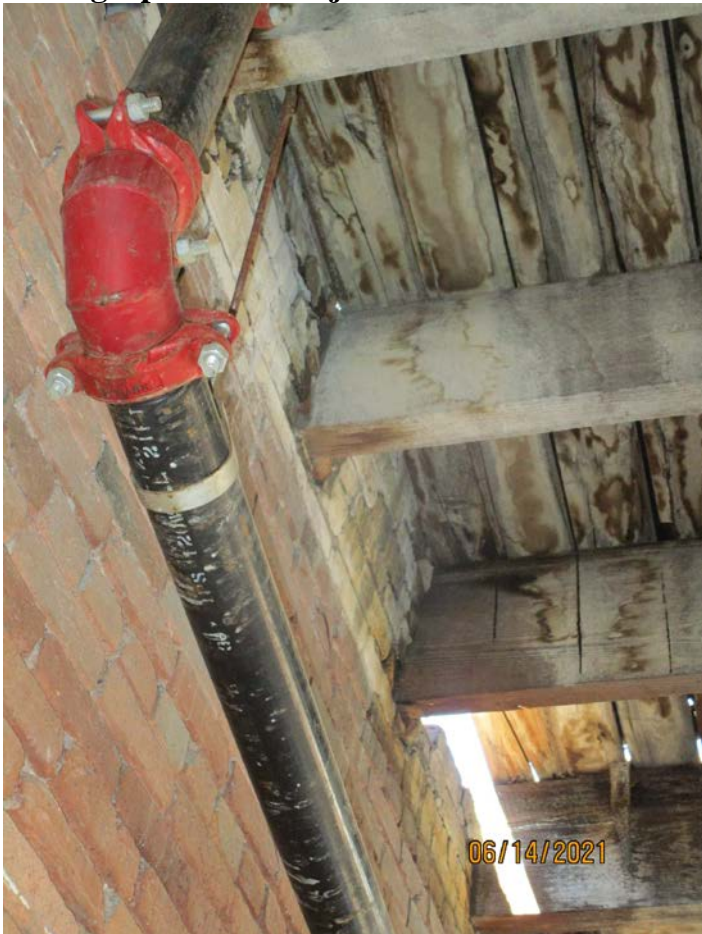
**Photograph 83: Roof joist movement at Building 172.**

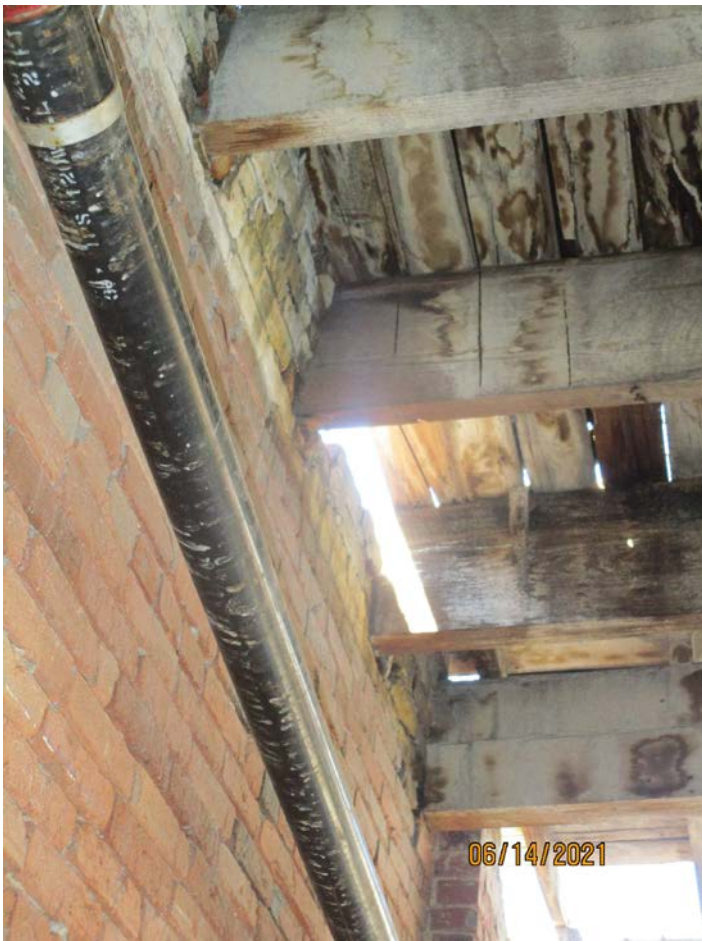
**Photograph 84: Masonry elevator shaft at Building 172.**

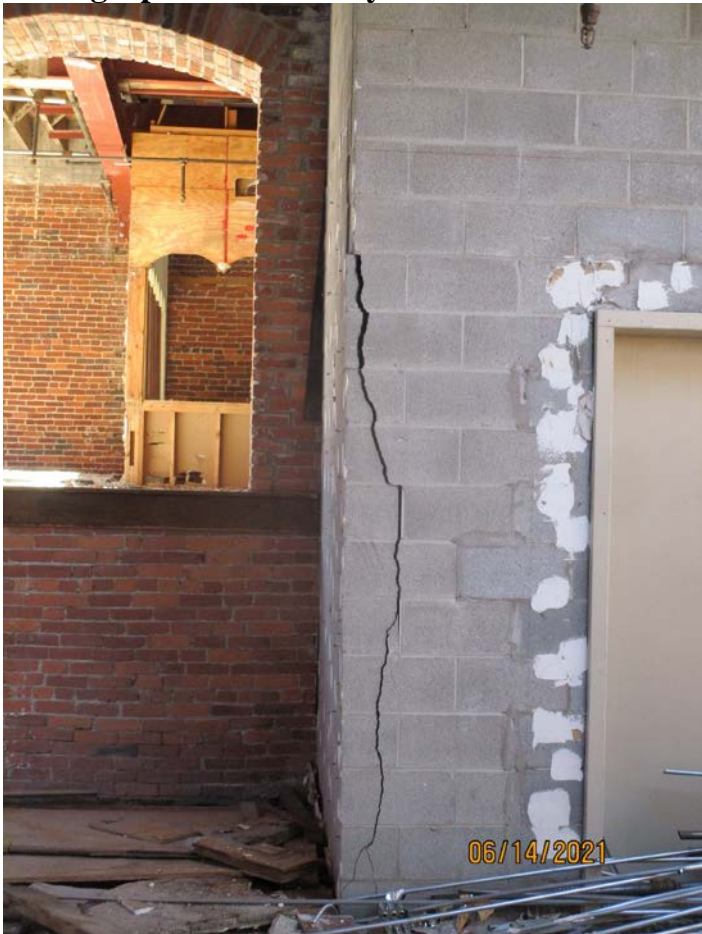
**Photograph 85: Masonry elevator shaft at Building 172.**

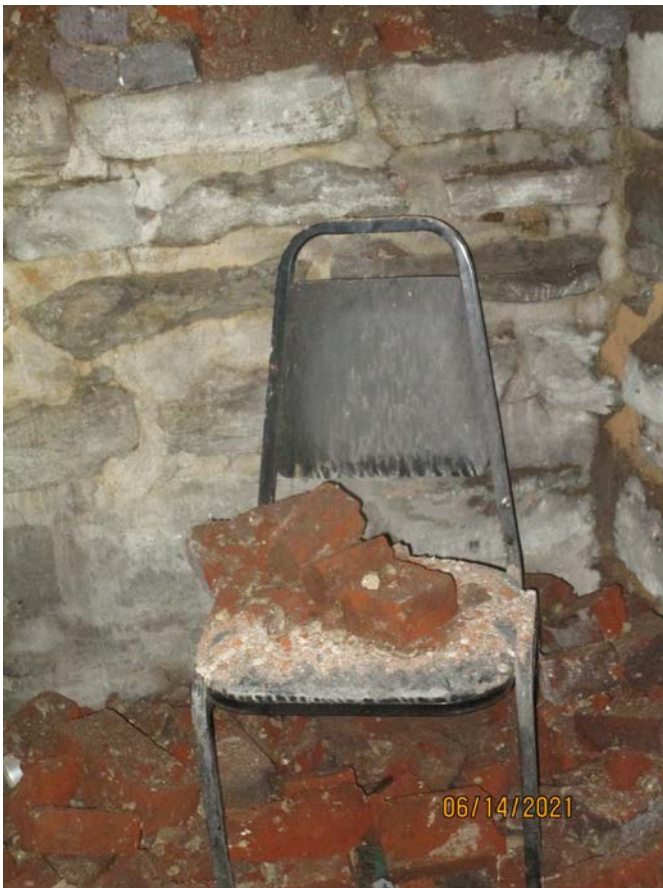
**Photograph 88: Recently fallen bricks at Building 176 (EMC photo #53 6/7/2021).**

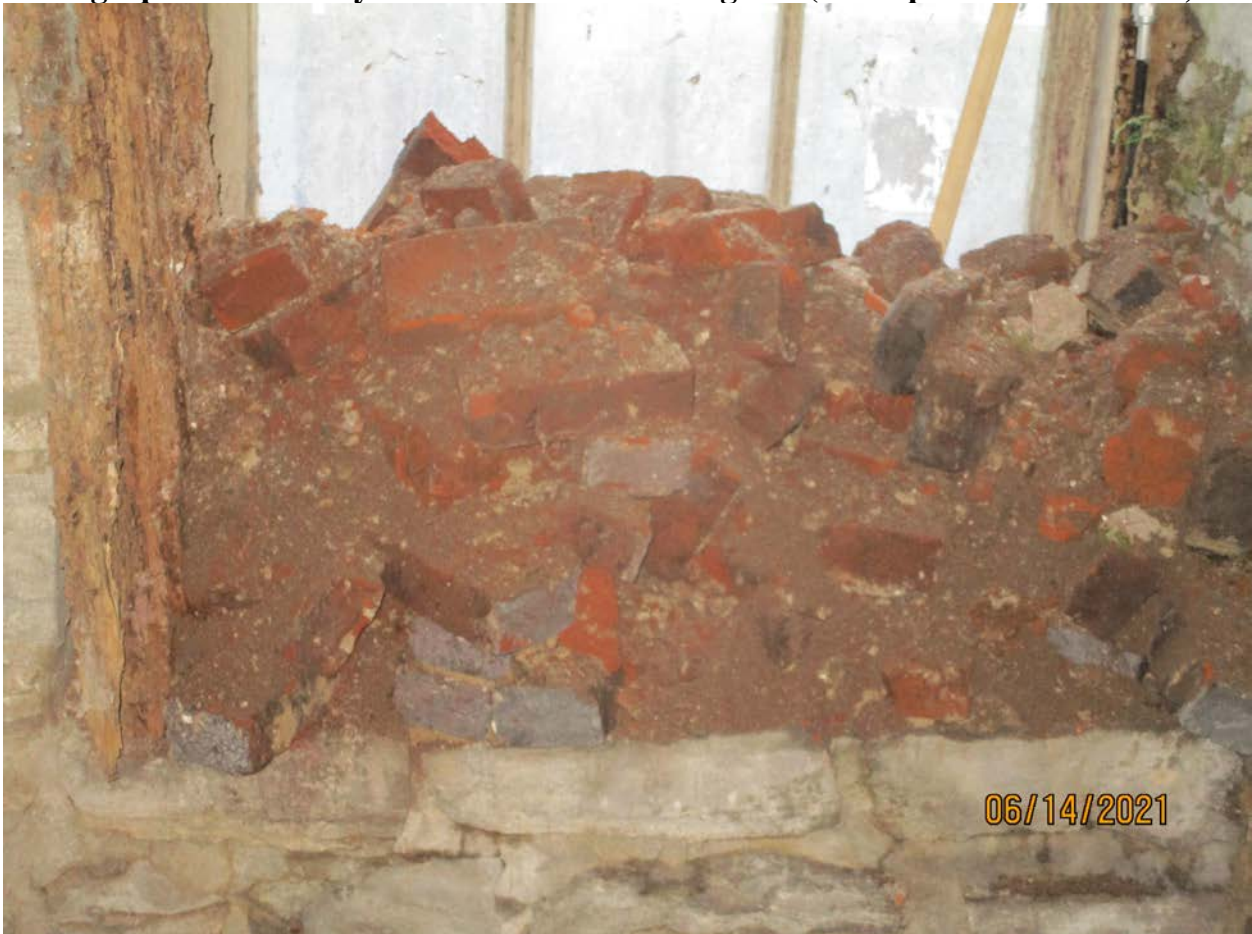
**Photograph 89: Recently fallen bricks at Building 176 (EMC photo #53 6/7/2021).**

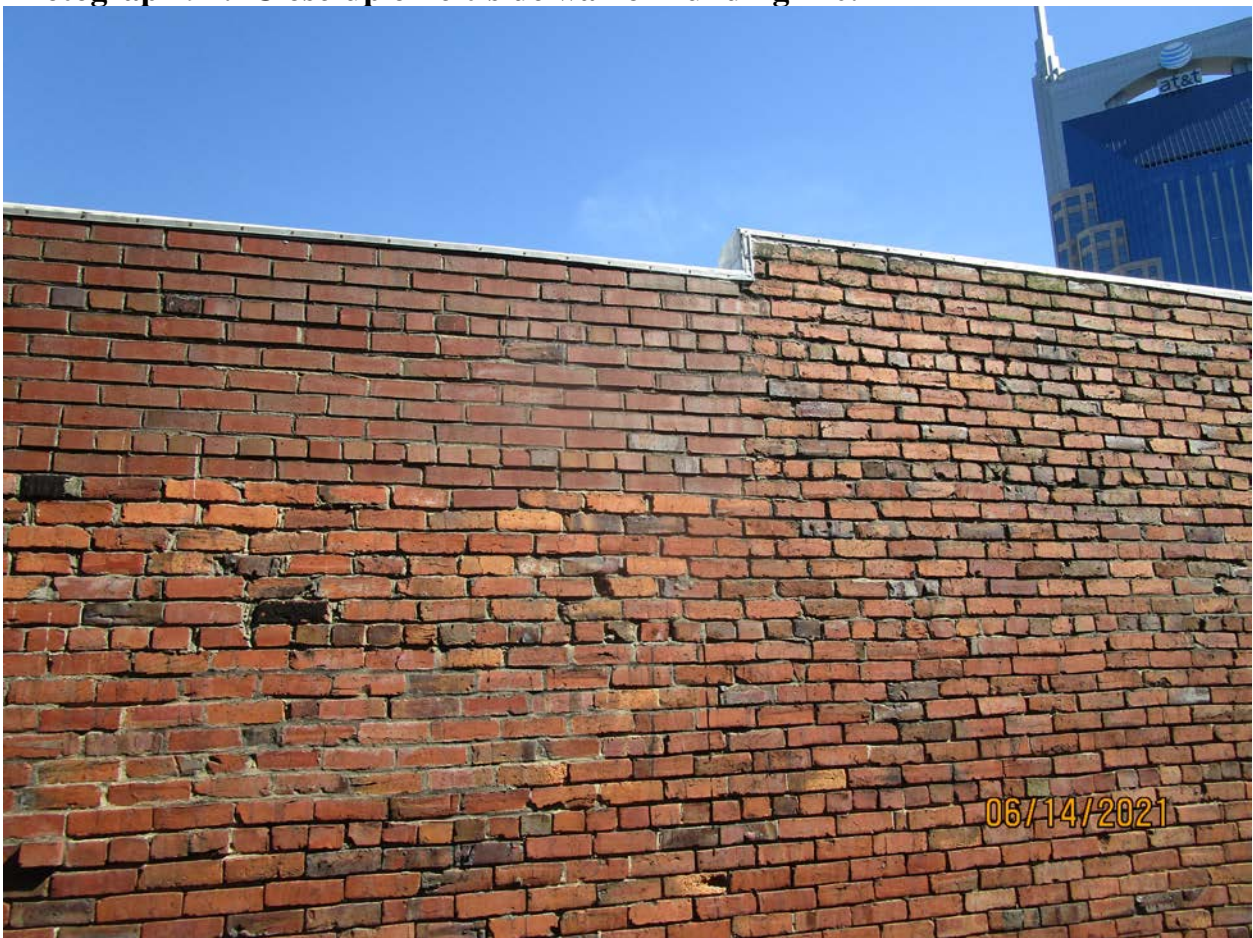
Due to the amount of movement of this left sidewall, and the deteriorated state of the mortar (Photographs June 14, 2021, photographs 92 through 99), it is my recommendation to remove and reconstruct this wall in its entirety. The soft mortar conditions of this wall can be observed in photographs 94 and 96 where light finger pressure is used to sweep the mortar from the joints. The out-of-plumb condition of this wall can be observed in Photographs June 14, 2021, photographs 93, 95, 97, and 99. The interior walls common to Building 170 will also have to be addressed as they also will require reworking and/or reconstruction to return them to a safe load-bearing condition.

**Photograph 93: Out-of-plumb left-side wall of Building 170.**

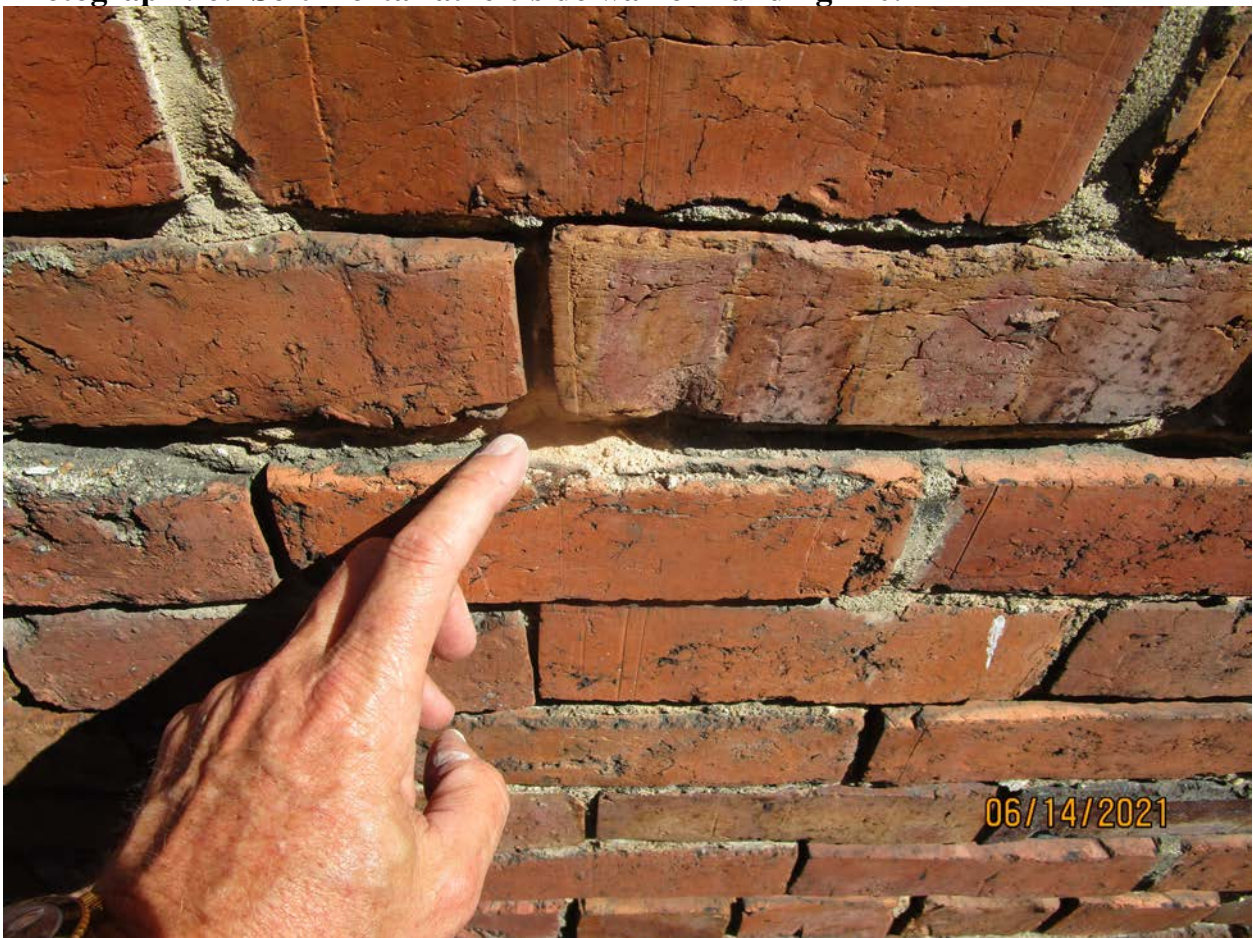
**Photograph 97: Out-of-plumb left-side wall of Building 170.**

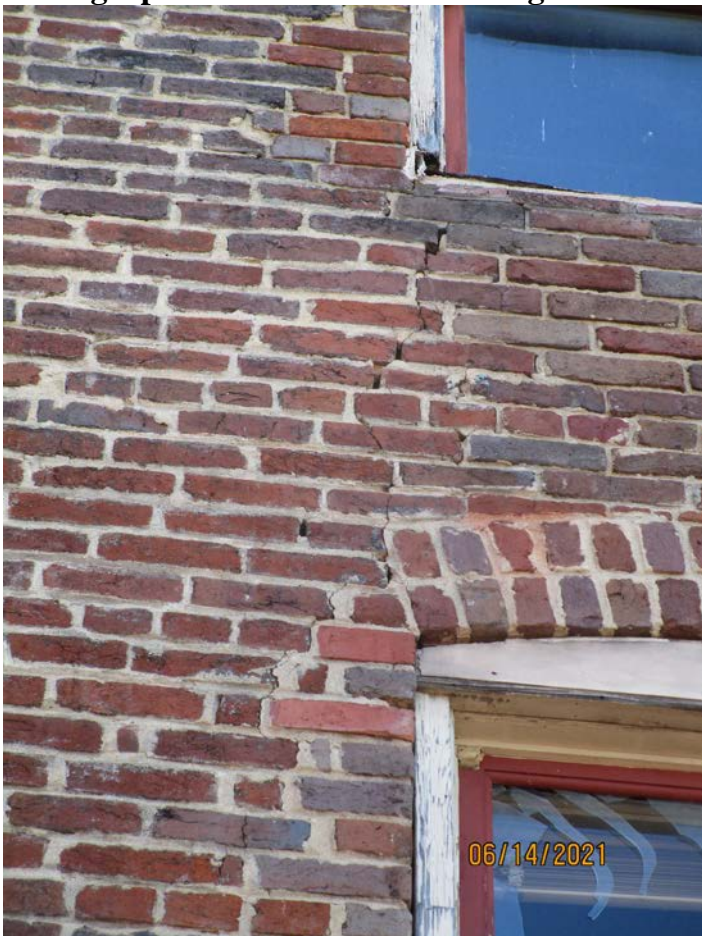
The right sidewall of Building 174 was reviewed from the exterior and mortar issues similar to Building 170 was observed (Photographs June 14, 2021, photographs 100 and 104). This wall appears to be relatively plumb; however, additional investigation will be required due to vine growth on the wall to determine if it can be salvaged or if it will require to be removed and rebuilt.

**Photograph 100: Brick cracks at right-side wall of Building 174.**

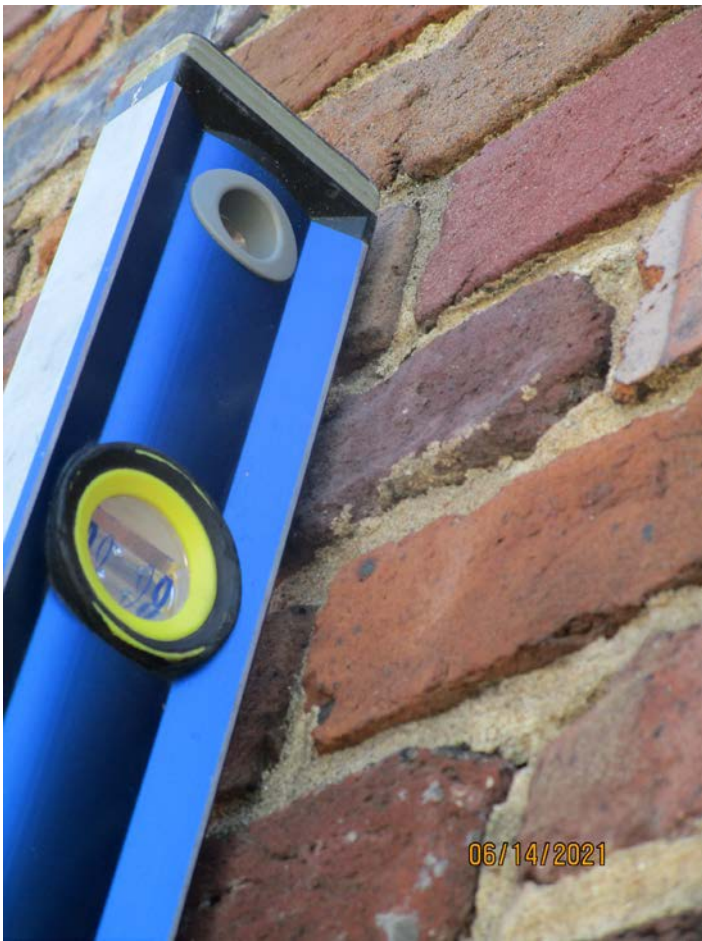
**Photograph 104: Brick cracks at right-side wall of Building 174.**

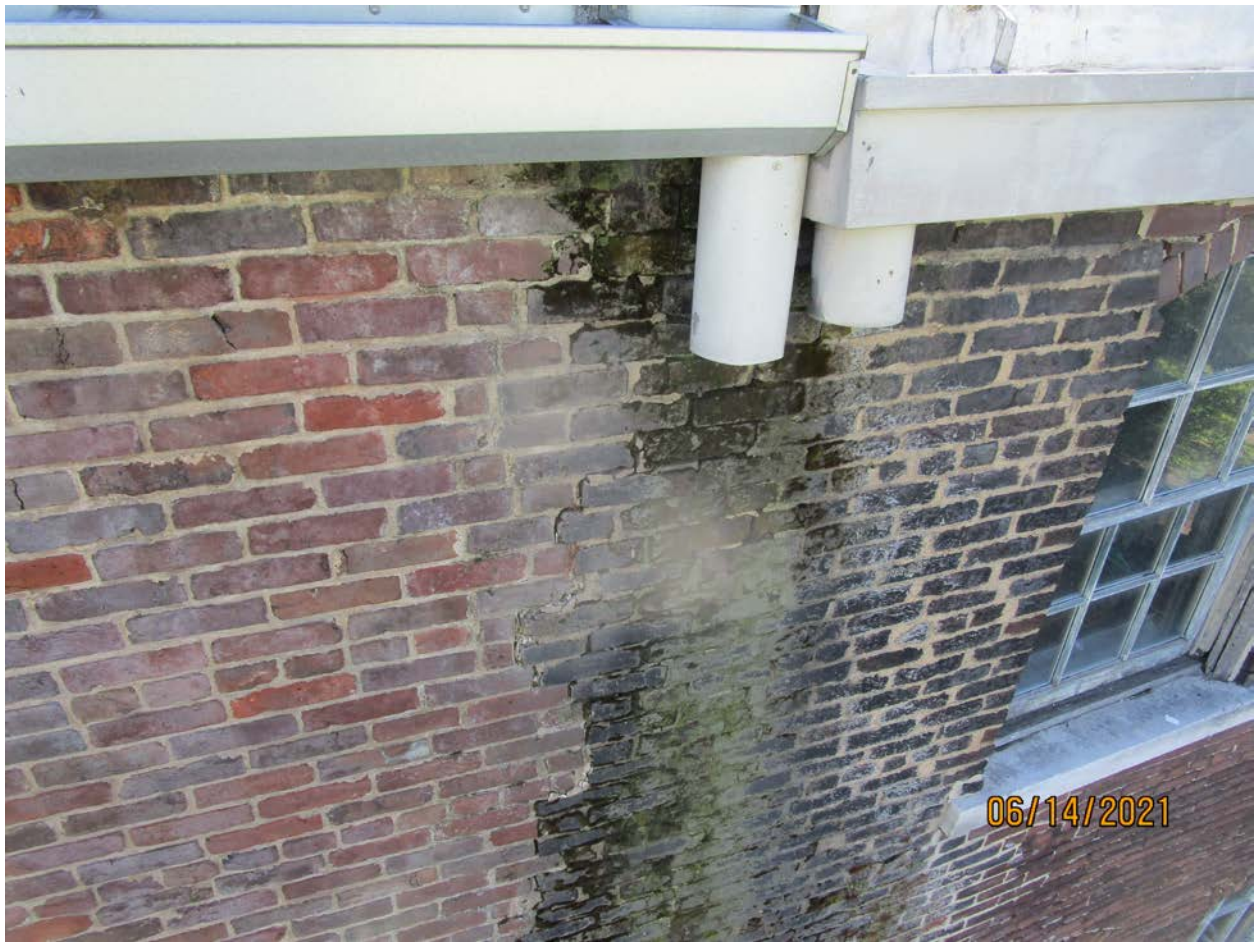
The rear wall of Building 174 has extensive deterioration and lateral movement and will require it to be removed and rebuilt (Photographs June 14, 2021, photographs 109 through 120).

The rear walls of both Buildings 176 and 174 were reviewed from a vertical lift (photographs 109 through 120). The mortar is in extremely poor condition, and water has been running down the rear face of the wall due to the lack of a rainwater leader, which has severely compromised the wall common to this location. The lateral movement of these walls would suggest that the walls can no longer perform as intended.

**Photograph 110: Rear wall intersection of Buildings 176 and 174.**

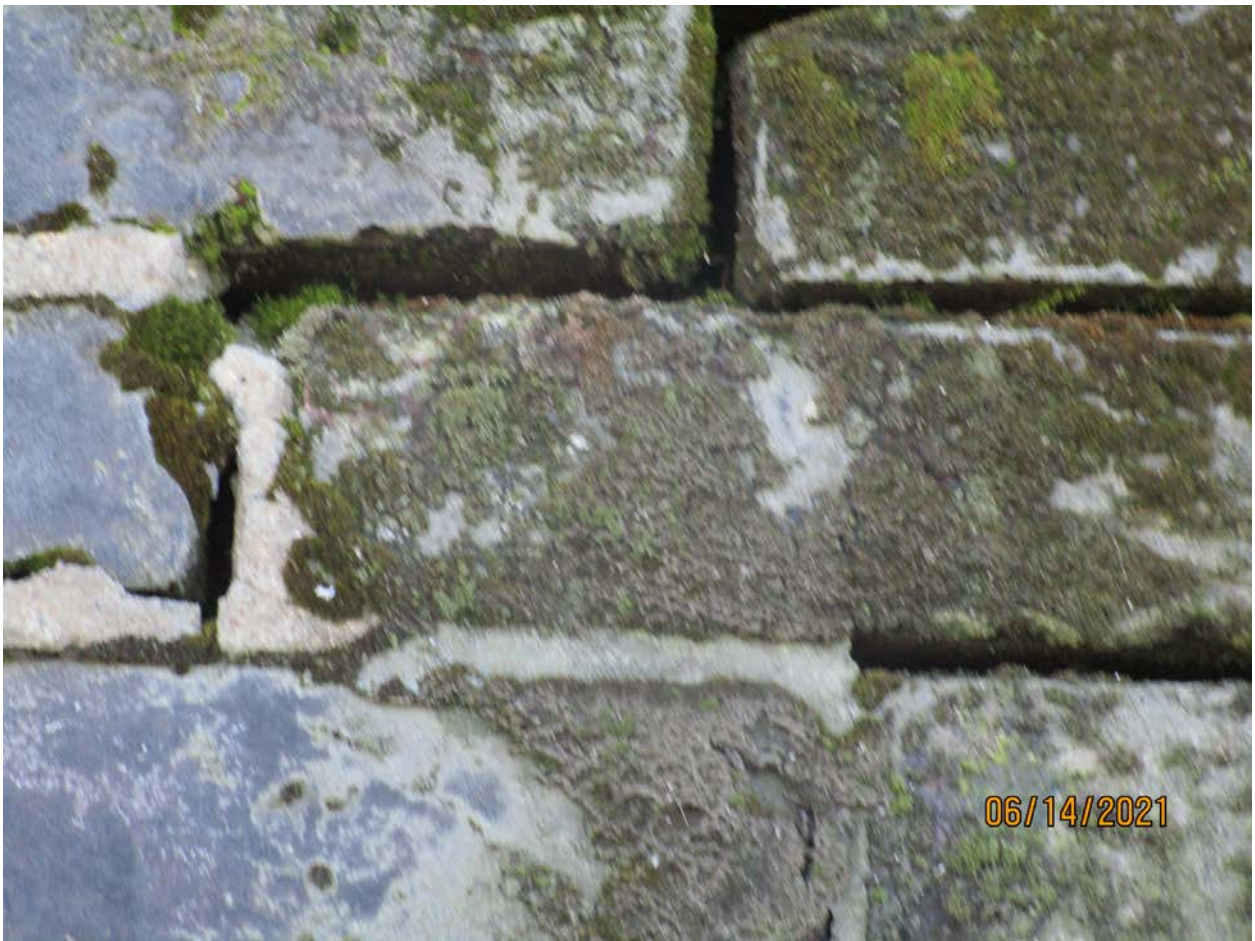
**Photograph 112: Rear wall intersection of Buildings 176 and 174.**

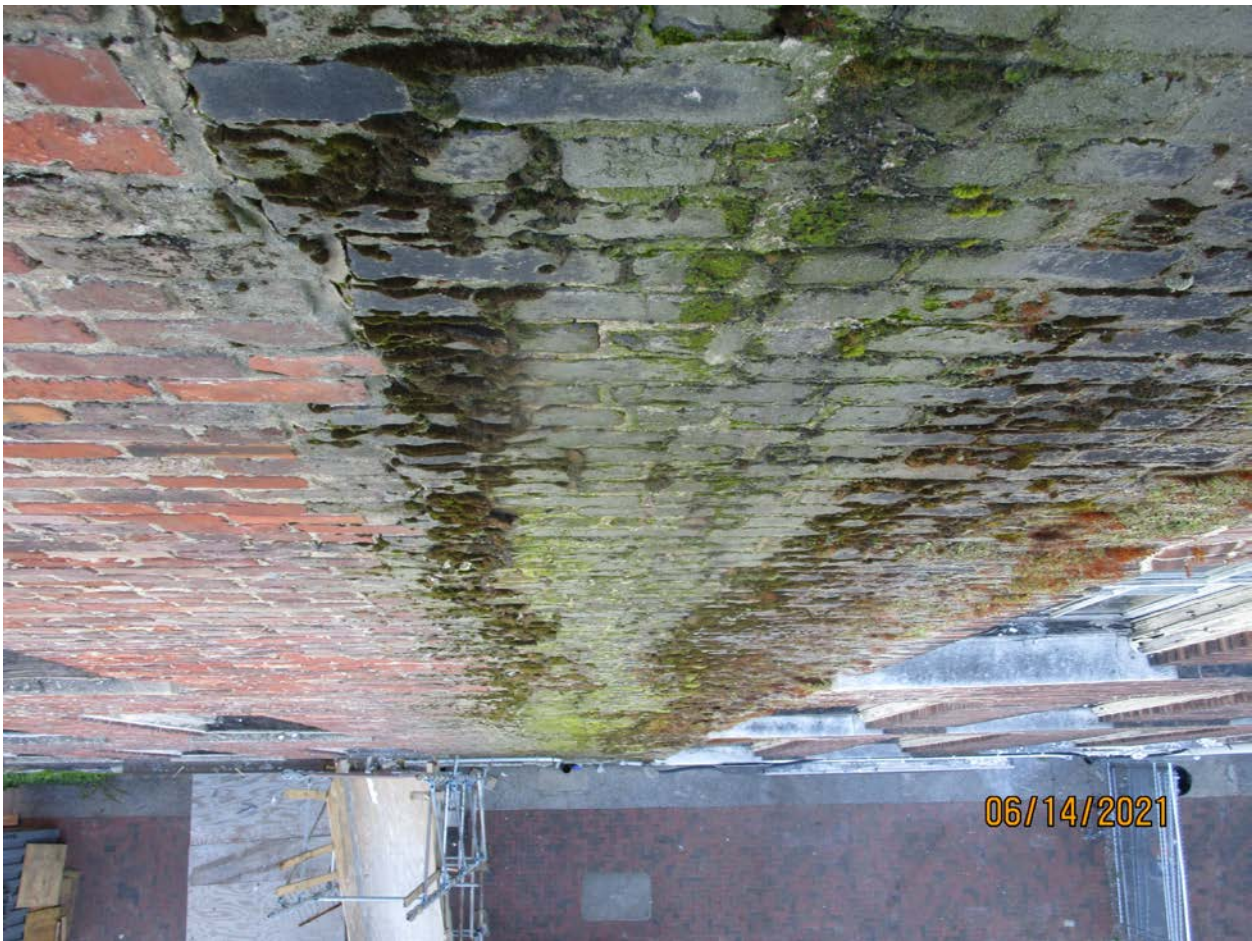
**Photograph 114: Rear wall intersection of Buildings 176 and 174.**

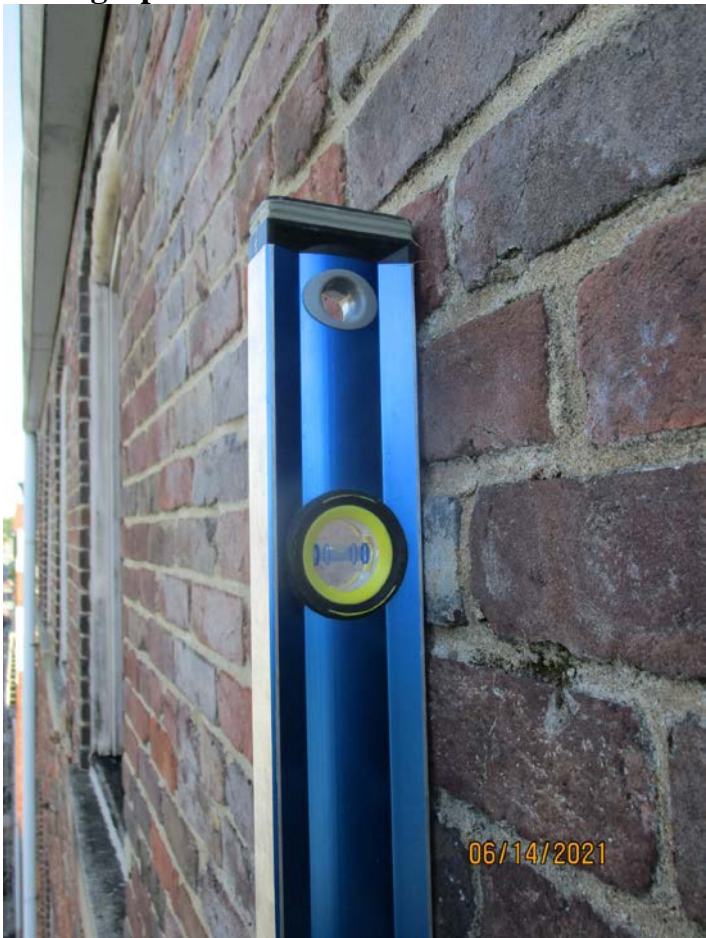
**Photograph 115: Rear wall intersection of Buildings 176 and 174.**

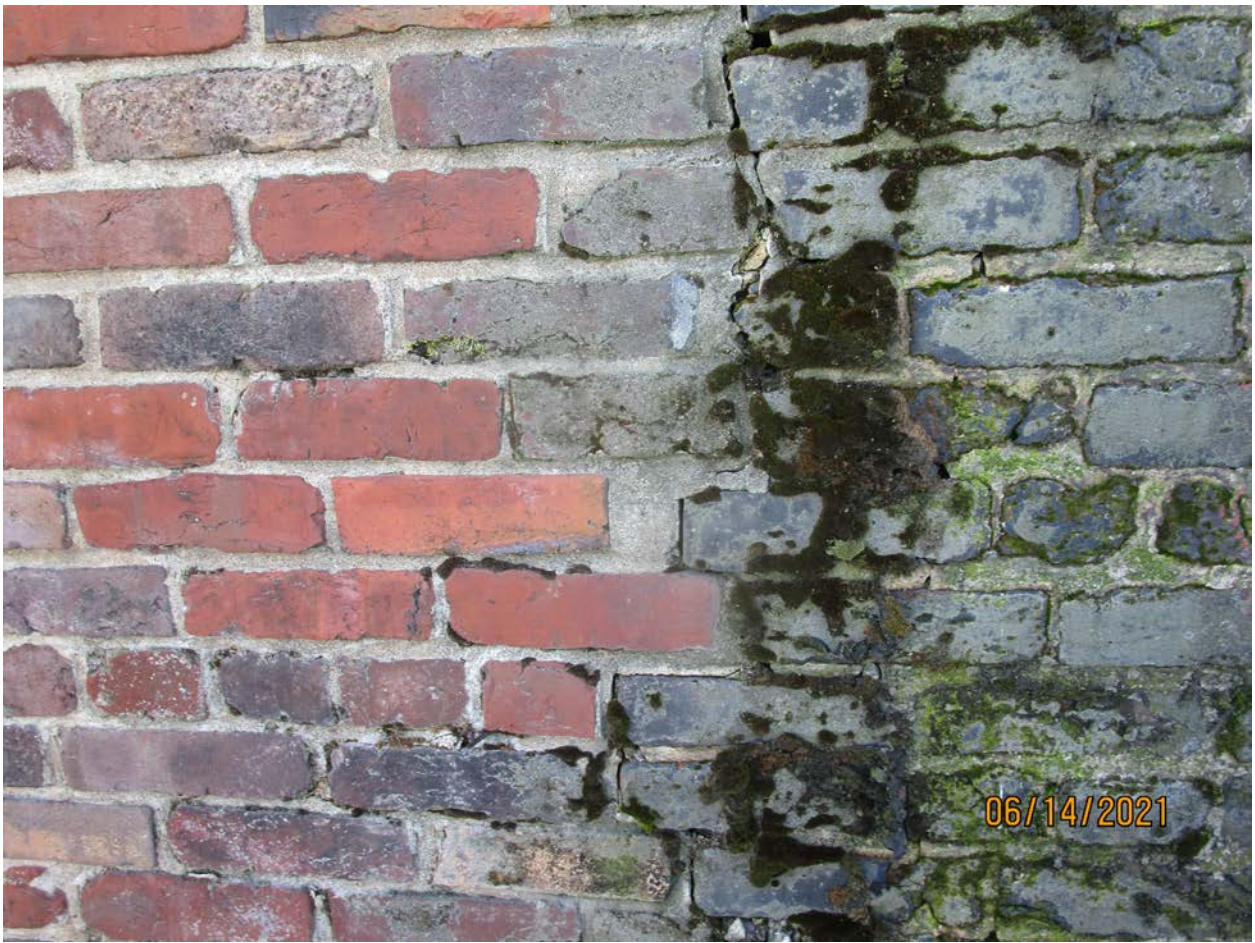
**Photograph 116: Rear wall intersection of Buildings 176 and 174.**

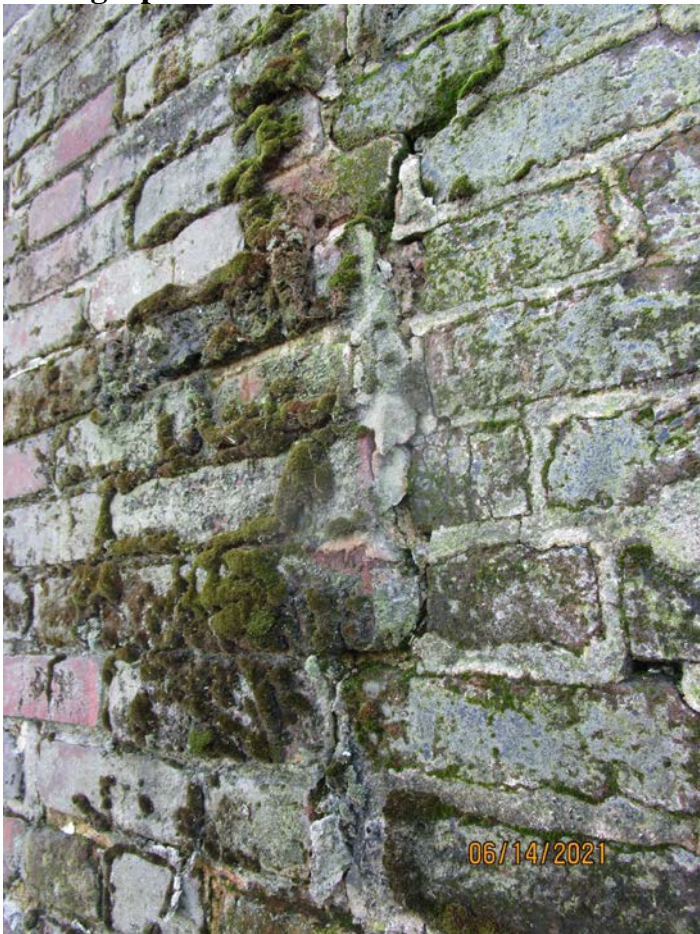
**Photograph 117: Rear wall intersection of Buildings 176 and 174.**

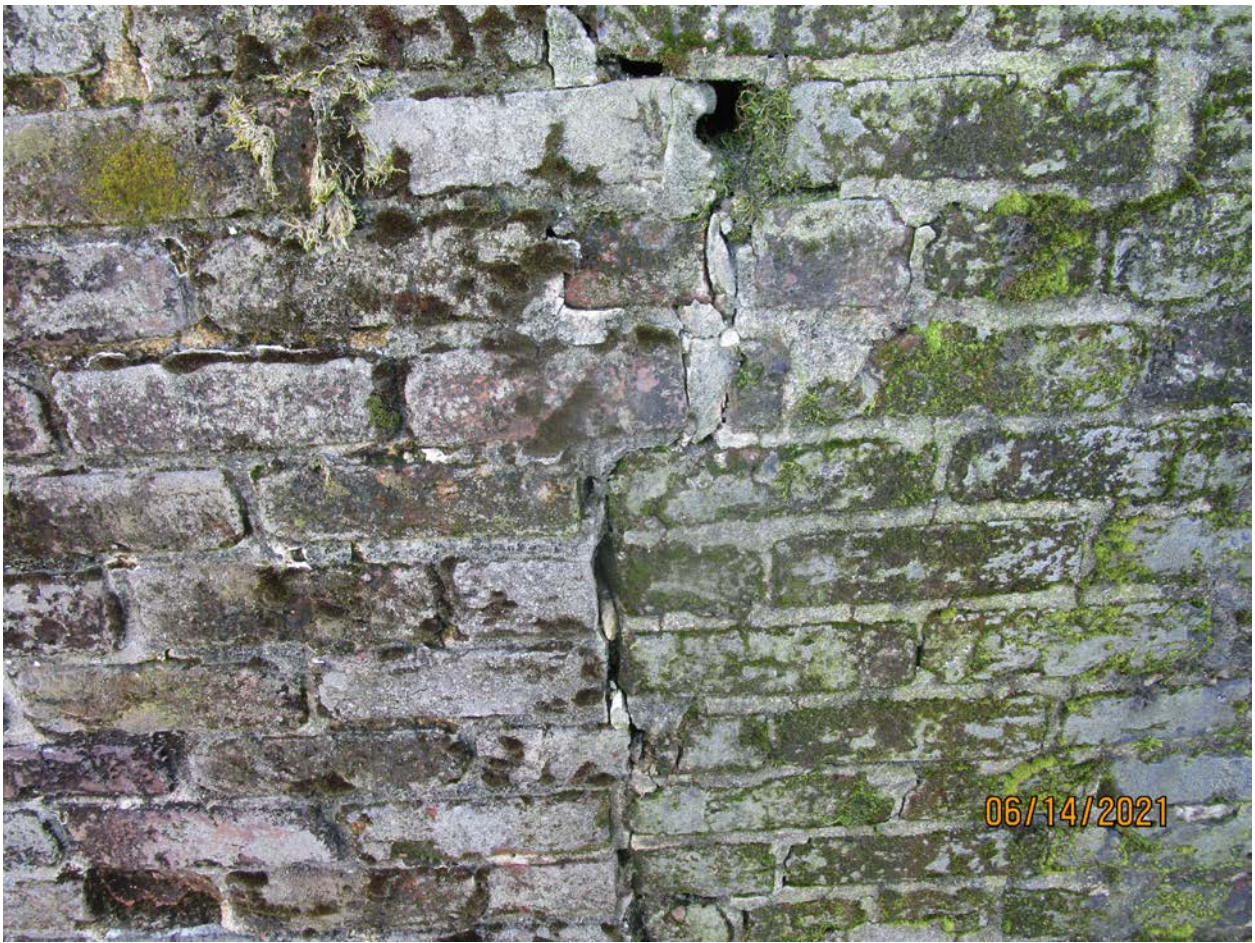
**Photograph 118: Rear wall intersection of Buildings 176 and 174.**

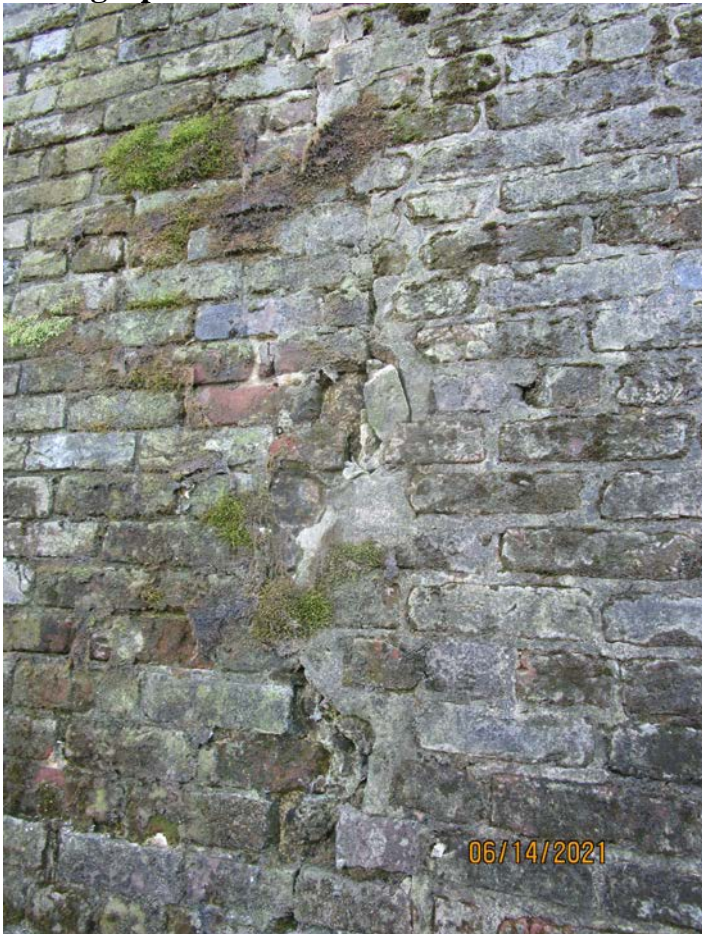
**Photograph 119: Rear wall intersection of Buildings 176 and 174.**
