STAFF RECOMMENDATION
1702 Forrest Avenue
July 21, 2021

Application: Demolition: Economic Hardship
District: Lockeland Springs Historic Conservation Zoning Overlay
Council District: 06
Base Zoning: R6
Map and Parcel Number: 08310029700
Applicant: Nicole Piersiak
Project Lead: Joseph Rose joseph.rose@nashville.gov

<p>Description of Project: The applicant requests demolition of a contributing building due to extreme disrepair, arguing for economic hardship and demolition of a non-contributing outbuilding.</p> <p>Recommendation Summary: Staff recommends approval of full demolition of all structures at 1702 Forrest, finding that demolition meets section III.B (2) (b) as the necessary demolition required to repair the primary building will result in a non-contributing building and the outbuilding is a non-contributing building and the project meets section III.B (2) (a) as repairs are not possible in a manner that retain the historic building.</p>	<p>Attachments</p> <ul style="list-style-type: none">A: PhotographsB: Engineer Report-FieldsC: Engineer Report-Engineered Solutions and Thunder River ConstructionD: Diligent Home InspectionE: Purchase DocumentationF: Tax HistoryG: Appraisal H

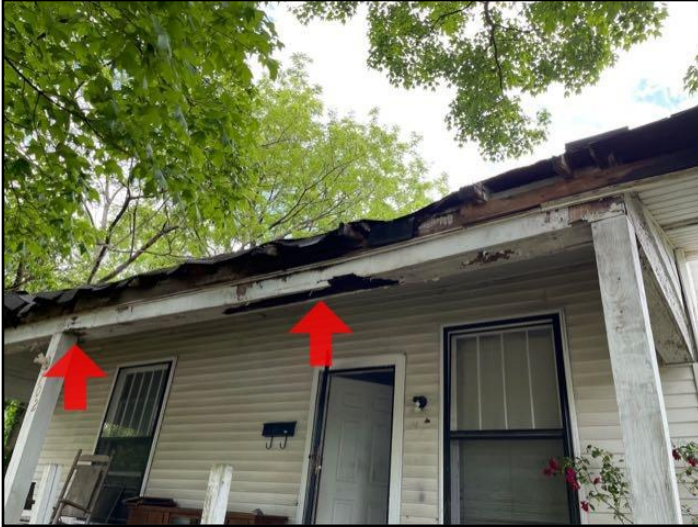
- The front porch roof structure was heavily rotted and damaged in various locations and is likely at risk of failure.
- Soffit and fascia was damaged or missing throughout the eaves of the home.
- Gutters were damaged or missing in throughout the exterior of the home.
- Vinyl siding was heavily damaged in various areas.
- Window trim was rotten in multiple locations.
- The glazing of some windows was damaged/broken.
- Large sections of siding were loose or had fallen off of the home.
- The vinyl siding was installed in contact with the ground at the back of the home.
- The wooden siding at the back of the home was heavily deteriorated.
- Debris is piled against the home.

7. Heavy rot and deterioration

Due to the severity of the issues noted, immediate repair or replacement by a licensed and qualified contractor is recommended. Further damage will likely be found during repairs.

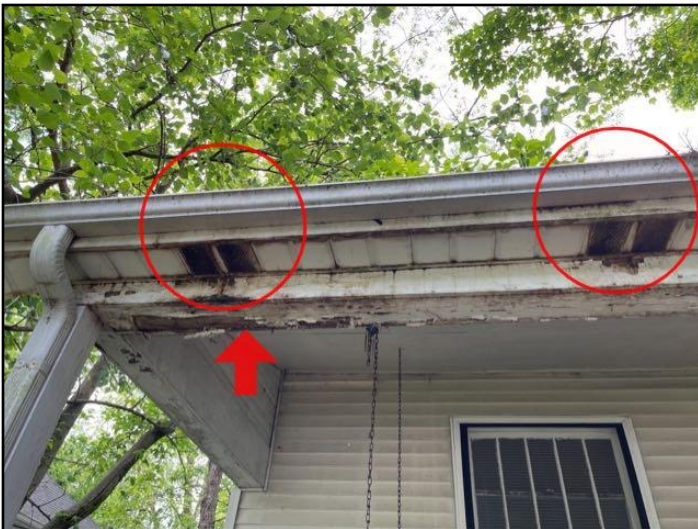
9. Rot and damage to soffit/fascia

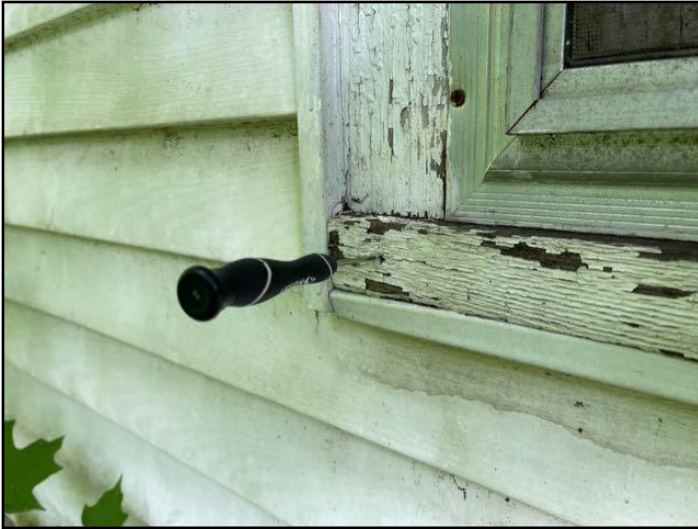
15. Rot in window trim

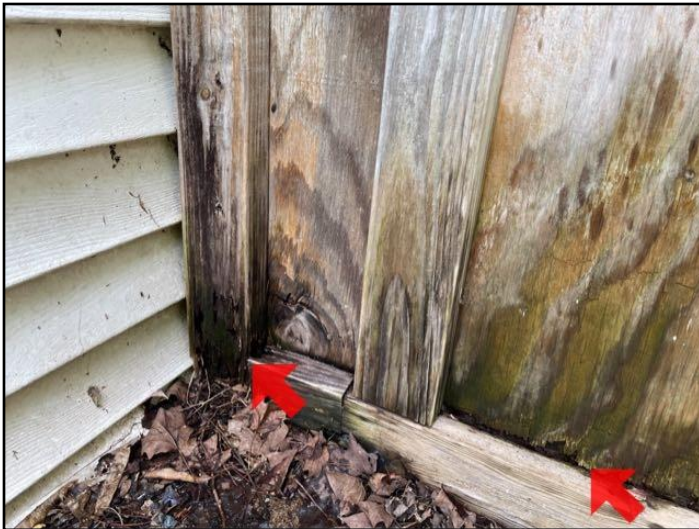
19. Heavy deterioration in wood siding

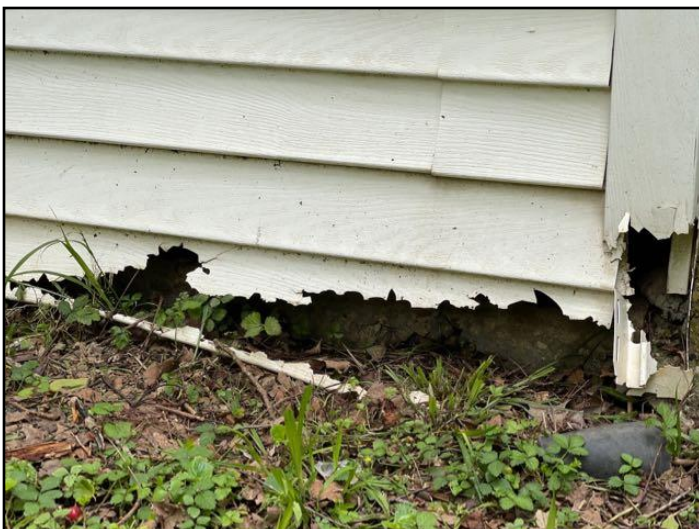
21. Damaged vinyl siding

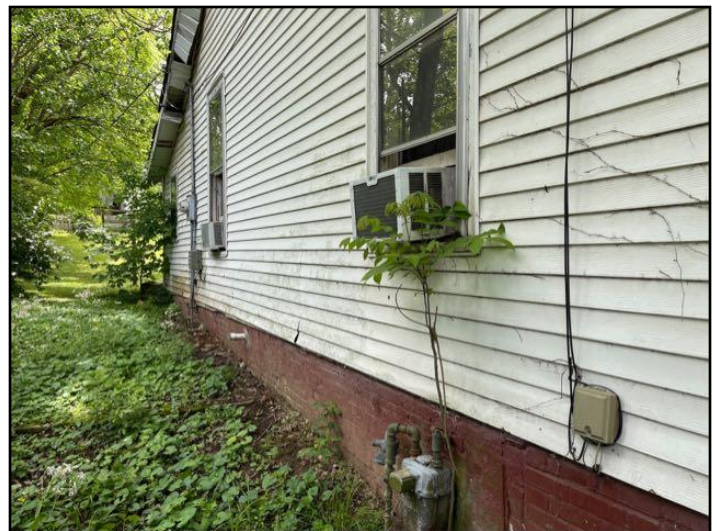
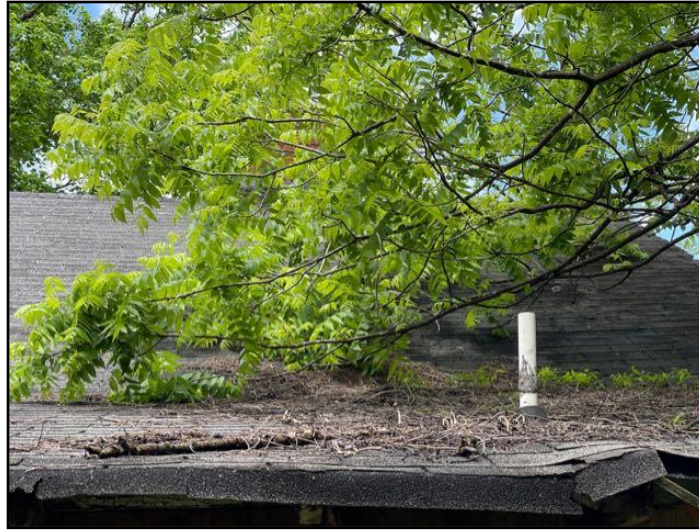
Trees and shrubs in contact with the house create easy paths for pests, such as carpenter ants to reach the structure. Also, tree limbs were noted in direct contact with the roof. Limbs in contact with the roof can cause abrasion damage to materials. Limbs should be trimmed away from roofing materials.

31. Trees or shrubs too close to building

32. Trees or shrubs too close to building

33. *Trees or shrubs too close to building*

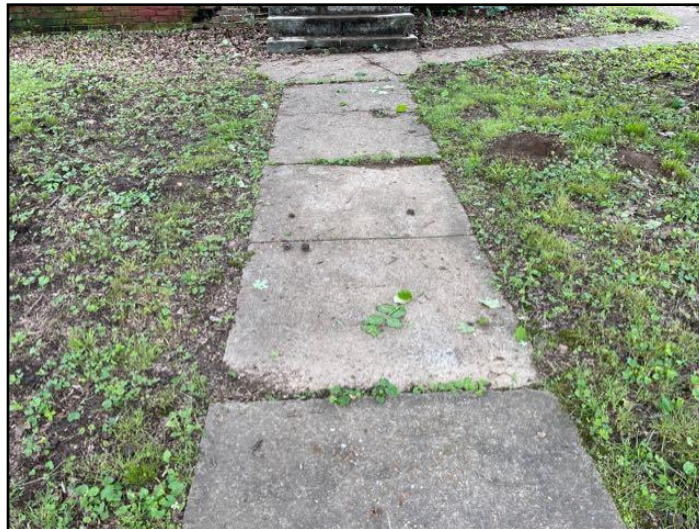
The walkway surface was uneven in some areas, resulting in trip hazards.

34. *Uneven (trip hazard)*

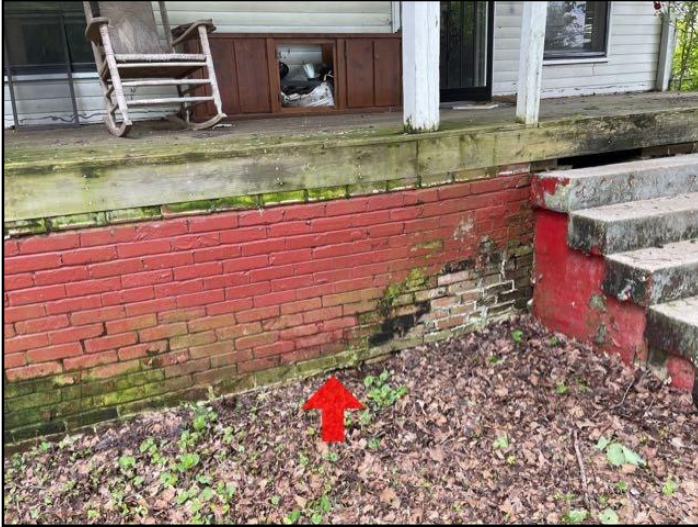
- Evidence of movement and masonry deterioration was noted in the brick foundation wall in multiple locations.
- The bottom side of the foundation wall footing was exposed in multiple locations.

41. Movement in foundation wall

Due to the advanced level of deterioration and insect damage along with the poor general condition of floor system/foundation materials, the viability of the structure could not be verified by a visual only inspection. All issues should be repaired or replaced, as needed, by a licensed and qualified structural contractor under the guidance of a licensed and qualified structural engineer. Large scale renovation and/or replacement will likely be required.

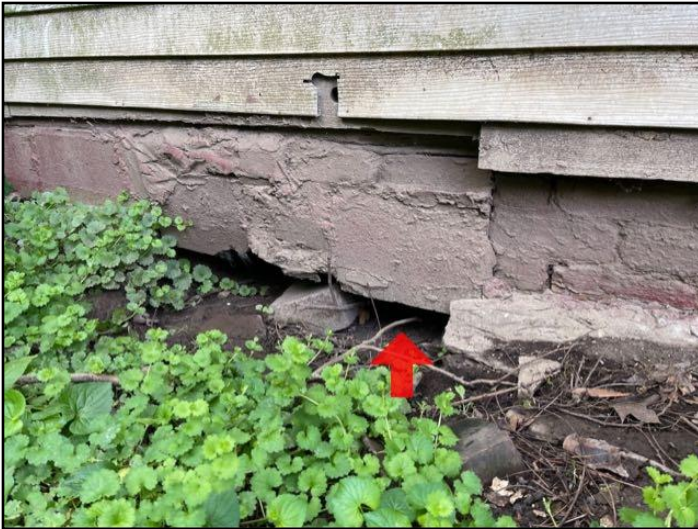
43. unsupported foundation wall

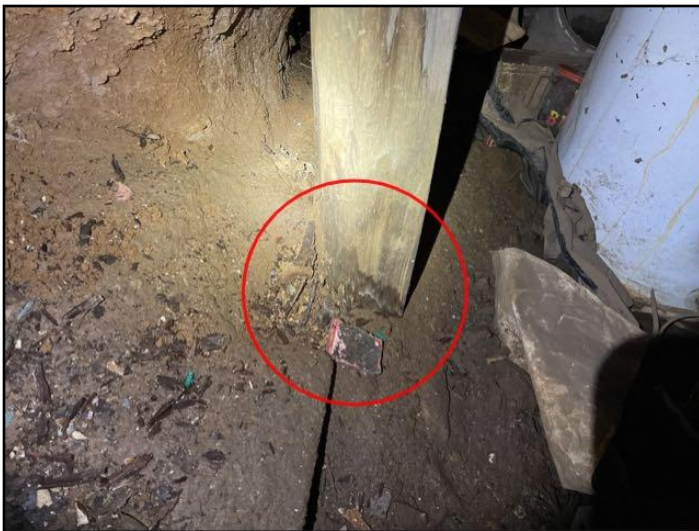
51. Column in contact with dirt

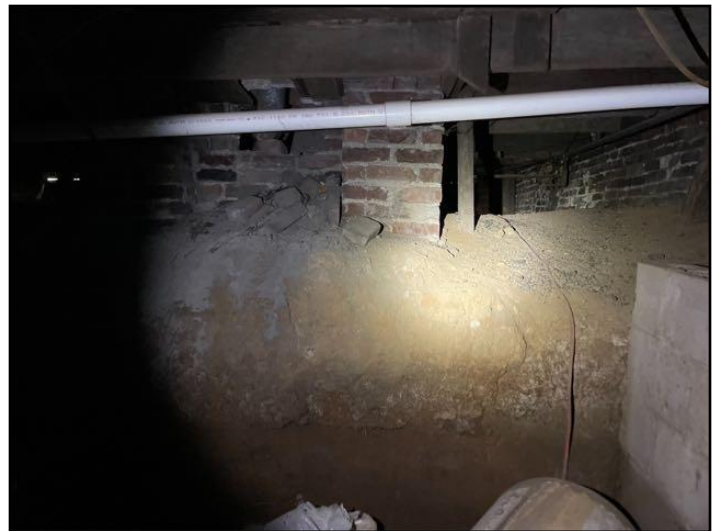
52. Masonry column near dugout wall

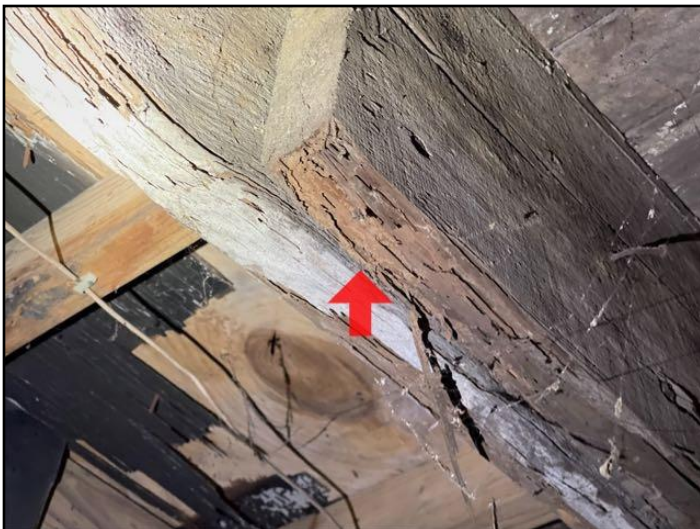
- Extensive insect damage was present throughout the floor framing of the home.
- Rot and deterioration resulting from active moisture was noted on various floor framing members and wall framing members.

59. Extensive insect damage

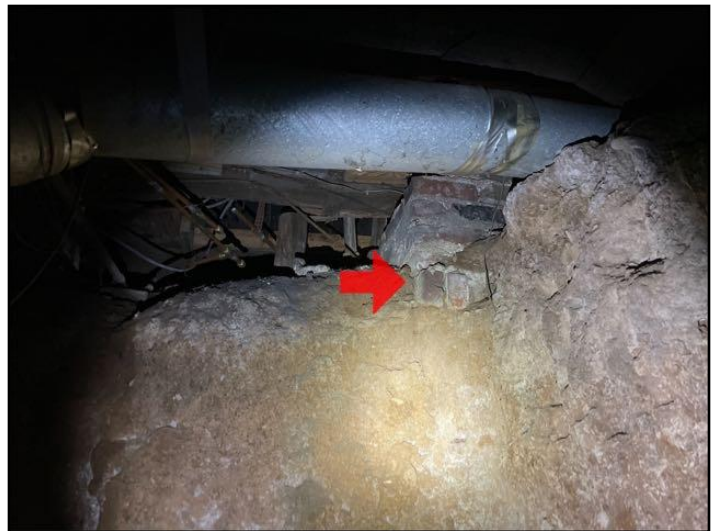
64. Column near edge of dug-out wall

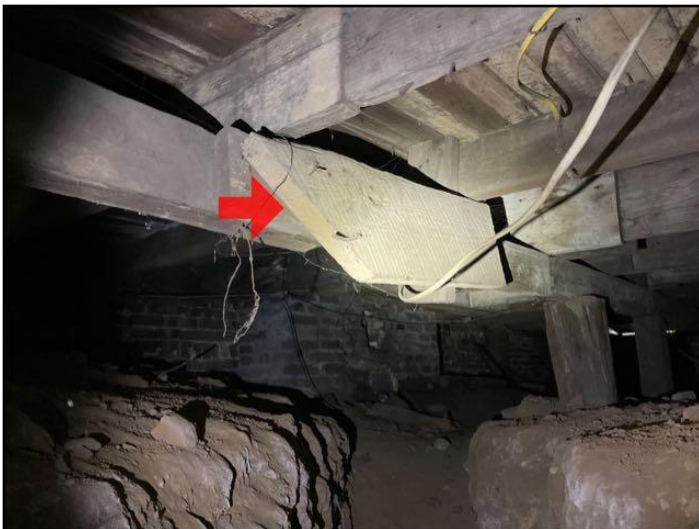
- A built-up beam was crushed due to extensive insect damage.
- Beams were spliced together, poorly supported at the ends and not in contact with joists.

67. Improperly spliced beam

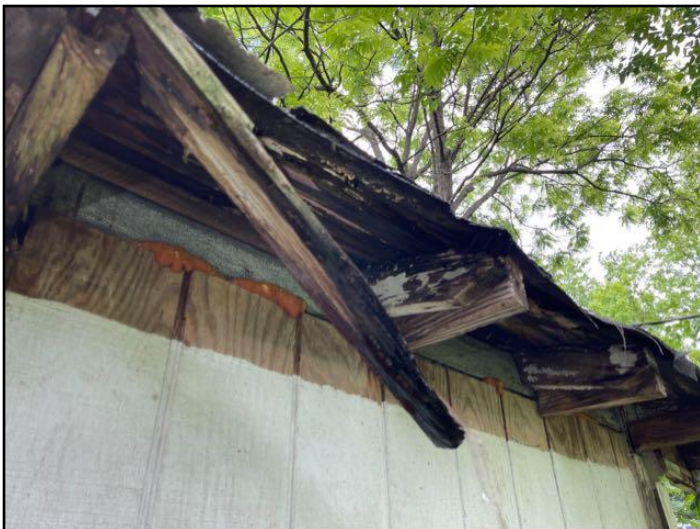
74. Rafter tails and sheathing deteriorated

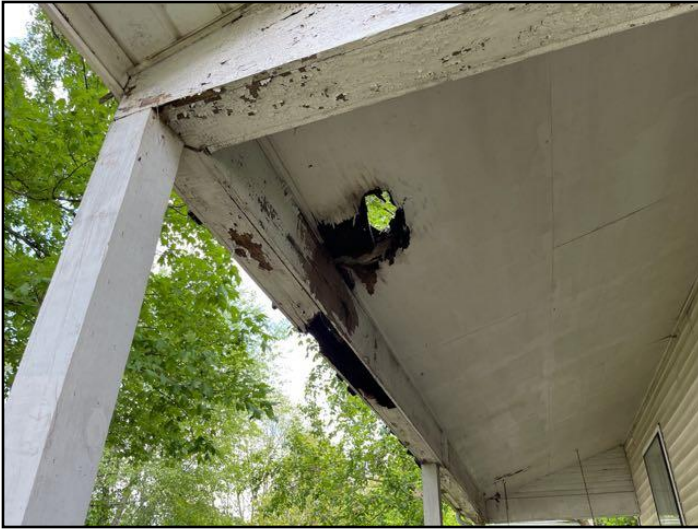
76. Hole through roof

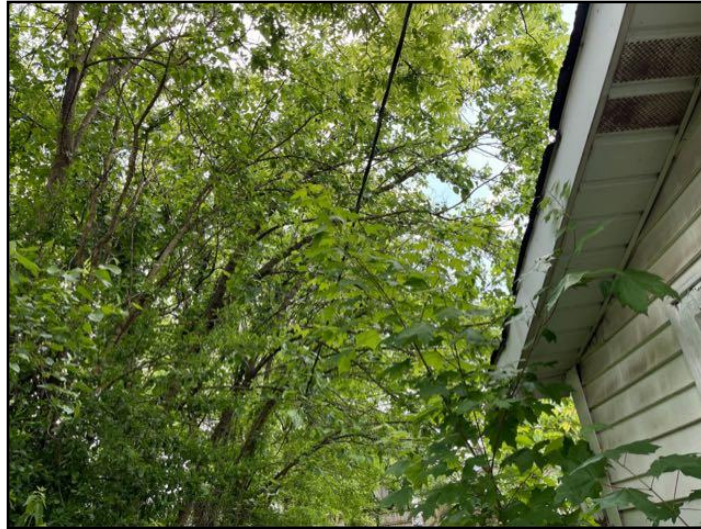
83. Branches / vines interfering with wires

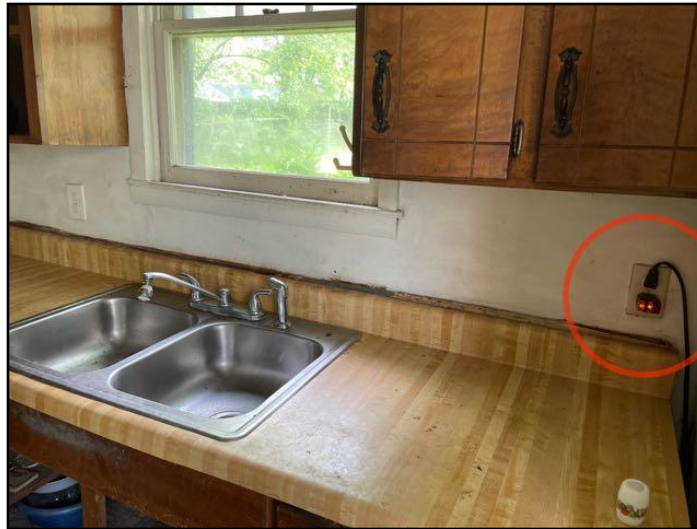
14. Condition: • [No GFCI/GFI \(Ground Fault Circuit Interrupter\)](#)

89. No GFCI/GFI (Ground Fault Circuit...

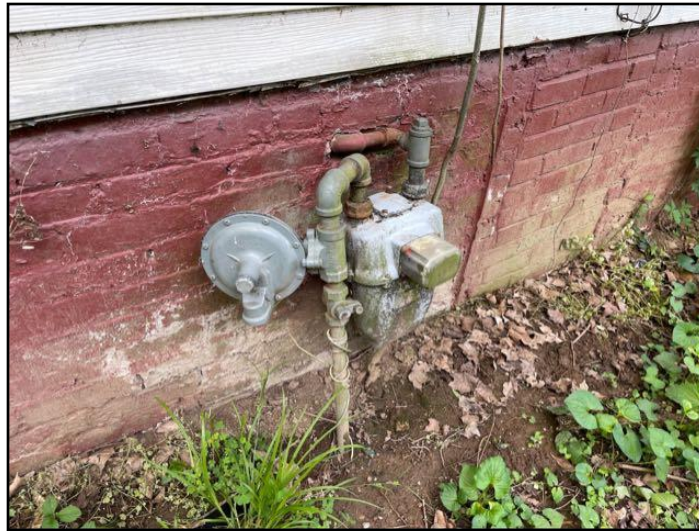
- The gas was shut off at the meter. This prevented operation of all gas-fired appliances.

92. The gas was shut off at the meter. This...

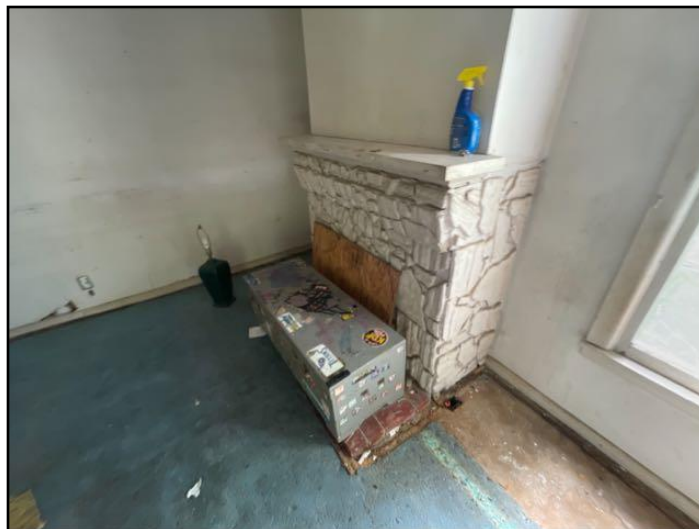
Fireplace/wood stove: • Access to fireplace blocked by storage.

93. Storage preventing inspection

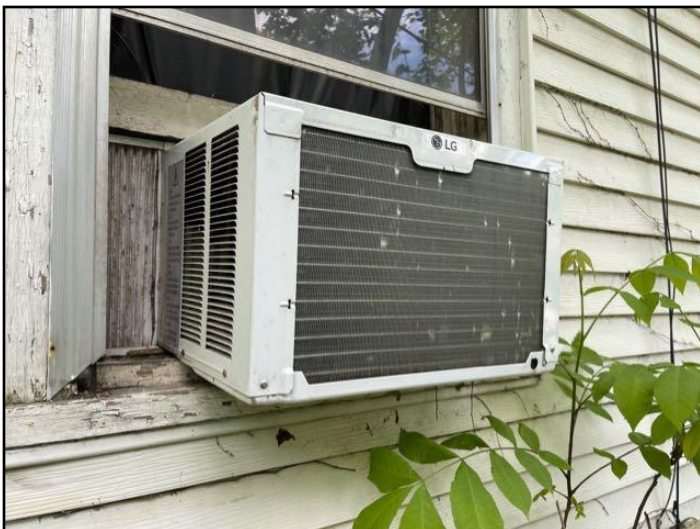
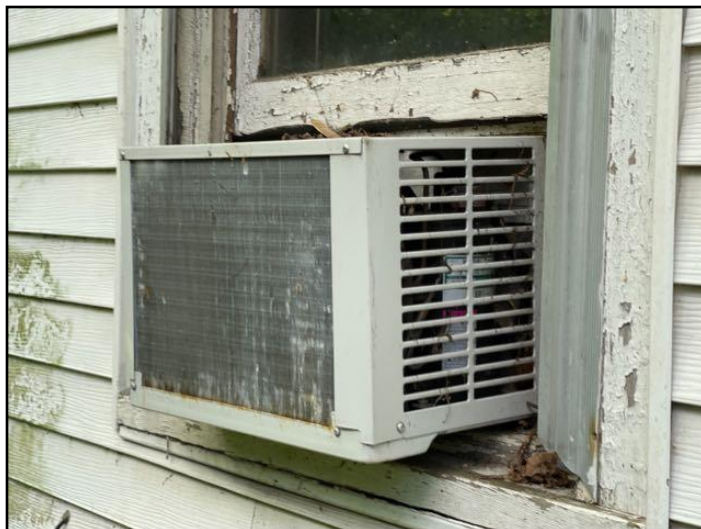
- Window cooling system

97. Window cooling system

98. Window cooling system

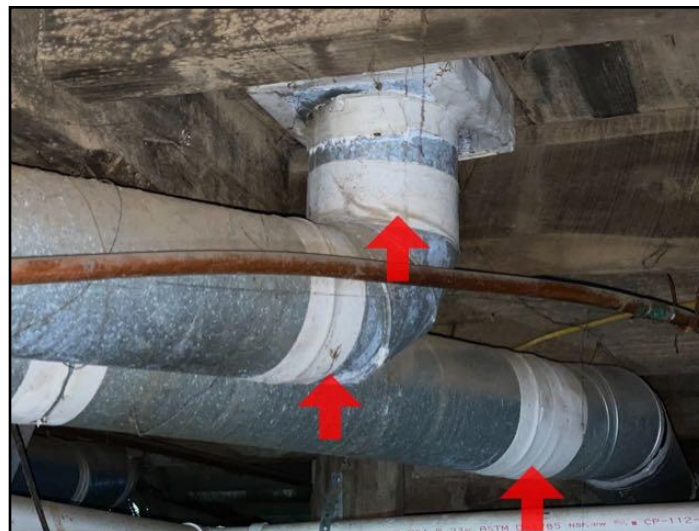
An asbestos-like material was noted on duct work. In general, it is recommended that the material be left undisturbed, and if removal is desired, that testing be performed to verify that asbestos is present. Laboratory testing is required to make a positive determination. If asbestos is present, it is recommended that removal be performed by a qualified remediation contractor.

101. Possible asbestos material

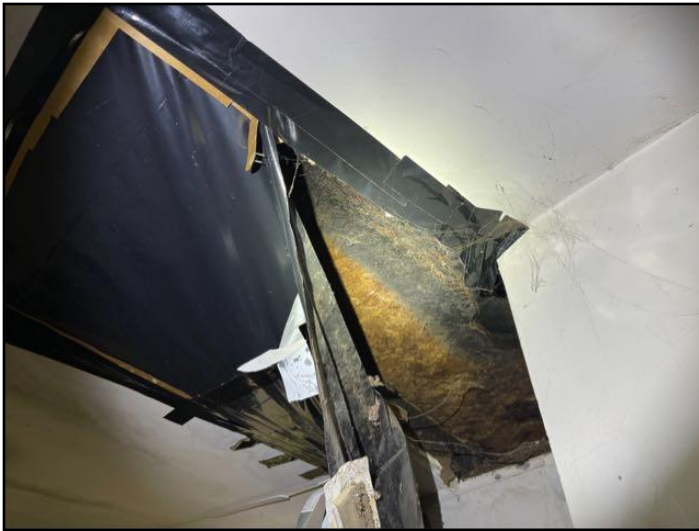
119. Hole in ceiling (moisture in roof sheathing)

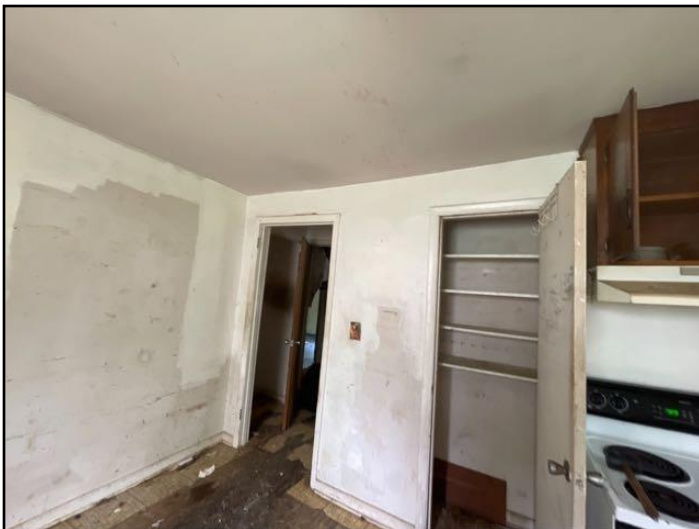
121. General poor condition

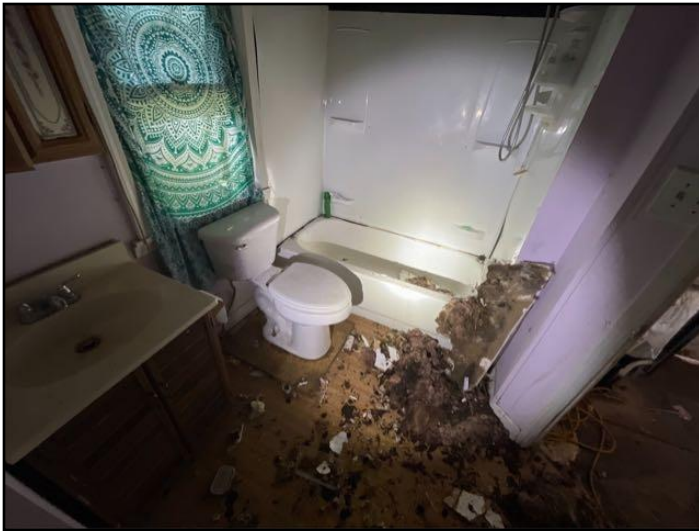
123. Wet insulation in bathroom from active leak

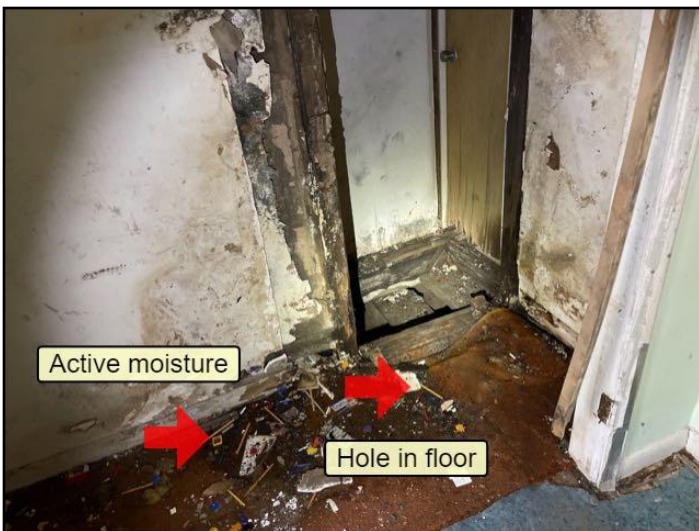
125. Hole in floor

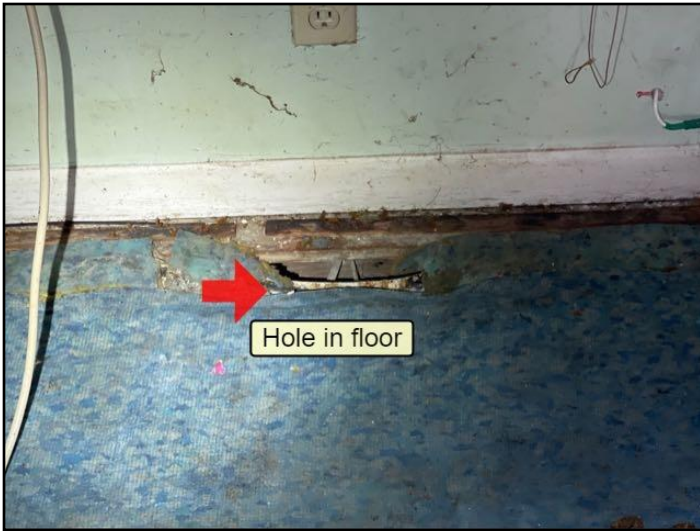
127. Hole in floor

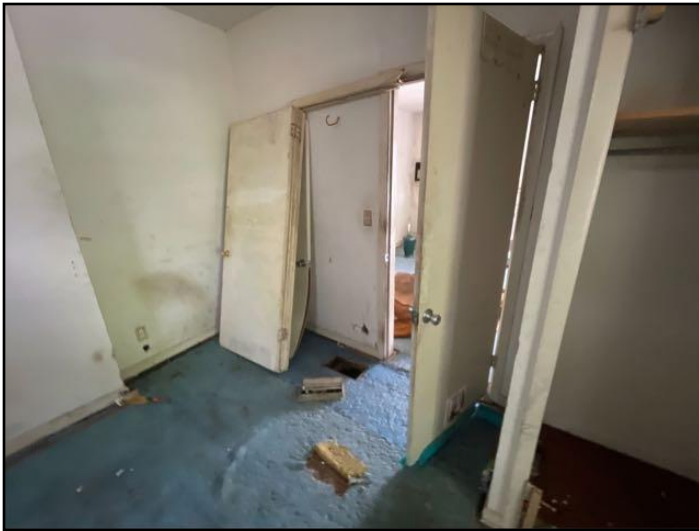
131. Doors not installed

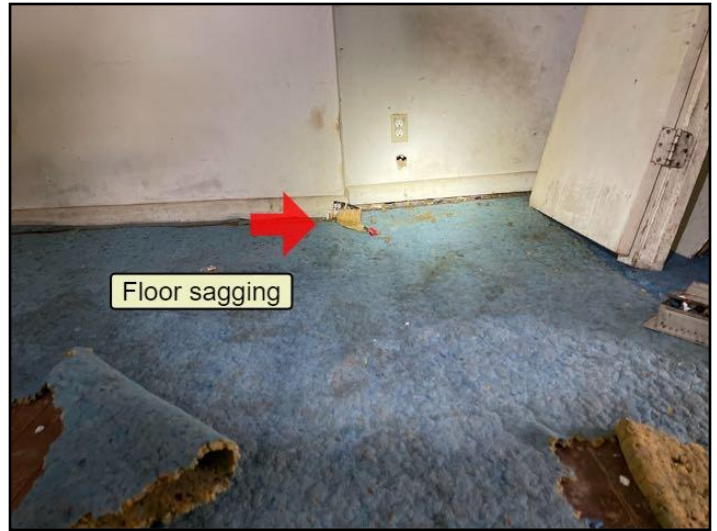
132. Floor system sagging
