METROPOLITAN GOVERNMENT OF NASHVILLE AND DAVIDSON COUNTY

STAFF RECOMMENDATION 949 Russell Street July 21, 2021

Application: Demolition
District: Edgefield Historic preservation Zoning Overlay
Council District: 06
Base Zoning: R8
Map and Parcel Number: 082120038300
Applicant: Troy Harper
Project Lead: Robin Zeigler, robin.zeigler@nashville.gov

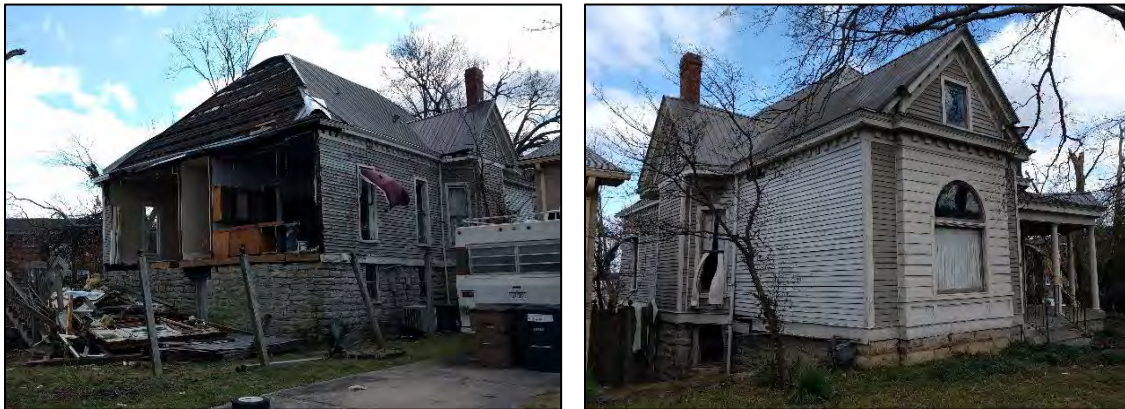
The house at 949 Russell Street was damaged in the March 2020 tornado. The rear wall, roofing material, and some windows were removed by the storm. An application for demolition was submitted to the Codes department in July 2020.

Figures 5 and 6: The house as seen after the storm on March 6, 2020.

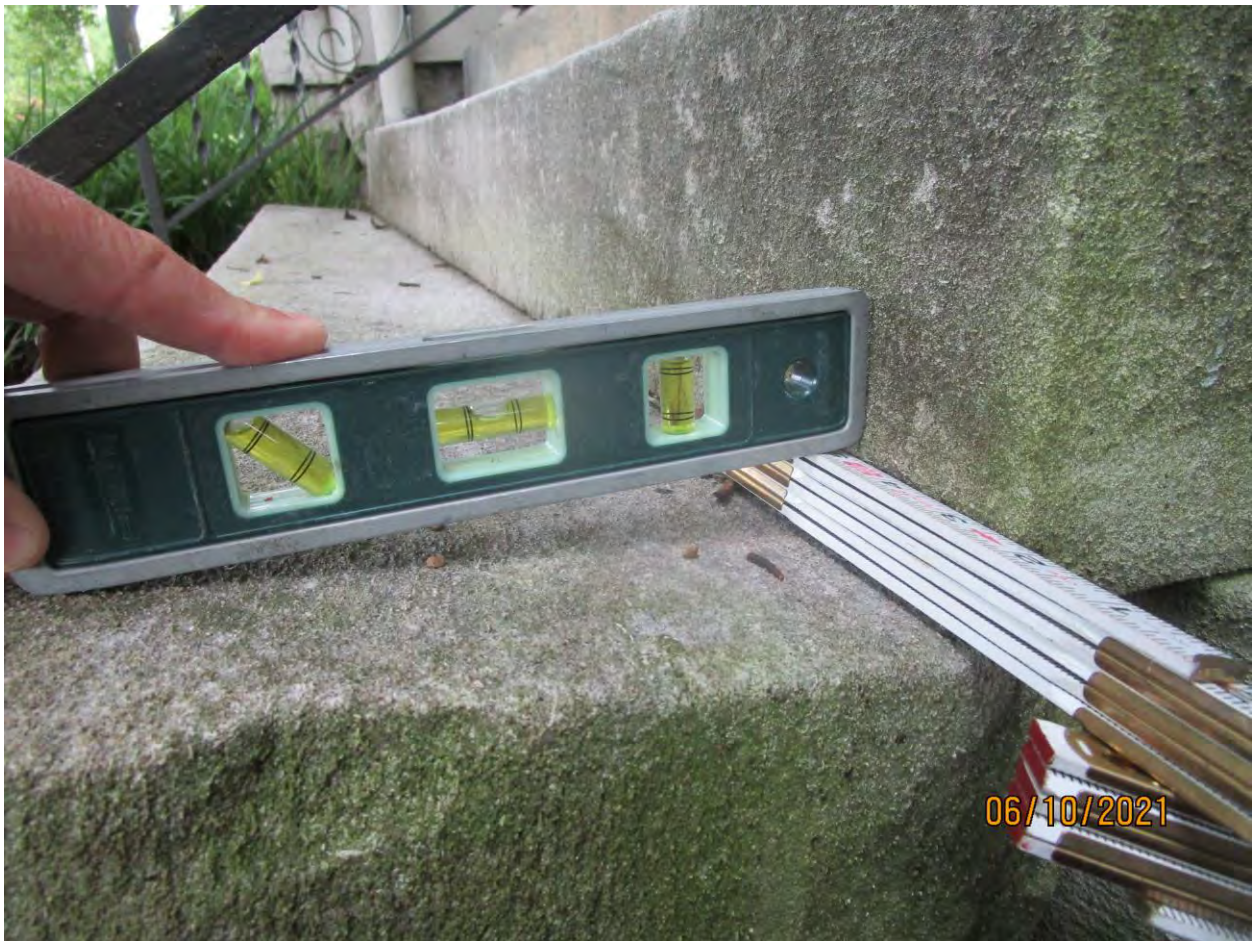
- Reviewing the front porch area, multiple deficiencies were observed. These deficiencies consist of the front porch step being out-of-flat approximately one-inch over an eight-inch step width (photograph 3). An overview of the front porch can be observed in photographs 1, 5, and 9). Also negatively affecting the front porch area are vertical (photographs 9 and 10) and horizontal movements (photographs 4, 6, and 7) common to the front porch slab. Also common to the front porch was settlement of the stone foundation walls (photographs 13 through 15). The settlement of these cut-stone foundation walls obviously is contributing to the overall horizontal and vertical movements of the front porch area.

Photograph 3: Out-of-level front steps.

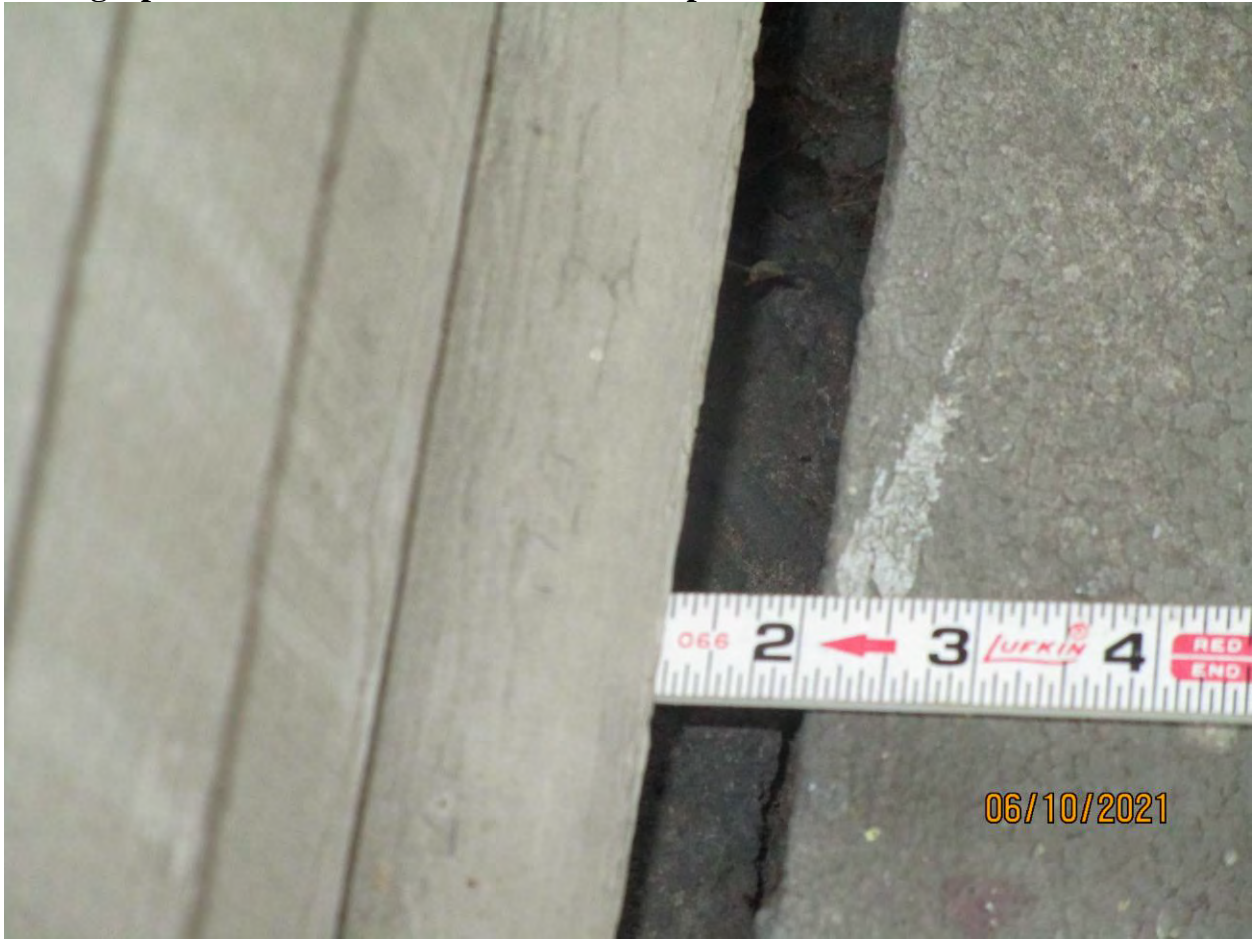
Photograph 4: Horizontal movement of front porch.

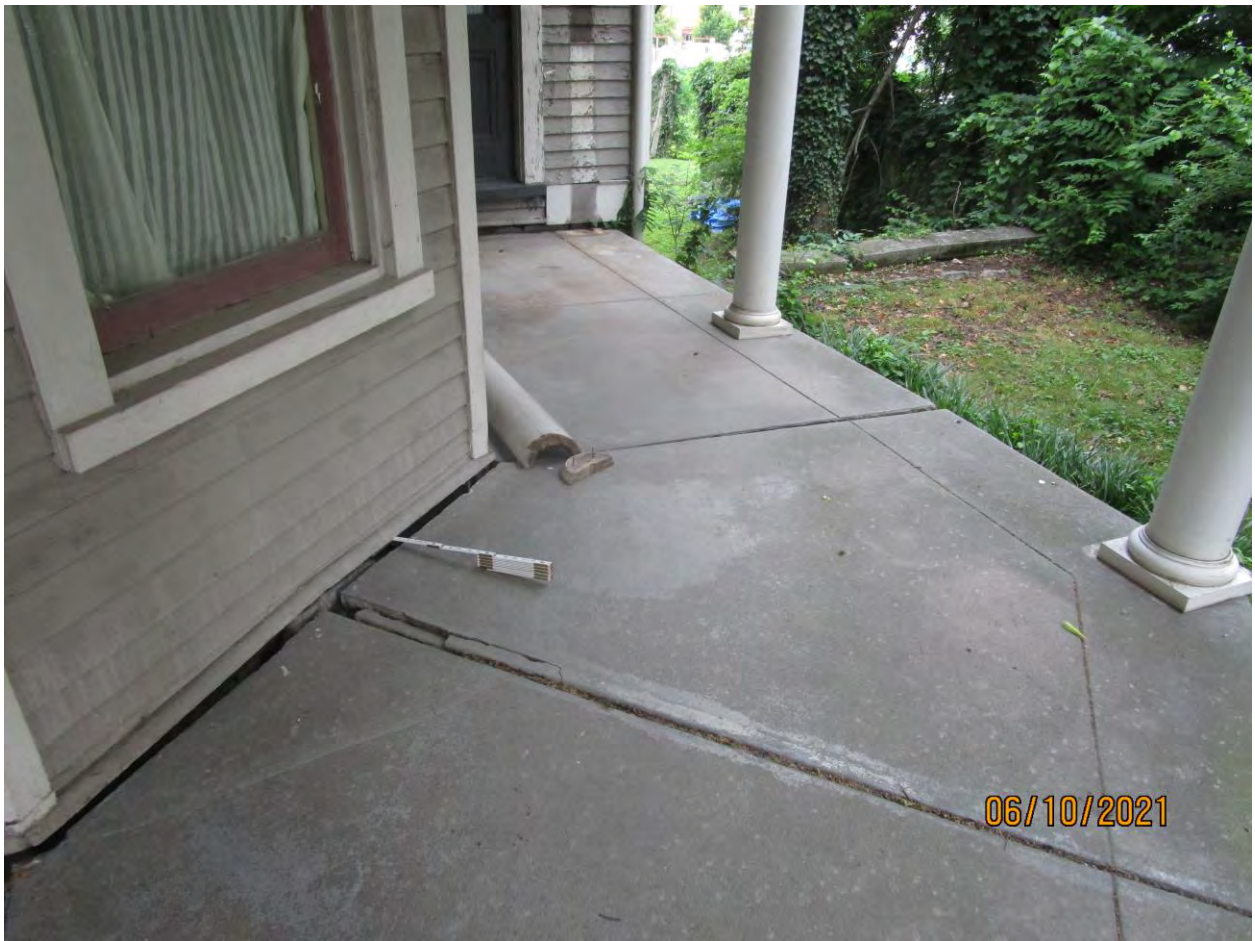
Photograph 5: Overview of front porch.

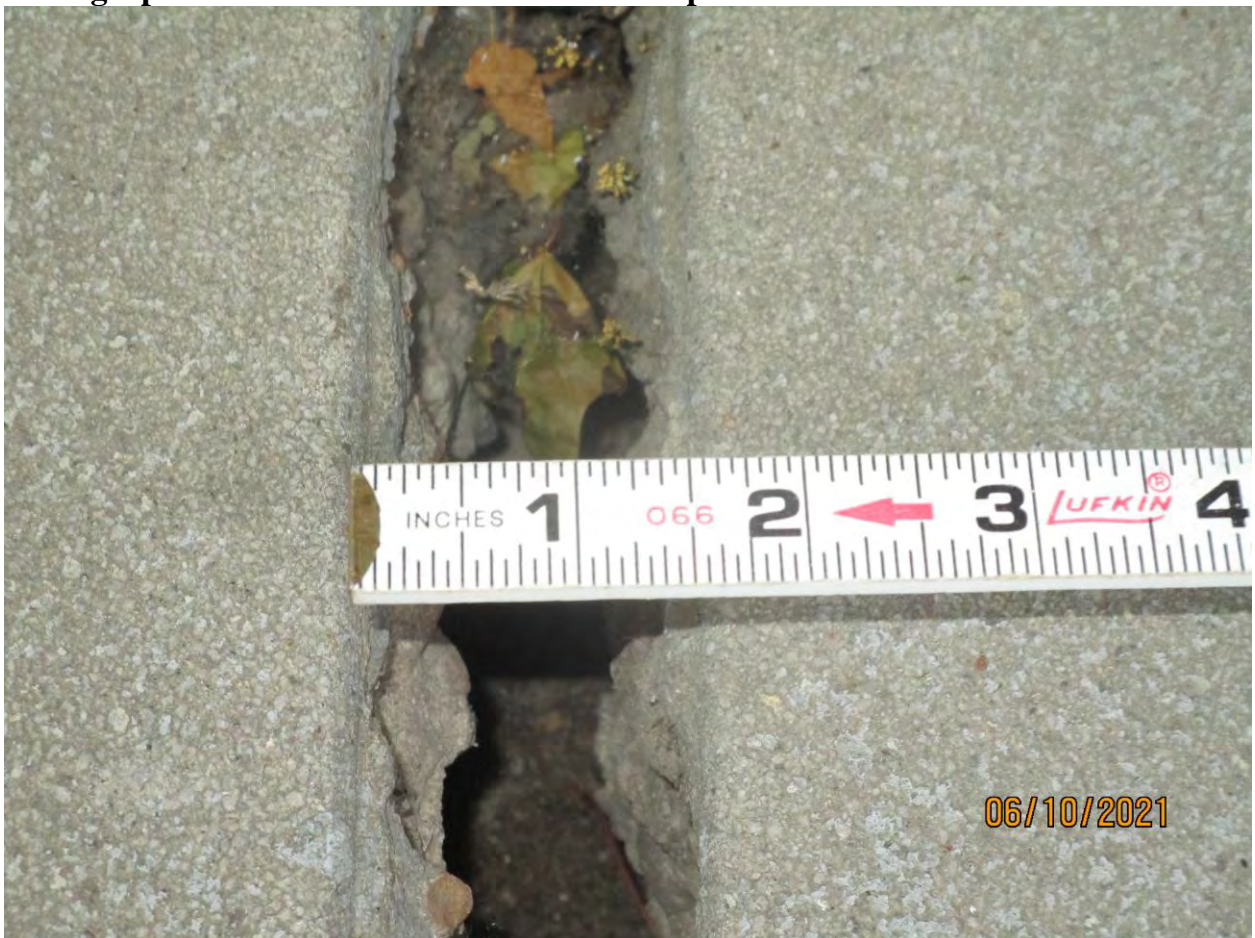
Photograph 6: Horizontal movement of front porch.

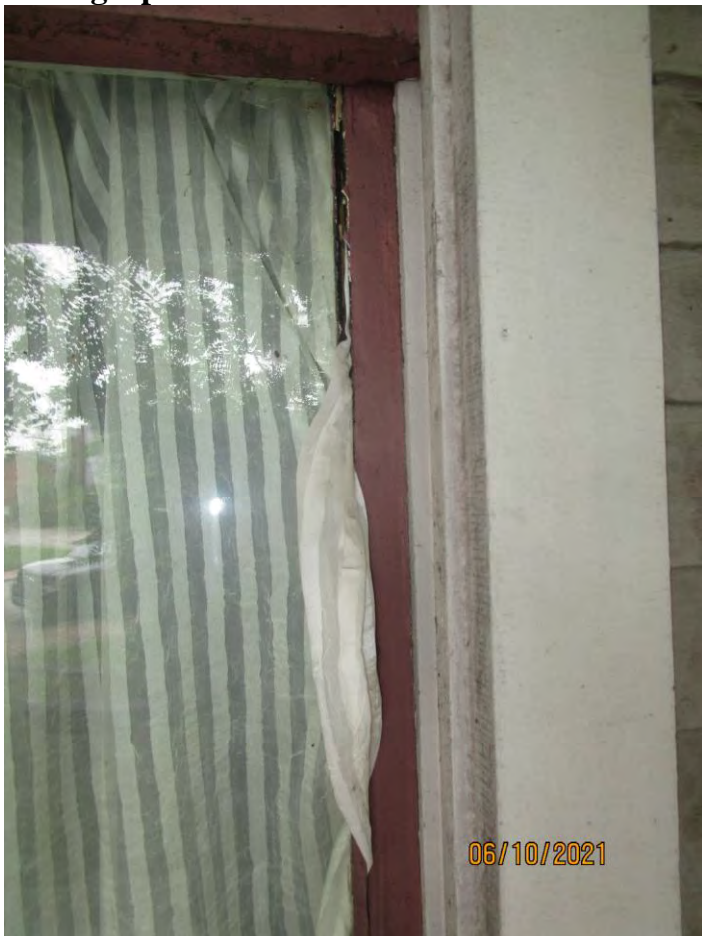
Photograph 8: Suction forces on front windows.

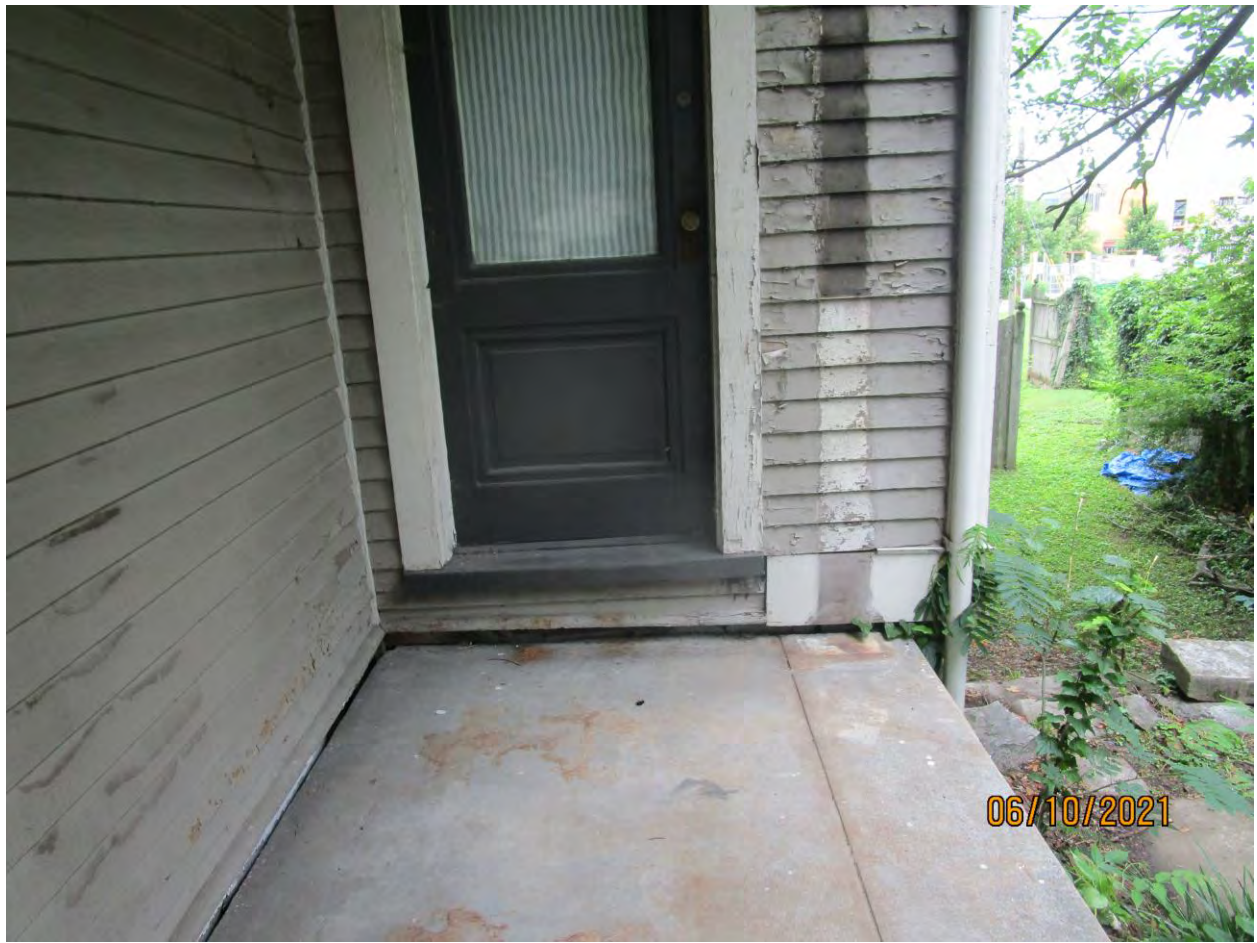
Photograph 9: Vertical settlement of front porch.

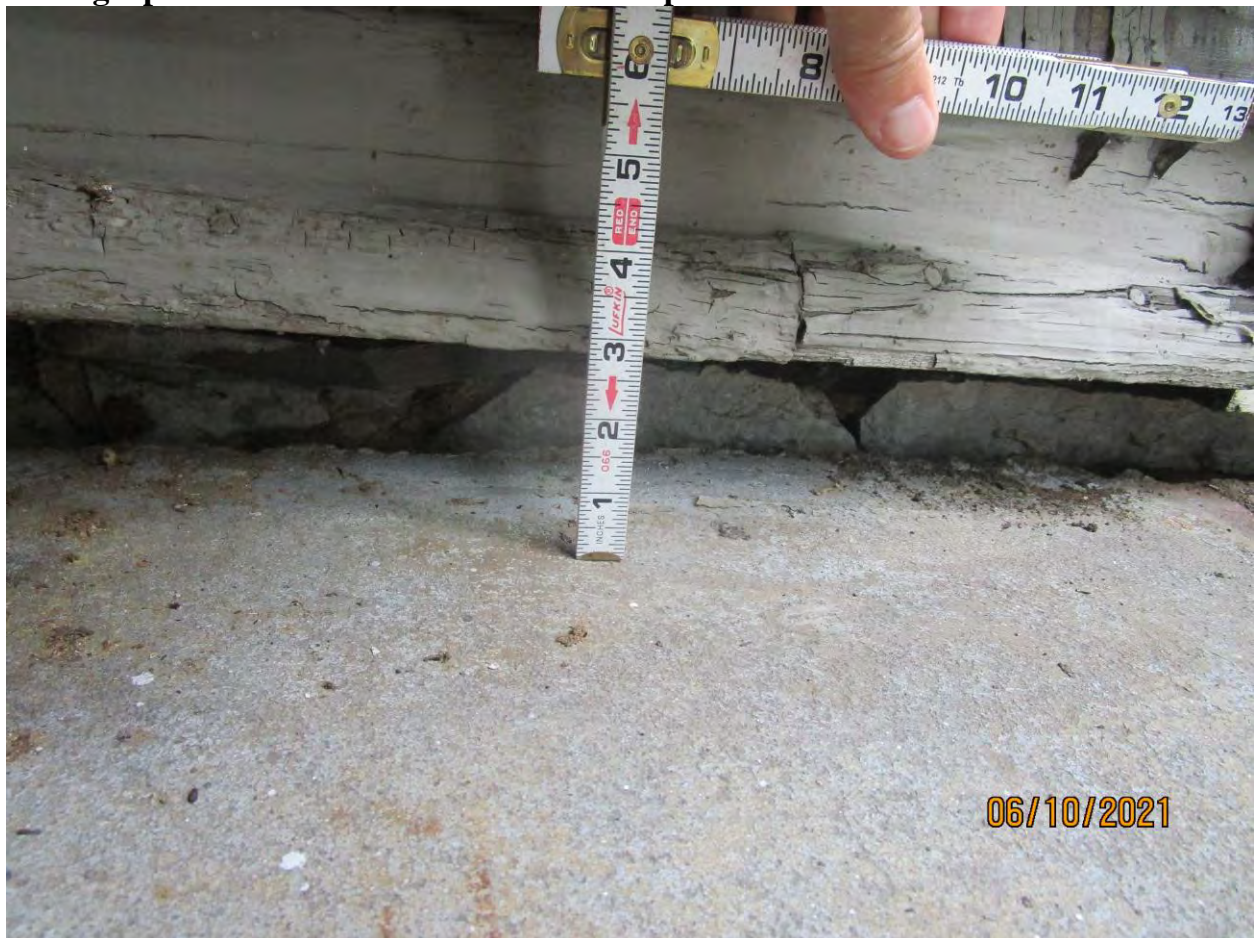
Photograph 10: Vertical settlement of front porch.

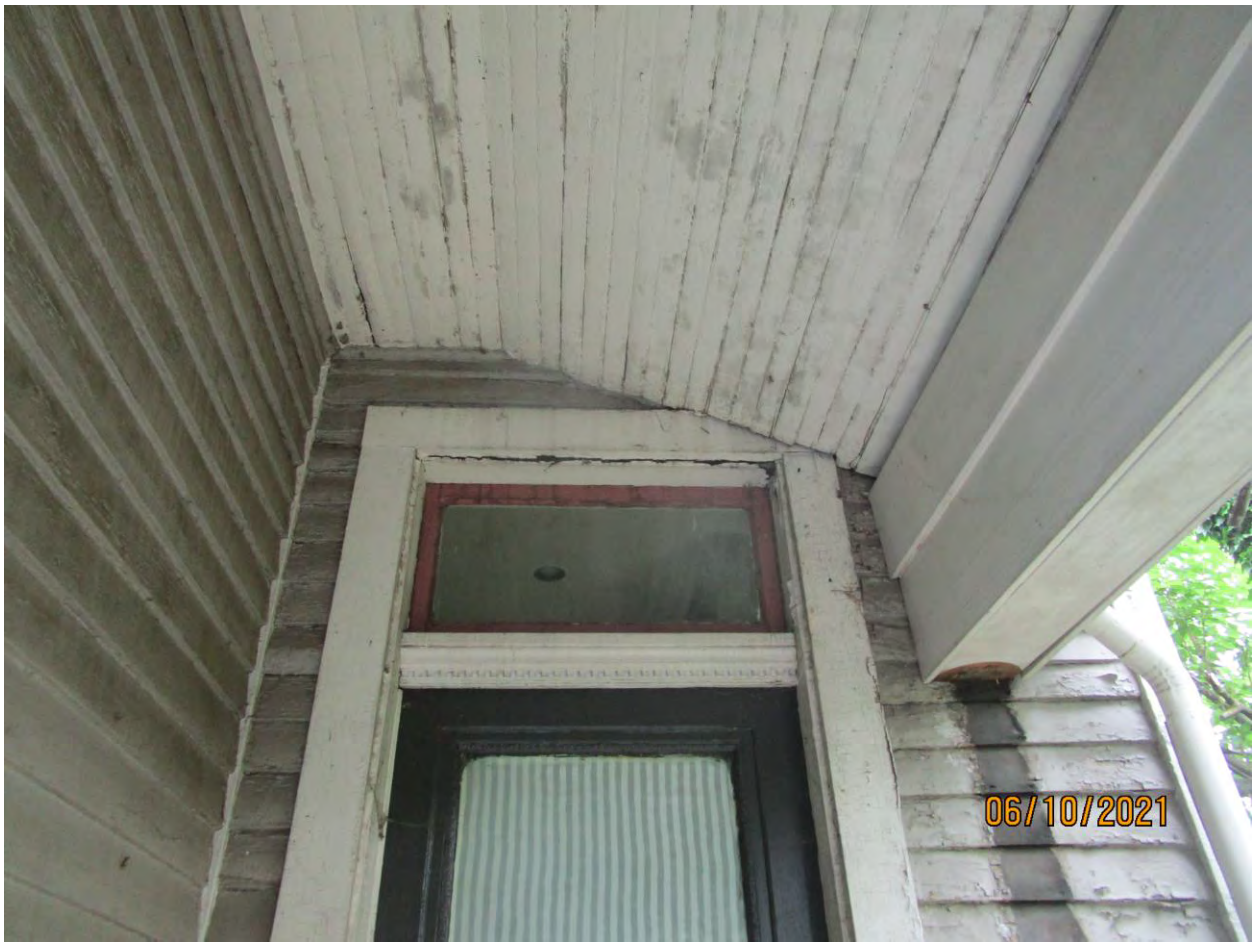
- As is typical with most historical homes, past water infiltration issues typically caused rotted wood and deteriorated structural members. From reviewing the front porch area, it is obvious that the low roof portion common to the right side of the porch has experienced water infiltration issues in the past as is evident by the deflected wood ceiling (photographs 11 and 12).

Photograph 11: Rotten wood at side door of porch area.

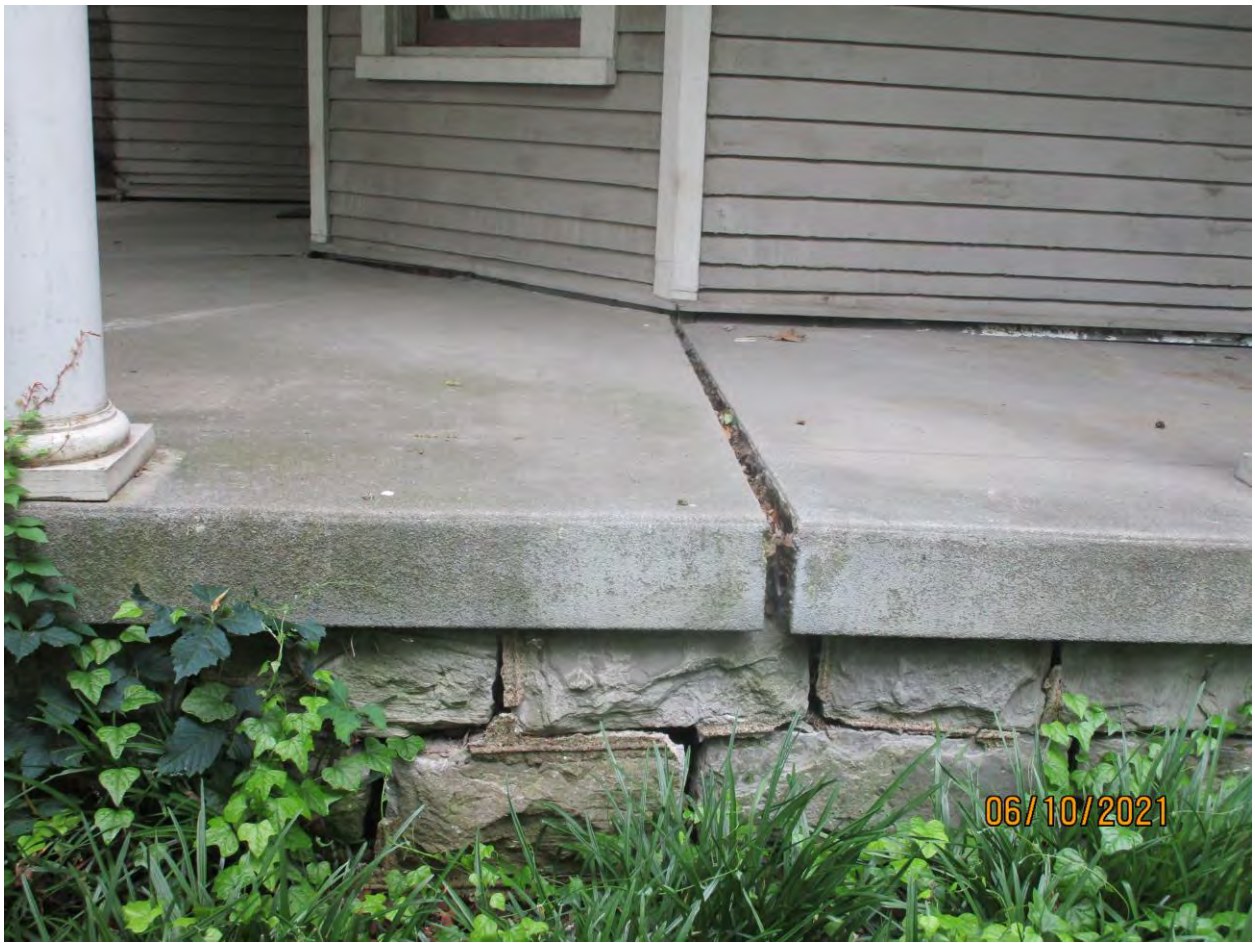
Photograph 15: Settlement of front porch foundation wall.

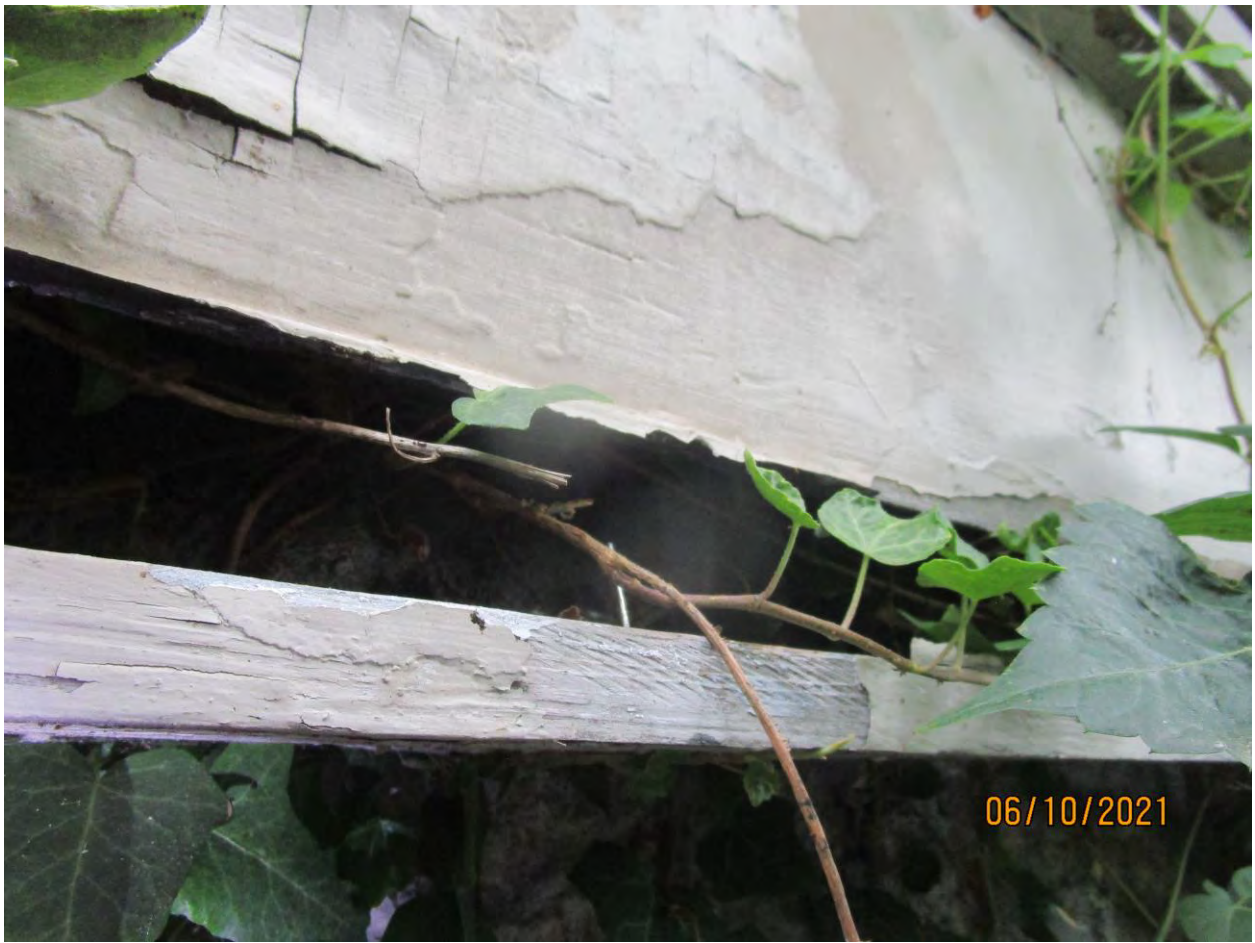
- I also observed that the band board located at the bottom face of the home appears to have been subjected to moisture as is evident by the deteriorated wood (photograph 17).

Photograph 17: Rotten band board at right side.

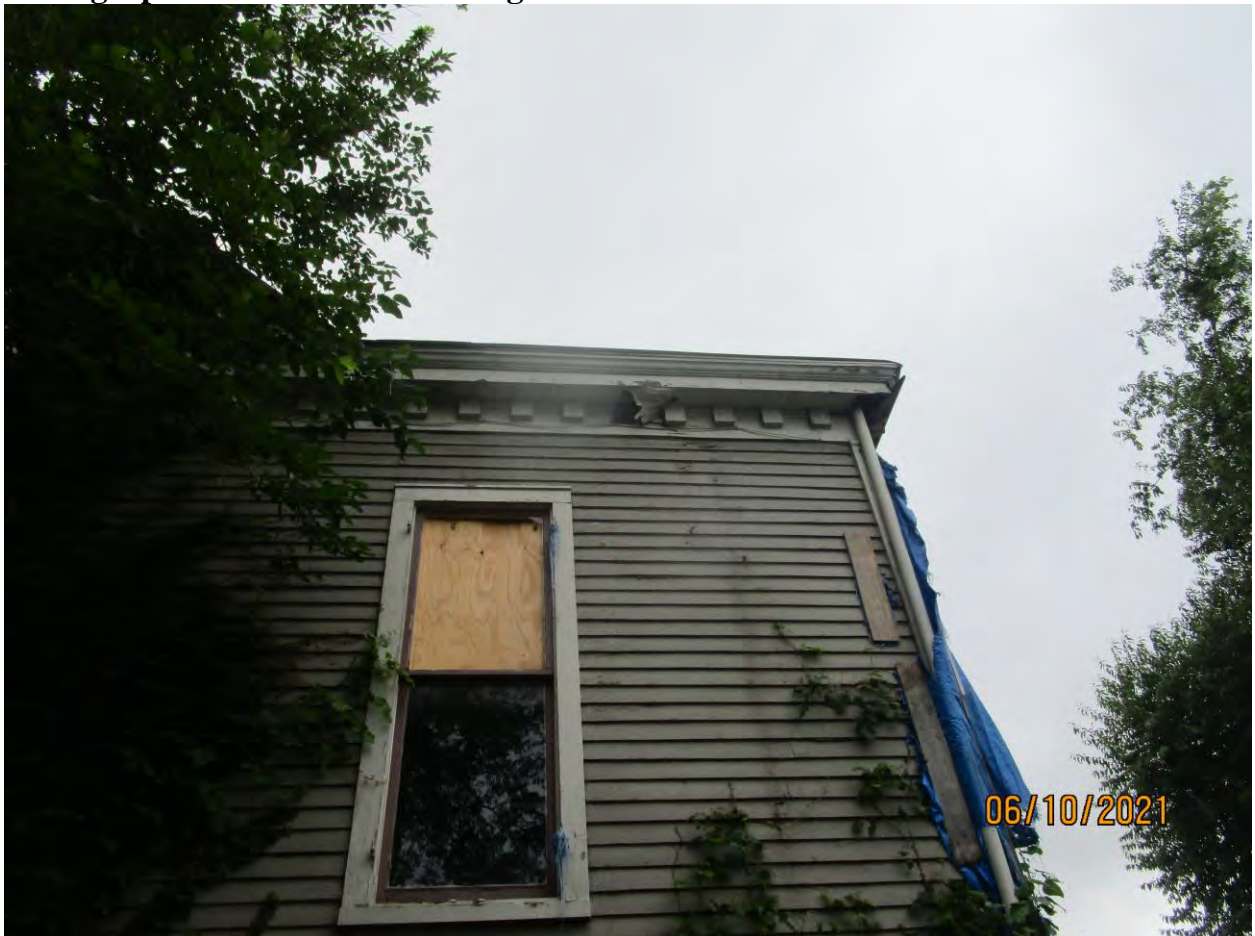
Photograph 18: Rotten soffit at right rear corner.

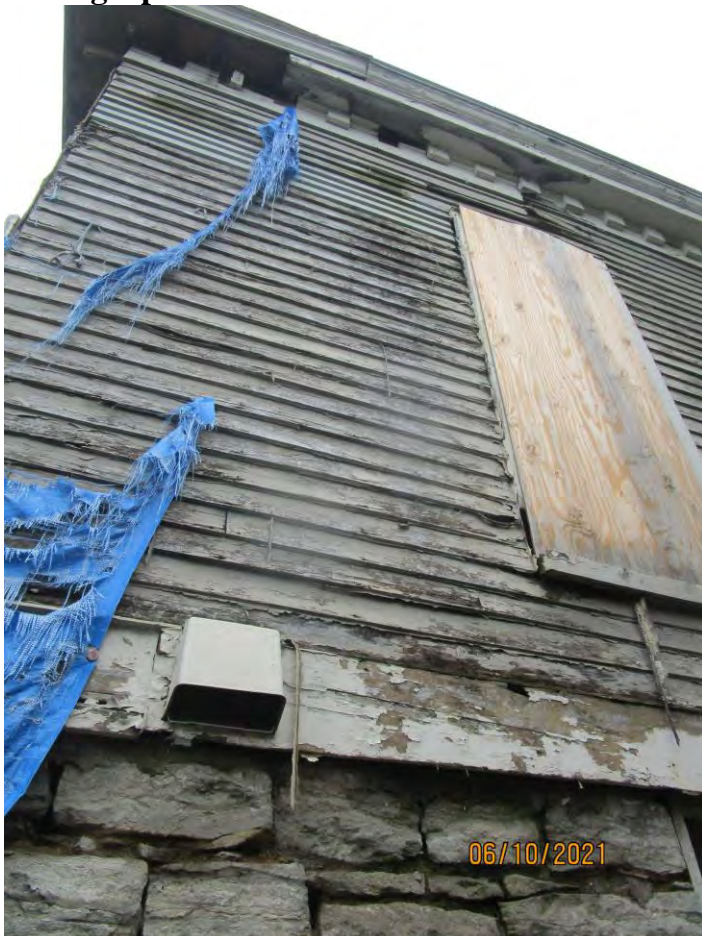
- Due to the effects of the high winds, the entire rear wall of the home was displaced as well as the rear porch (photographs 21 and 22).
- The left side of the home was observed, and the same deterioration common to the interior gutter has created rotten wood common to the soffit and, most likely, common to the interior wall cavity. Examples of the rotten soffits on the left sidewall can be observed in photographs 24, 25, 26, and 28.

Photograph 24: Rotten soffit at left rear corner.

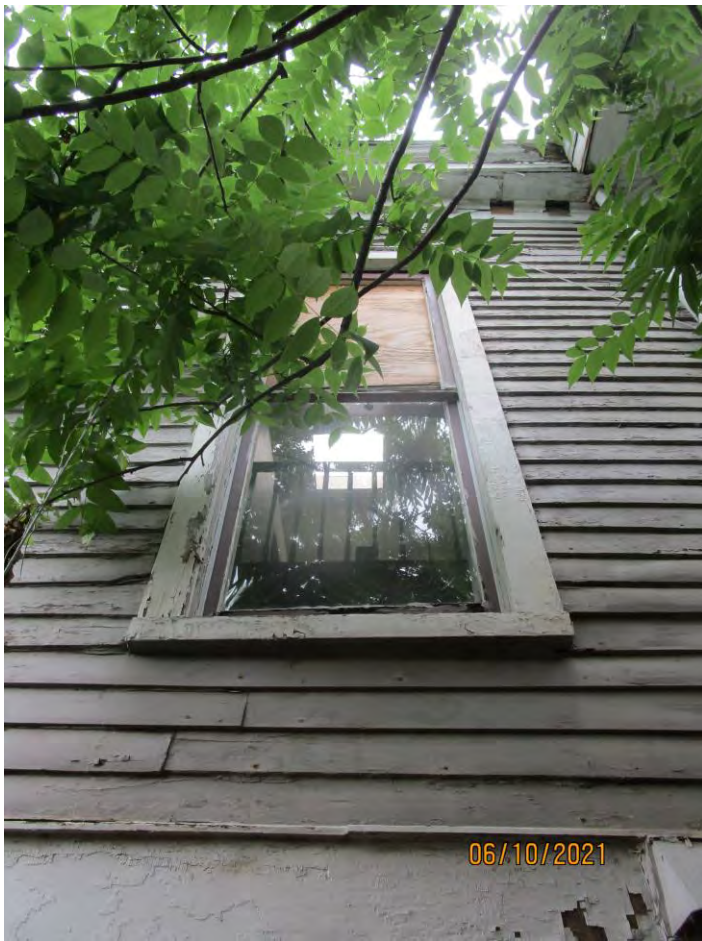
Photograph 25: Rotten soffit at left sidewall at interior gutter.

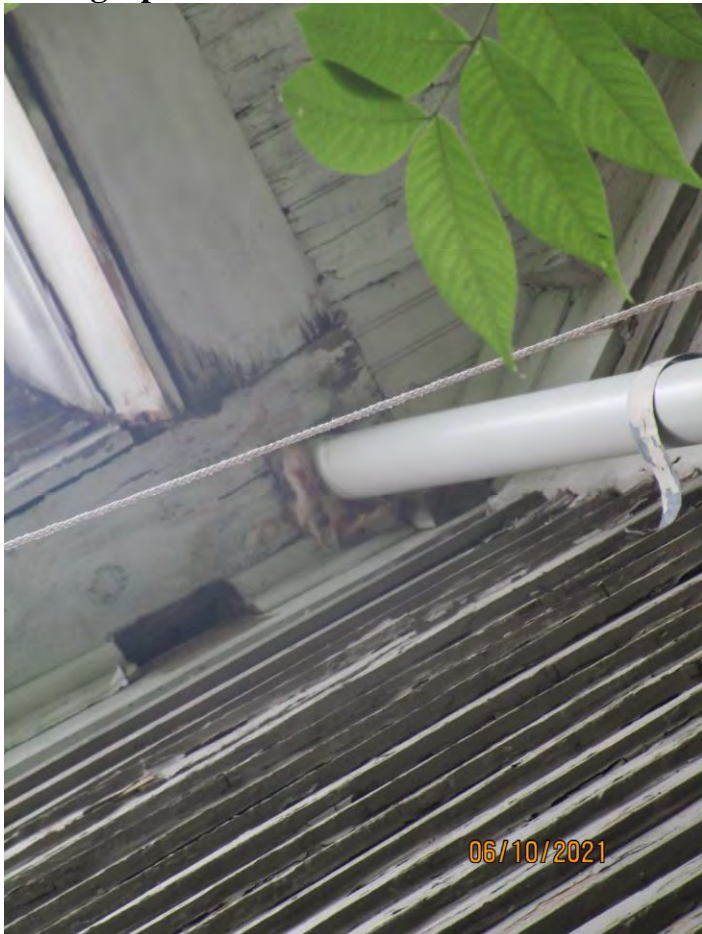
Photograph 26: Rotten soffit at left sidewall at interior gutter.

Photograph 27: Rotten soffit at left sidewall.

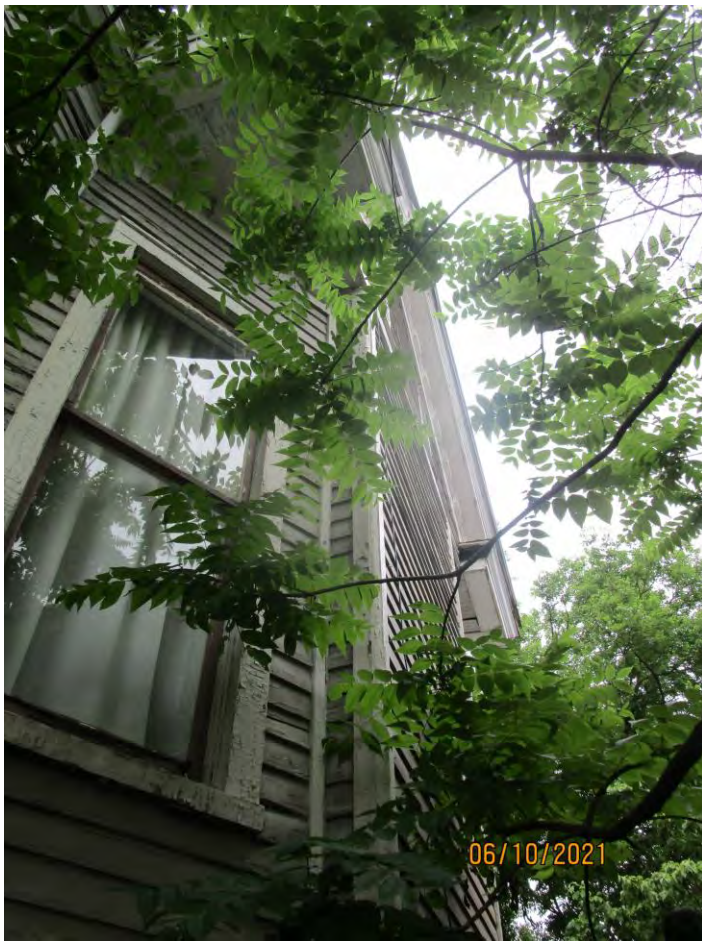
Photograph 28: Rotten soffit at left sidewall.

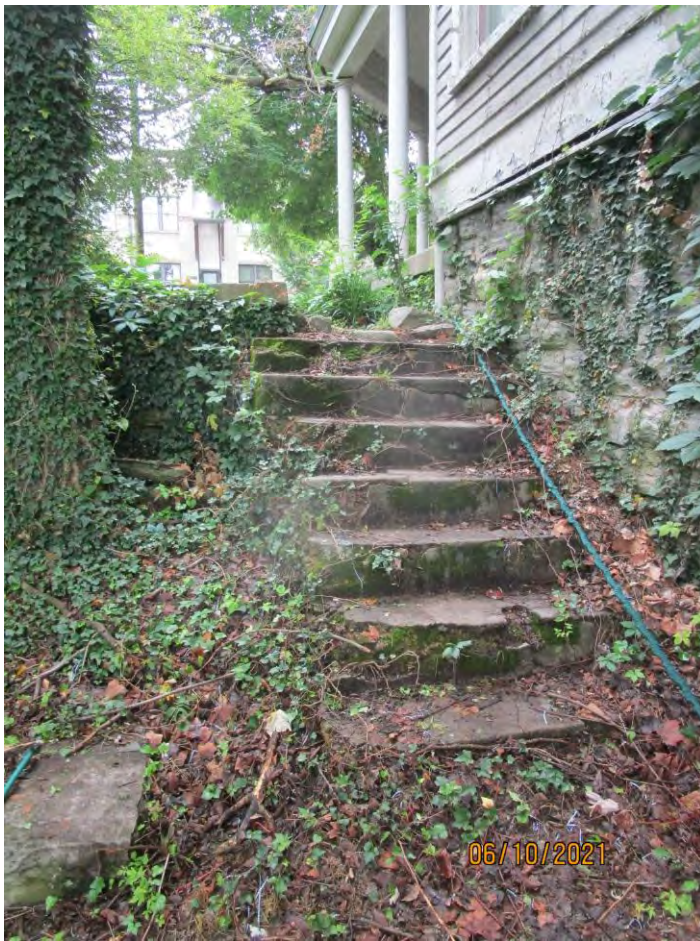
- The site steps at the right side of the home have deteriorated and sill be required to be removed and replace (photographs 29 and 20).

Photograph 29: Deteriorated steps at right side of property.

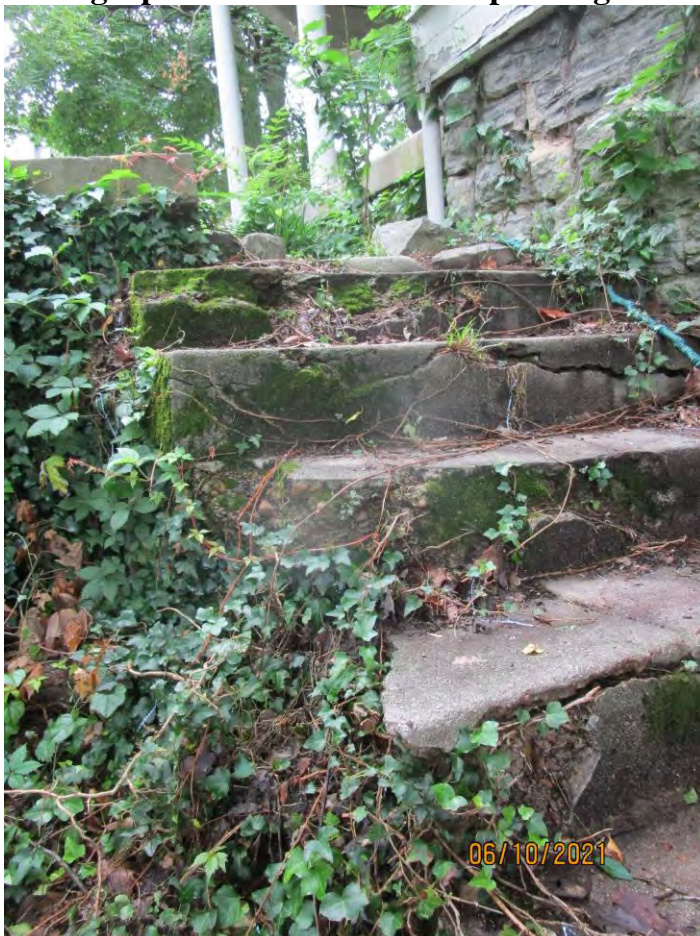
Photograph 30: Deteriorated steps at right side of property.

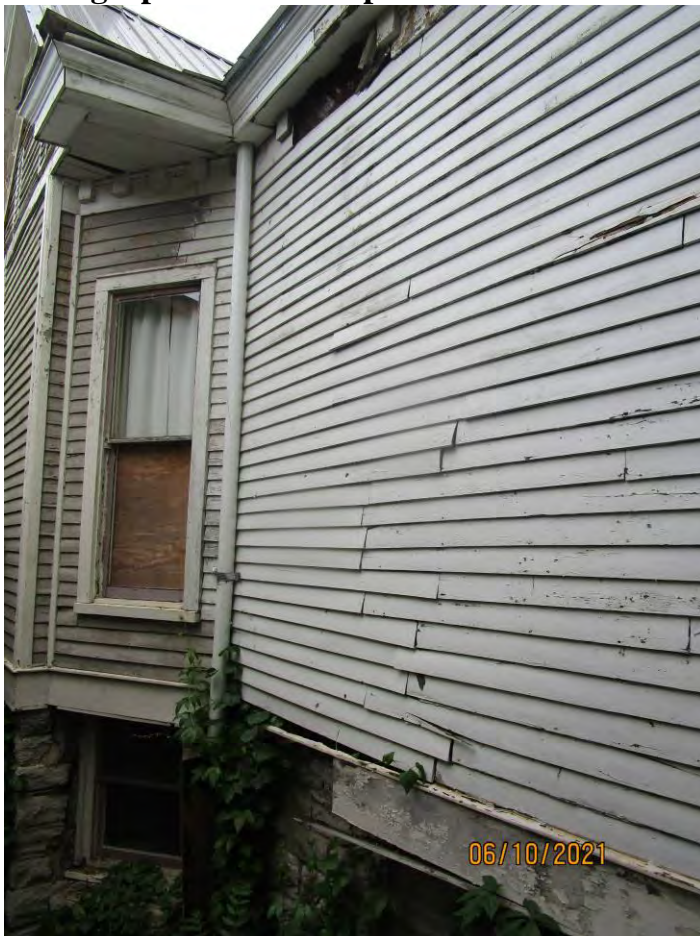
- Due to the high tornadic wind forces, the left sidewall of the home was displaced vertically by approximately four inches at the base of the wall (overview in photographs 31 and 32; interior photograph 69). As can be seen in photograph 33, the wood siding common to this area has been replaced in the past as is evident by the joint.

Photograph 31: Close-up of left sidewall at front of house.

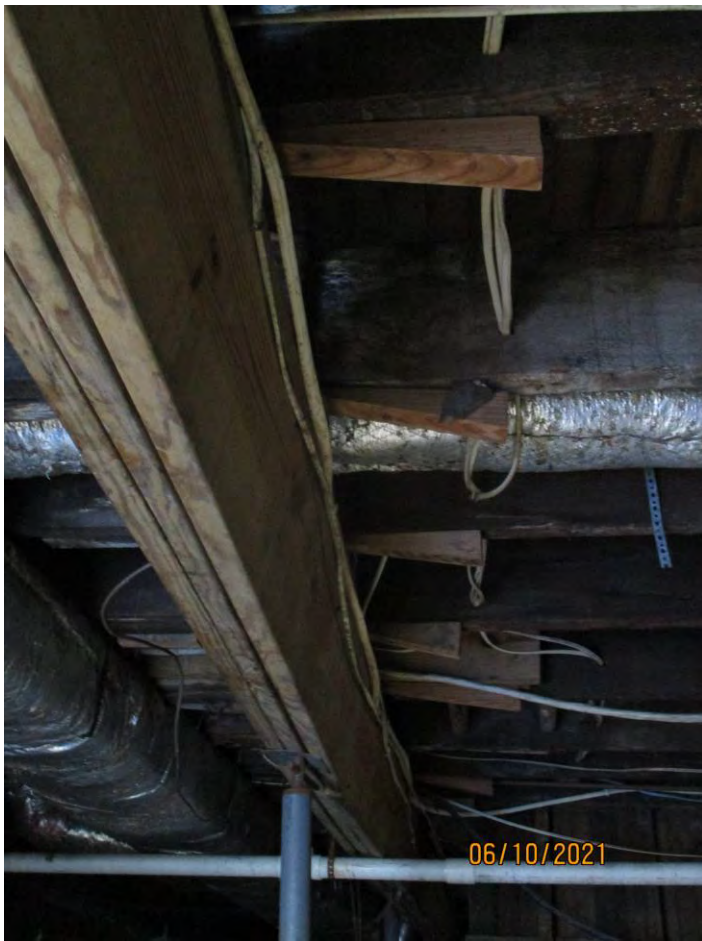
- From observing the crawlspace, multiple deficiencies were observed. The first deficiency was one of the interior wood beams that had been previously repaired in the past and is now failing (photographs 38 and 39).

Photograph 38: Previously replaced wood beam (inadequate).

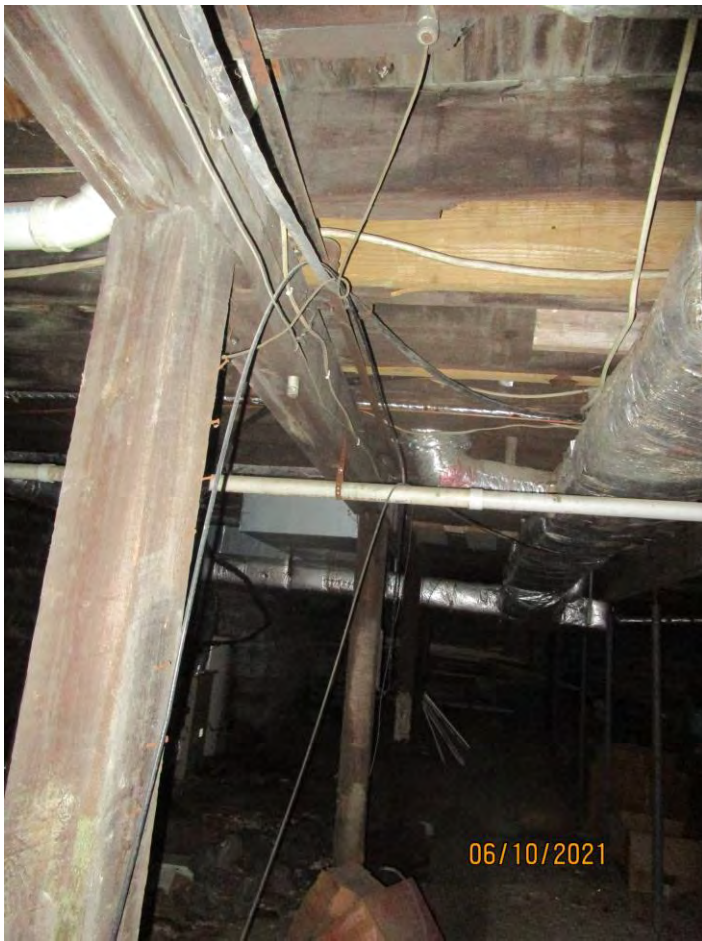
Photograph 39: Previously replaced wood beam (inadequate).

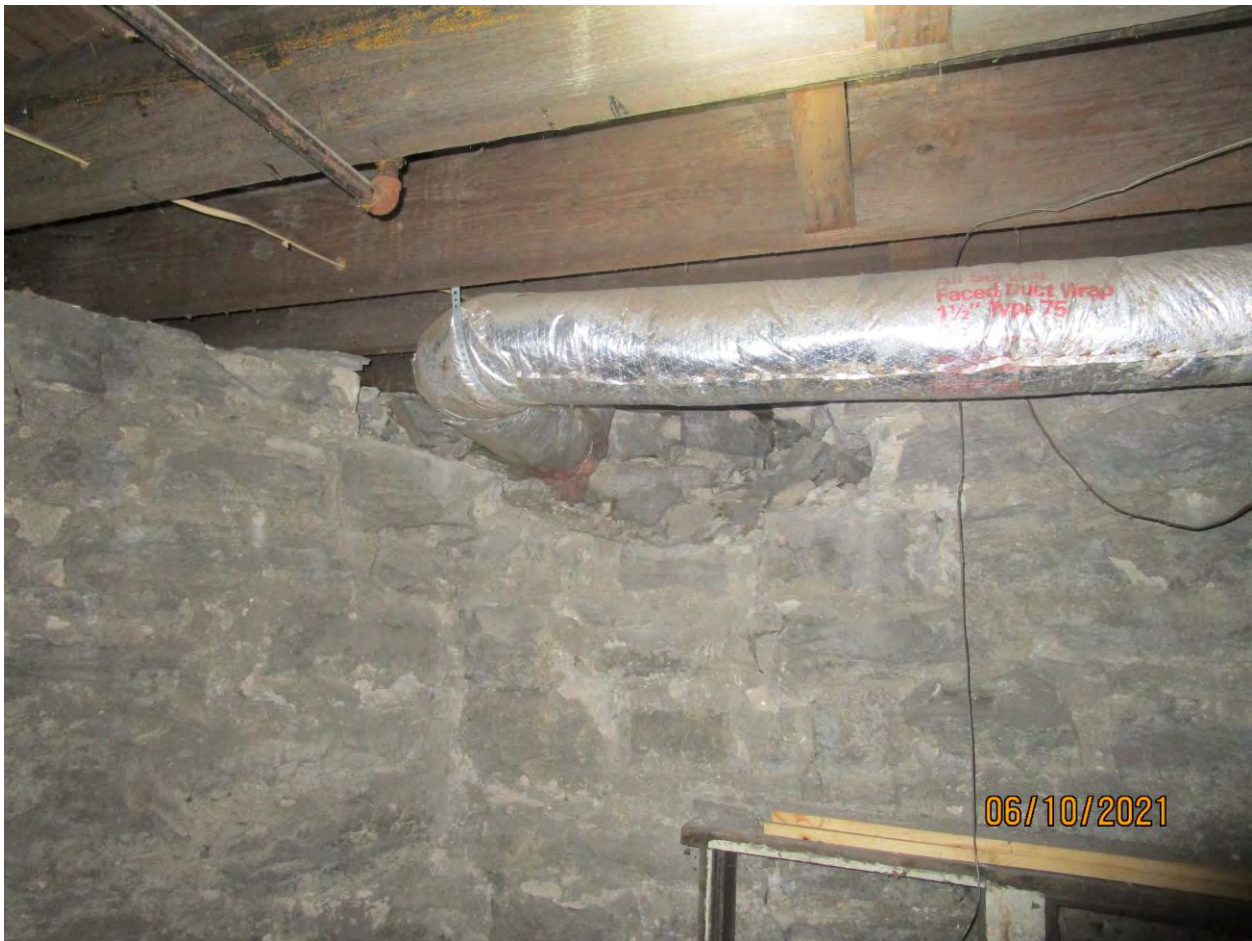
Photograph 46: Right sidewall foundation wall issues.

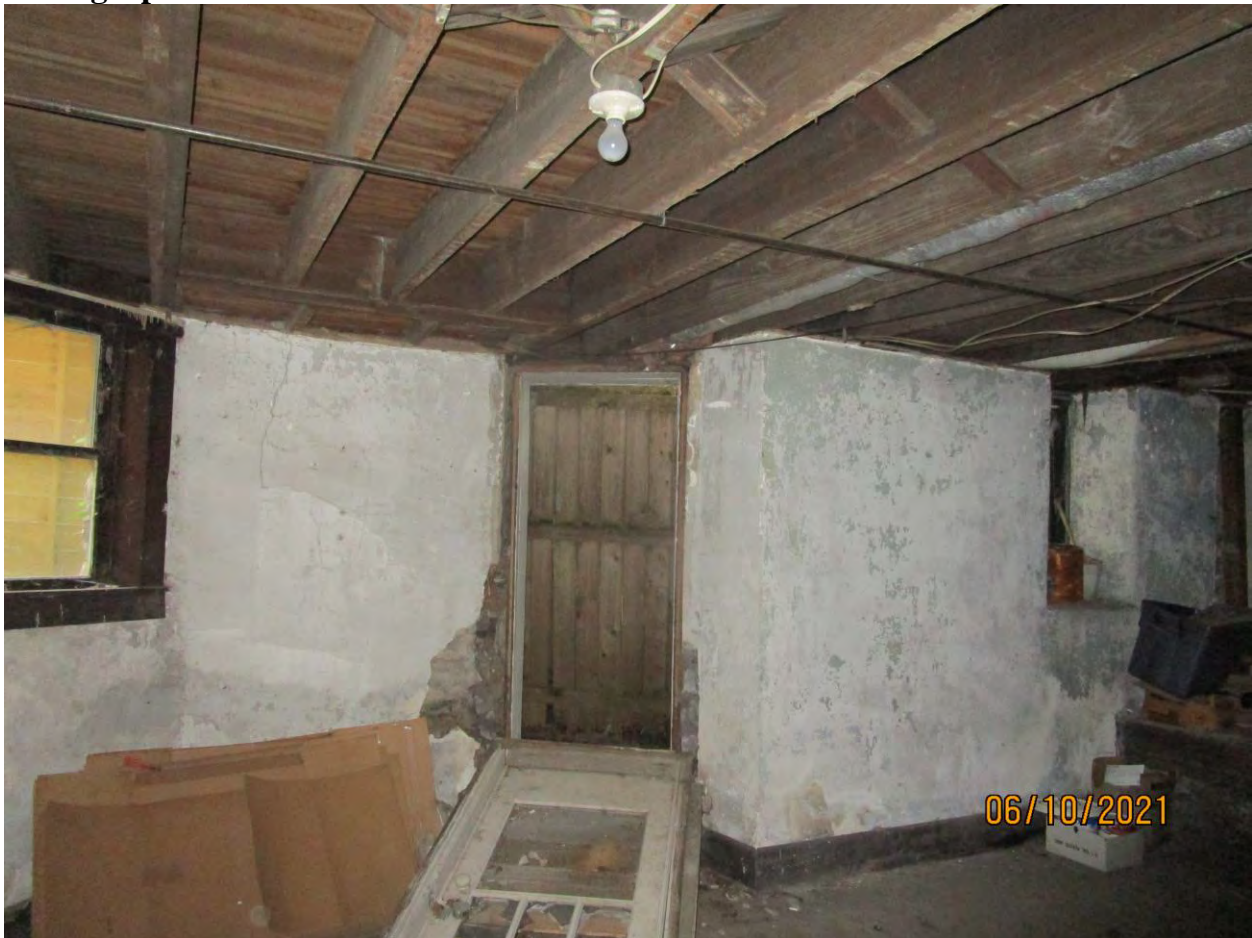
Photograph 47: Front wall foundation wall issues.
