METROPOLITAN GOVERNMENT OF NASHVILLE AND DAVIDSON COUNTY

STAFF RECOMMENDATION 949 Russell Street July 21, 2021

Application: Demolition
District: Edgefield Historic preservation Zoning Overlay
Council District: 06
Base Zoning: R8
Map and Parcel Number: 082120038300
Applicant: Troy Harper
Project Lead: Robin Zeigler, robin.zeigler@nashville.gov

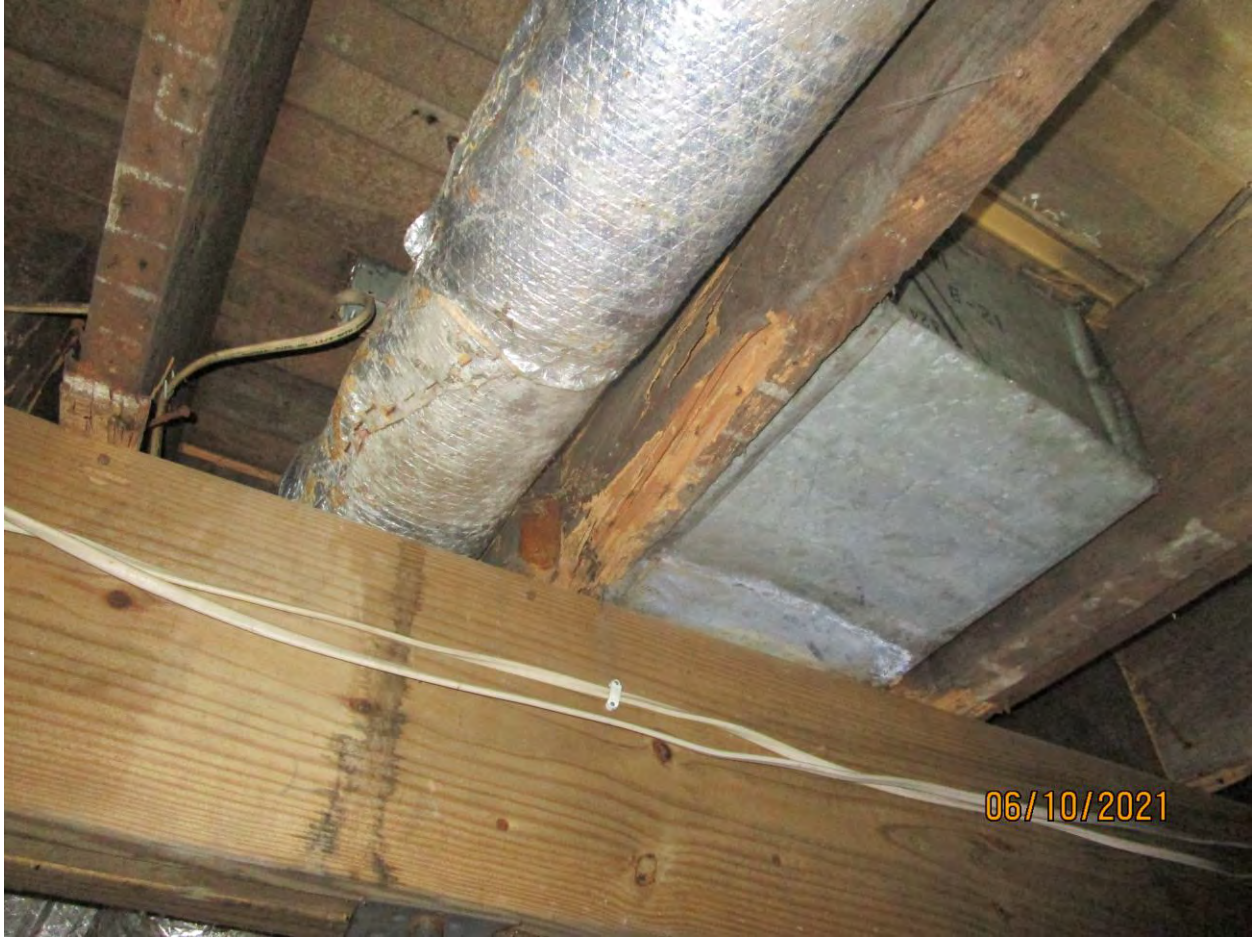
Photograph 50: Typical insect infestation of wood joists.

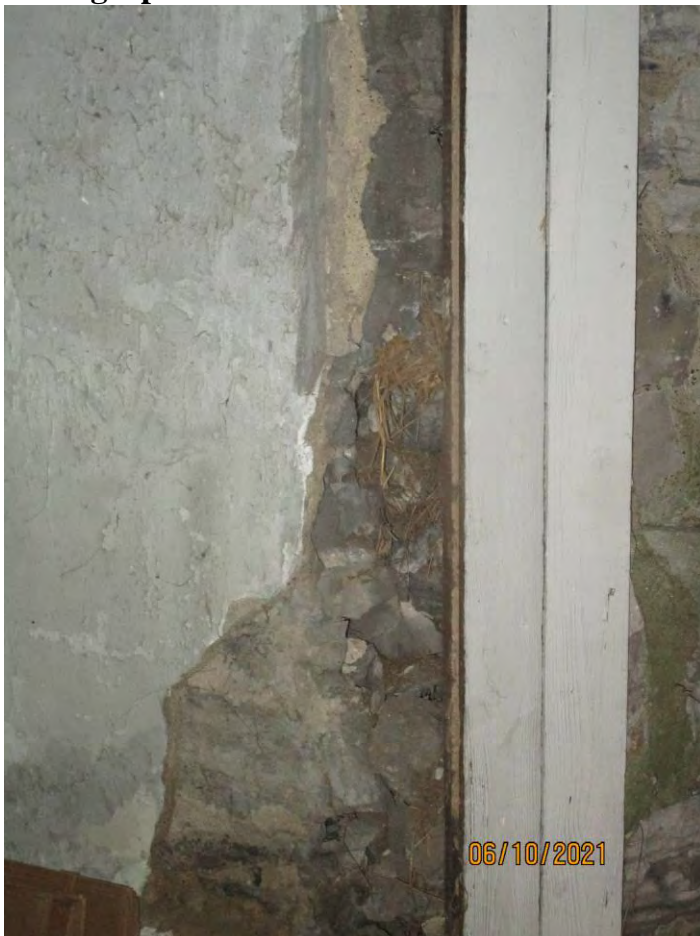
Photograph 52: Left sidewall foundation issues.

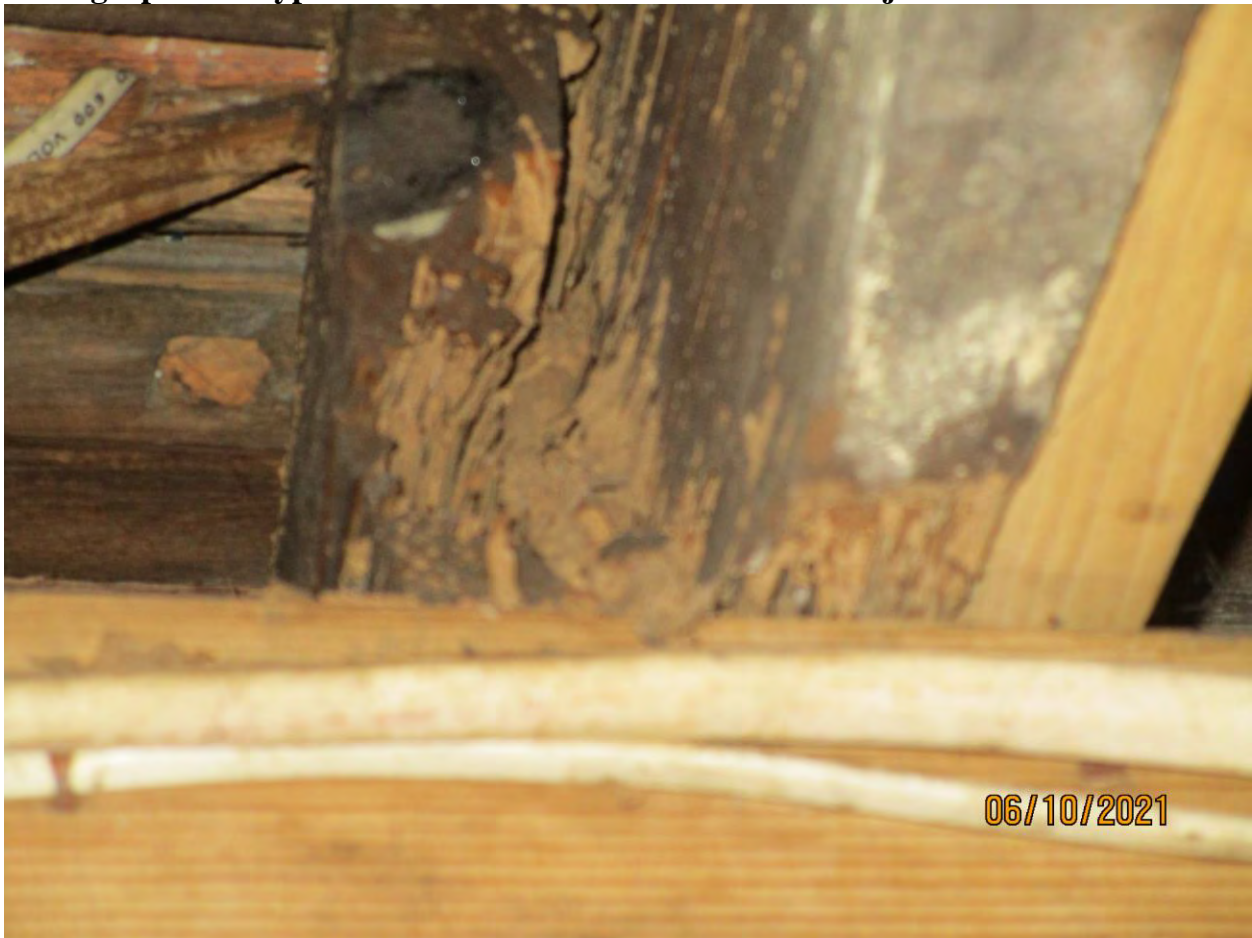
Photograph 53: Typical insect infestation issues with wood joists.

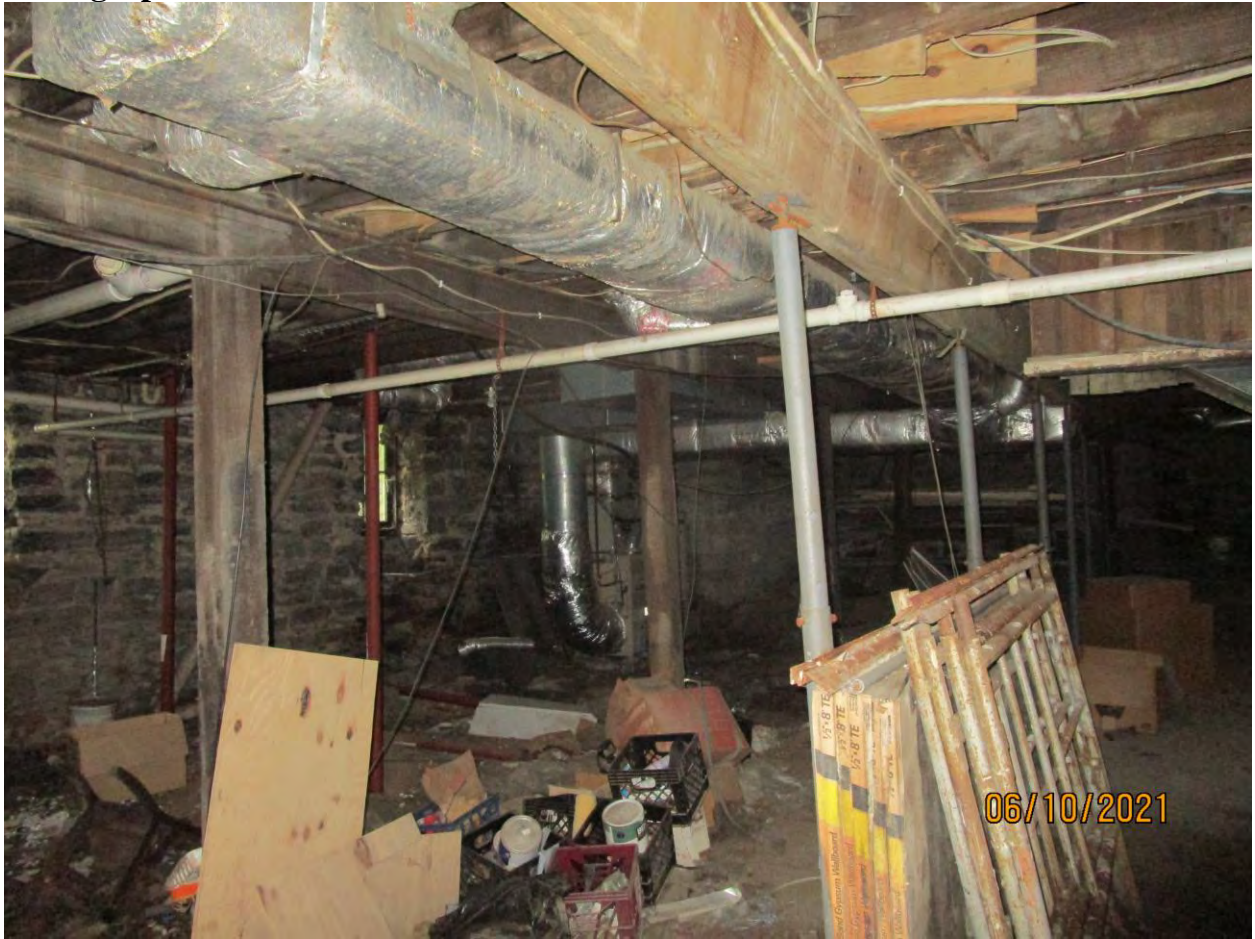
Photograph 55: Typical insect infestation issues with wood joists.

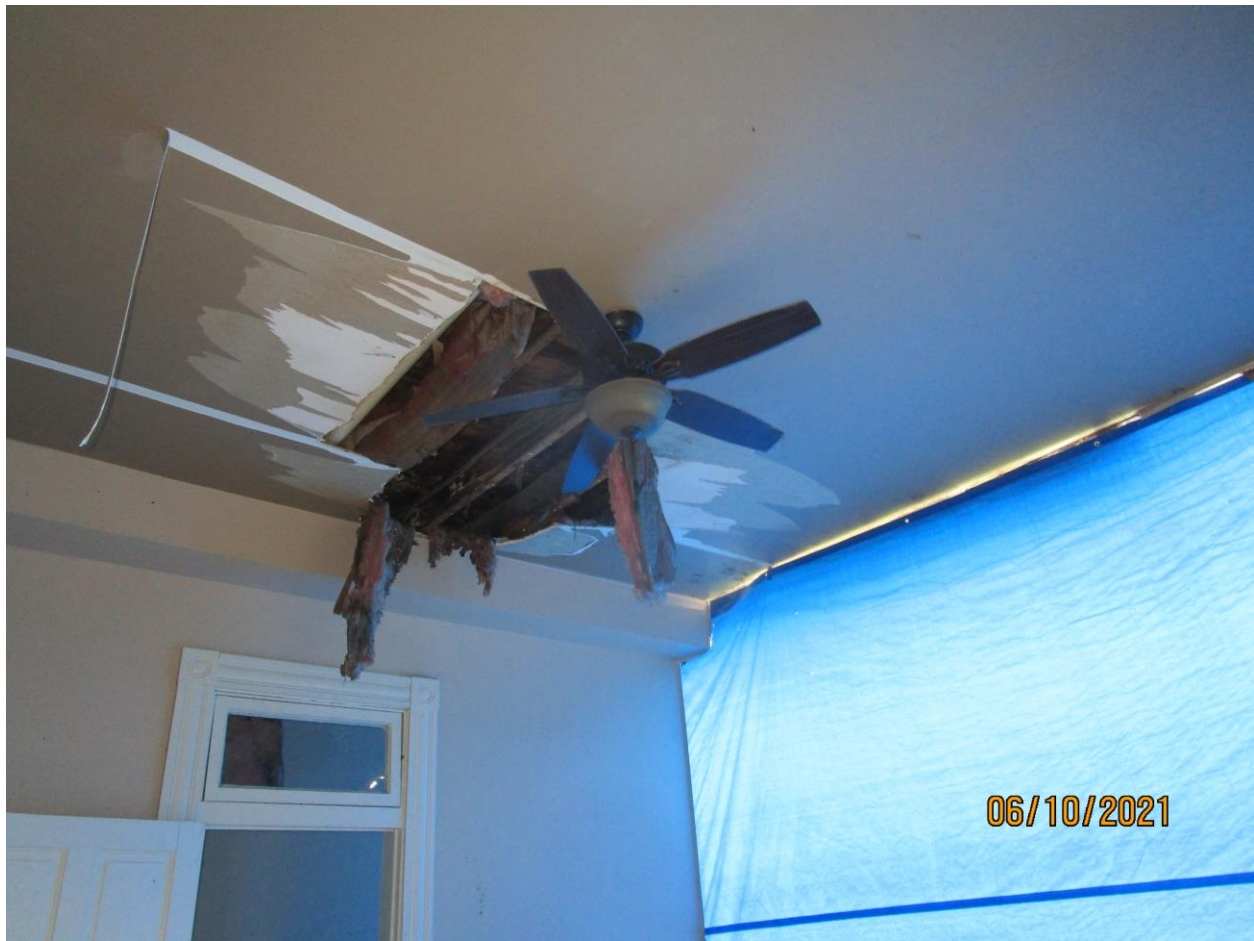
- As can be seen in photographs 61 and 62, the wood joists common to the second-floor buildout space were sistered in the past (photographs 62 and 63).

- The rear wall of the kitchen was also displaced due to the high winds (photograph 64).
- The wood framing common to the rear wall at the ceiling/roofline has deteriorated due to water infiltration at the entire rear wall (photographs 62, 63 and 65).

Photograph 62: Sistered floor joists above bedroom #2.

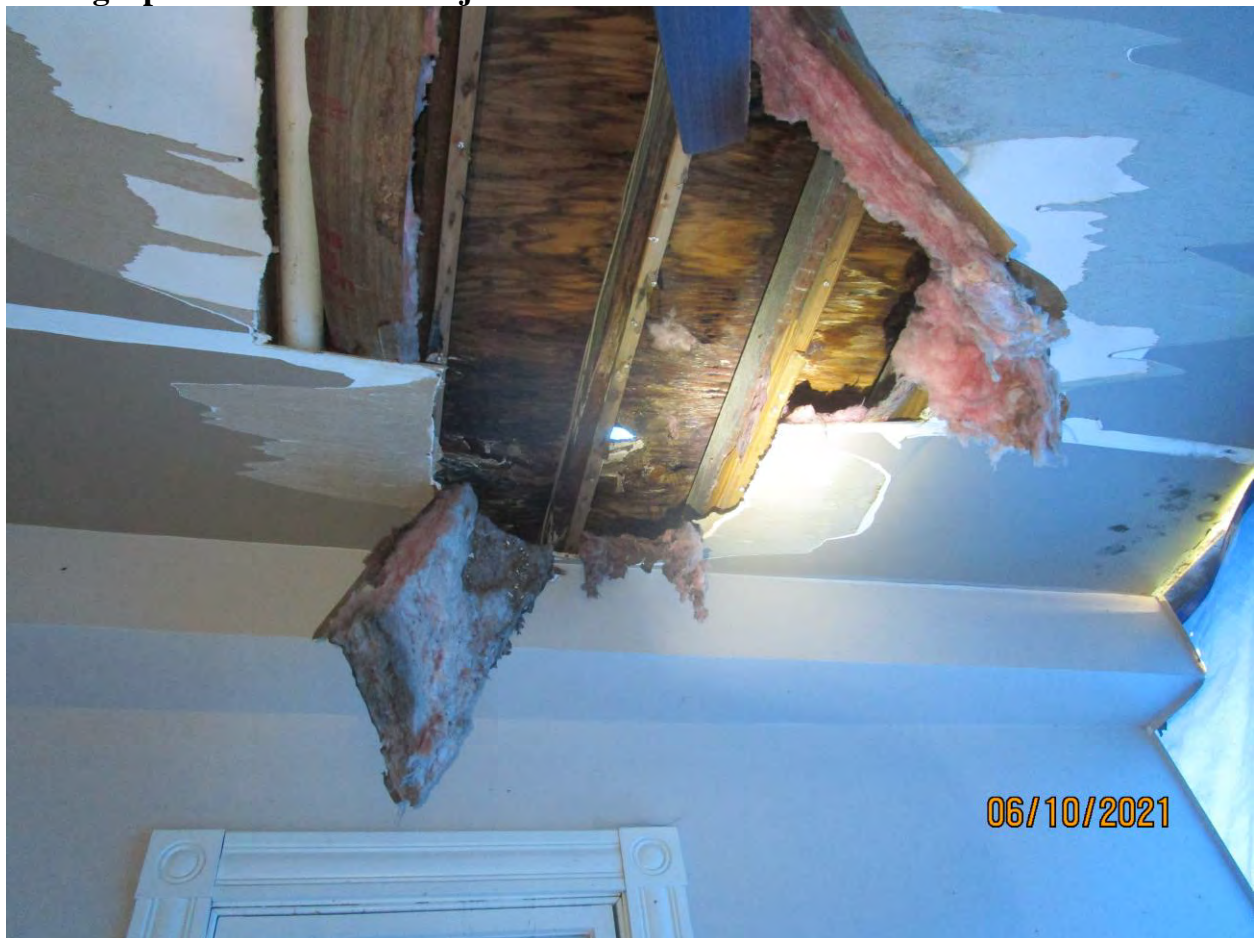
Photograph 63: Sistered floor joists above bedroom #2.

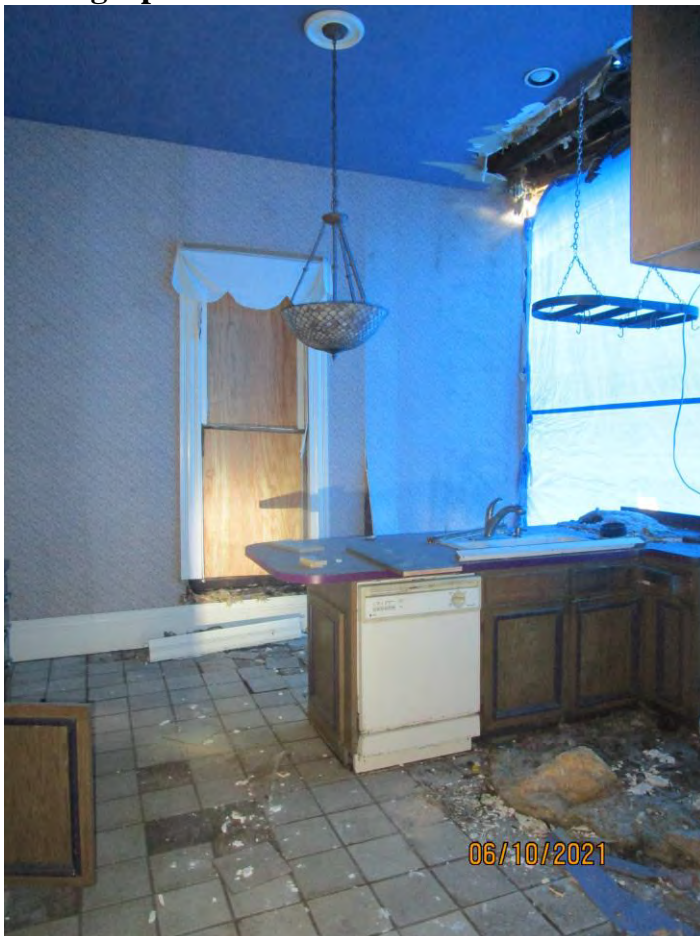
Photograph 65: Overview of kitchen ceiling.

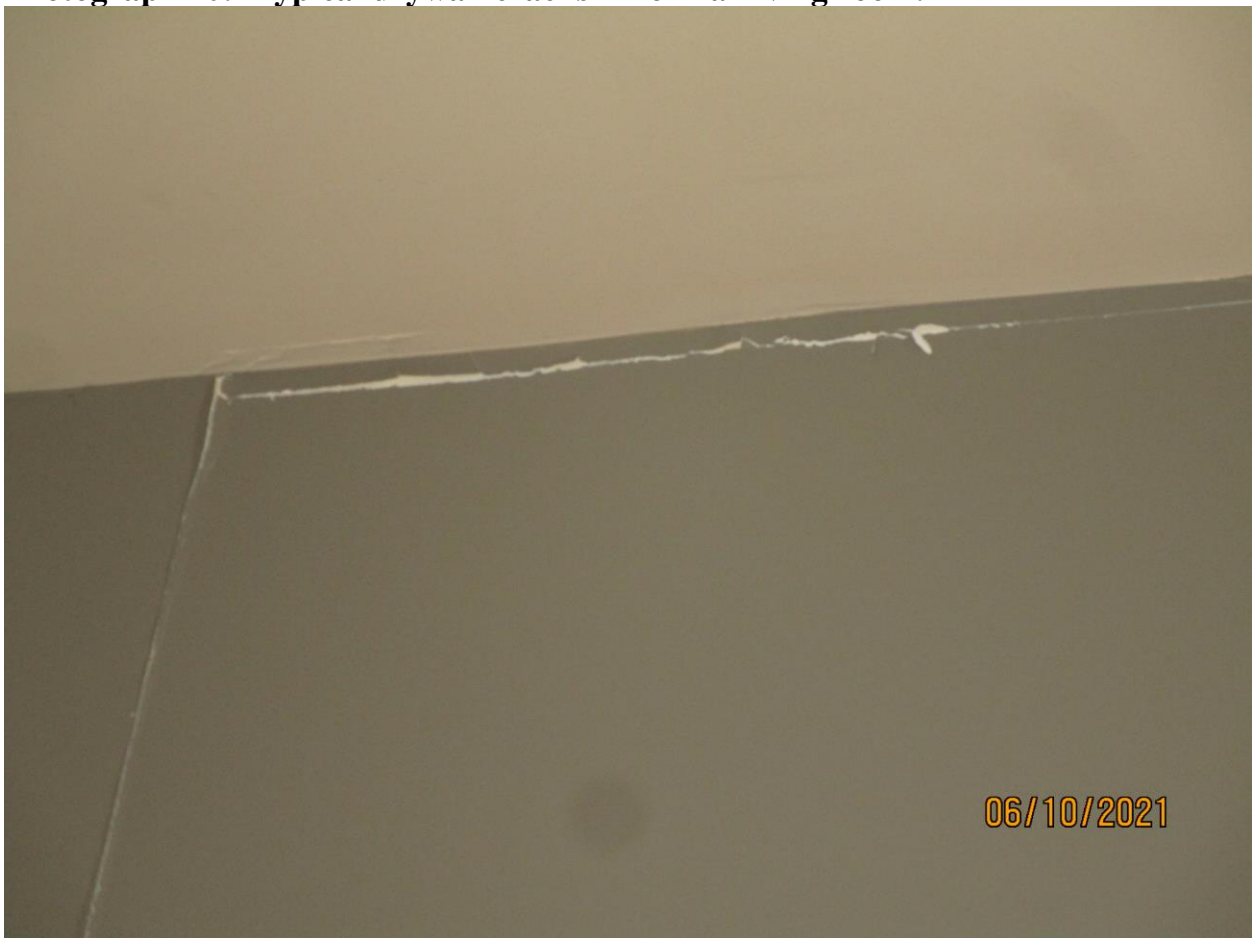
- The formal living room located on the left-front corner, which has previously been described as the left sidewall being displaced, can be observed in photograph 68. The amount of the displaced wall can be observed in photograph 69. Significant drywall cracking patterns are located throughout this room (photographs 70 through 73).

Photograph 70: Typical drywall cracks in formal living room.

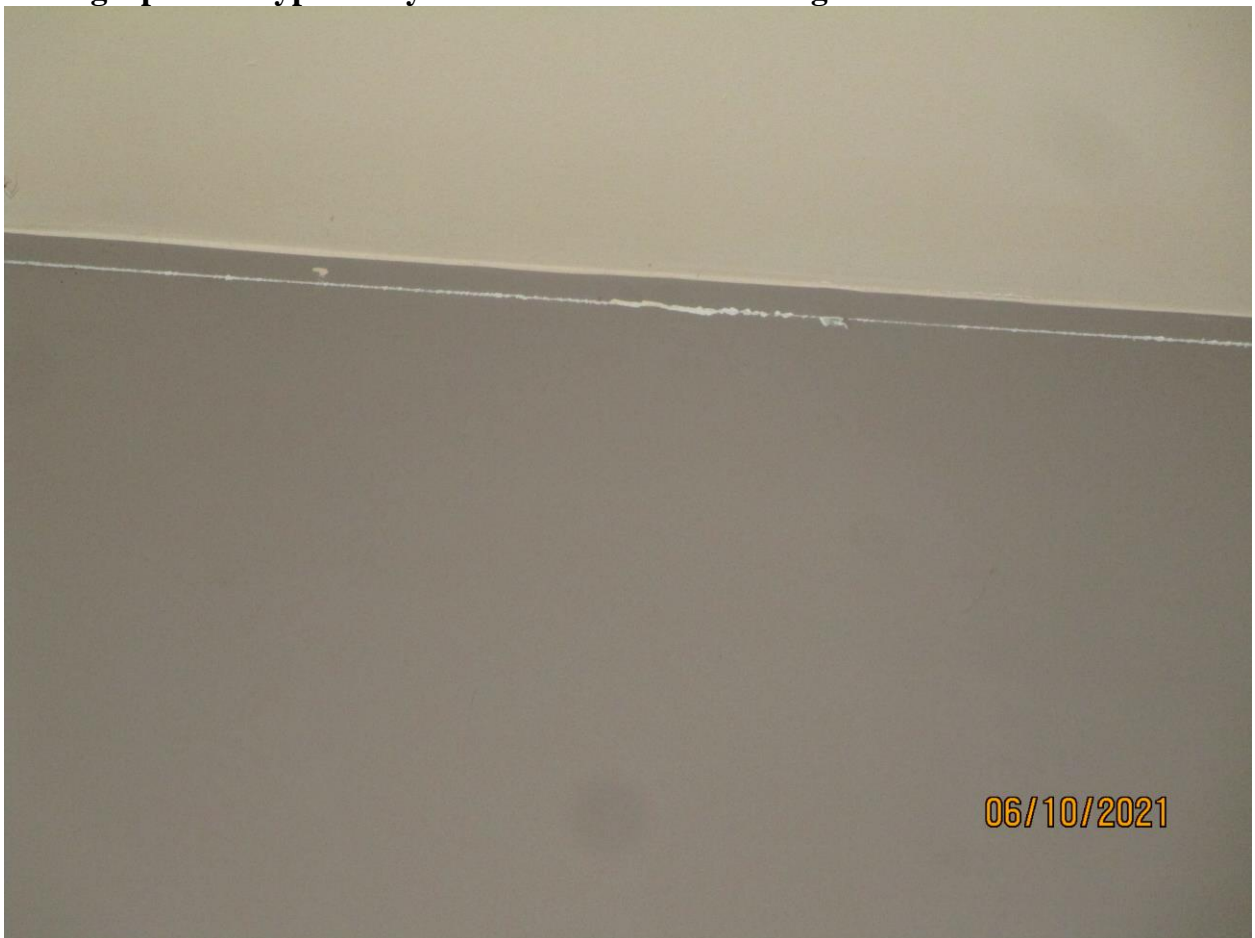
Photograph 72: Typical drywall cracks in formal living room.

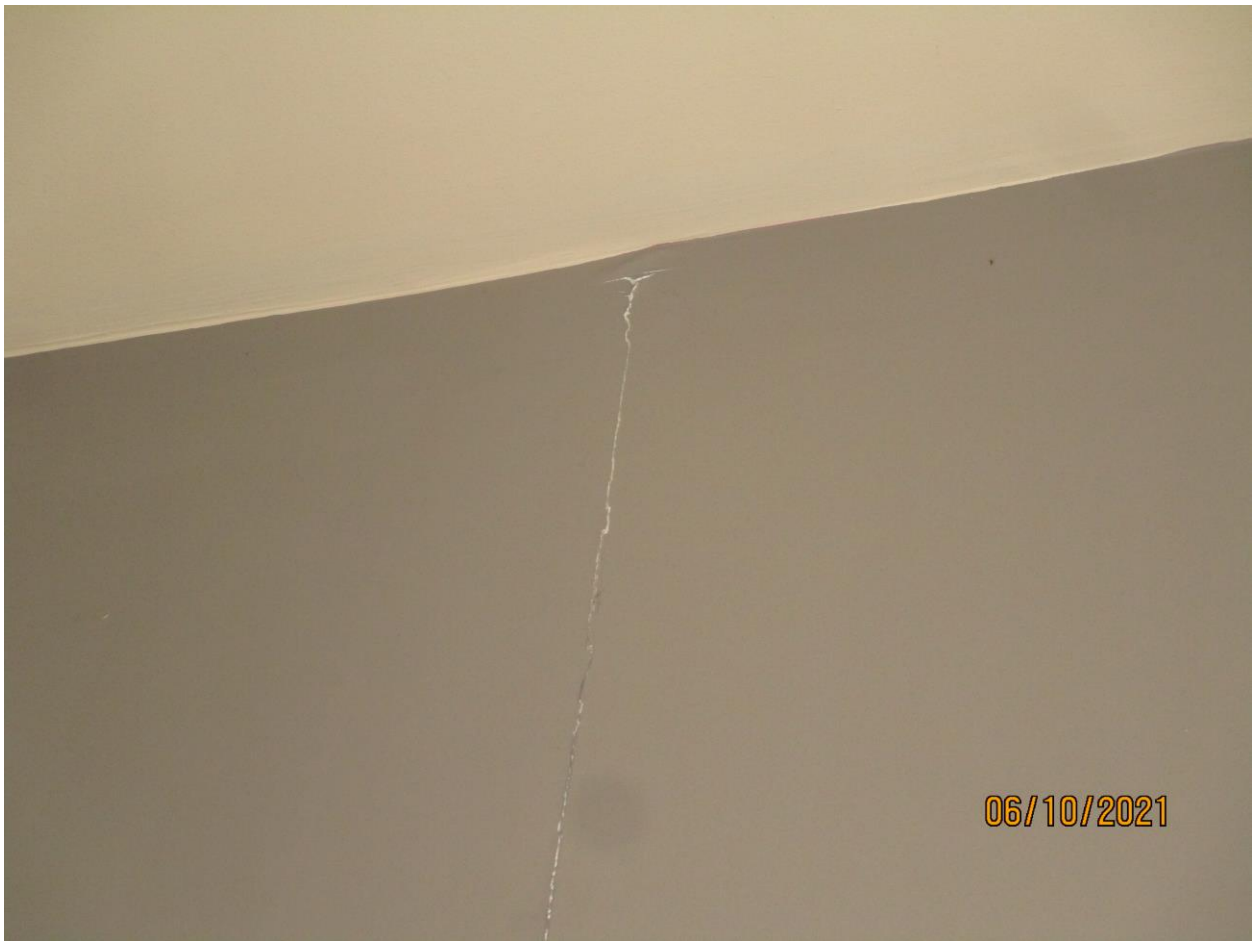
Photograph 73: Typical drywall cracks in formal living room.

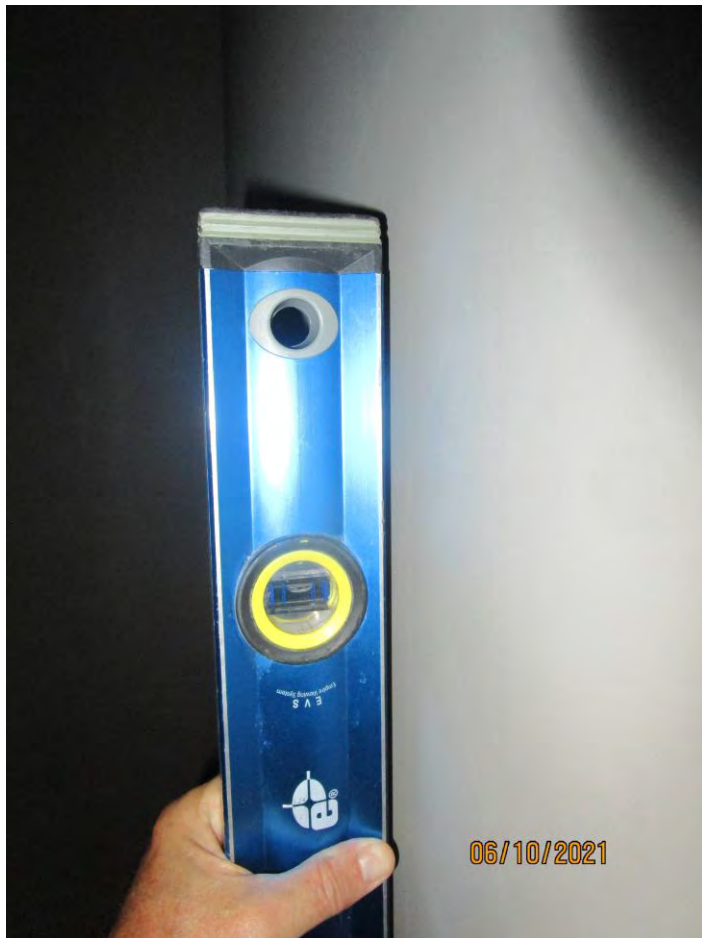
- The most significant structural deficiency was documented in photographs 74 through 80. As can be seen in these photographs, the right sidewall of the home, the two interior hallway walls, and the left sidewall of the home have racked approximately one-half inch in four feet. This racking condition, most likely, occurred at the same time that the rear wall of the home was totally displaced. Homes are sometimes built out-of-plumb. However, this does not appear to be the case with this specific home. When walls are built out-of-plumb, typically, the doorframes are plumbed to provide a functional door. From checking the door frames common to the hallway walls, the doorframes were also found to be out-of-plumb and racked in the same direction (photograph 80).

Photograph 74: Out-of-plumb right hallway wall.

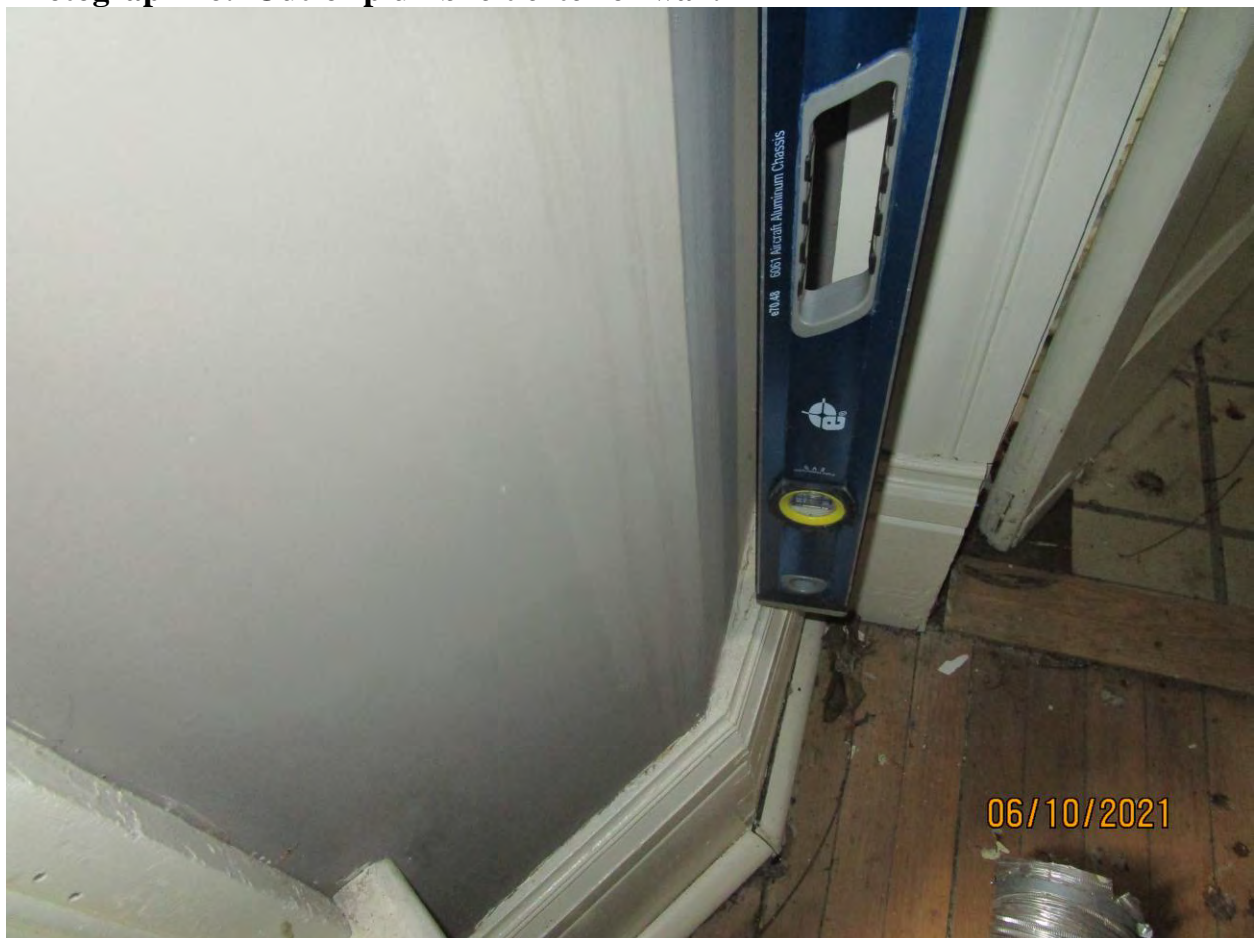
Photograph 75: Out-of-plumb right exterior wall.

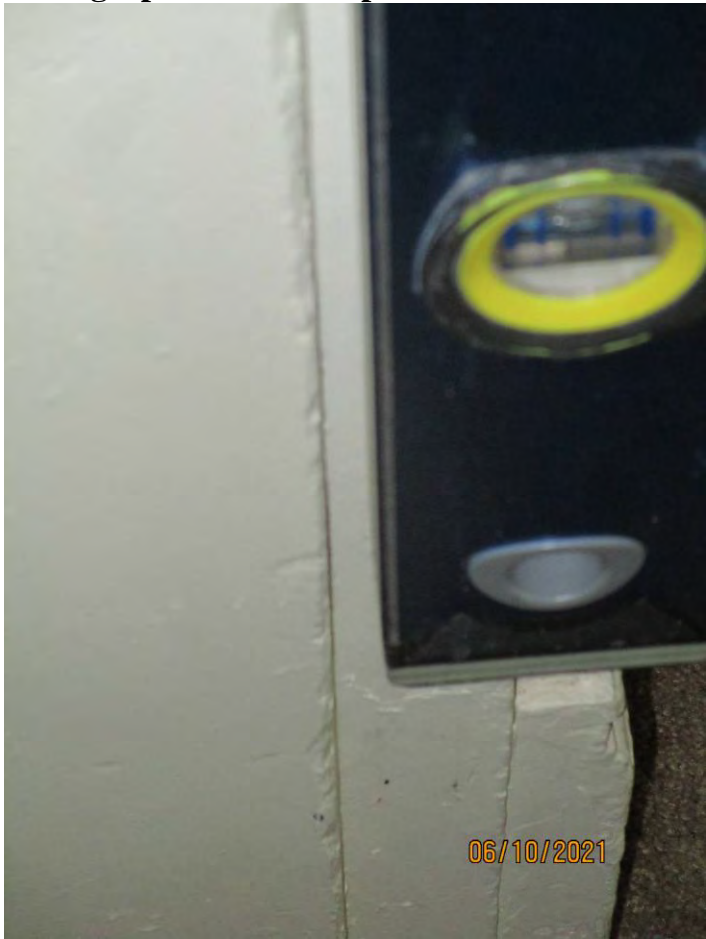
Photograph 79: Typical drywall cracks in dining room.

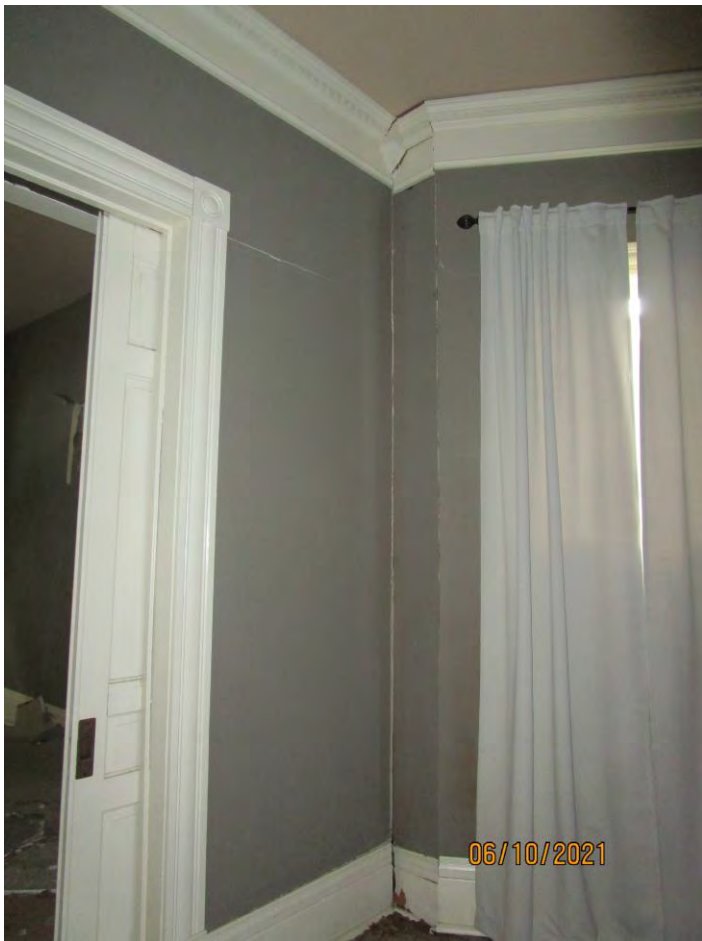
- Due to the severe racking of the home, the drywall was also significantly damaged in the dining room area (photographs 81 through 85). The drywall cracking patterns also persisted throughout the home (photographs 86 and 87).

Photograph 81: Typical drywall cracks in dining room.

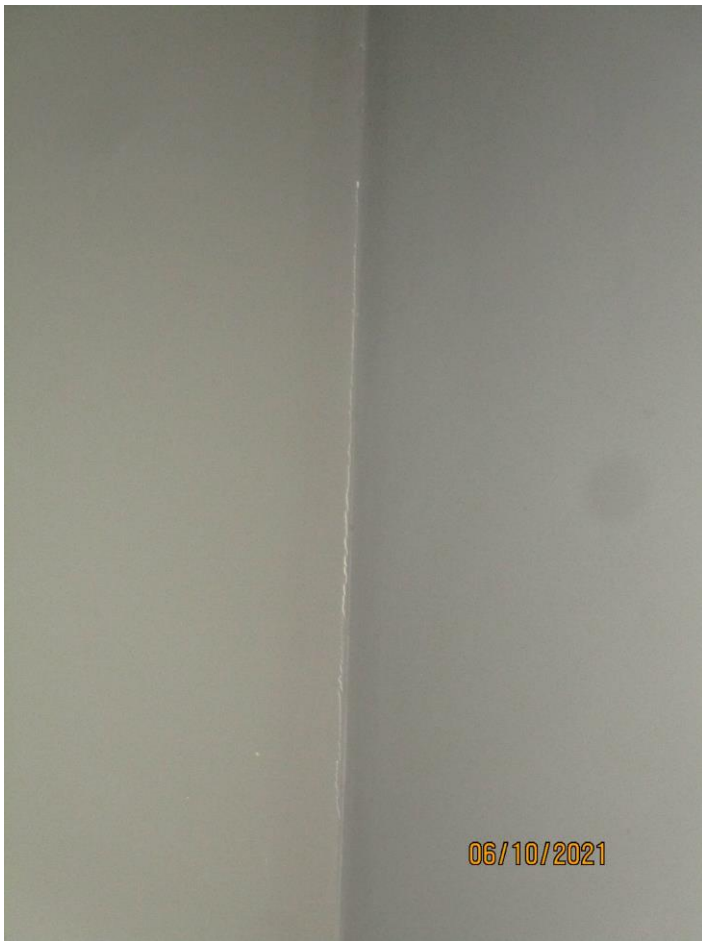
Photograph 83: Typical drywall cracks in dining room.

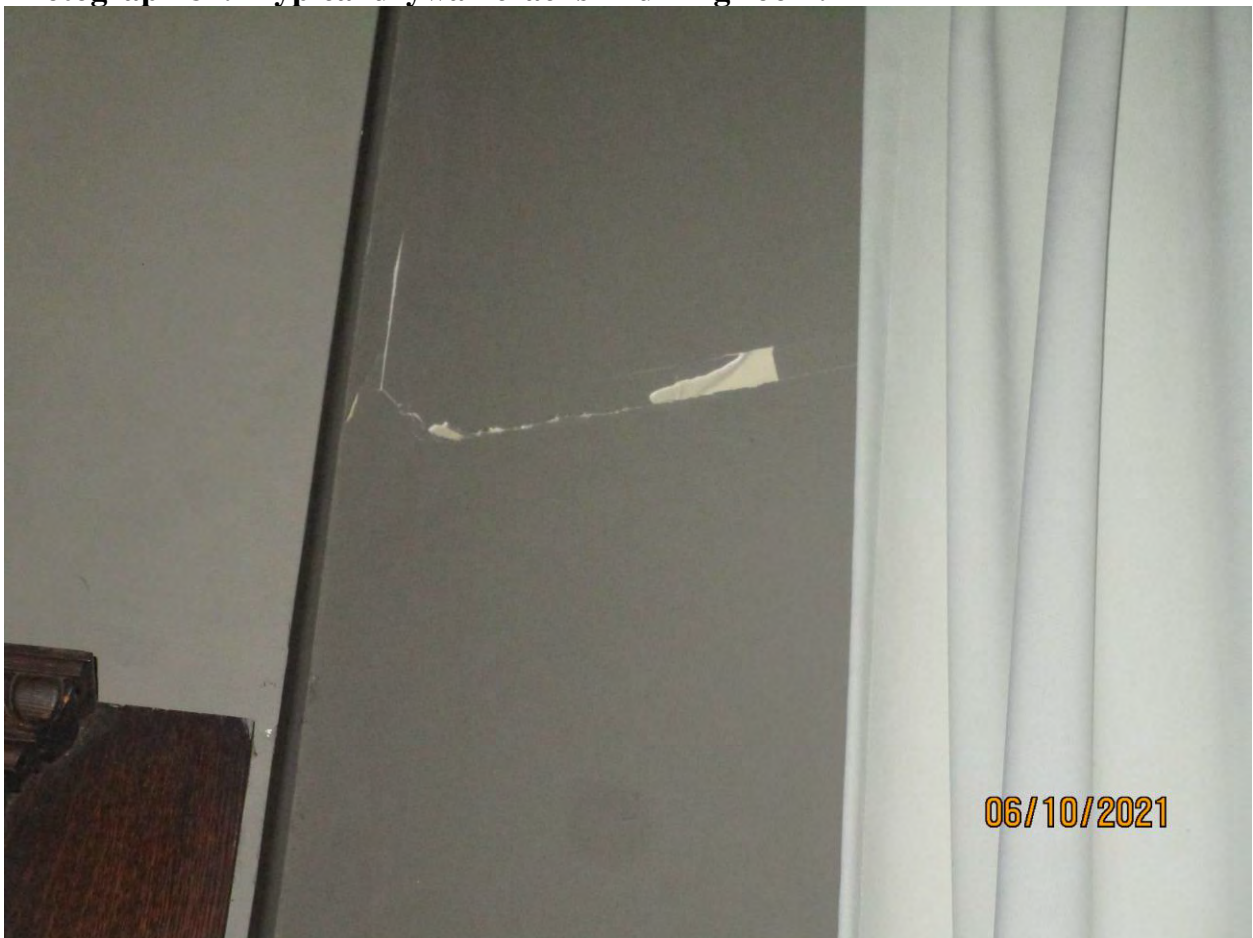
Photograph 84: Typical drywall cracks in dining room.

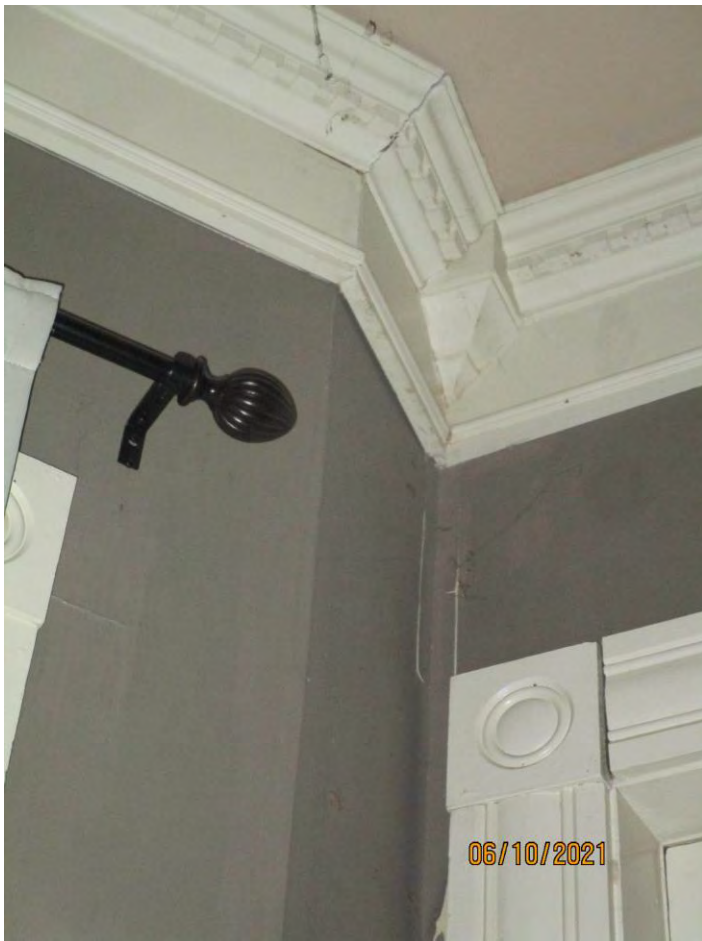
Photograph 85: Typical drywall cracks in dining room.

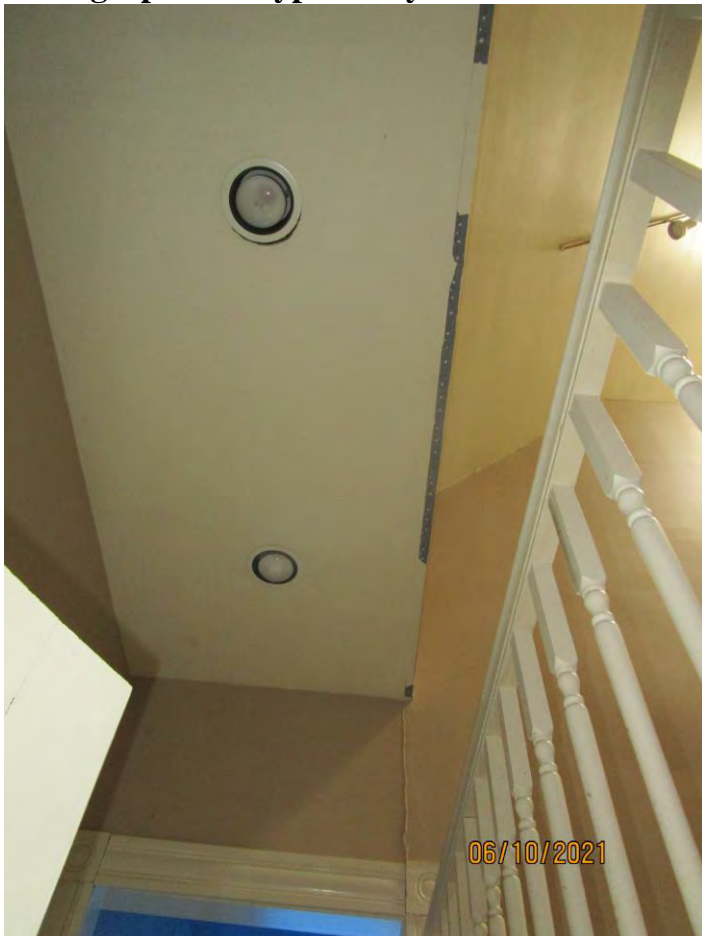
Photograph 86: Typical drywall cracks in laundry room.

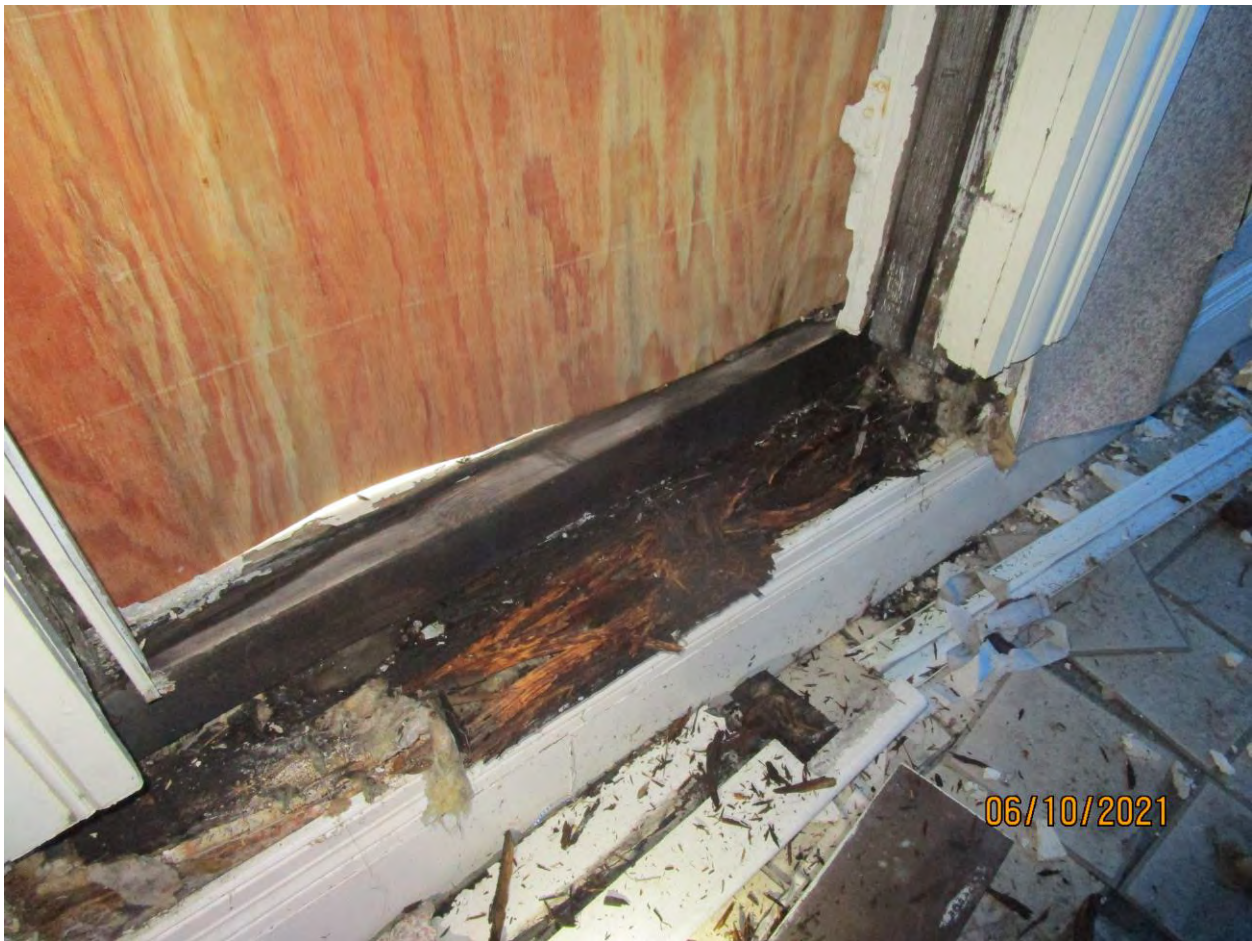
- As previously discussed, the interior gutters of the home typically leaked and subjected the interior cavities of the walls to an elevated moisture content. This is evident due to the broken-out window located in the kitchen (photographs 88 and 89). It has been my

Photograph 89: Rotten wall framing in kitchen.

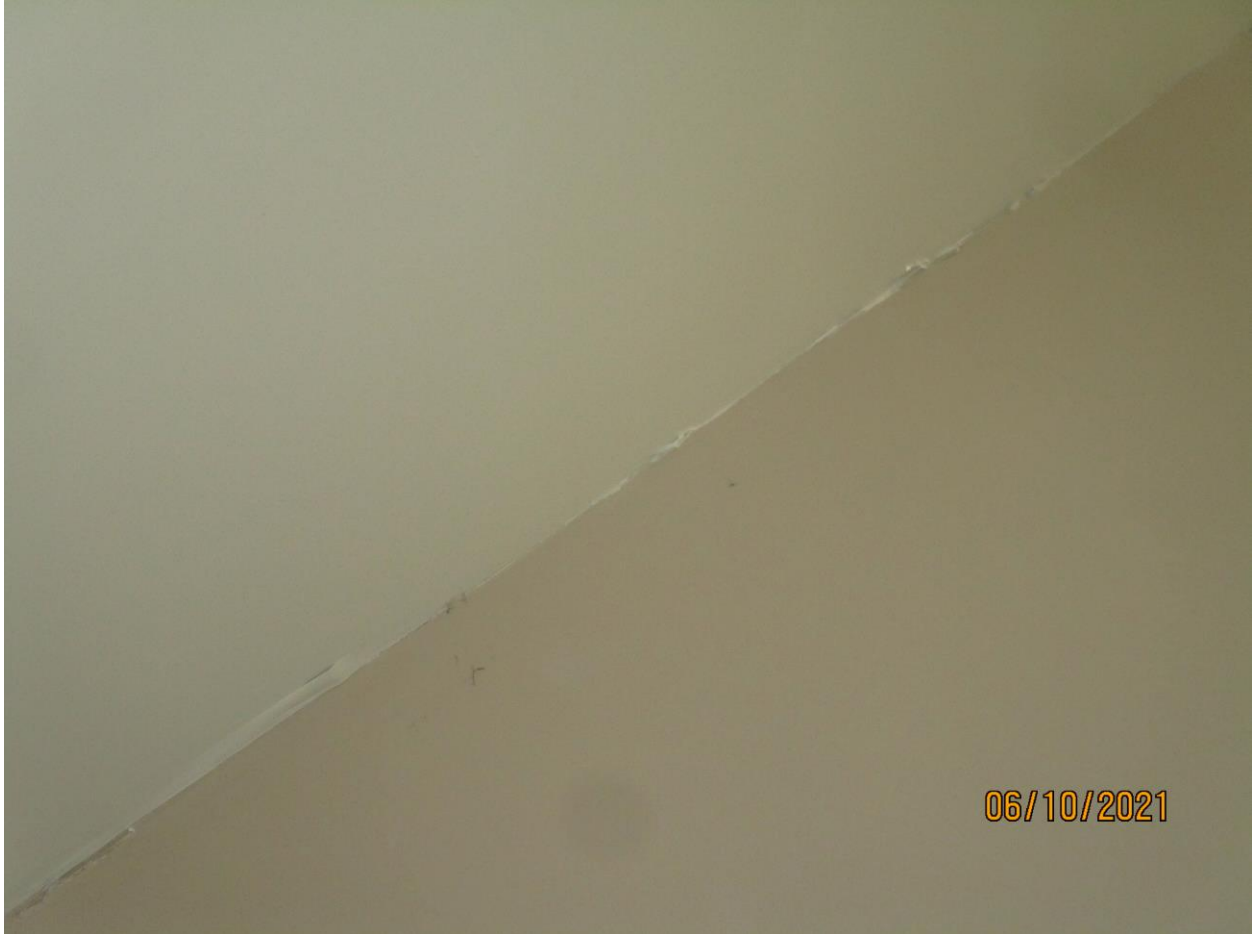
- From reviewing the second floor of the home (master bedroom), drywall cracking patterns were observed throughout this portion (photographs 90 through 93, 97, and 100 through 102).
- As is typical for floor coverings in the 1980's, particleboard was utilized in this portion of the home. Due to the tornadic wind forces damaging the envelope of the home, water infiltration has caused the particleboard panels to buckle due to an elevated moisture content (example in photograph 95).

Photograph 90: Typical drywall cracks in master bedroom.

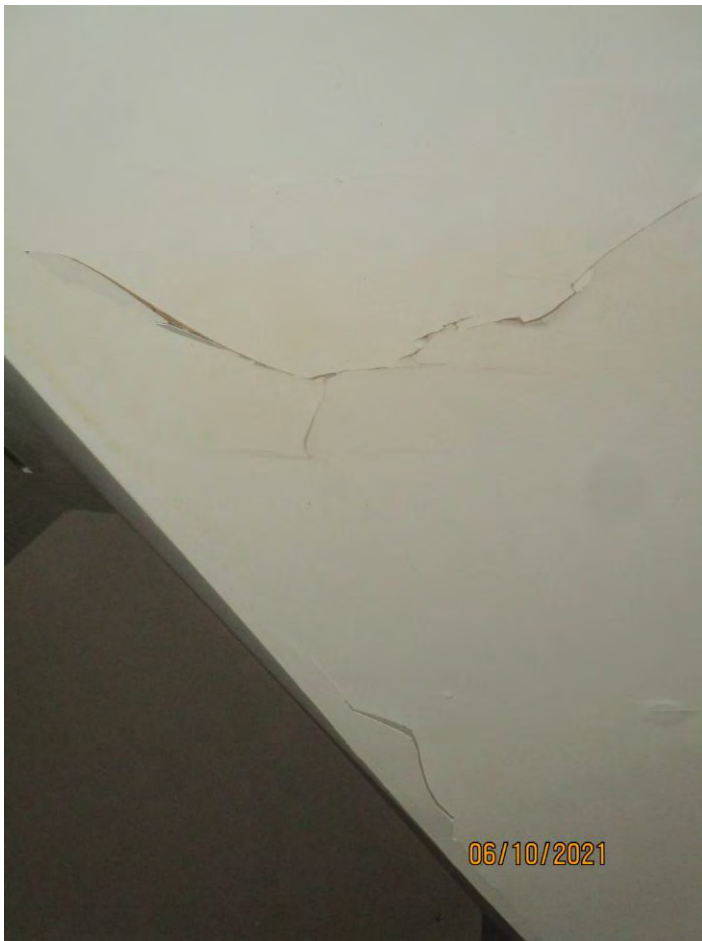
Photograph 91: Typical drywall cracks in master bedroom.

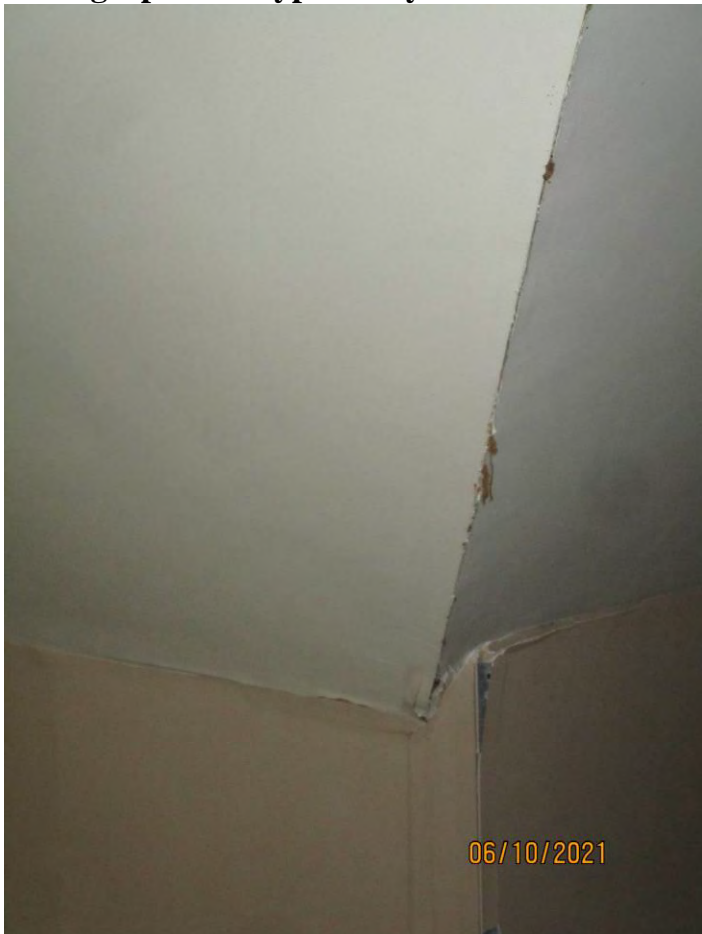
Photograph 92: Typical drywall cracks in master bedroom.

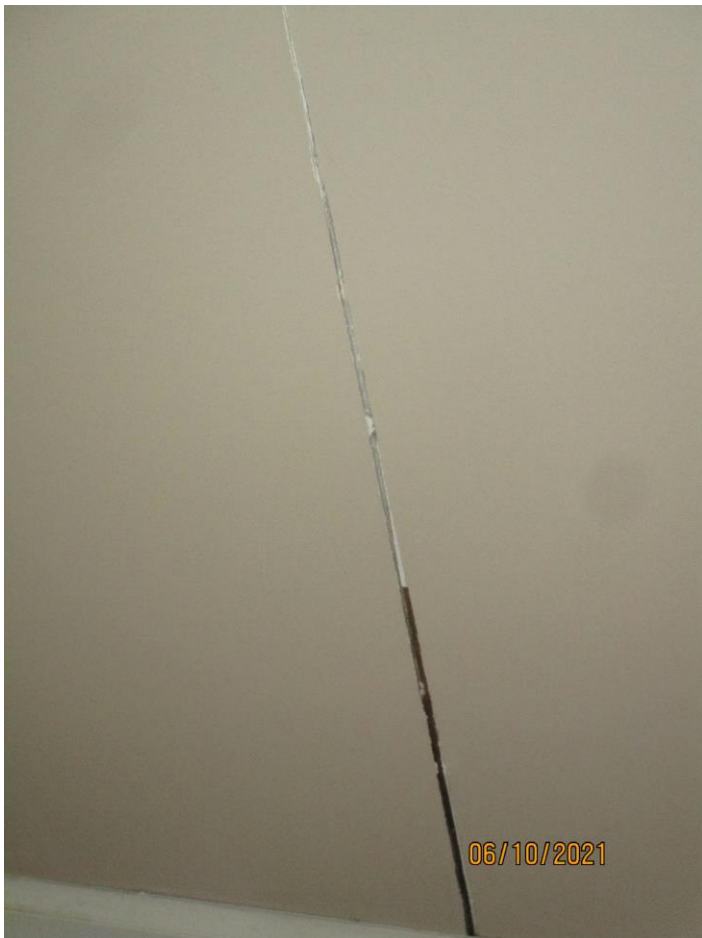
Photograph 93: Typical drywall cracks in master bedroom.
