METROPOLITAN GOVERNMENT OF NASHVILLE AND DAVIDSON COUNTY

STAFF RECOMMENDATION 949 Russell Street July 21, 2021

Application: Demolition
District: Edgefield Historic preservation Zoning Overlay
Council District: 06
Base Zoning: R8
Map and Parcel Number: 082120038300
Applicant: Troy Harper
Project Lead: Robin Zeigler, robin.zeigler@nashville.gov

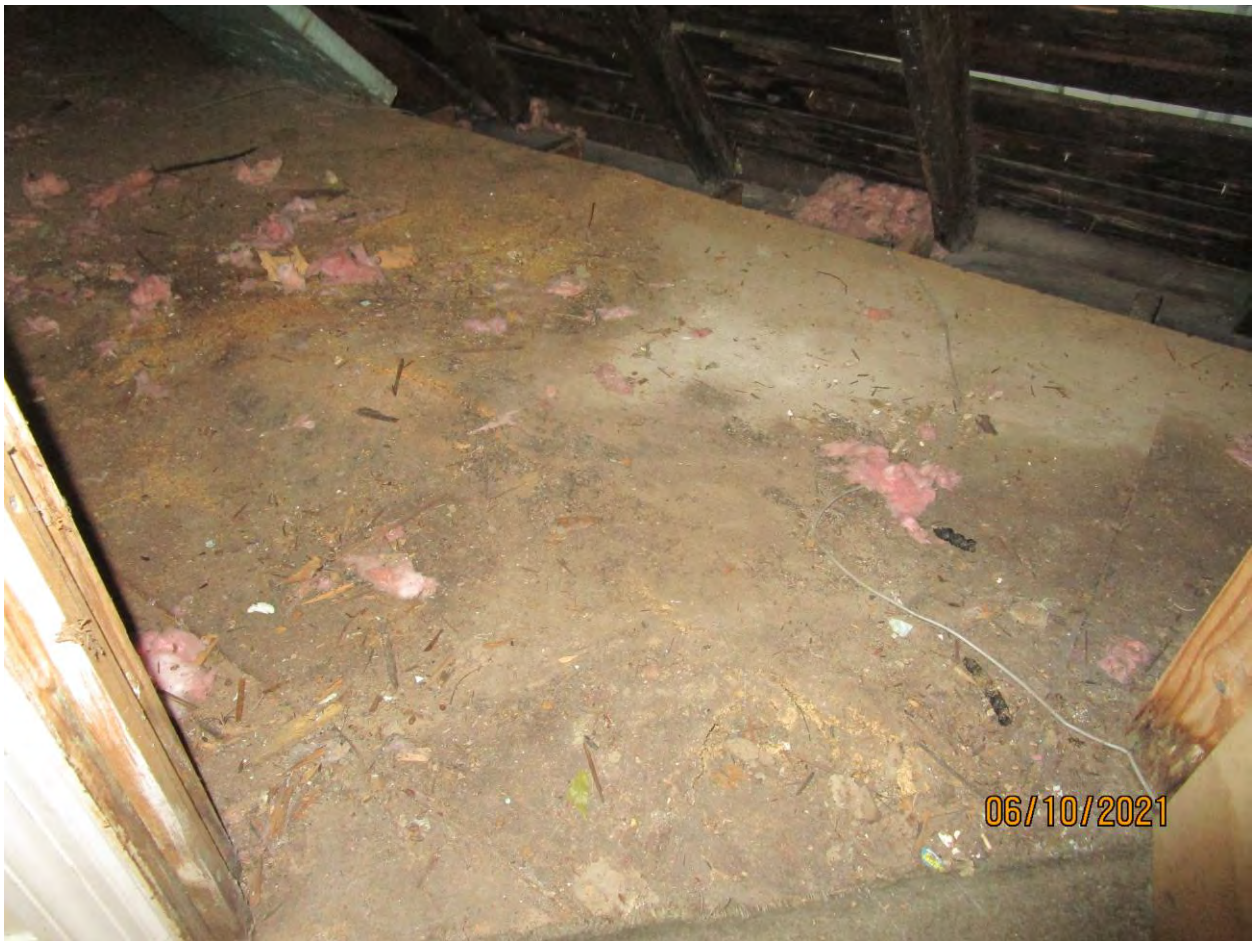
- From reviewing the second floor of the home (master bedroom), drywall cracking patterns were observed throughout this portion (photographs 90 through 93, 97, and 100 through 102).
- As is typical for floor coverings in the 1980's, particleboard was utilized in this portion of the home. Due to the tornadic wind forces damaging the envelope of the home, water infiltration has caused the particleboard panels to buckle due to an elevated moisture content (example in photograph 95).

Photograph 95: Buckled particle board in master bedroom.

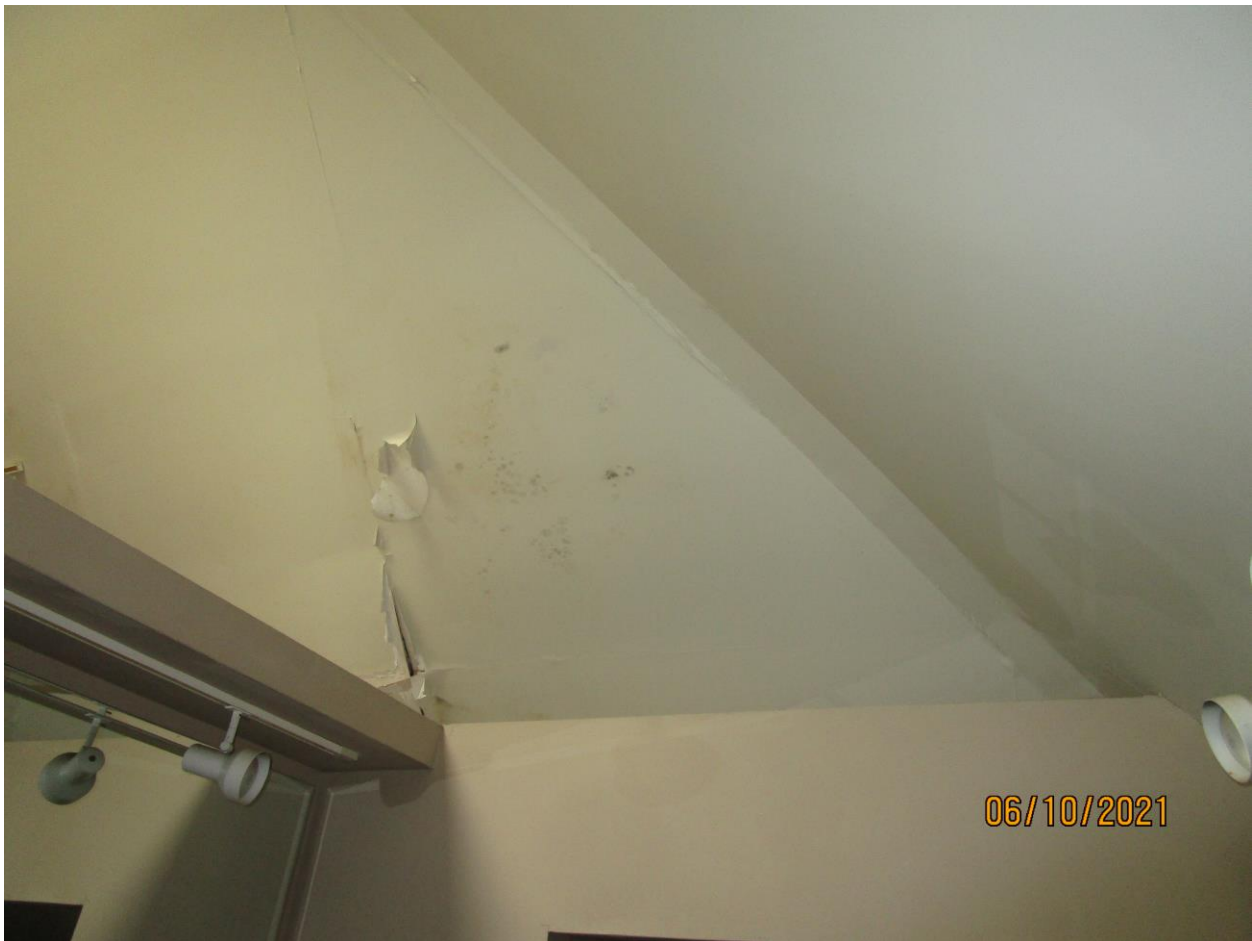
Photograph 97: Typical drywall cracks in master bedroom.

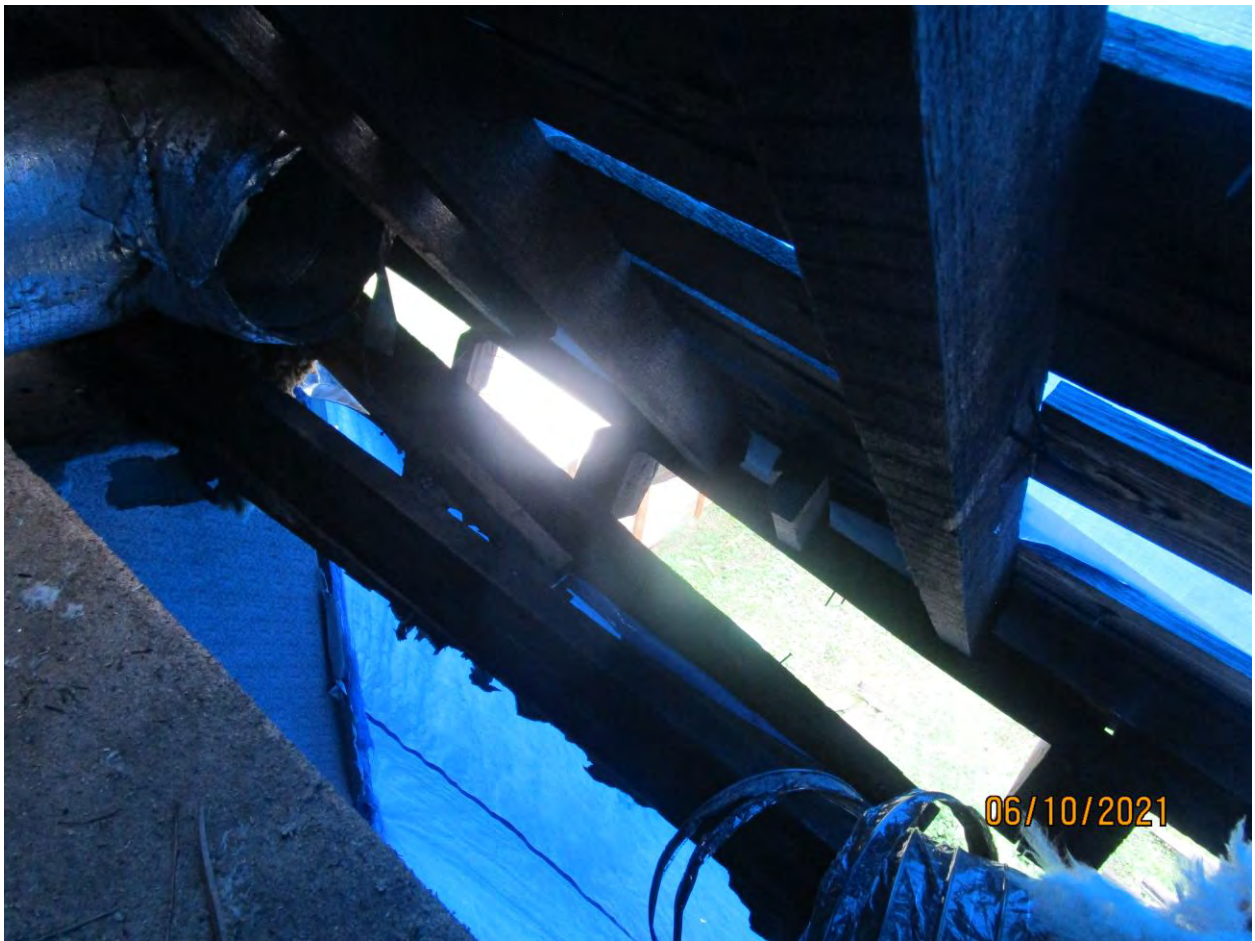
Photograph 99: View of displaced rear wall.

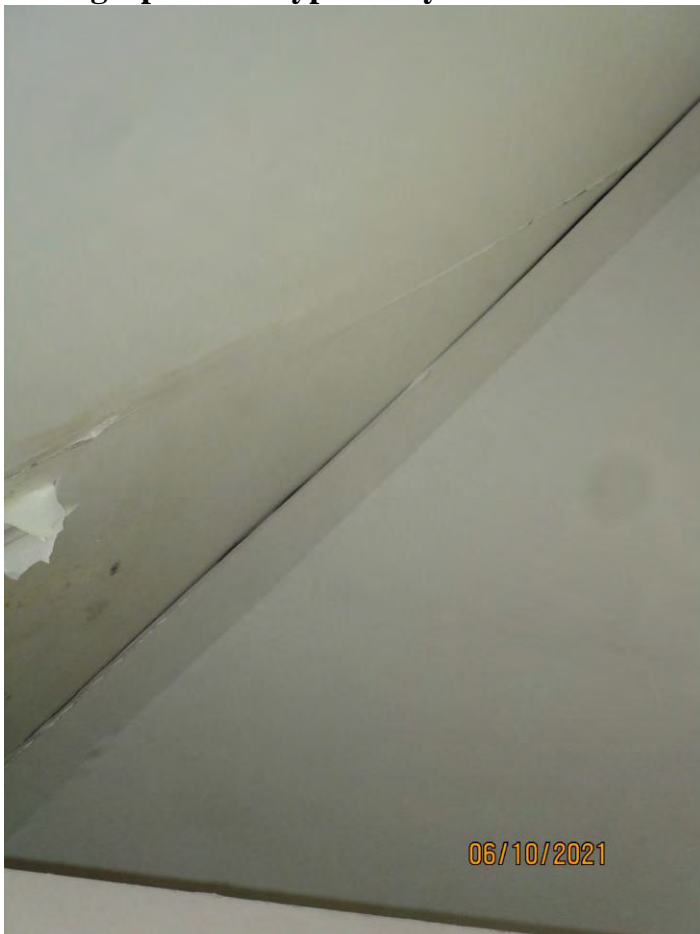
Photograph 100: Typical drywall cracks in master bedroom.

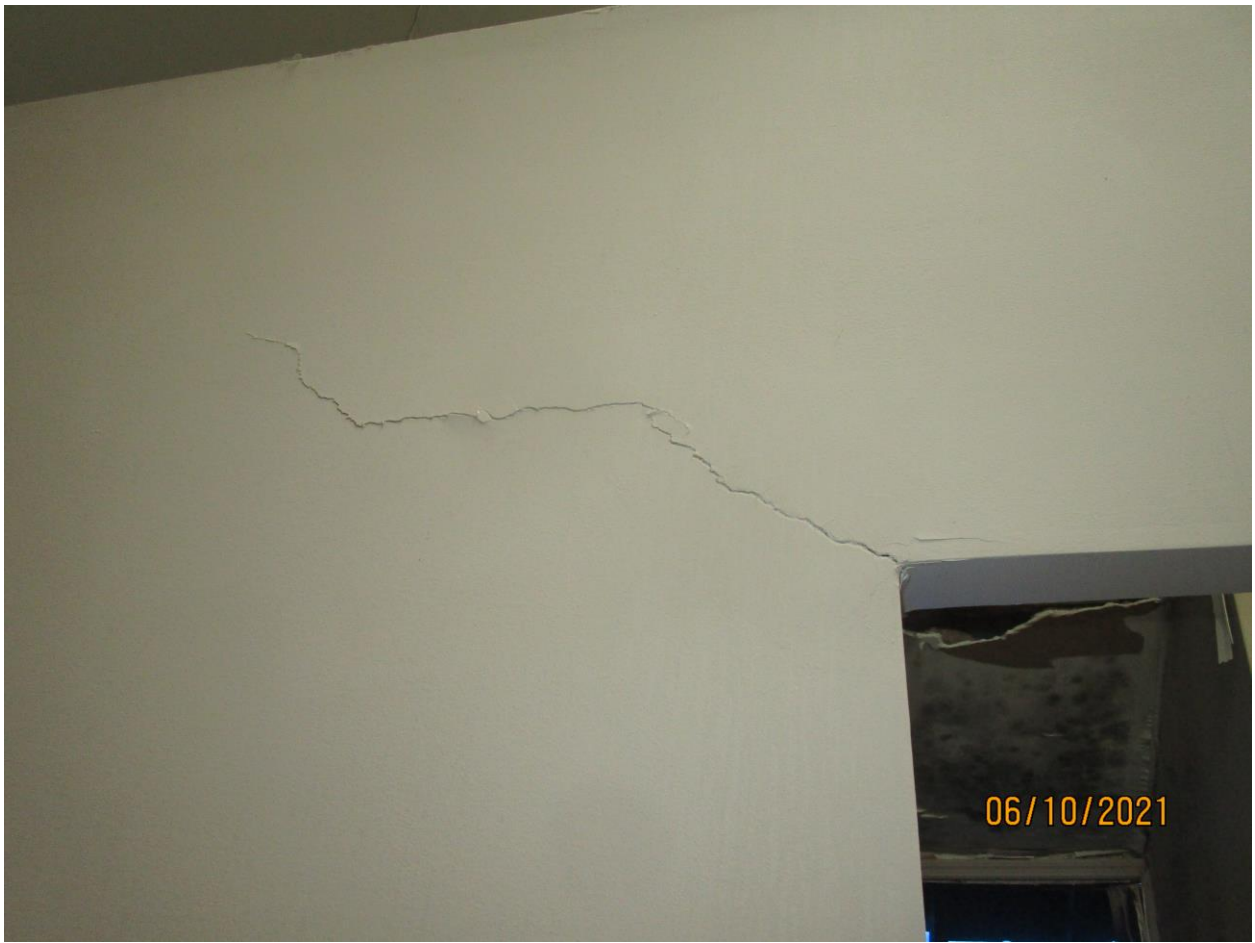
Photograph 101: Typical drywall cracks in master bedroom.

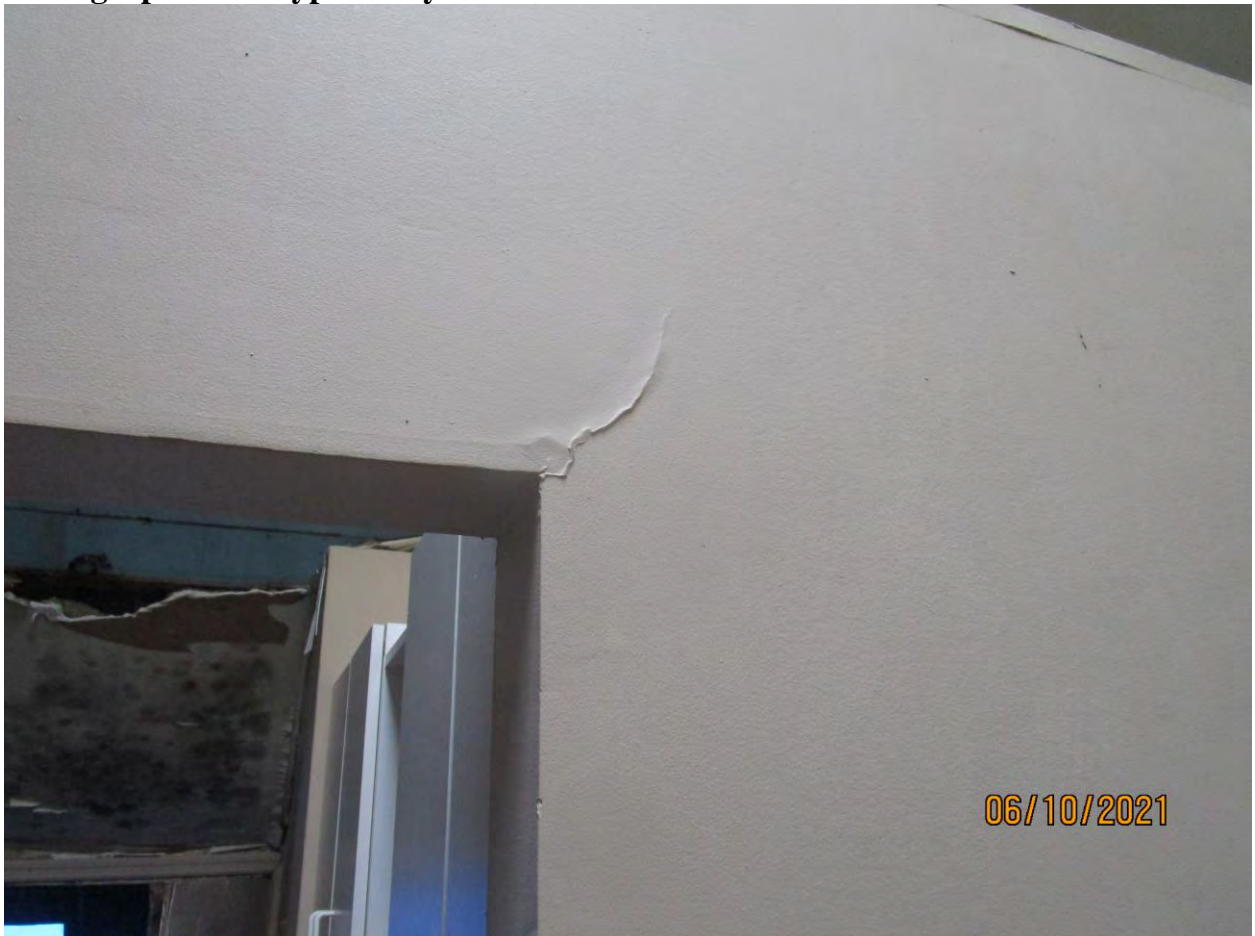
Photograph 102: Typical drywall cracks in master bedroom.

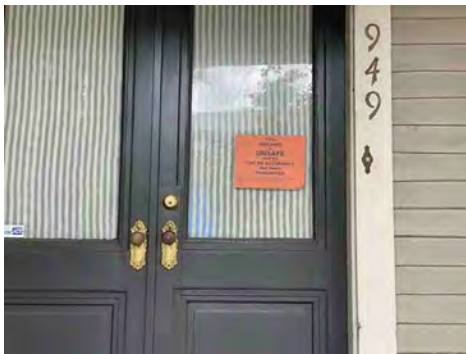
Unsafe to Enter

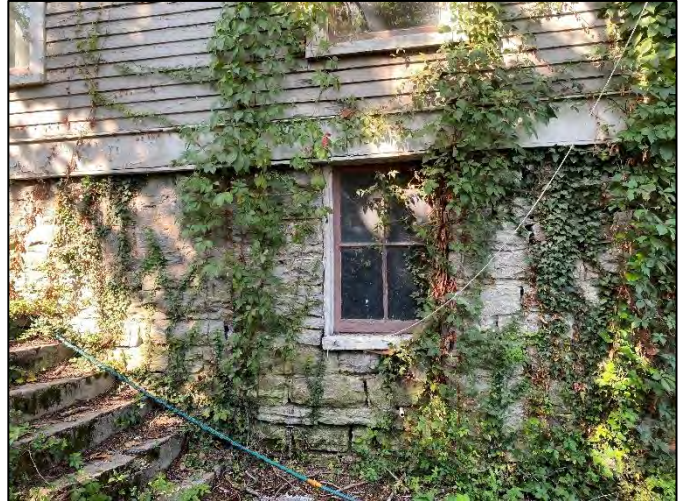
Access underneath the building was restricted for most site visits, but staff and Chairman Bell were able to view the cellar on the March 5 site visit. Previous visits only permitted what is visible from the exterior, and the photographs provided by the engineer during his inspection. The perimeter foundation is a load-bearing stone wall which overall is in good condition. There are cracks visible through the mortar joints, and bulging is evident on the west side. The engineer notes that the foundation walls are within 0.5 degree of plumb, except for the west side. There are mortar joints that have crumbled, which is to be expected for a building of this age. The northwest corner of the foundation wall was damaged during the tornado and requires replacement of the mortar joints and possibly relaying of the stones. A central beam has twisted at the north end of the house. Repairs have been made at unknown times, including mortar pointing and concrete patches. There are individual structural components that might require replacement, such as the termite-eaten beam in the engineer's photos, but there is not sufficient evidence that it is not reparable.

Figure 7: Foundation wall on the east side shows mortar joints that have deteriorated but is overall in good condition.

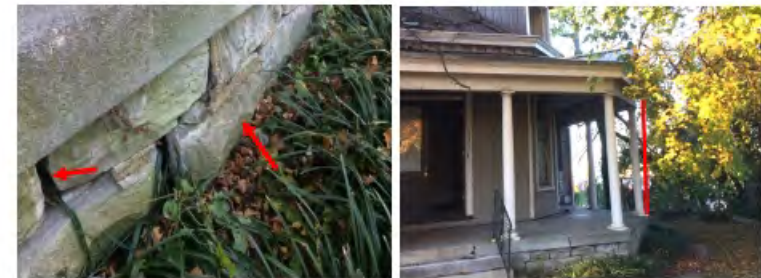
22. The porch section at the front door is cracked in the center and sloping towards the left, directing any water that blows onto the porch surface towards the right side wall of the front living room.

14. Remove and reconstruct the front porch and stairs as the current one cannot be repaired.
15. Patch the damaged hardwood floors.
16. Rebuild the eave gutter on the left hand side of the home on the front side of the bay.
