Operations Monitoring Report

Third Quarter FY24

**Thermal Engineering Group, Inc.
105 Hazel Path Court, Ste 2
Hendersonville, TN 37075**

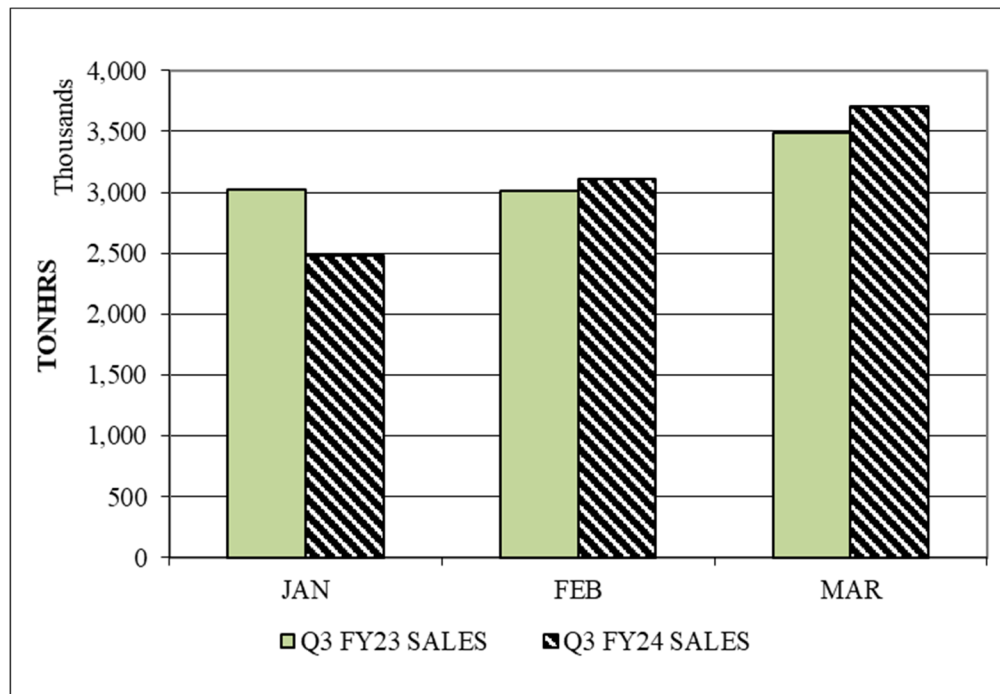
Figure 1. Chilled Water Sales Comparison

A comparison for the Third Quarter chilled water sales is shown in Figure 1. This data reflects a 2.4% decrease in sales for the current quarter over the same quarter of the previous fiscal year.

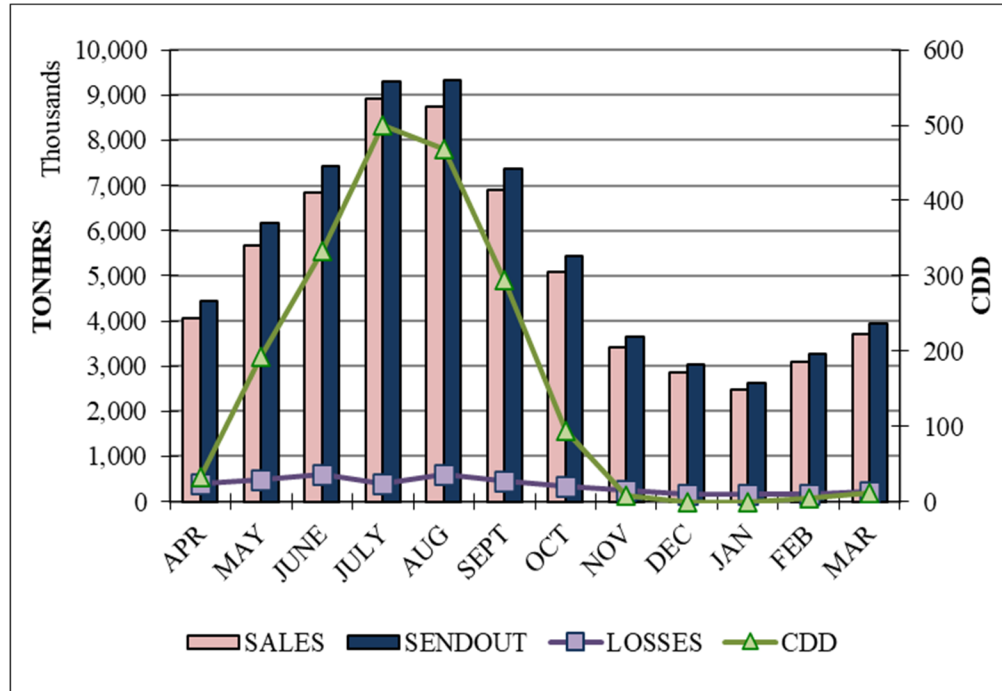
Figure 2. Chilled Water Sales, Sendout, Losses and CDD for the Previous Twelve Months

Figure 2 shows the chilled water sales, sendout and losses for the previous twelve months. The losses on this figure are defined as the difference in tonhrs per month between the recorded sendout and sales values and represent the total energy loss for chilled water in the EDS. The number of cooling degree days were 10.5% lower in FY24 than in FY23 and are tracked for comparison.

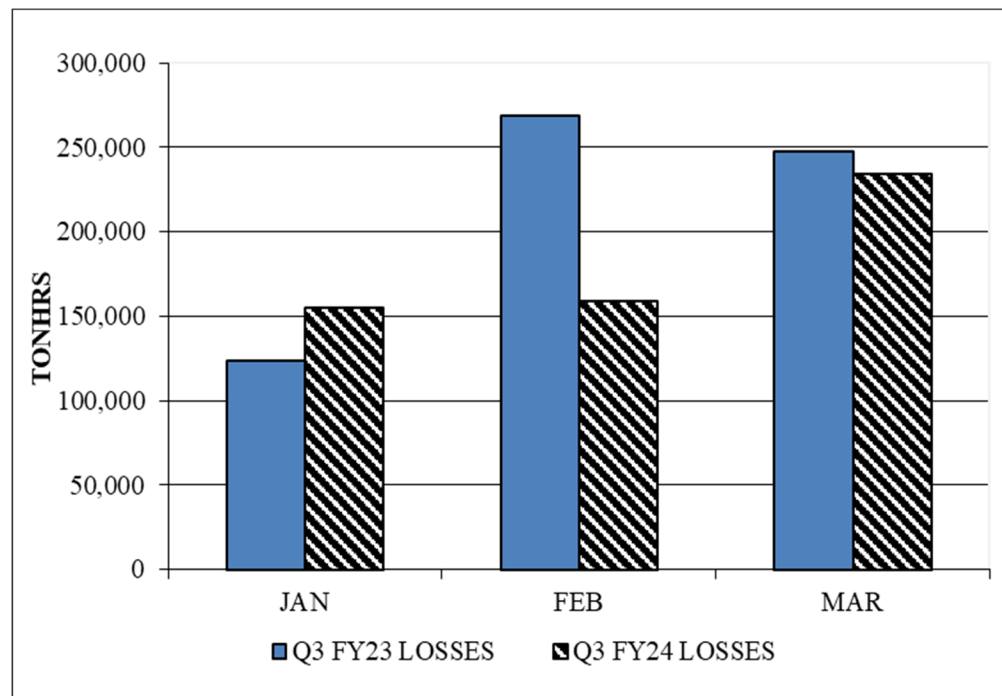
Figure 3. Chilled Water System Loss Comparison

A comparison of the total chilled water energy losses in the EDS for the Third Quarter is shown in Figure 3. These losses are the difference in chilled water sendout and sales and may reflect differences in the meter accuracy between the EGF sendout meter and the customer meters.

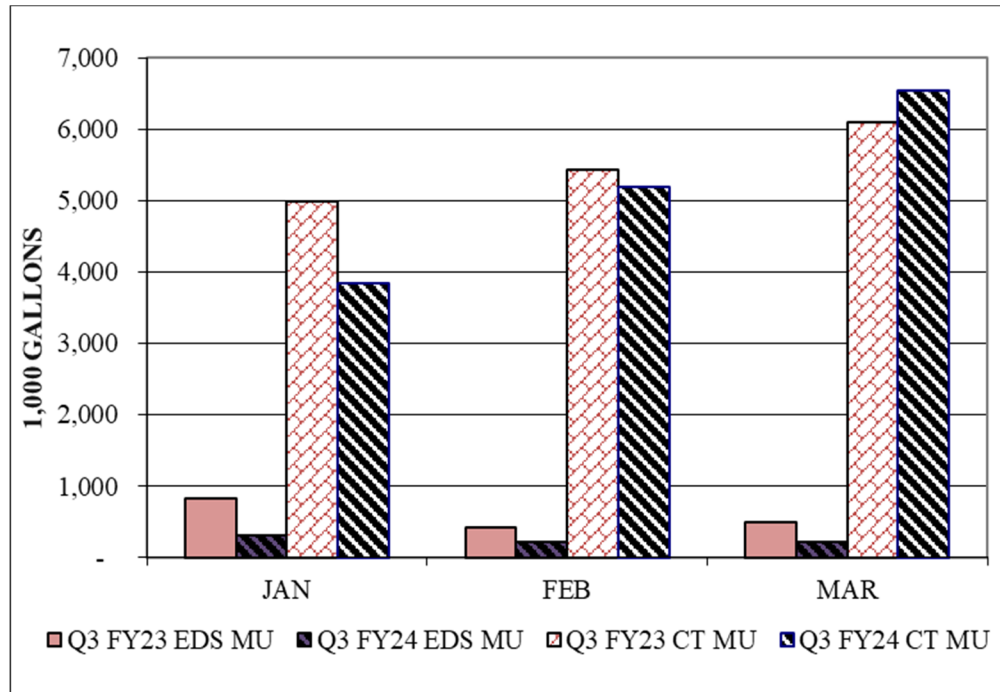
Figure 4. Chilled Water System City Water Usage Comparison

The make-up to the cooling towers decreased 5.7% over the previous Third Quarter. The water usage in the cooling towers is typically proportional to the production of chilled water and should vary with chilled water sales. The total chiller plant water use decreased 10.6% over the Third Quarter FY23 (due to a decrease in sales). The

overall city water make-up comparison for the chilled water system Third Quarter is shown in Figure 4.

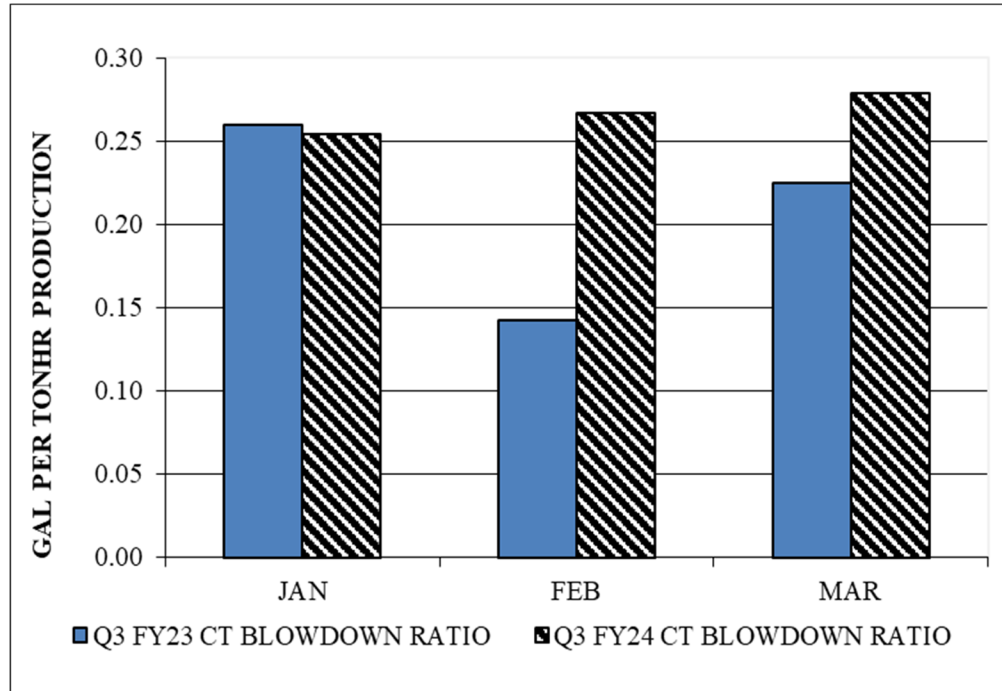
Figure 5. Cooling Tower Blowdown Ratio Comparison

Beginning in March 2023, CES and TEG began monitoring the cooling tower blowdown ratio in earnest. The relationship between the cooling tower blowdown and the chilled water production should be consistent and tracking this relationship may prove helpful in reducing the chiller plant water usage. CES has made operational changes with respect to this metric with the expectation of reducing the water usage and improving their performance relative to the chilled water-water guarantee. Improvements in this metric are shown in Figure 5. When a comparison is made between the Third Quarter FY24 and FY23, the ratio increased 28.3%. This metric will continue to be tracked and monitored to verify operational changes made by CES at the EGF have resulted in a decrease in chiller plant water usage. The data shown in Figure 5 indicates a more consistent ratio in the Third Quarter.

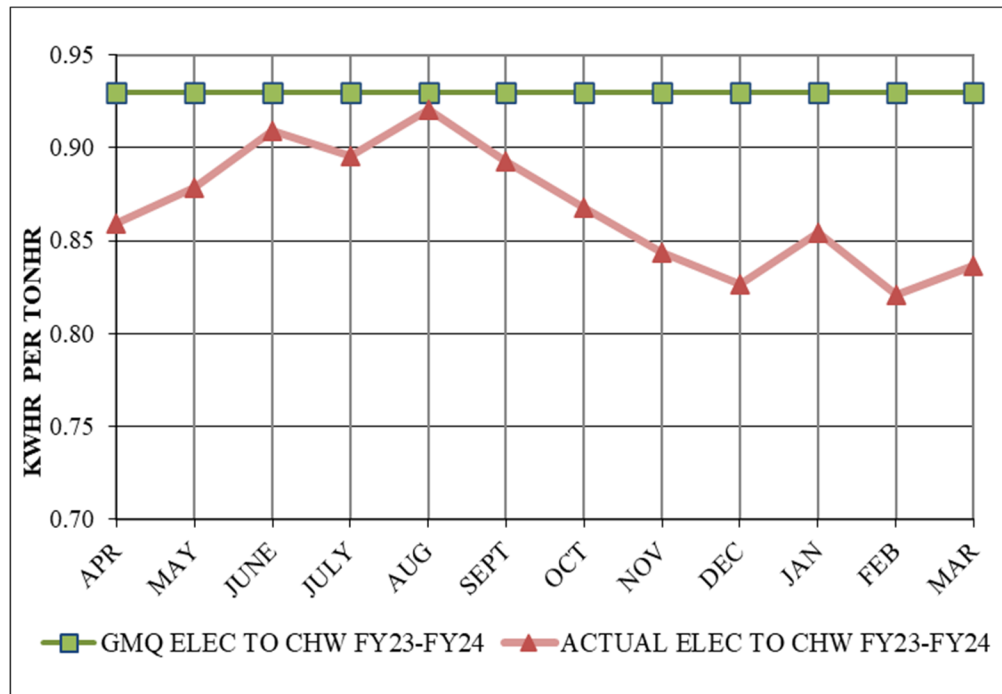
Figure 6. Chiller Plant Electric Performance Guarantee Comparison for the Previous Twelve Months

The performance of the chilled water portion of the EGF is presented in the following two charts, Figures 6 and 7, for the previous twelve months. The System Performance Guarantee levels as described in Amendment 2 of the ARMA were consistently achieved for these two chilled water metrics for each month of the Third Quarter. The chilled water-electric guarantee has also been met for the previous twelve months. The chilled water-water guarantee was met each month during the quarter.

The chilled water allocation of the electric consumption falls under the GMQ limit of 0.93 kWhr per tonhr for the current quarter on average with no excursions reported for the current fiscal year. The electric usage per unit of sales increased slightly over the previous Third Quarter. CES and TEG continue to monitor the improvements created by CES’s operational changes.

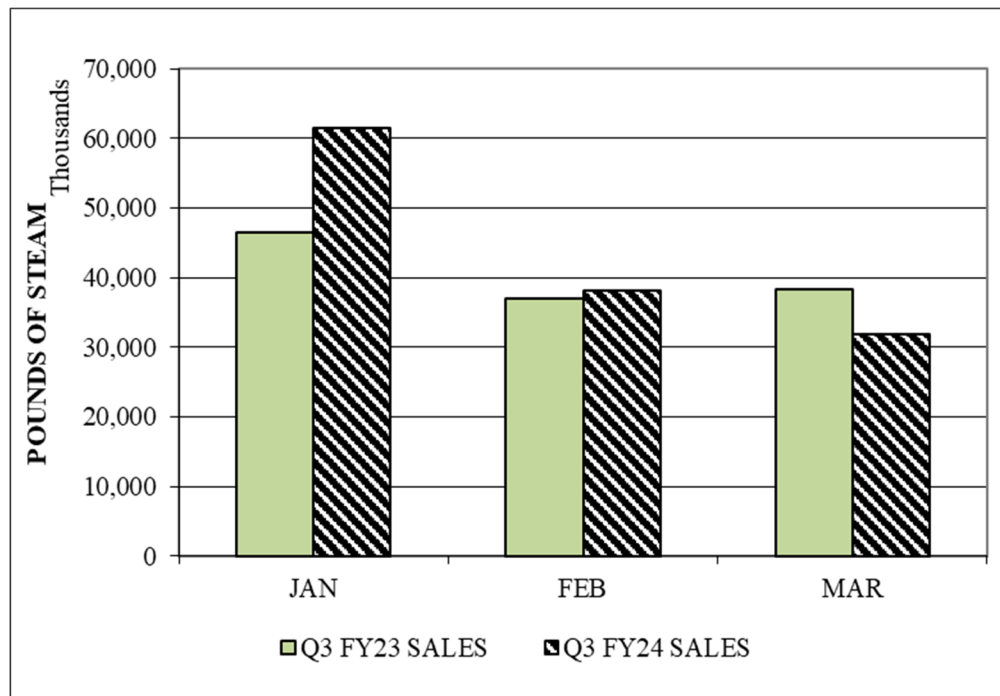
Figure 8. Steam Sales Comparison

The steam sendout increased by 9.5% over the previous Third Quarter (FY23), and the sales also increased 7.8%. However, the heating degree days during the quarter decreased 3.6% due largely to a milder than normal quarter. The steam system losses increased 28.9%, and the relative amount of condensate return increased slightly during the quarter. Condensate was dumped at a few customer buildings. Otherwise, the replacement of the condensate return pumps in MH-18 has improved the amount and consistency of the condensate return from the system. The peak steam demand for the current quarter was 145,600 pph, which reflects a 7.7% increase in the peak steam production over the previous Third Quarter. A comparison for the Third Quarter steam sales is shown in Figure 8.

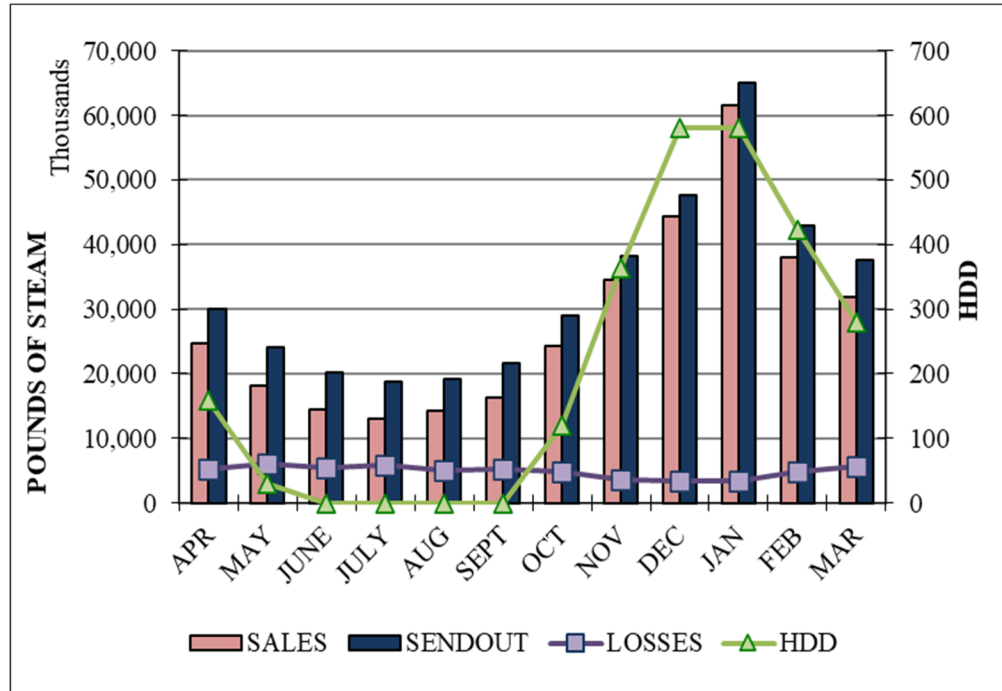
Figure 9. Steam Sales, Sendout, Losses and HDD for the Previous Twelve Months

Figure 9 shows the steam sales, sendout and losses for the previous twelve months. The losses on this figure are defined as the difference in pounds per month between the recorded sendout and sales values and represent the total mass loss in the EDS between the EGF and the customer meters.

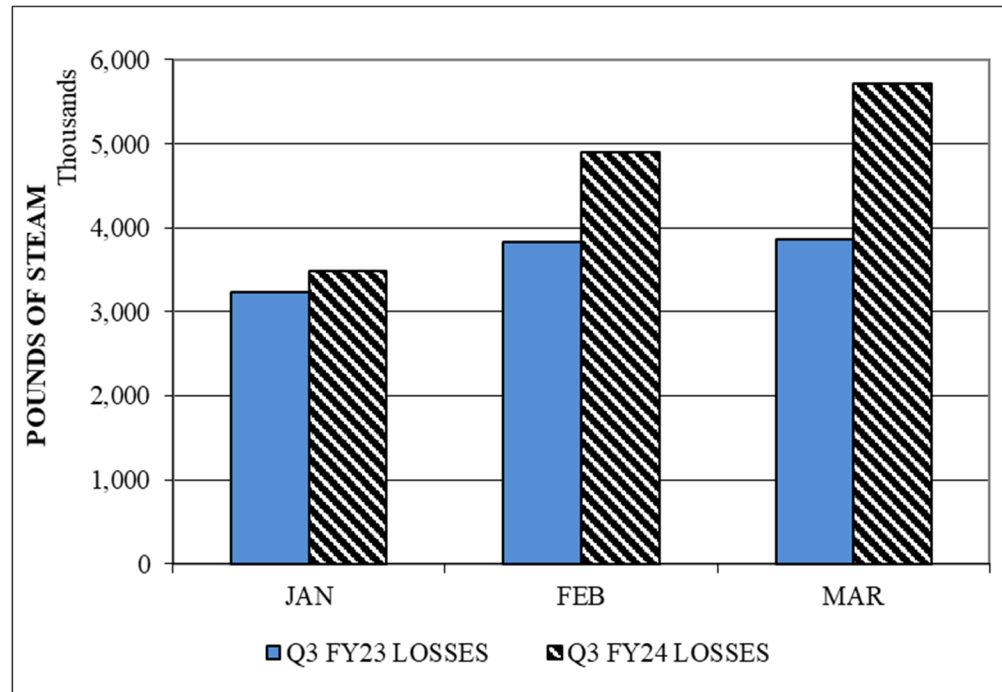
Figure 10. Steam System Losses

A comparison of the total steam mass losses in the EDS for the Third Quarter is shown in Figure 10. The mass loss is caused by the heat loss in the EDS between the EGF and the customer meters, resulting in a mass loss at steam traps. Faulty traps, steam leaks or meter error could also be a contributing cause of these losses. Whenever steam sales are low, steam losses are typically higher, which is reflected in the values for March in Figure 10.

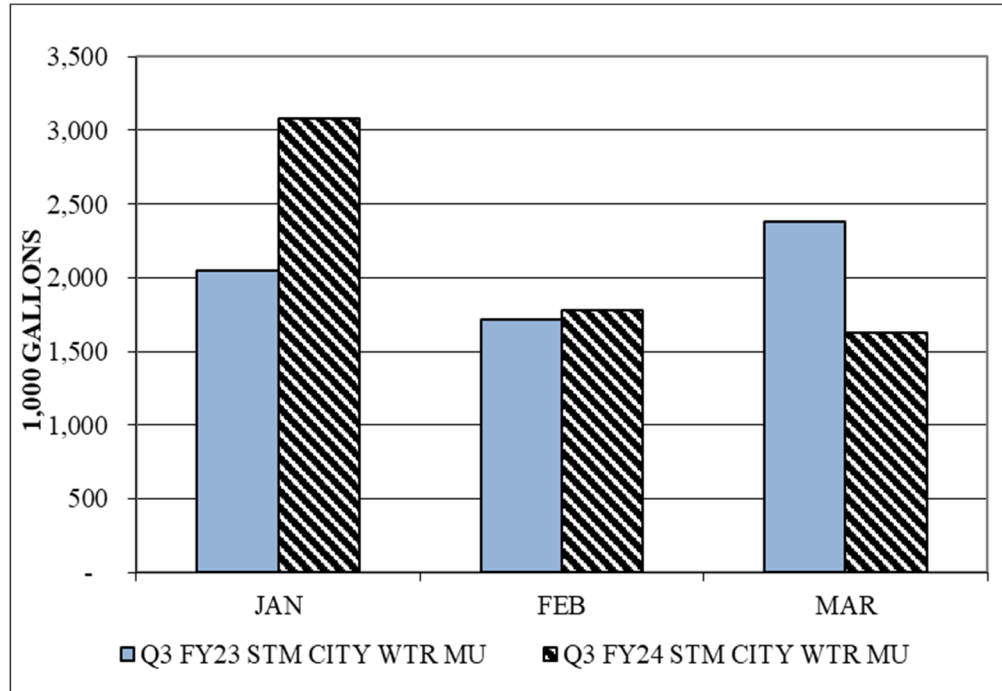
Figure 11. Steam System City Water Make-up Comparison

The amount of city water make-up (MU) to the steam system consists of the loss in mass between the EGF and the customers, in the condensate return from the customers to the EGF and losses at the EGF. The amount of make-up to the steam system increased 8.7% over the Third Quarter FY23. Condensate was dumped for project DES196 and at a few customer buildings. The corresponding data for steam system make-up is shown in the comparison of Third Quarter data in Figure 11.

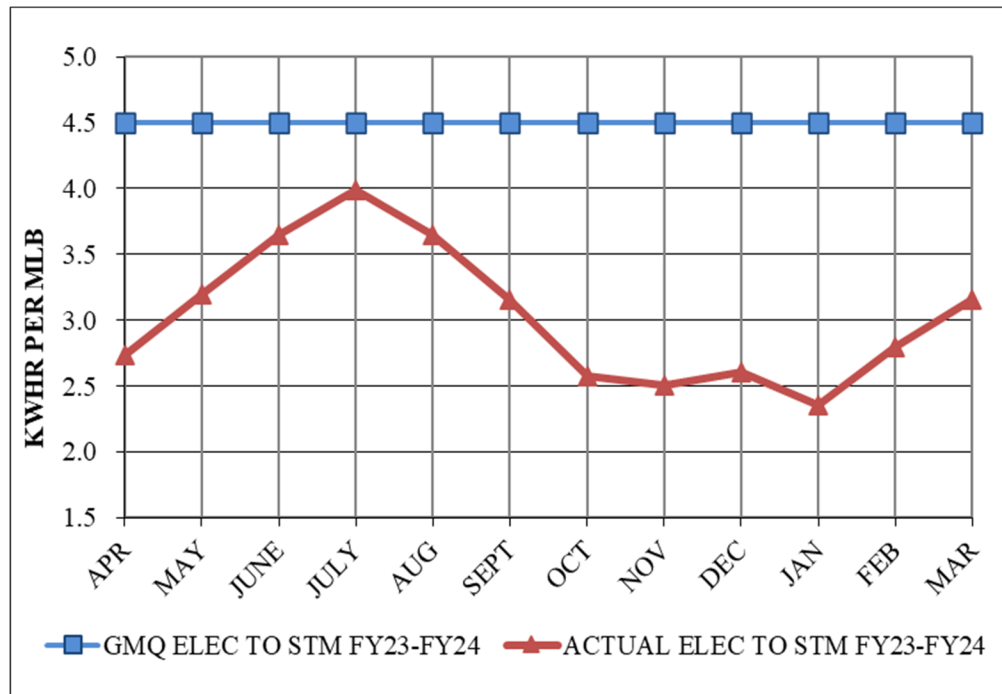
Figure 12. Steam Plant Electric Performance Guarantee for the Previous Twelve Months

The performance of the steam system of the EGF is presented in the following three charts, Figures 12, 13 and 14. The steam electric conversion factor was met each month of the quarter. The steam plant electric consumption for the current quarter was 8.7% higher in FY24 than in FY23. The steam-electric metric increased 4.1% over the previous Third Quarter. The monthly steam-to-electric conversion factors, along with the guaranteed values, are shown in Figure 12.

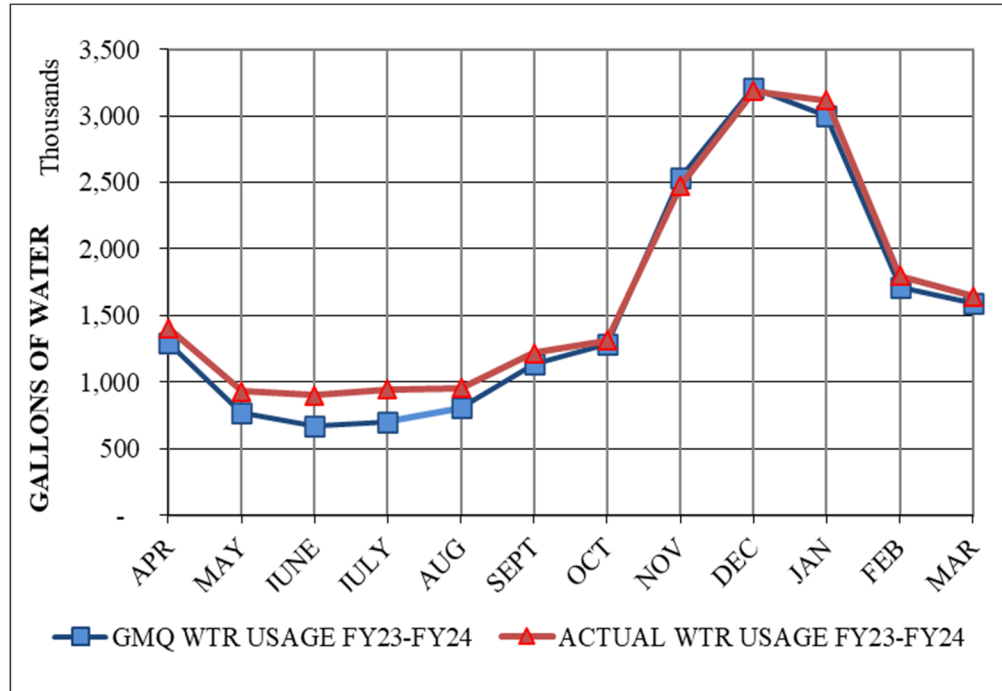
Figure 13. Steam Plant Water Performance Guarantee for the Previous Twelve Months

The steam water conversion factor exceeded the guaranteed values for each month during the quarter. CES and TEG continue to monitor the performance of the EGF as CES makes efforts to improve the DES performance. The guaranteed steam-water performance value is based on an equation which incorporates the amount of steam sendout and condensate return and did not change with the adoption of the new performance values in Amendment 2. CES has verified the accuracy of the meter readings and continues to review the operation. The steam water conversion factors are shown in Figure 13.

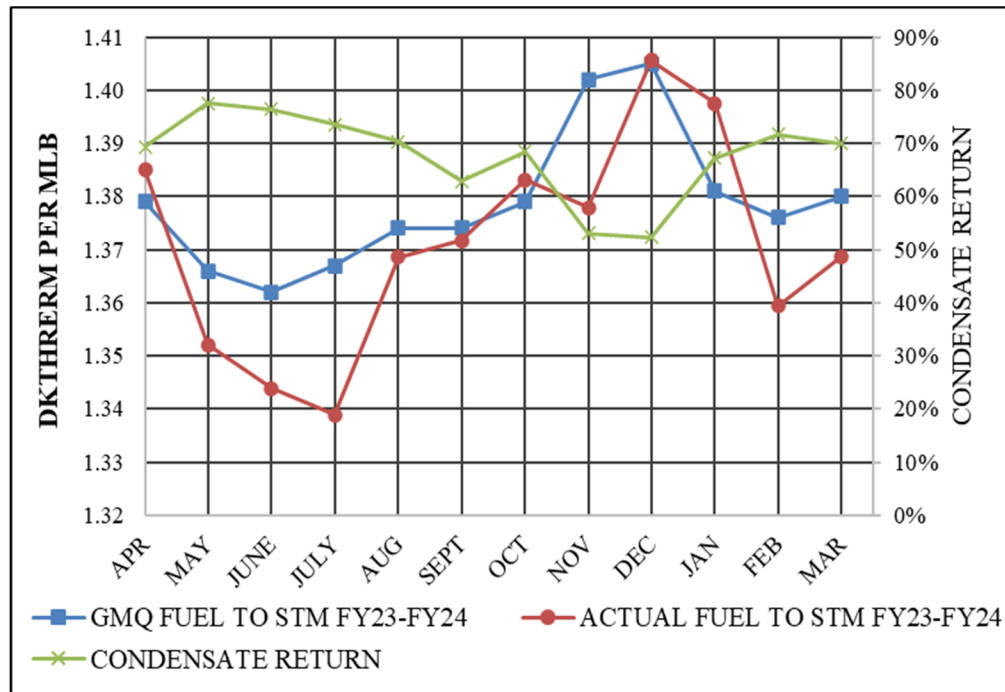
Figure 14. Steam Plant Fuel Performance Guarantee for the Previous Twelve Months

The steam fuel conversion factor met the guaranteed values for each month in the quarter. The fuel consumption per unit of steam sendout increased 0.6% over the previous Third Quarter. The relative amount of condensate return is shown on this graph to reflect the influence that the condensate return has on the plant efficiency. Although the performance level for this metric changed with the adoption of Amendment 2, the equation used to calculate the value relies heavily on readings from the condensate return and steam sendout meters. Figure 14 shows the performance of the conversion factors for the previous twelve months.

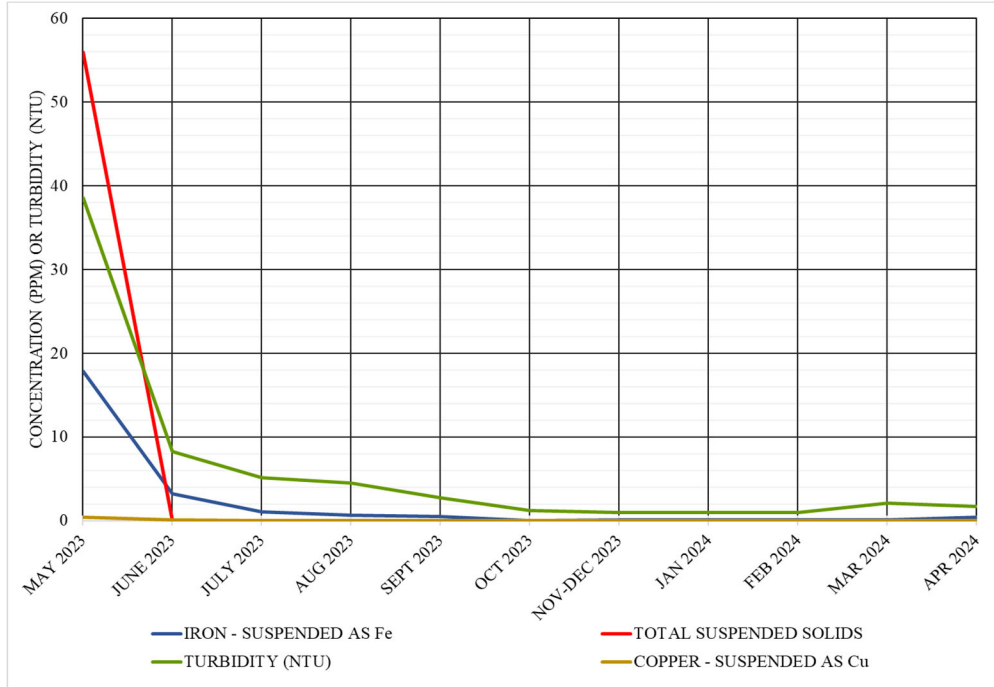
Figure 15. Chilled Water Composition Downstream of Side Stream Filter

- The side stream filter was installed in FY23 and became operational on May 9, 2023.
 - Although the filter has significantly reduced the amount of suspended solids in the chilled water and improved the turbidity of the system, the turbidity and iron levels have increased slightly in March and April. These results may be indicative of customers re-opening portions of their in-building systems which have been isolated during the winter months.

- Figure 15 shows the results of several measured metrics within the chilled water system.
