Operations Monitoring Report

First Quarter FY25

**Thermal Engineering Group, Inc.
105 Hazel Path Court, Ste 2
Hendersonville, TN 37075**

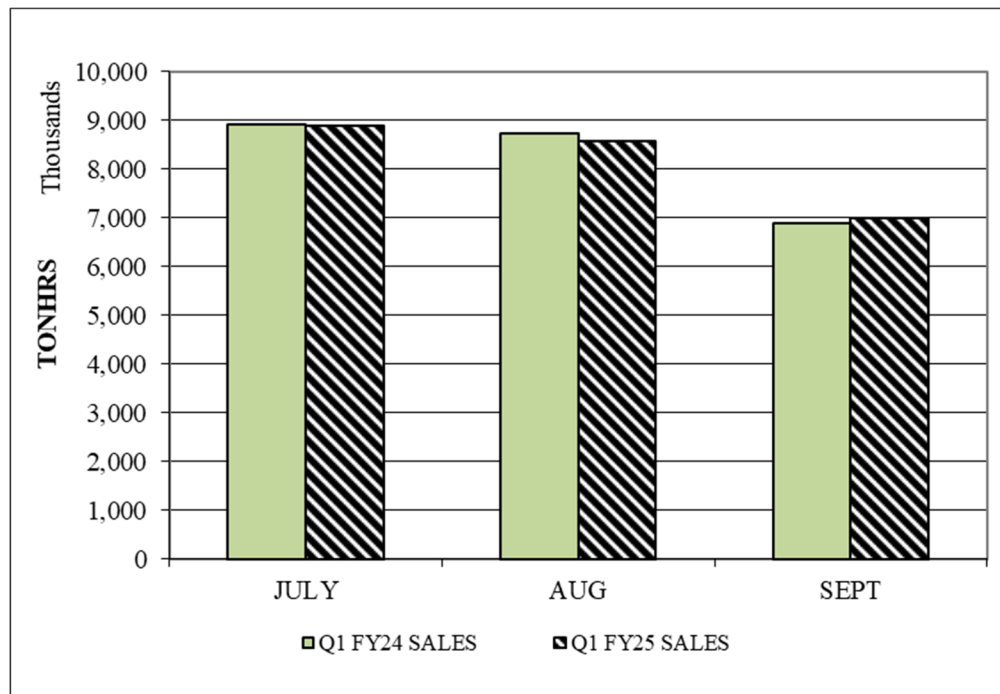
Figure 1. Chilled Water Sales Comparison

A comparison for the First Quarter chilled water sales is shown in Figure 1. This data reflects only a slight change in sales for the current quarter over the same quarter of the previous fiscal year. With an increase of 7.7% in the number of cooling degree days, the change in chilled water sales may be attributable to unusually dry summer. Lower relative humidities will decrease the amount of latent cooling necessary at customer buildings, decreasing the monthly usage of cooling required.

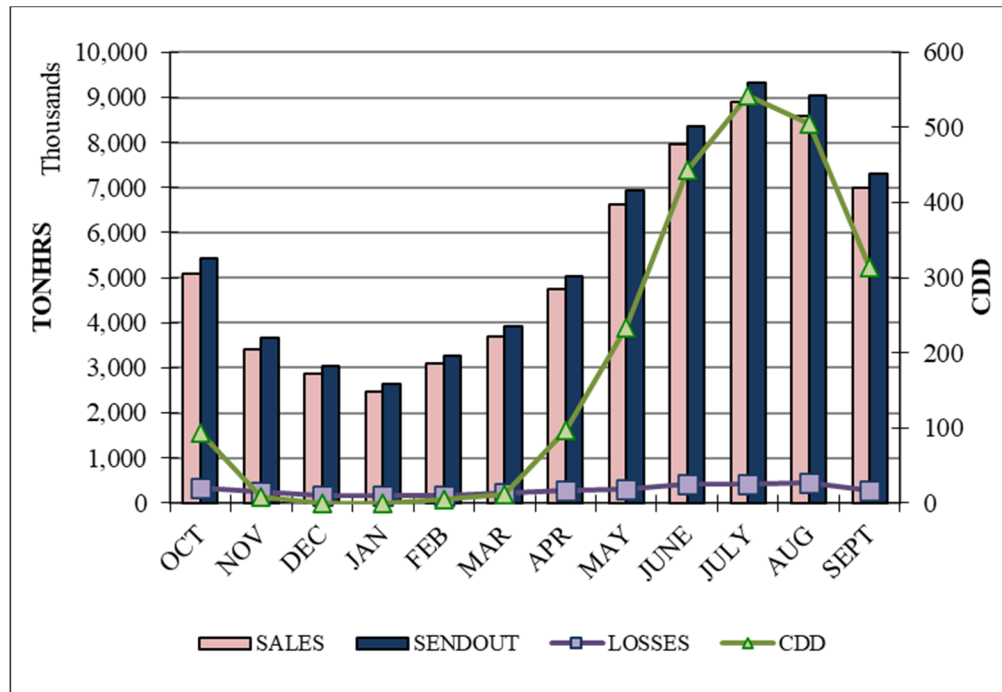
Figure 2. Chilled Water Sales, Sendout, Losses and CDD for the Previous Twelve Months

Figure 2 shows the chilled water sales, sendout and losses for the previous twelve months. The losses in this figure are defined as the difference in tonhrs per month between the recorded sendout and sales values and represent the total energy loss for chilled water in the EDS.

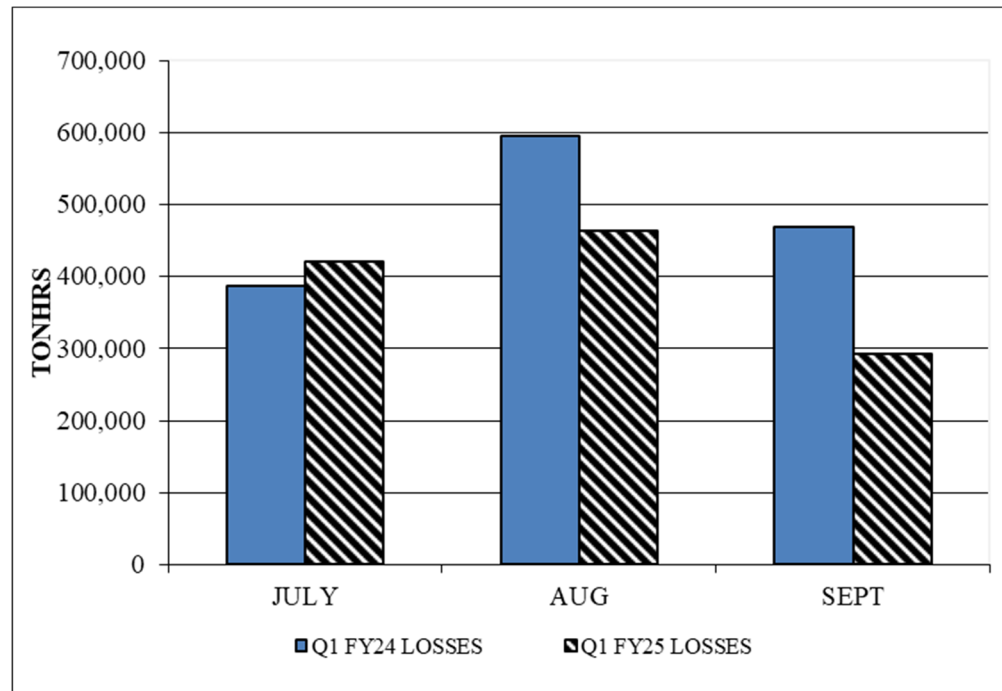
Figure 3. Chilled Water System Loss Comparison

A comparison of the total chilled water energy losses in the EDS for the First Quarter FY25 is shown in Figure 3. These losses are the difference in chilled water sendout and sales and may reflect differences in the meter accuracy between the EGF sendout meter and the customer meters. The losses decreased 18.9% over the previous First Quarter.

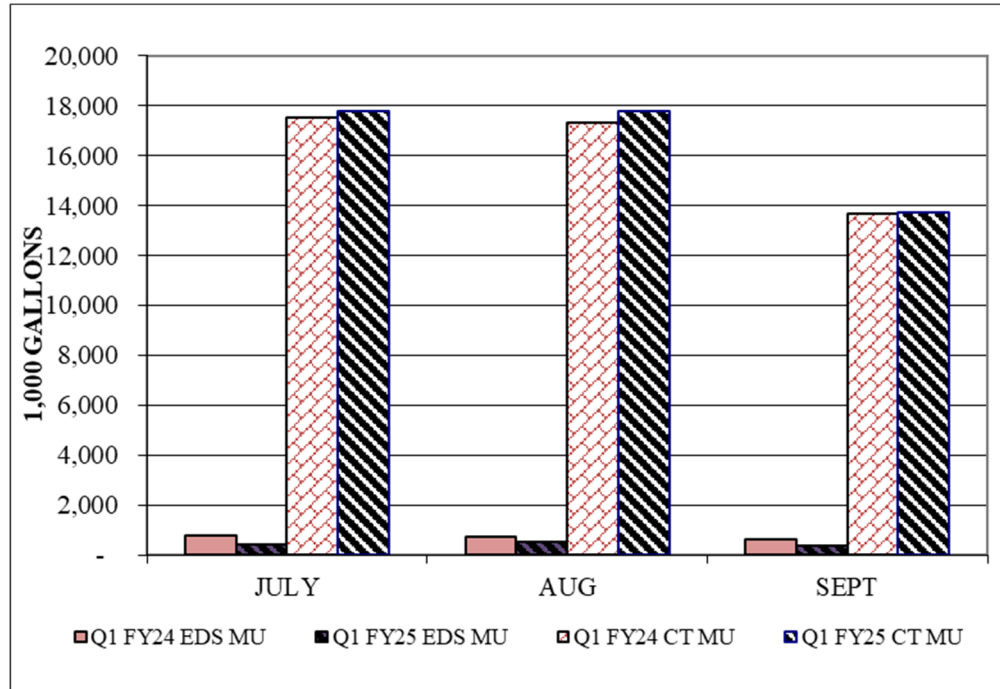
Figure 4. Chilled Water System City Water Usage Comparison

The make-up to the cooling towers increased 1.6% over the previous First Quarter. The water usage in the cooling towers is typically proportional to the production of chilled water and should vary with chilled water sales. The total chiller plant water use decreased marginally over the First Quarter. The overall city water make-up comparison for the chilled water system First Quarter is shown in Figure 4.

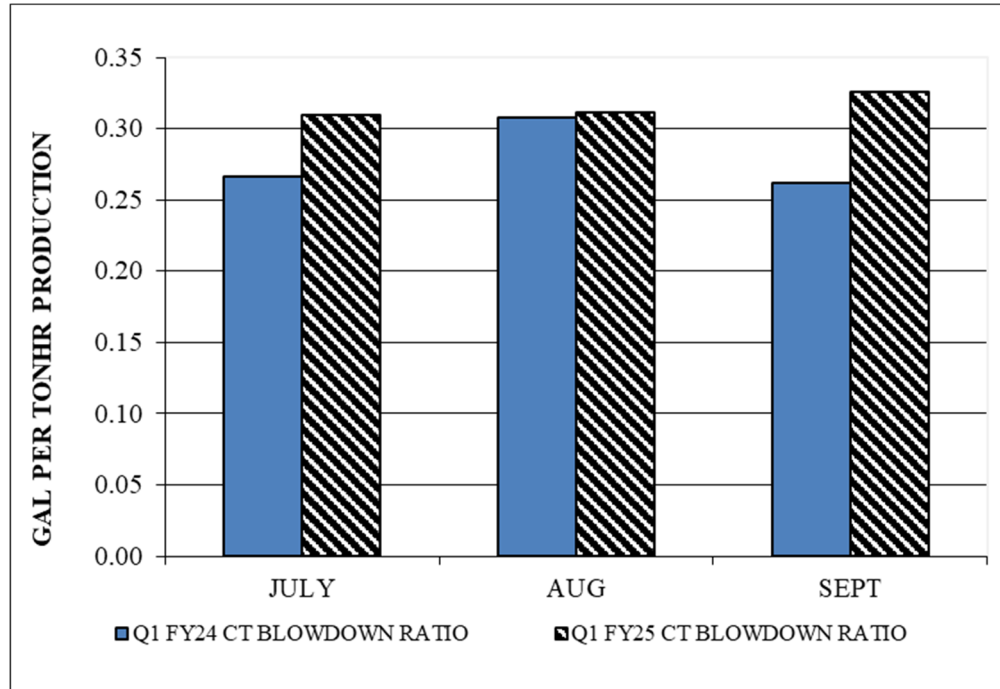
Figure 5. Cooling Tower Blowdown Ratio Comparison

With the implementation of the revised performance guarantee with Amendment 2 for the chilled water-water, DEAO began less frequently achieving the required performance. Beginning in March 2023, DEAO and TEG began monitoring the cooling tower blowdown more closely with the intent on reducing the water usage for the chilled water system. The blowdown is monitored and controlled to maintain the conductivity of the condensing water within a range of 1,000 to 1,150 micromhos. The relationship between the cooling tower blowdown and the chilled water production should be consistent and tracking this relationship may prove helpful in reducing the chiller plant water usage. DEAO has made operational changes with respect to the ratio of the cooling tower blowdown to the chilled water production with the expectation of reducing the water usage and improving their performance relative to the chilled water-water guarantee. A comparison of the First Quarter values between FY24 and FY25 are shown in Figure 5.

When a comparison is made between the First Quarter FY25 and FY24, the average cooling tower blowdown ratio increased 12.4%. This metric will continue to be tracked and monitored to verify operational changes made by DEAO at the EGF have resulted in a decrease in chiller plant water usage

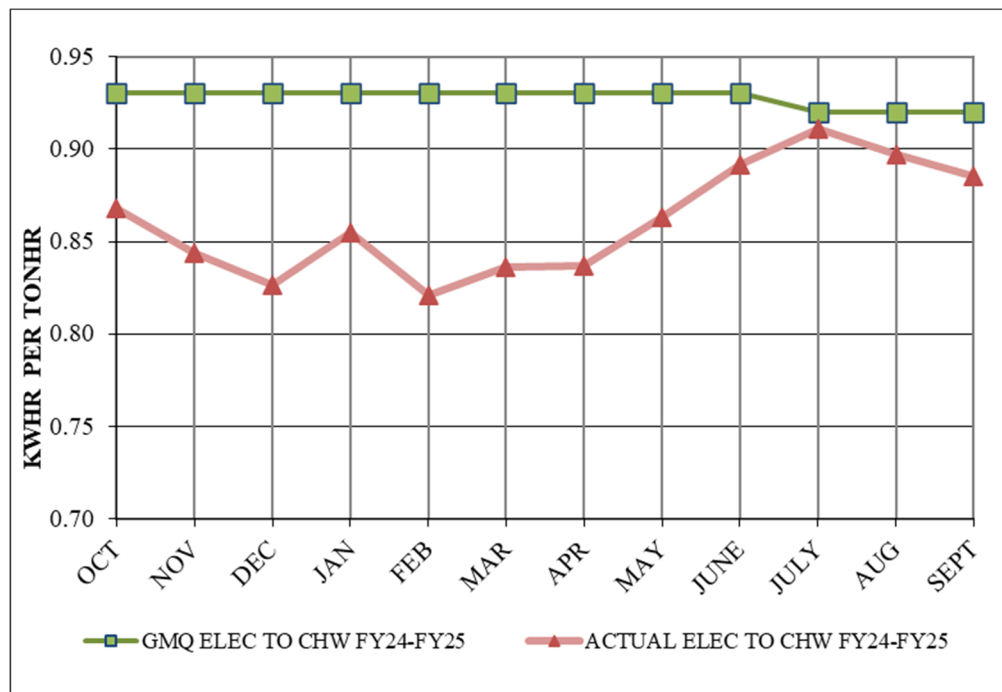
Figure 6. Chiller Plant Electric Performance Guarantee Comparison for the Previous Twelve Months

The performance of the chilled water portion of the EGF is presented in the following two charts, Figures 6 and 7, for the previous twelve months. The System Performance Guarantee for both metrics changed with Amendment 3 beginning with July 2024. The chilled water-electric metric decreased from 0.93 kWhrs per tonhr of sales to 0.92 kWhrs per tonhr of sales, thus increasing the GMQ efficiency which should result in an actual improvement in the chiller plant efficiency. The GMQ level prior to July 2024 is shown at the Amendment 2 level of 0.93 kWhrs per tonhr of sales. Even with the change in the metric, DEAO met the guaranteed performance metric each month of the First Quarter.

The electricity usage per unit of sales decreased 1.5% over the previous First Quarter indicating an increase in efficiency. DEAO and TEG continue to monitor the improvements created by DEAO’s operational changes.

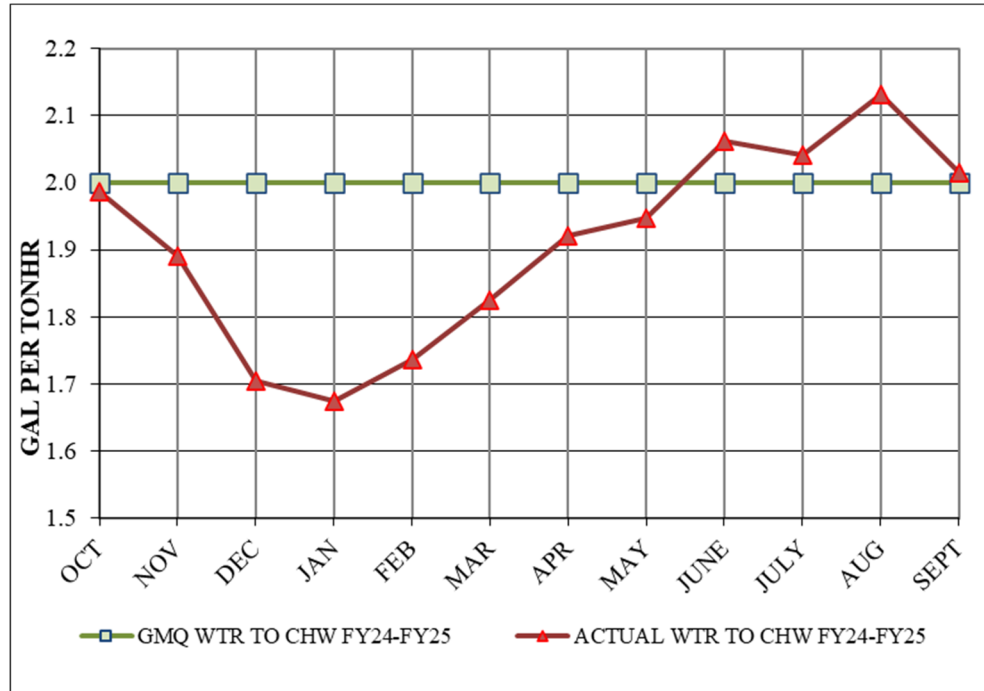
Figure 7. Chiller Plant Water Consumption Performance Guarantee Comparison for the Previous Twelve Months

The chilled water-water metric likewise changed with Amendment 3. Although the guarantee (GMQ) remains 2.0 gallons per tonhr of sales, the equation determining the “actual” water usage upon which the comparison is made has changed. The new value reduces the limit for EDS make-up from 30,000 gallons per day to 20,000 gallons per day and memorializes the exclusion of the side stream filter backwash. This latter addendum had been agreed upon between DEAO, Metro, and TEG after acceptance of the side stream filter installation.

“actual” = total chiller plant city water make-up
– side stream filter backwash
– EDS make-up

The total consumption of city water for the chiller plant for the current quarter decreased marginally over the previous First Quarter. The EDS make-up decreased 40.9%, but the cooling tower blowdown increased 11.0%. The side stream filter backwash decreased 23.2%. However, DEAO did not meet the new metric any month during the quarter. Figure 7 shows the chilled water-water metric for the previous twelve months. The calculation for the “actual” water metric for months prior to July 2024 uses the methodology from Amendment 2. The First Quarter FY25 data uses the Amendment 3 methodology. TEG and DEAO continue to monitor the water usage and chiller plant performance with the goal of decreasing the energy and water usage for the system.

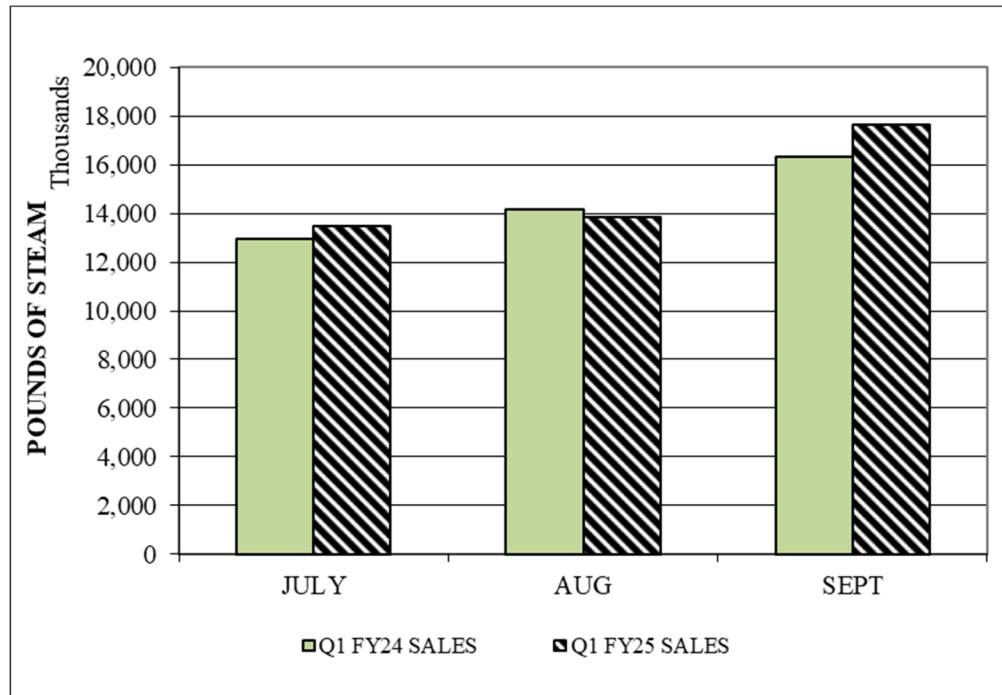
Figure 8. Steam Sales Comparison

The steam sendout increased 4.7% over the previous First Quarter (FY24), and the sales increased 3.4%. No heating degree days are reported for the First Quarter FY24 or FY25. The steam system losses increased 8.2%. The relative amount of condensate return increased 11.4% during the quarter. The peak steam demand for the current quarter is 52,072 pph, which reflects a 13.4% increase in the peak steam production over the previous First Quarter. A comparison for the First Quarter steam sales is shown in Figure 8.

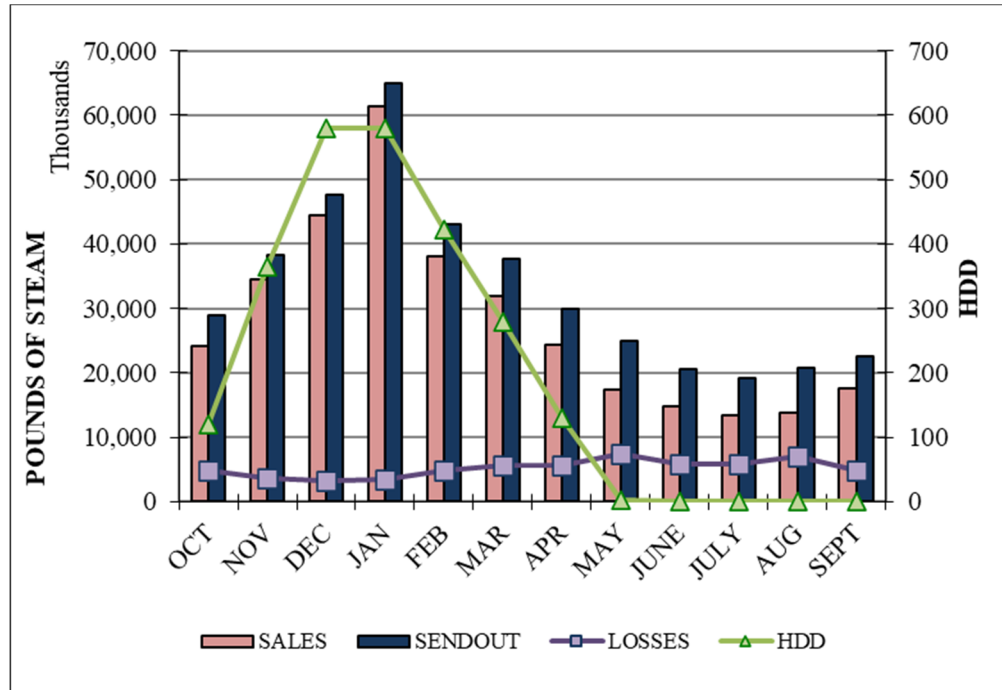
Figure 9. Steam Sales, Sendout, Losses and HDD for the Previous Twelve Months

Figure 9 shows the steam sales, sendout and losses for the previous twelve months. The losses on this figure are defined as the difference in pounds per month between the recorded sendout and sales values and represent the total mass loss in the EDS between the EGF and the customer meters.

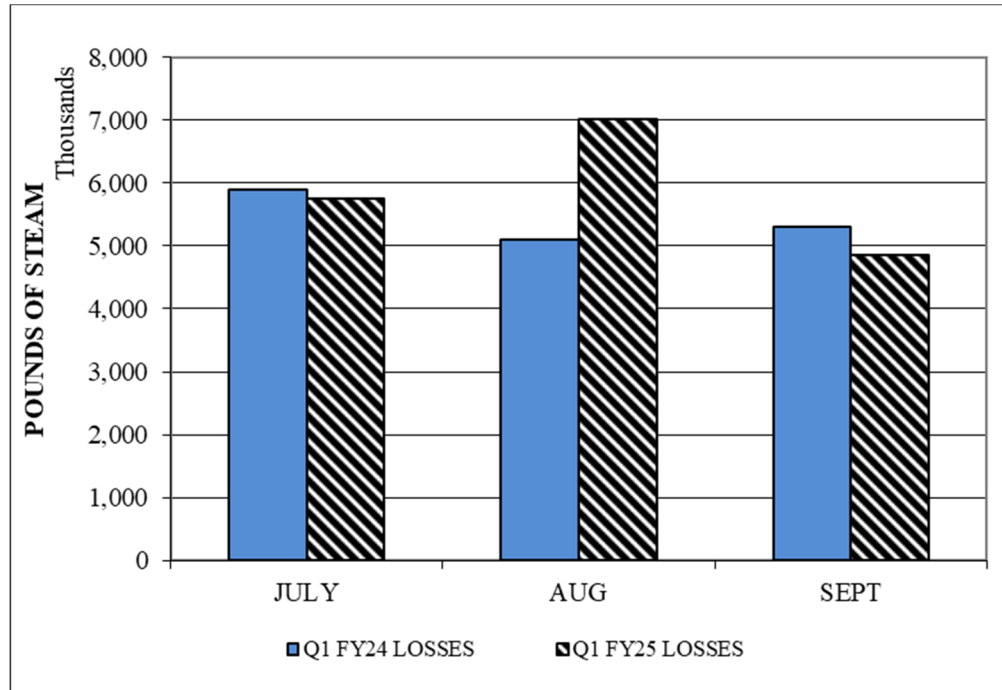
Figure 10. Steam System Losses

A comparison of the total steam mass losses in the EDS for the First Quarter is shown in Figure 10. The mass loss is caused by the heat loss in the EDS between the EGF and the customer meters, resulting in a mass loss at steam traps. Faulty traps, steam leaks or meter error could also be a contributing cause of these losses.

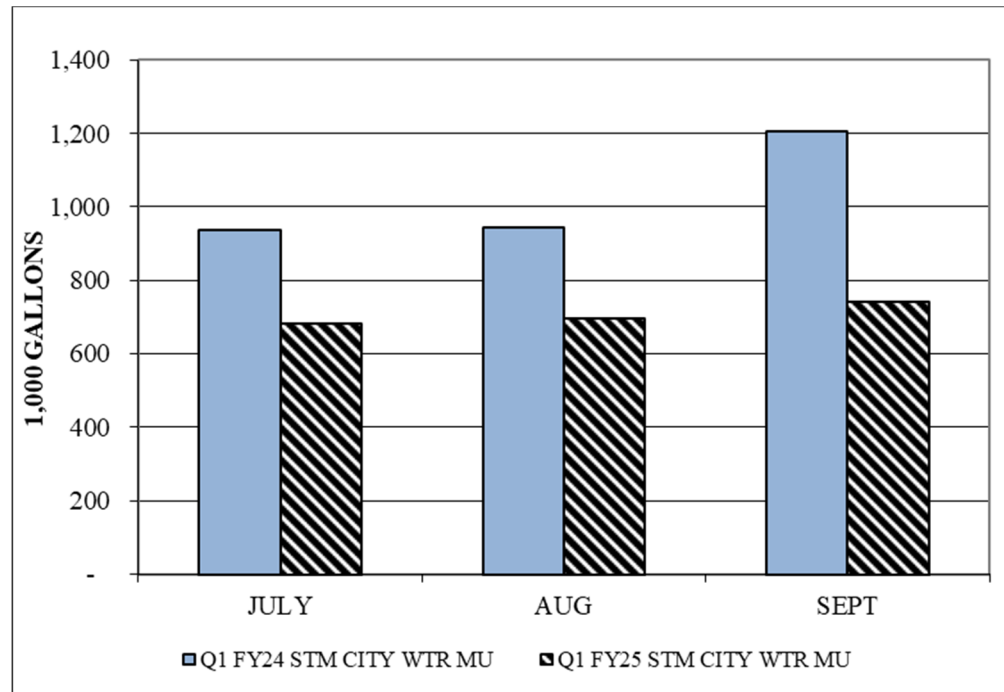
Figure 11. Steam System City Water Make-up Comparison

The amount of city water make-up (MU) to the steam system consists of the loss in mass between the EGF and the customers, in the condensate return from the customers to the EGF and losses at the EGF. The amount of make-up to the steam system decreased 31.3% over the First Quarter FY24. The corresponding data for steam system make-up is shown in the comparison of First Quarter data in Figure 11.

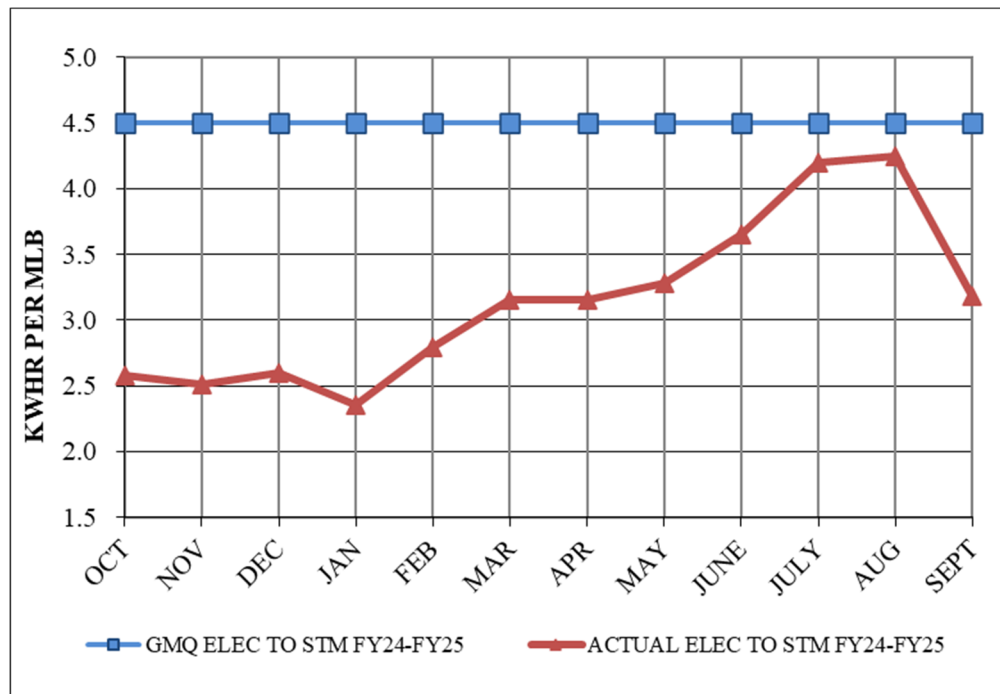
Figure 12. Steam Plant Electric Performance Guarantee for the Previous Twelve Months

The steam electric conversion factor was met each month of the quarter. The steam plant electric consumption for the current quarter was 10.7% higher in FY25 than in FY24. The steam-electric metric increased 7.7% over the previous First Quarter. The monthly steam-electric conversion factors, along with the guaranteed values, are shown in Figure 12.

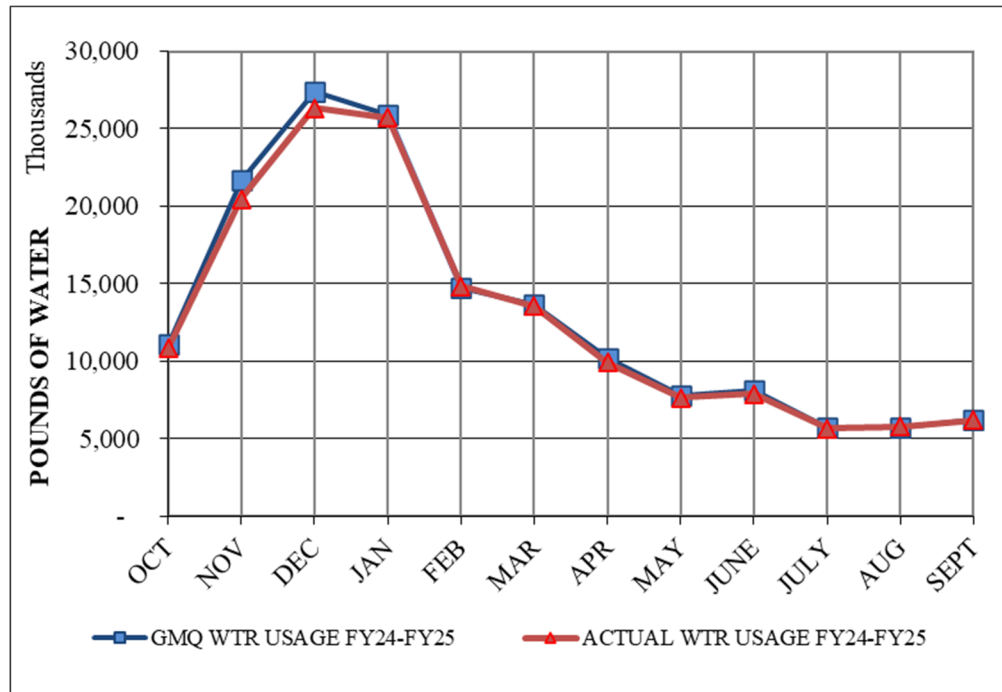
Figure 13A. Steam Plant Water Performance Guarantee for the Previous Twelve Months Using a Mass Comparison

Since the Amendment 3 metric is based on pounds of water and the Amendment 2 metric is based on gallons using a different equation to determine both the GMQ and “actual” values, a comparison is difficult to make between the historic values and the Amendment 3 equation. Therefore, the performance for the previous twelve months is represented by the following two graphs. Figure 13A using pounds and Figure 13B using gallons. The guaranteed and actual volumes (gallons) prior to July 2024 use the Amendment 2 methodology. However, the GMQ

volumes shown for July, August, and September 2024 convert the pounds values to gallons assuming a density based on the average condensate return temperature. Similarly, the mass values shown for data prior to July 2024 assume a constant density over the month based on the recorded average monthly condensate return temperature and converting the volumetric data to mass (pounds). These conversions will need to be made for FY25 and until enough historic data using the Amendment 3 methodology has been collected such that the real time density correction will be recorded.

For the First Quarter, the boiler plant water usage decreased 31.3%. This decrease resulted in a 32.0% decrease in the steam-water metric with the volumetric comparison methodology from Amendment 2 and a 31.3% decrease with the density correction formulation similar to Amendment 3. Using the Amendment 3 methodology, the metric was met in July and September 2024 but was not met during the First Quarter FY24 while applying the Amendment 3 methodology on the historic data. Please note the performance metric is based on the actual amount of condensate return each month resulting in a variation in the GMQ value.

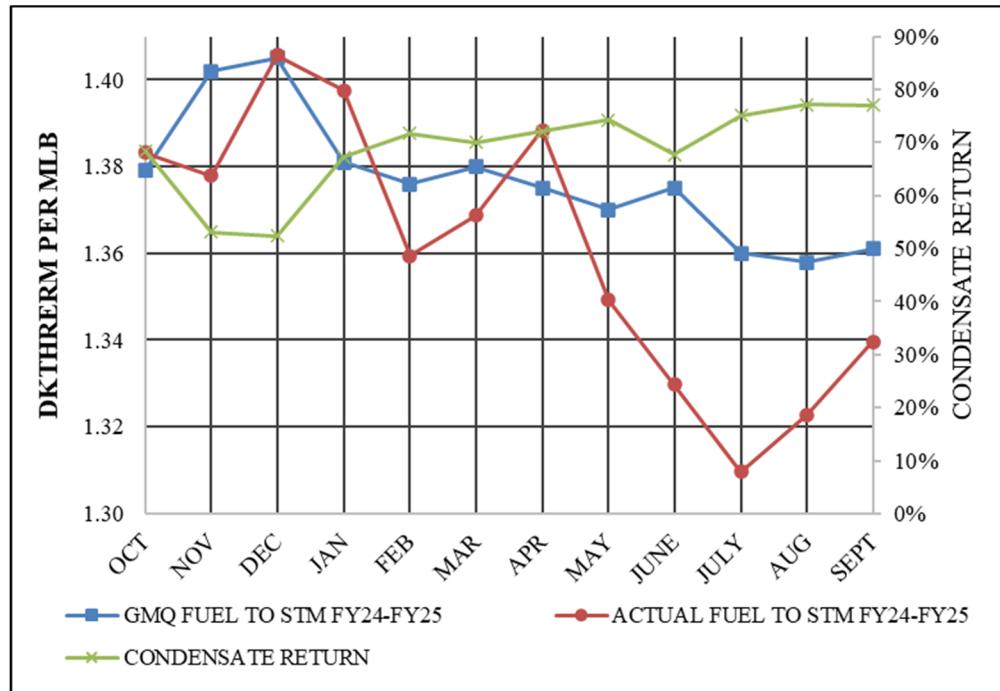
Figure 14. Steam Plant Fuel Performance Guarantee for the Previous Twelve Months

consumption per unit of steam sendout decreased 2.7% over the previous First Quarter. The relative amount of condensate return is shown on this graph to reflect the influence the condensate return has on the plant efficiency.

Figure 14 shows the performance of the conversion factors for the previous twelve months.

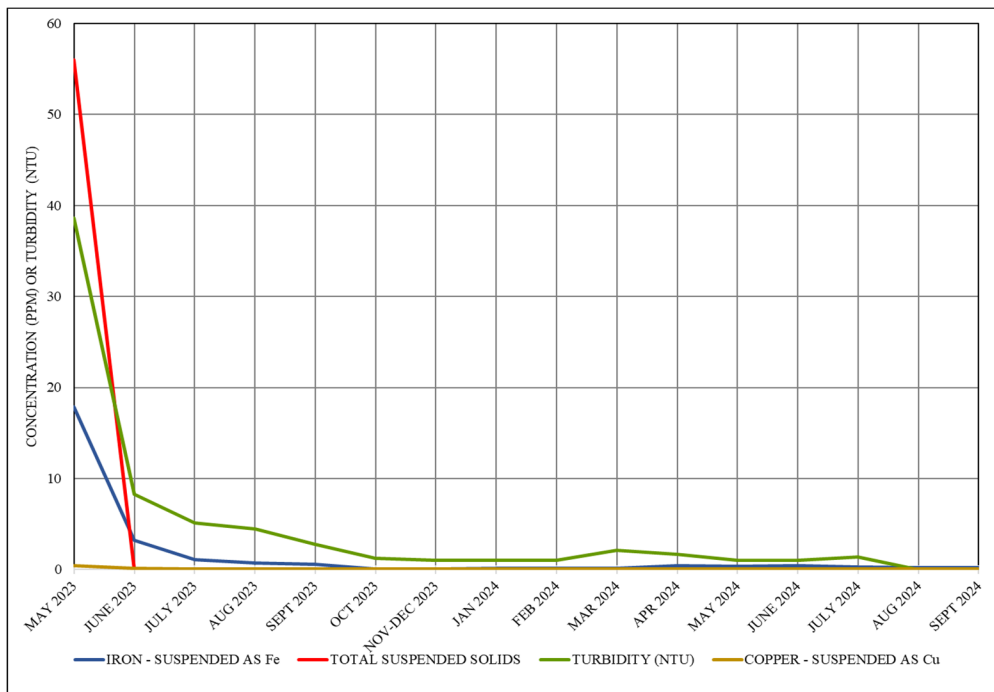
Figure 15. Chilled Water Composition Downstream of Side Stream Filter

- The side stream filter has significantly reduced the amount of suspended solids in the chilled water and improved the turbidity of the system except the turbidity and iron levels increased slightly in March and April. These results may be indicative of customers re-opening portions of their in-building systems which have been isolated during the winter months.

- Values shown in Figure 15 at or near zero may be at or below the detectable limit and are represented by “zero”.
 - Figure 15 shows the results of several measured metrics within the chilled water system which may be affected by the side stream filter.
