**METROPOLITAN GOVERNMENT OF NASHVILLE AND DAVIDSON COUNTY**

**STAFF RECOMMENDATION**  
**170-176 Second Avenue North**  
**July 21, 2021**

**Application:** Demolition  
**District:** Second Avenue Historic Preservation Zoning Overlay  
**Council District:** 19  
**Base Zoning:** DTC  
**Map and Parcel Number:** 09306206600 and 09302401900  
**Applicant:** Callen Trust, property owner  
**Project Lead:** Robin Zeigler, robin.zeigler@nashville.gov

**Description of Project:** The property owner requests to demolish four historic buildings in the Second Avenue Historic Preservation Zoning Overlay, damaged in the 2020 Christmas morning explosion.

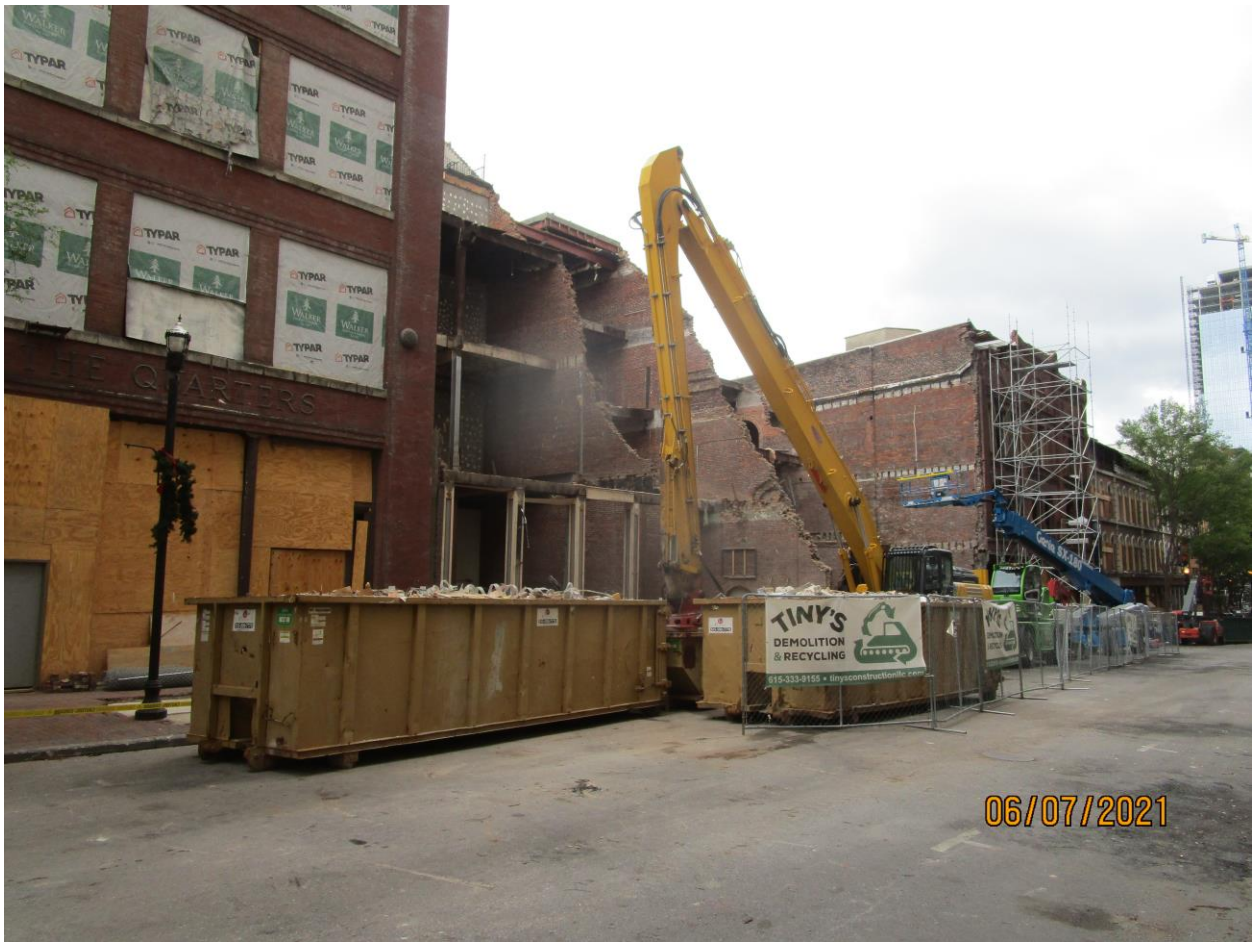
**Photograph 1: Front elevation.**

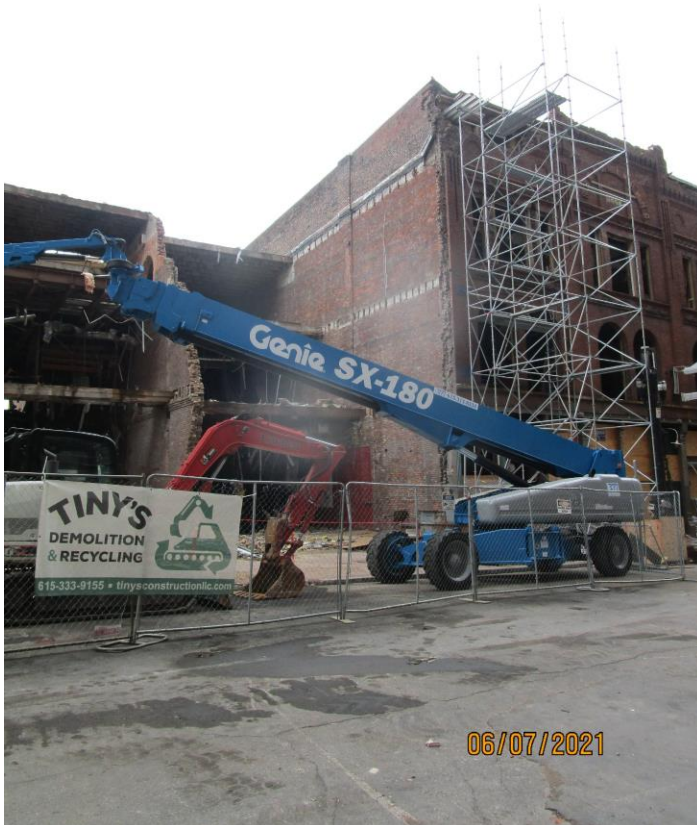
The front face of Building 170 from Second Avenue North can be observed in Photographs June 7, 2021, photographs 2 and 11. As can be seen in these photographs, the intensity of the blast caused the floor and roof framing to be stepped-back dramatically to remove all the broken and splintered wood members.

**Photograph 2: View of Building 170.**

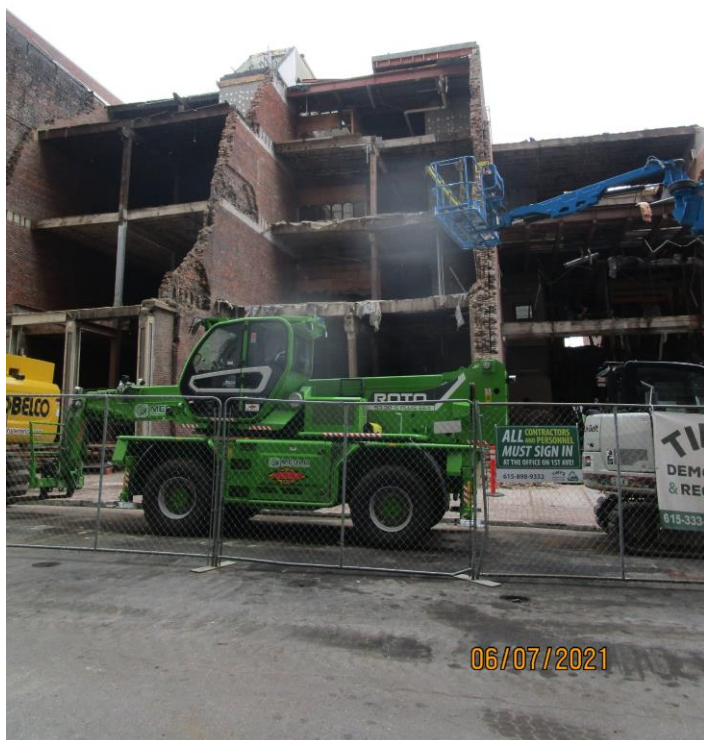
The front elevation of Building 174 can be observed in Photographs June 7, 2021, photographs 4 and 7.

**Photograph 4: View of Building 174.**

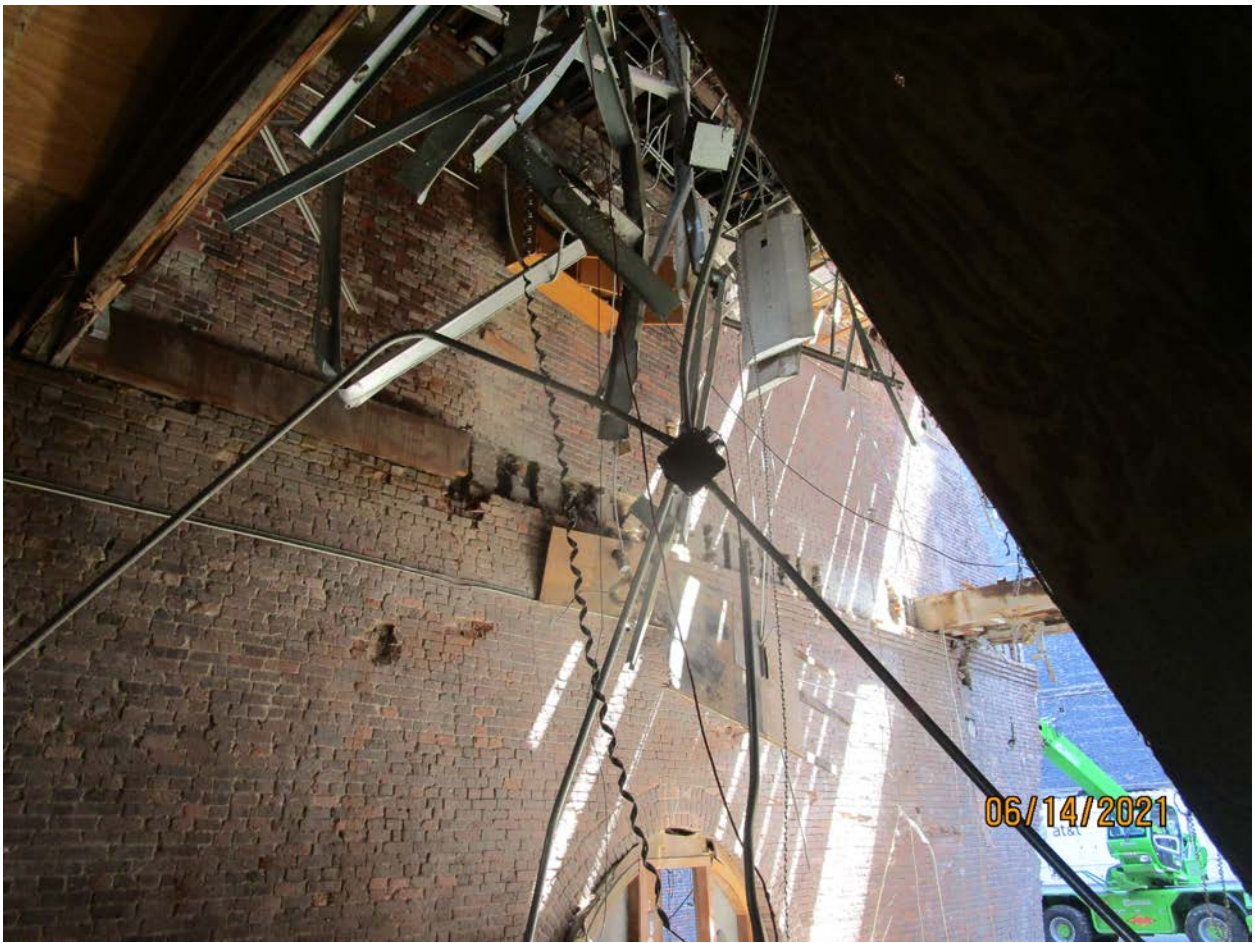
**Photograph 4: Overview of second floor framing of Building 172.**

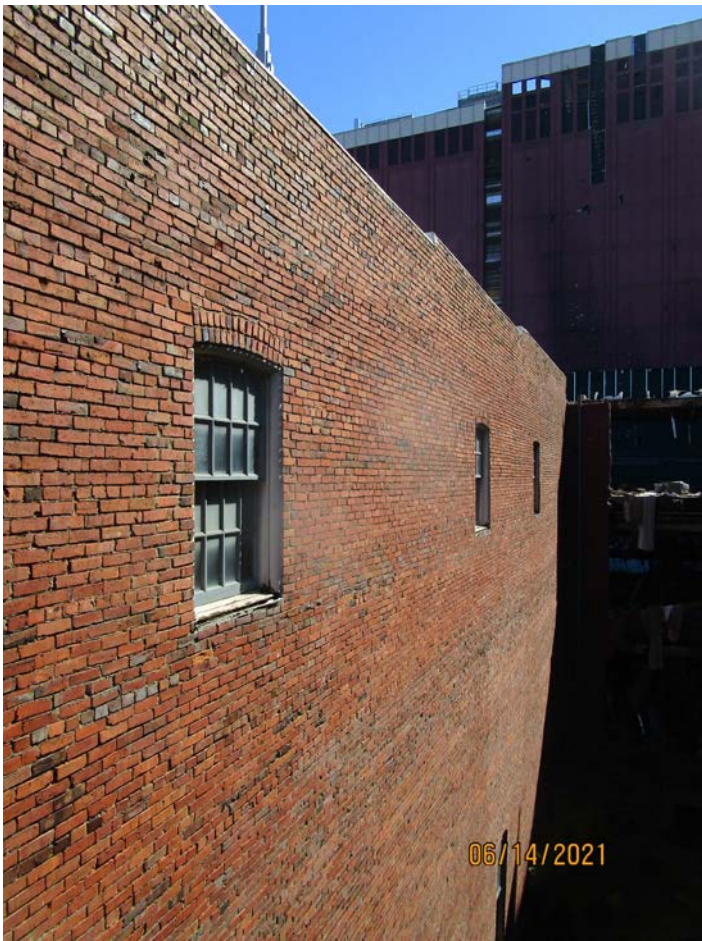
Due to the amount of movement of this left sidewall, and the deteriorated state of the mortar (Photographs June 14, 2021, photographs 92 through 99), it is my recommendation to remove and reconstruct this wall in its entirety. The soft mortar conditions of this wall can be observed in photographs 94 and 96 where light finger pressure is used to sweep the mortar from the joints. The out-of-plumb condition of this wall can be observed in Photographs June 14, 2021, photographs 93, 95, 97, and 99. The interior walls common to Building 170 will also have to be addressed as they also will require reworking and/or reconstruction to return them to a safe load-bearing condition.

**Photograph 92: Close-up of left-side wall of Building 170.**

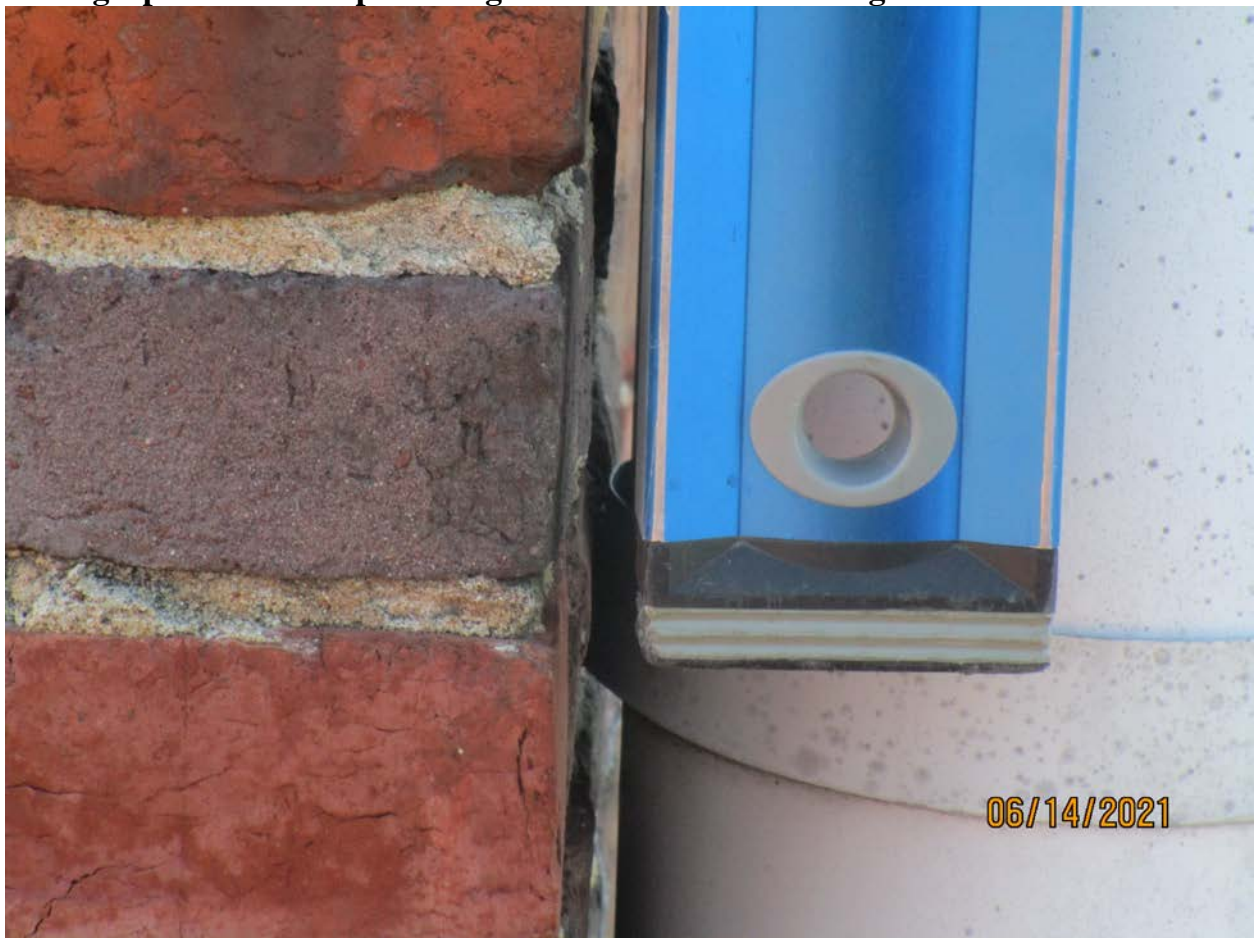
The rear wall of Building 174 has extensive deterioration and lateral movement and will require it to be removed and rebuilt (Photographs June 14, 2021, photographs 109 through 120).

The rear walls of both Buildings 176 and 174 were reviewed from a vertical lift (photographs 109 through 120). The mortar is in extremely poor condition, and water has been running down the rear face of the wall due to the lack of a rainwater leader, which has severely compromised the wall common to this location. The lateral movement of these walls would suggest that the walls can no longer perform as intended.

**Photograph 109: Rear wall intersection of Buildings 176 and 174.**
