STAFF RECOMMENDATION
1702 Forrest Avenue
July 21, 2021

Application: Demolition: Economic Hardship
District: Lockeland Springs Historic Conservation Zoning Overlay
Council District: 06
Base Zoning: R6
Map and Parcel Number: 08310029700
Applicant: Nicole Piersiak
Project Lead: Joseph Rose joseph.rose@nashville.gov

<p>Description of Project: The applicant requests demolition of a contributing building due to extreme disrepair, arguing for economic hardship and demolition of a non-contributing outbuilding.</p> <p>Recommendation Summary: Staff recommends approval of full demolition of all structures at 1702 Forrest, finding that demolition meets section III.B (2) (b) as the necessary demolition required to repair the primary building will result in a non-contributing building and the outbuilding is a non-contributing building and the project meets section III.B (2) (a) as repairs are not possible in a manner that retain the historic building.</p>	<p>Attachments</p> <ul style="list-style-type: none">A: PhotographsB: Engineer Report-FieldsC: Engineer Report-Engineered Solutions and Thunder River ConstructionD: Diligent Home InspectionE: Purchase DocumentationF: Tax HistoryG: Appraisal H

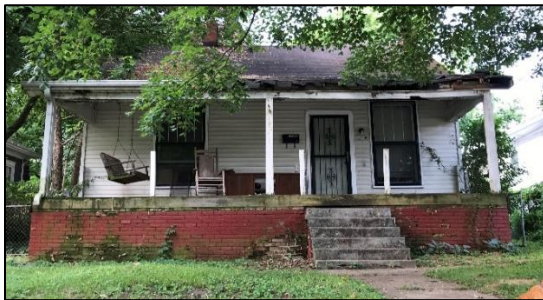
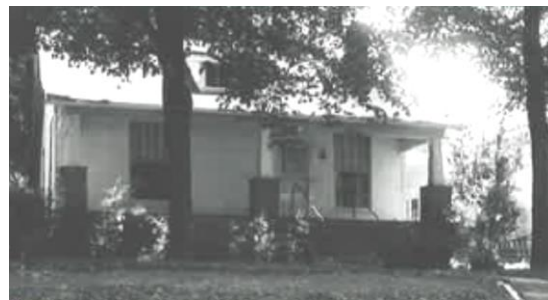
Figures 1 and 2: 1702 Forrest Avenue in 2021 and in 1969.

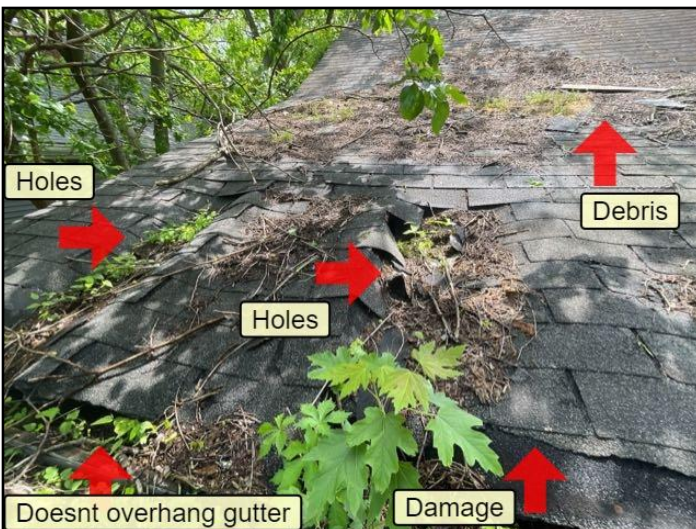
1. Near end of life expectancy

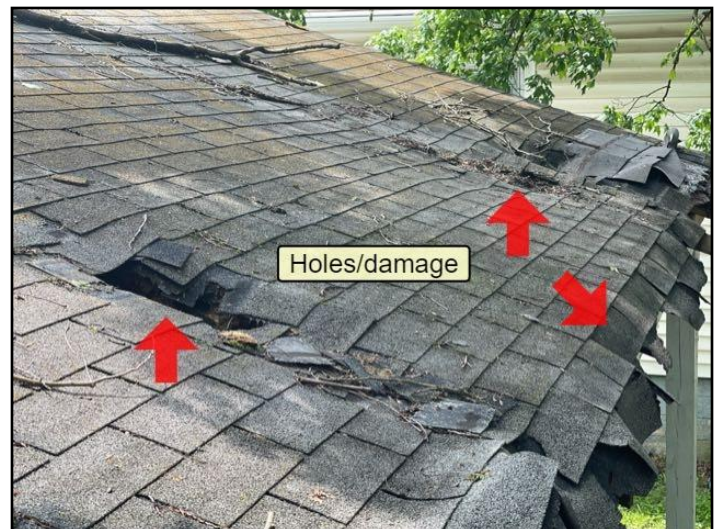
2. Near end of life expectancy

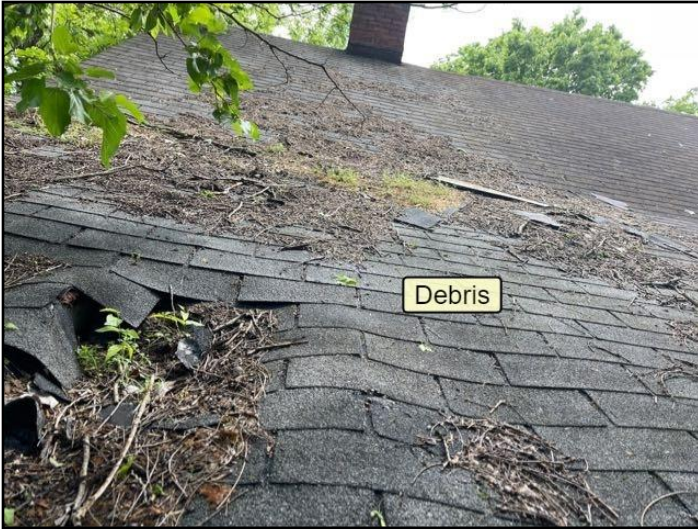
3. Near end of life expectancy

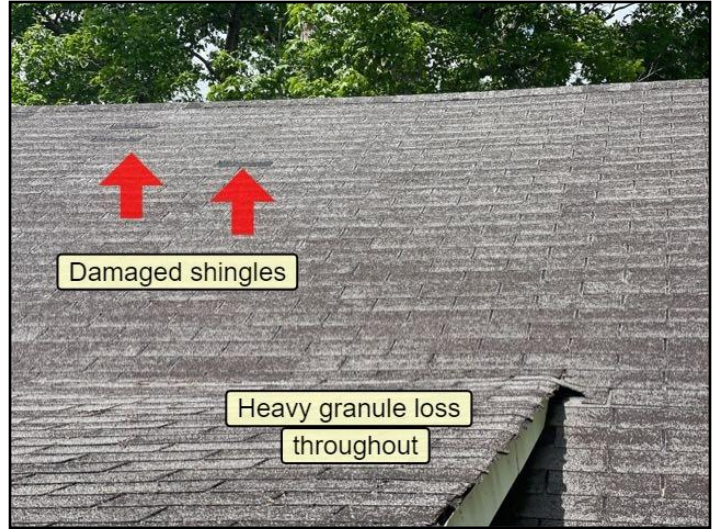
4. Near end of life expectancy

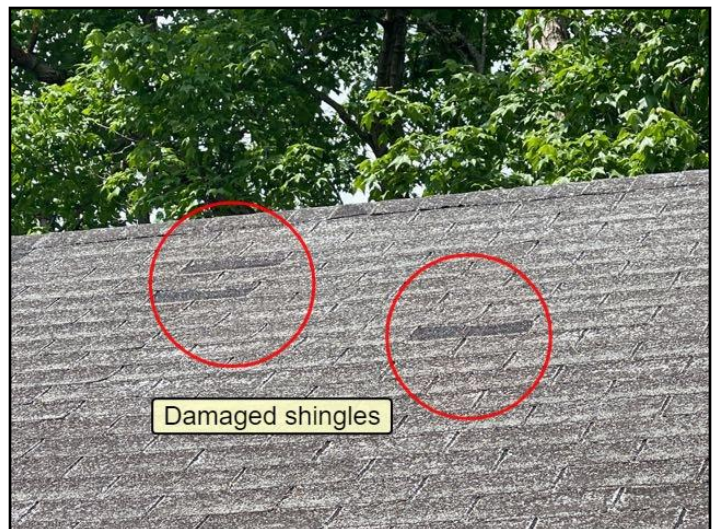
6. Near end of life expectancy

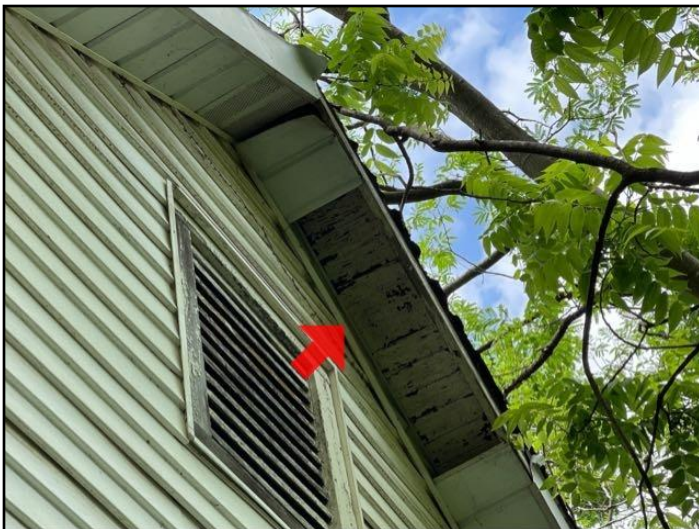
13. Soffit missing

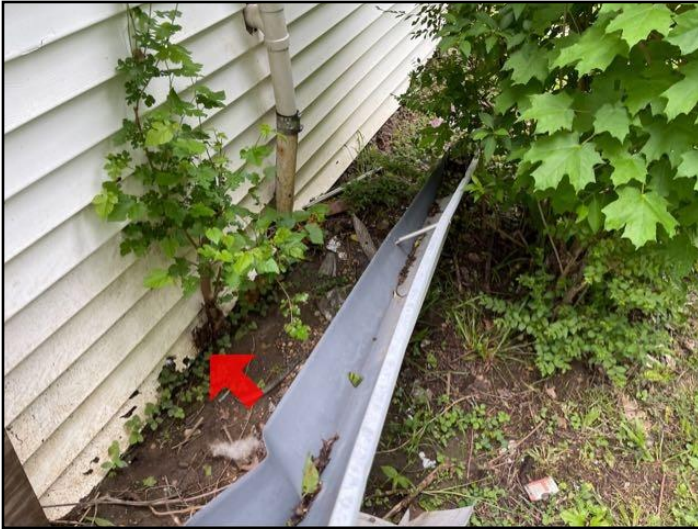
23. Vinyl in contact with ground

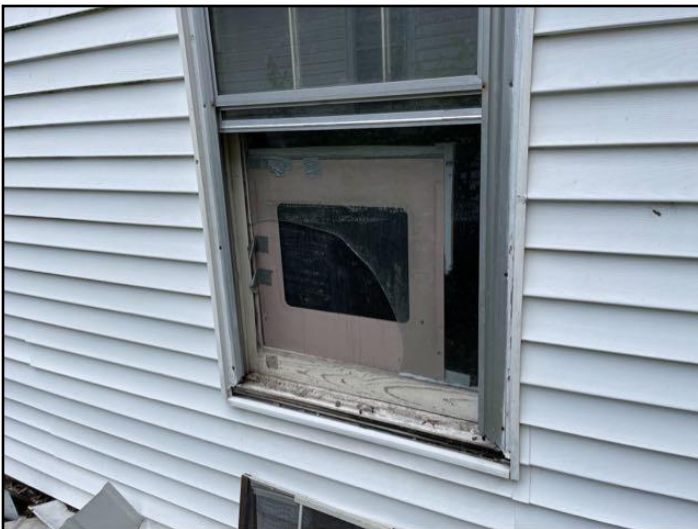
25. Broken glazing

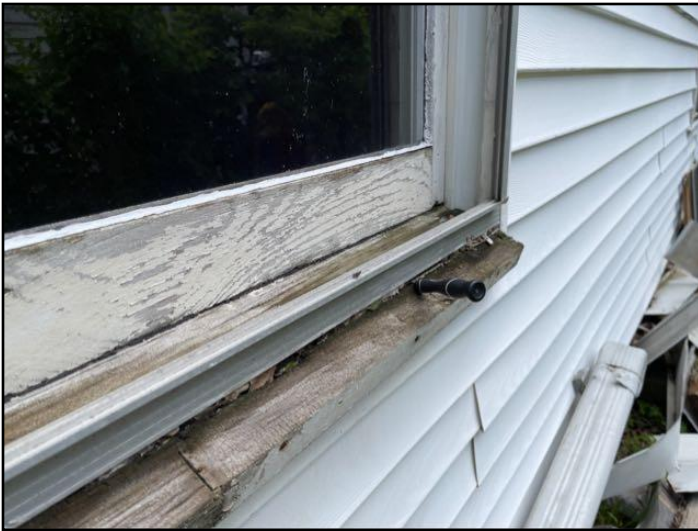
27. Window rot

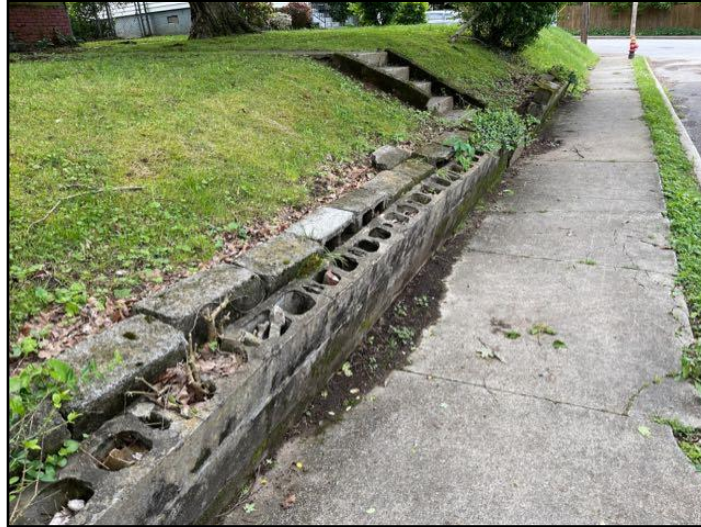
The retaining wall at the front side of the home was leaning heavily. Without repair the retaining wall is likely to eventually fall. Repair of the retaining wall by a licensed and qualified contractor is recommended.

35. *Leaning*

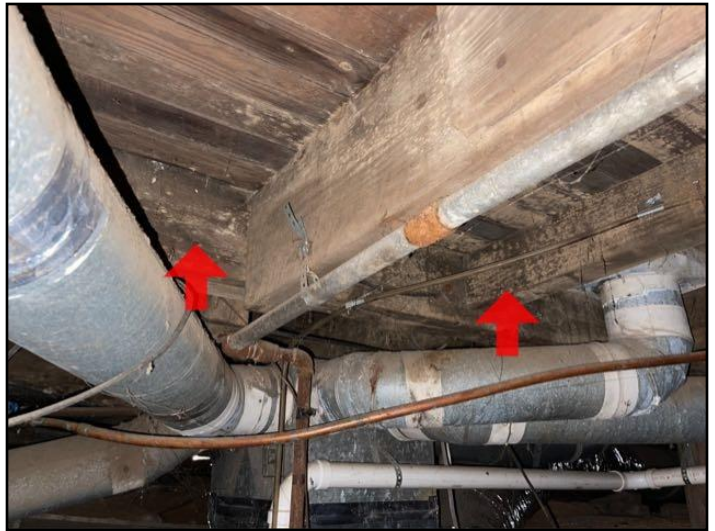
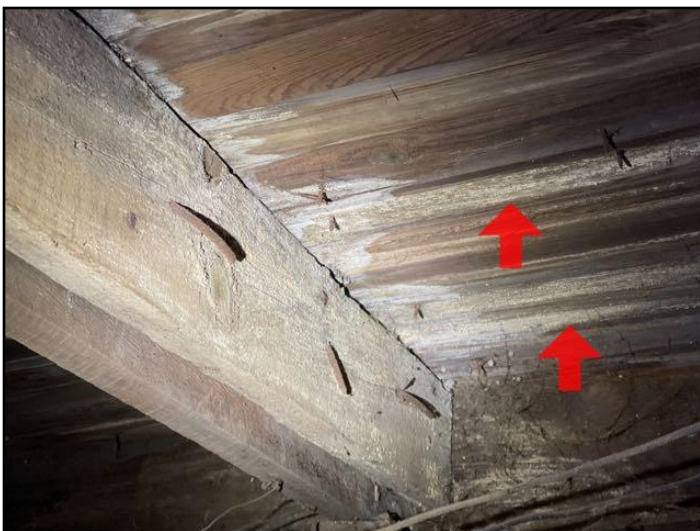
Significant levels of microbial growth (possible mold) were observed on materials in locations throughout the crawlspace and interior of the home. The observed growth was well beyond levels typically found within vented crawlspaces in Middle Tennessee. The presence of microbial growth at this level serves as an indicator of long-term environmental issues within the crawlspace which, if not addressed, can result in further damage to materials, as well as an unhealthy environment for occupants of the home. For further information or a deeper evaluation, please contact the DILIGENT office.

37. Heavy Microbial Growth

38. Heavy Microbial Growth

39. Heavy Microbial Growth

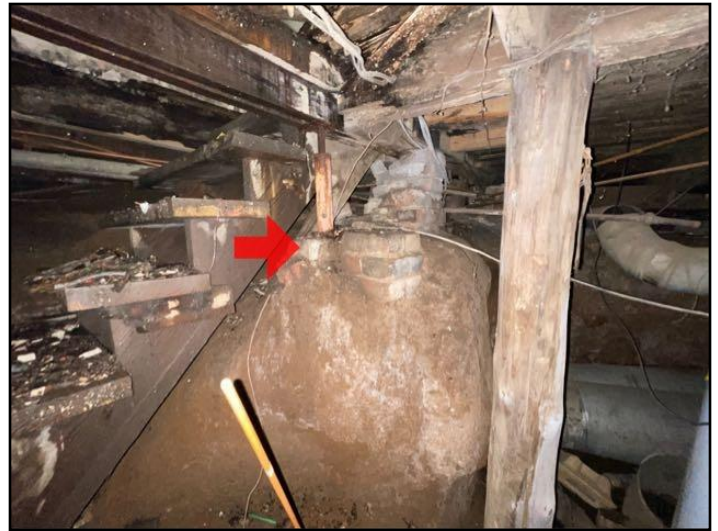
- Multiple piers and columns were in close proximity to the dug-out portion of the crawlspace and their integrity may be compromised as a result.
- Masonry columns were damaged potentially compromising their integrity.

50. Column on edge of dug-out wall

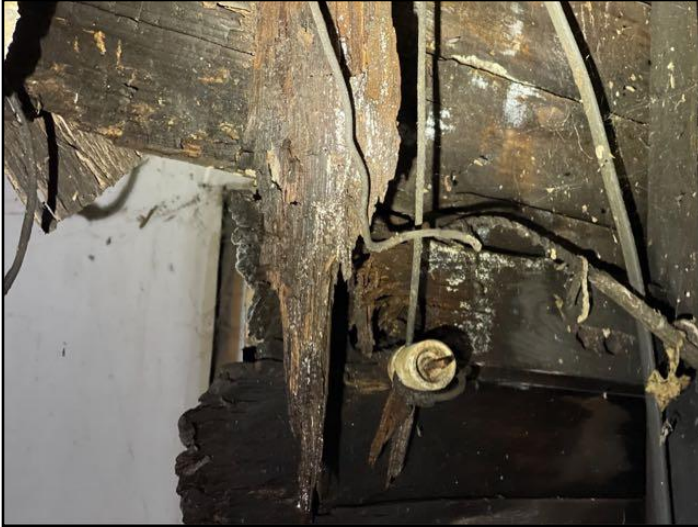
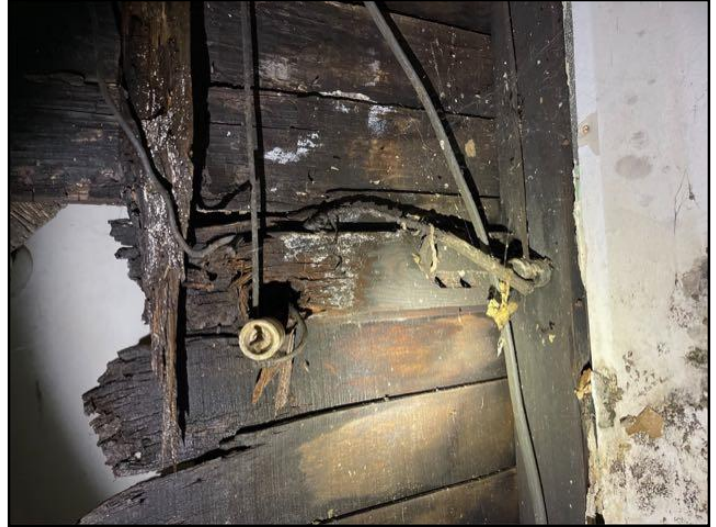
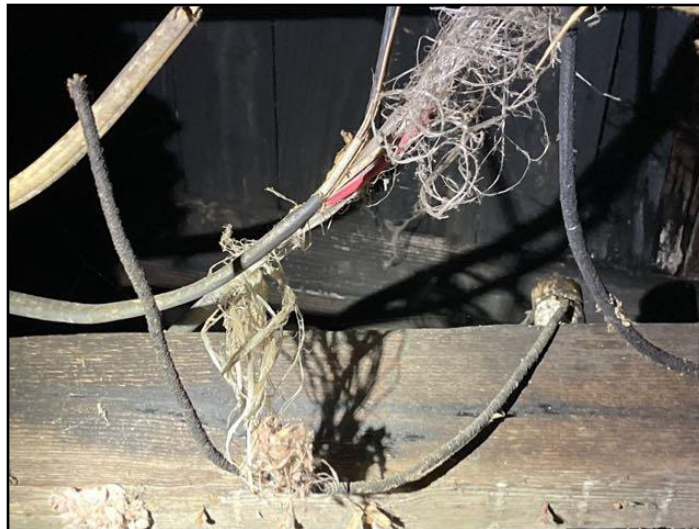
85. Abandoned wire

86. Abandoned wire

87. Abandoned wire

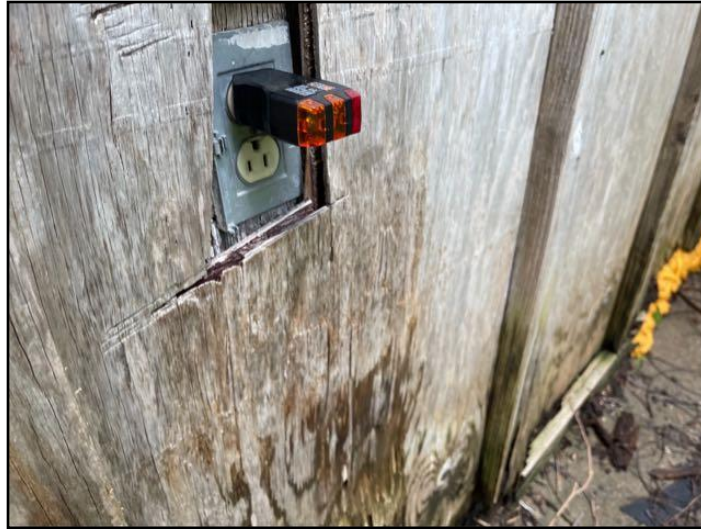
88. Inoperative

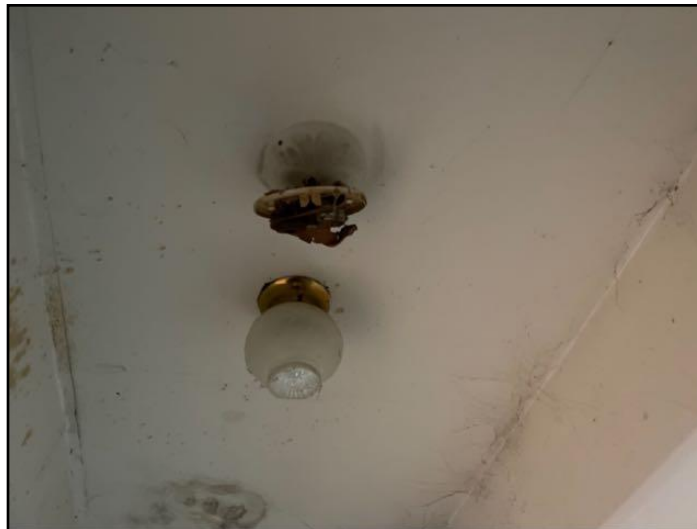
15. Condition: • Missing

The number of smoke detectors was less than recommended. Modern standards call for smoke alarms in each sleeping area, in hallways outside of sleeping areas and at least one on each level of the home.

90. Missing

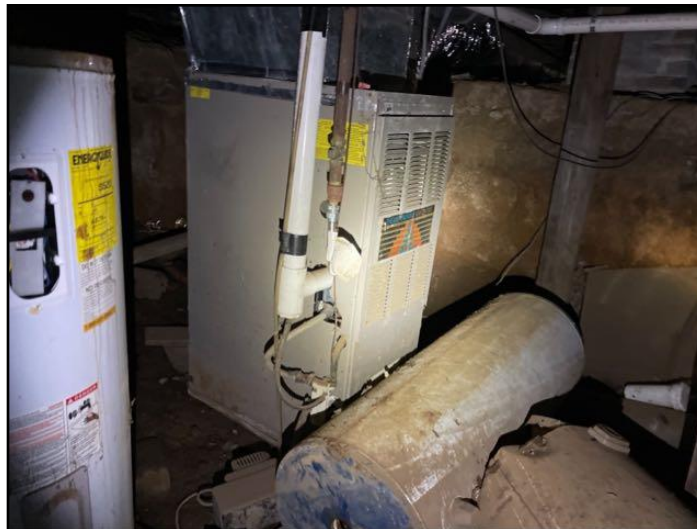
Access to furnace cabinet blocked by abandoned water heater - data plate not found

91. *No access*

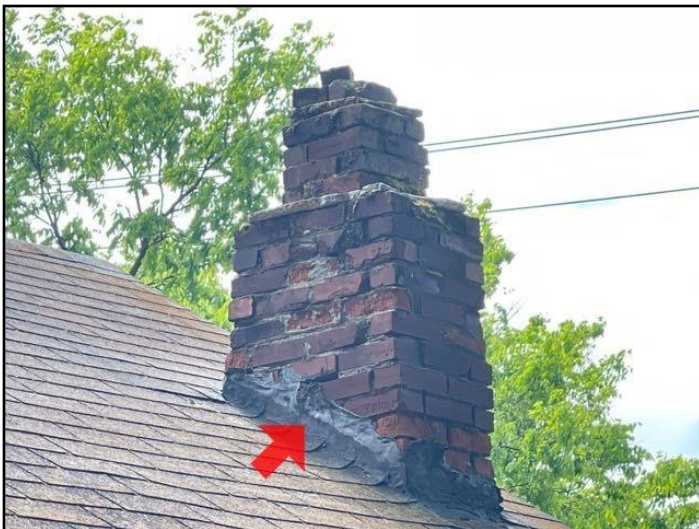
17. Condition: • The masonry chimneys were heavily deteriorated and should be further evaluated and repaired as needed by a licensed and qualified contractor. Additionally, the chimneys were poorly flashed and may result in leaks within the roof structure.

95. Deteriorated/poor flashing

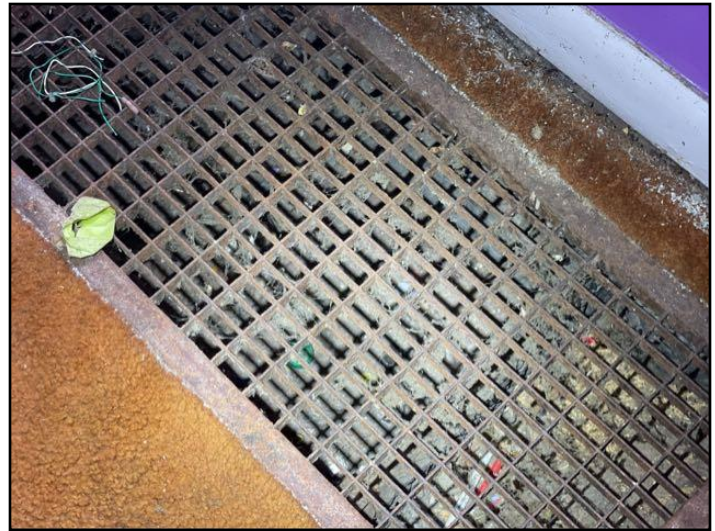
An excessive amount of dirt and debris was present in the duct system in areas throughout the house. This is mainly an indoor air quality issue, but may prevent the unit from functioning properly as well. Replacement of the ducts may be necessary.

100. Dirty

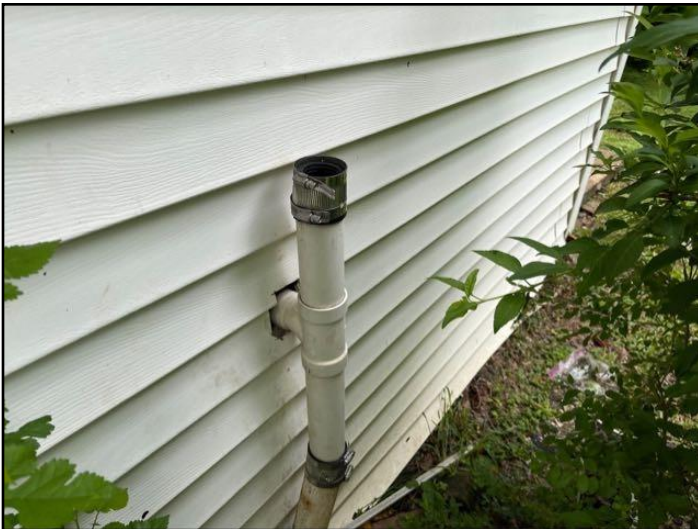
- One plumbing vent did not extend above the roofline.
- ABS and PVC pipes may be connected together, however, this could not be definitively verified.
- Rust and evidence of past pinhole leaks was found in cast iron waste plumbing.
- The kitchen faucet was not connected to the supply lines.

103. *improper vent*

Because no running water was present at the time of the inspection the plumbing systems could not be fully inspected. Further evaluation and repair, as needed, by a licensed and qualified plumber is recommended prior to turning on the water.

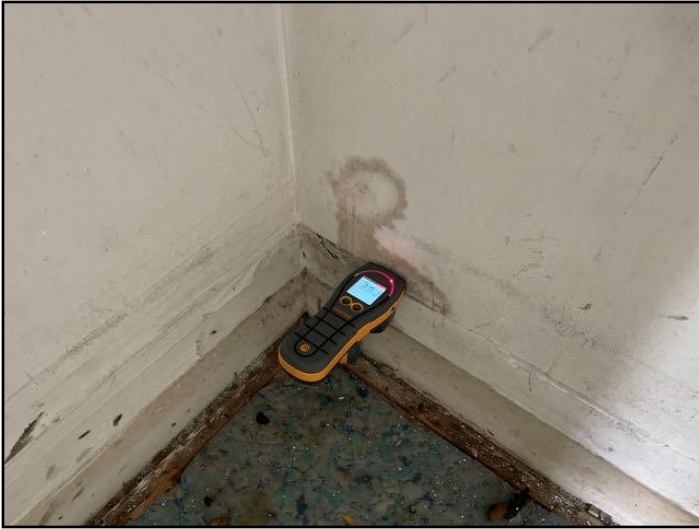
- Active moisture was found in walls, beneath windows, and in the ceiling in multiple locations.
- Microbial growth was noted on the walls and floor throughout the home creating a potential health hazard.
- Animal feces and live animals were found in the home resulting in a potential health hazard.
- Holes and deterioration was found in various locations of the walls, ceilings, and floors creating a potential fall hazard.
- Doors throughout the home were damaged or missing.
- Cracks indicating structural movement were noted above windows and doors in multiple locations.
- Floors were sagging or uneven in multiple locations.
- Flooring was missing or damaged throughout the home.

107. Active moisture

Repair of these issues by a licensed and qualified contractor is recommended. Further damage will likely be found during repairs.

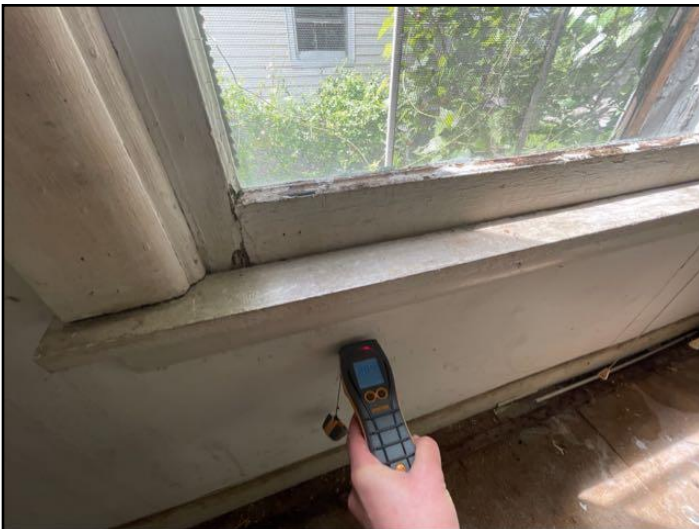
109. Active moisture

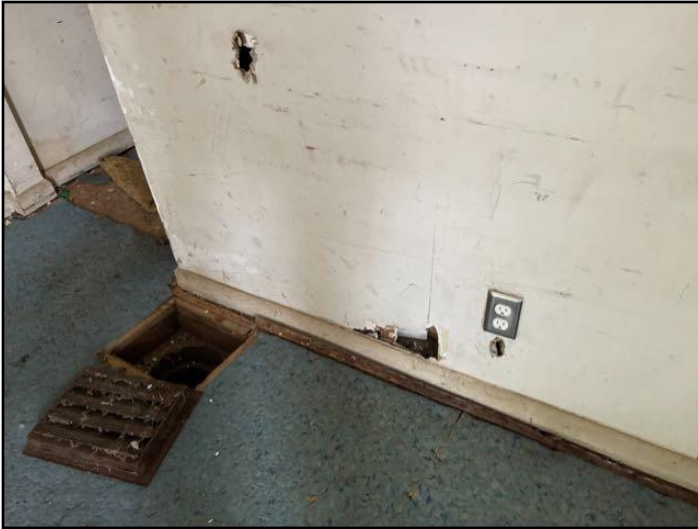
111. Damage

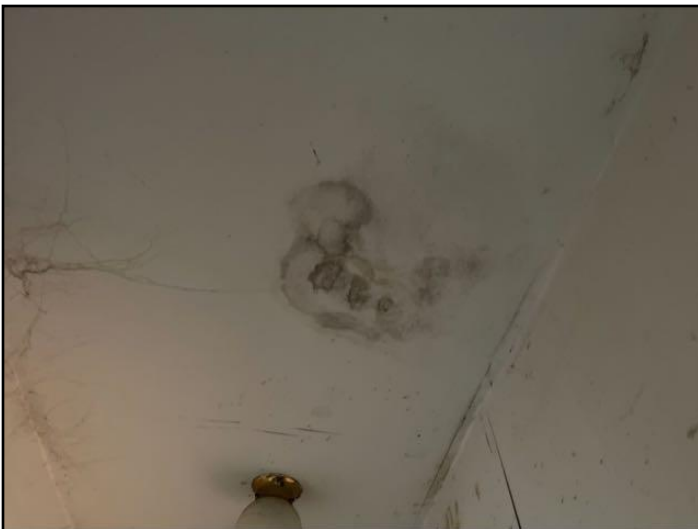
113. Active moisture

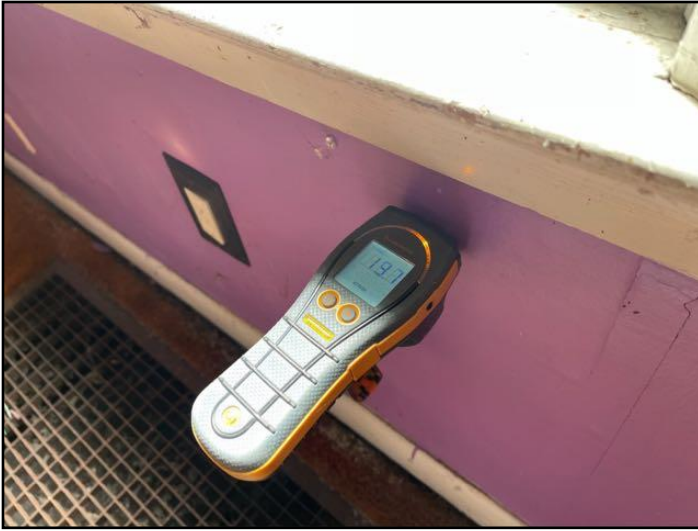
115. Active moisture
