METROPOLITAN GOVERNMENT OF NASHVILLE AND DAVIDSON COUNTY

STAFF RECOMMENDATION 949 Russell Street July 21, 2021

Application: Demolition
District: Edgefield Historic preservation Zoning Overlay
Council District: 06
Base Zoning: R8
Map and Parcel Number: 082120038300
Applicant: Troy Harper
Project Lead: Robin Zeigler, robin.zeigler@nashville.gov

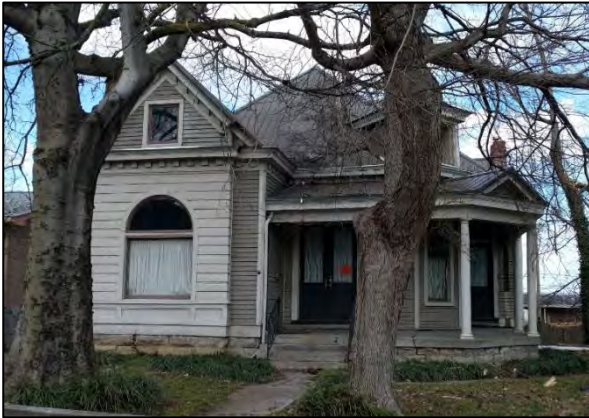
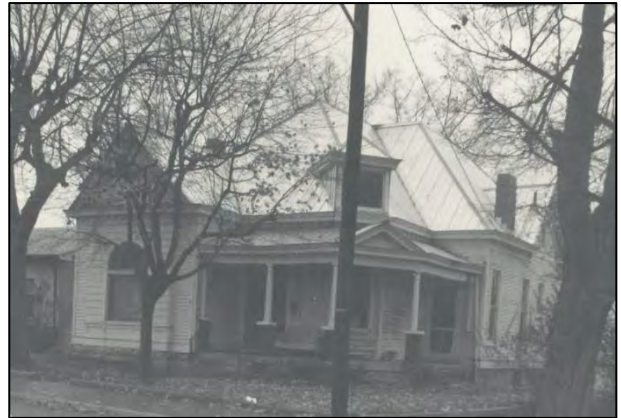
Figures 1 and 2: 949 Russell St in 2020 and in 1979

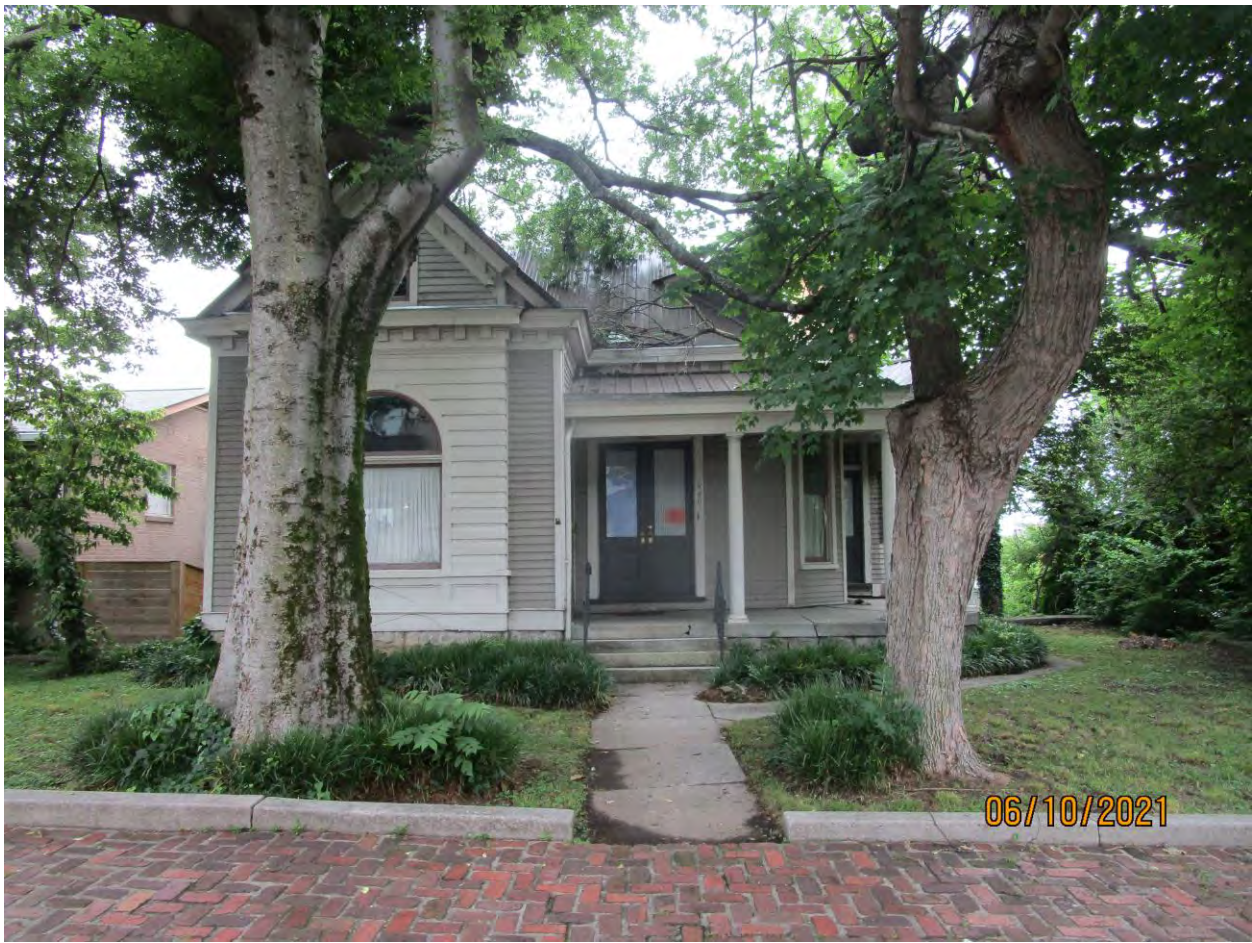
Photograph 1: Front elevation.

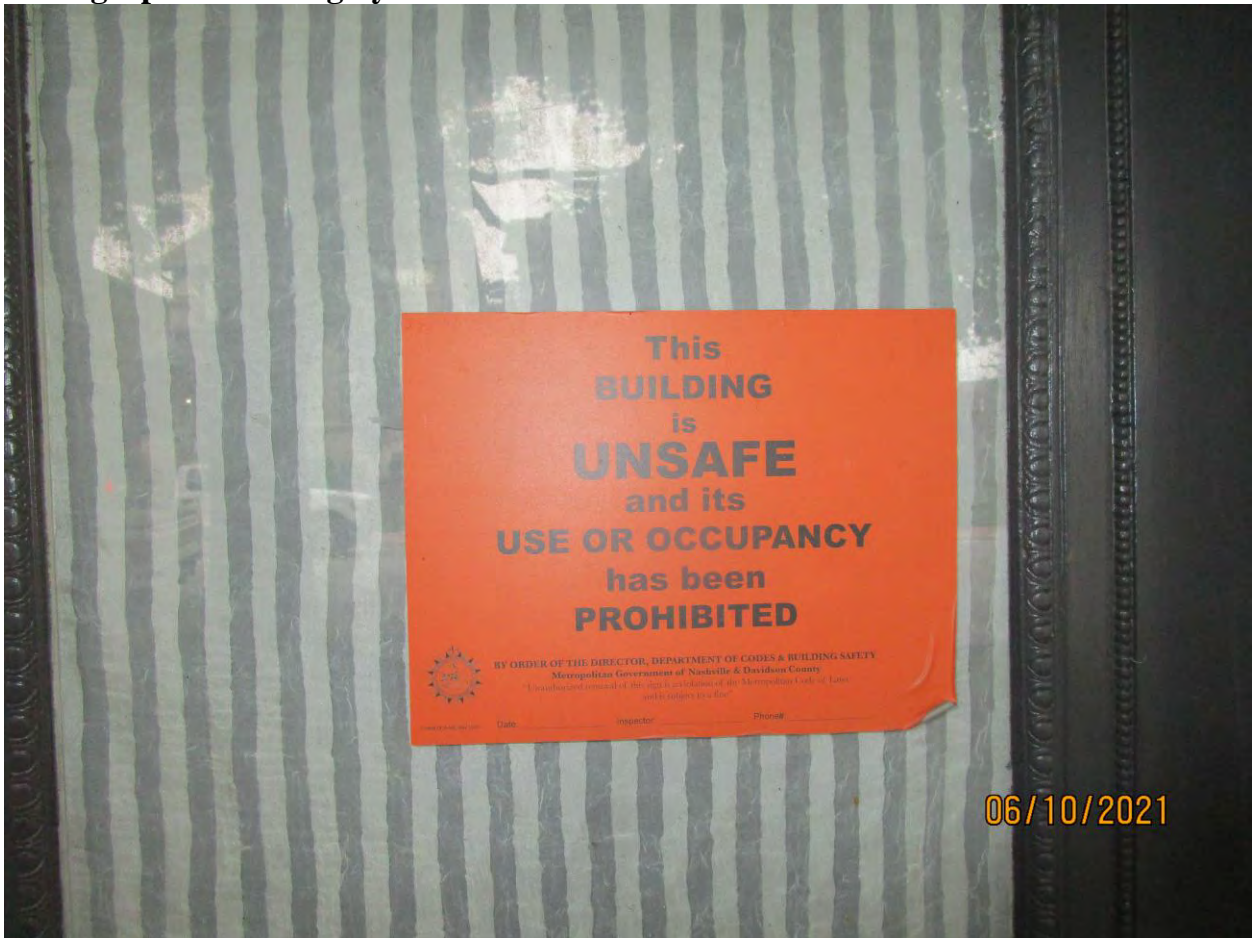
- Upon entering the site, the first observation was that the Metropolitan Codes Officials have posted the home as an unsafe building (photograph 2), sometimes referred to as a "red tag."

Photograph 2: Posting by Metro Codes.

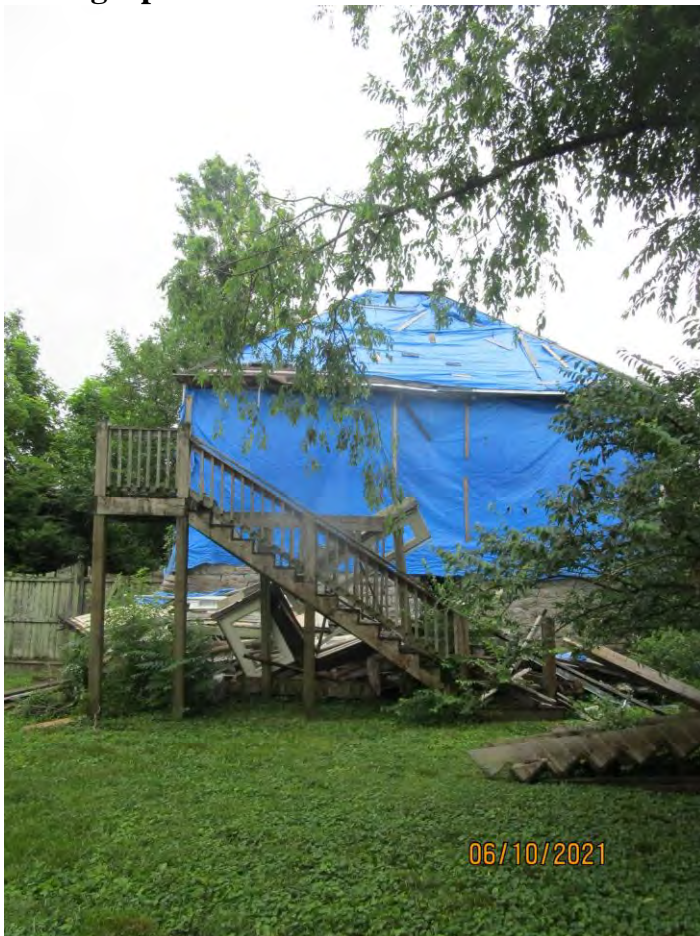
- Due to the effects of the high winds, the entire rear wall of the home was displaced as well as the rear porch (photographs 21 and 22).
- The left side of the home was observed, and the same deterioration common to the interior gutter has created rotten wood common to the soffit and, most likely, common to the interior wall cavity. Examples of the rotten soffits on the left sidewall can be observed in photographs 24, 25, 26, and 28.

Photograph 22: Rear elevation.

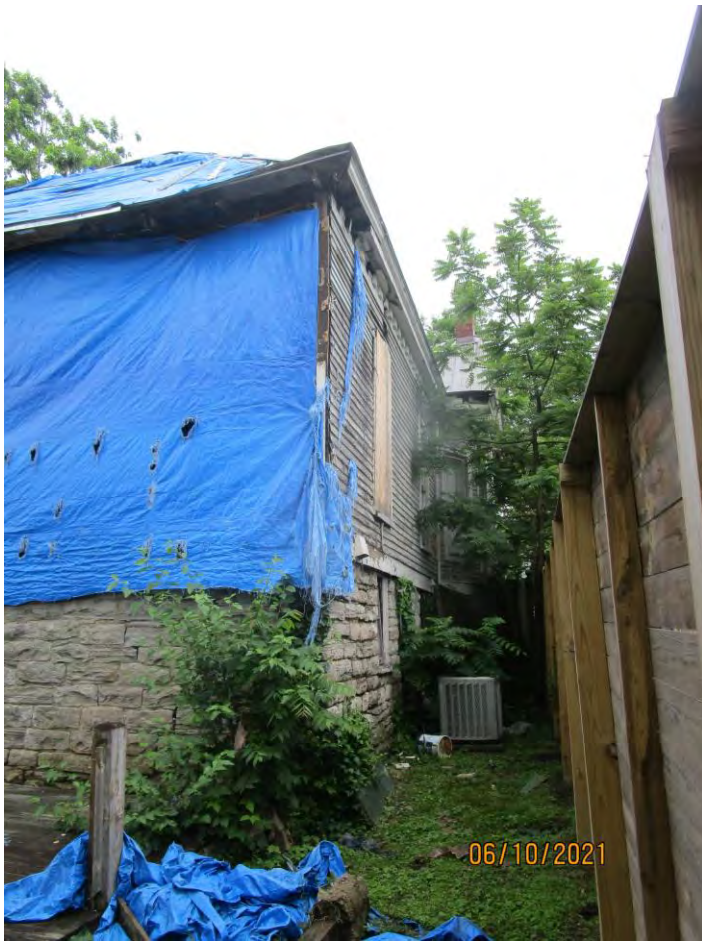
Photograph 23: Left-side elevation.

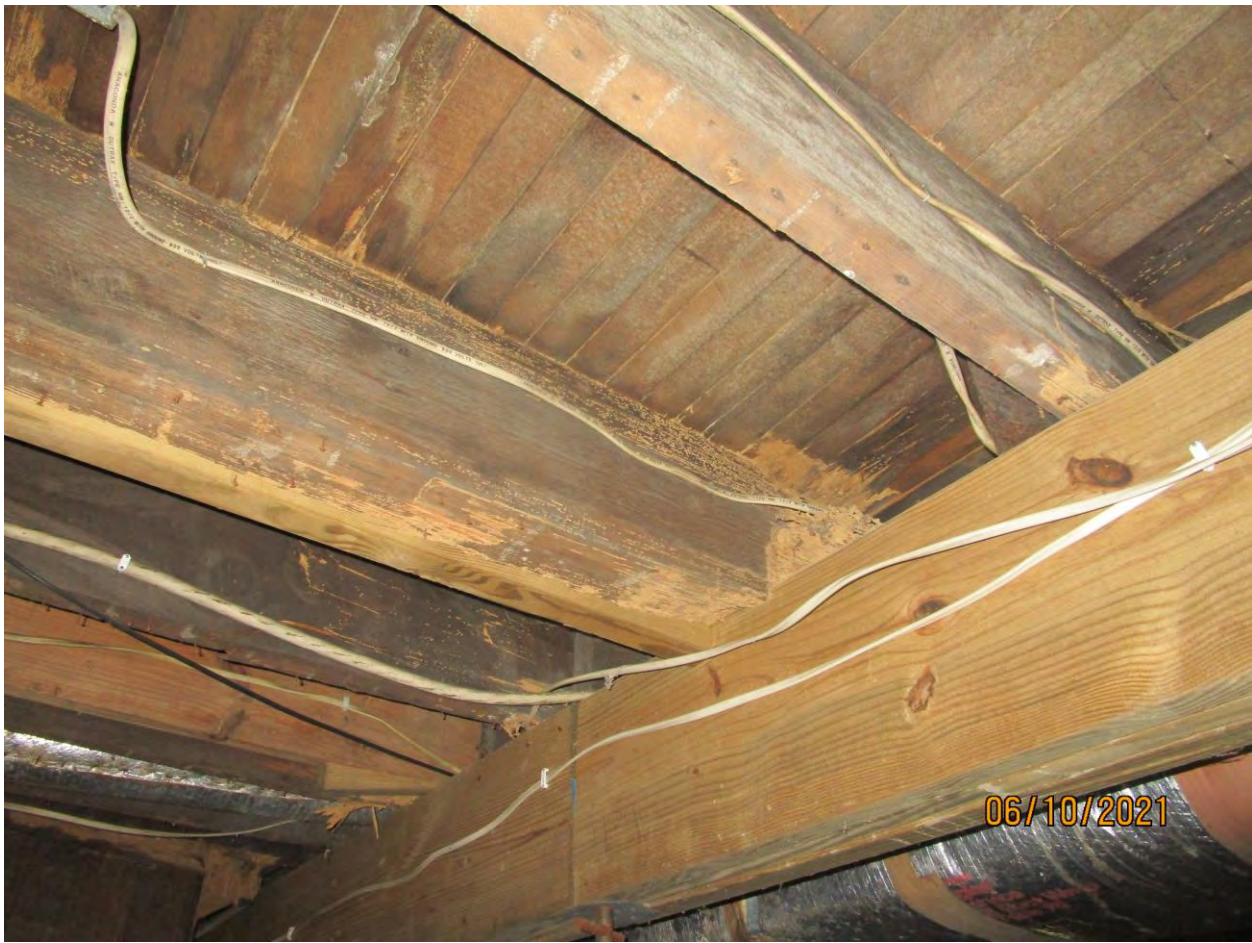
Photograph 49: Typical insect infestation of wood joists.

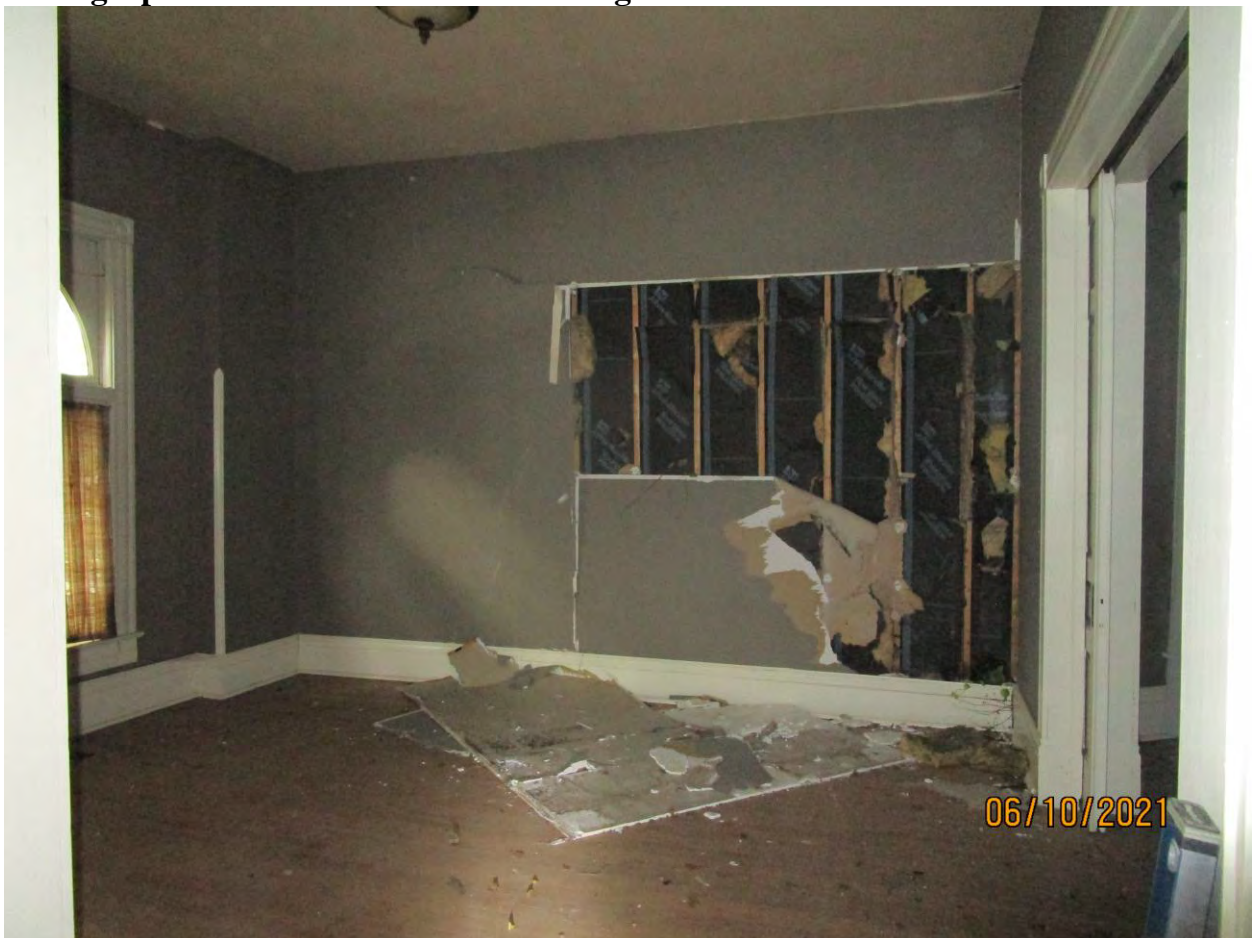
- The formal living room located on the left-front corner, which has previously been described as the left sidewall being displaced, can be observed in photograph 68. The amount of the displaced wall can be observed in photograph 69. Significant drywall cracking patterns are located throughout this room (photographs 70 through 73).

Photograph 69: Displaced left sidewall of formal living room.

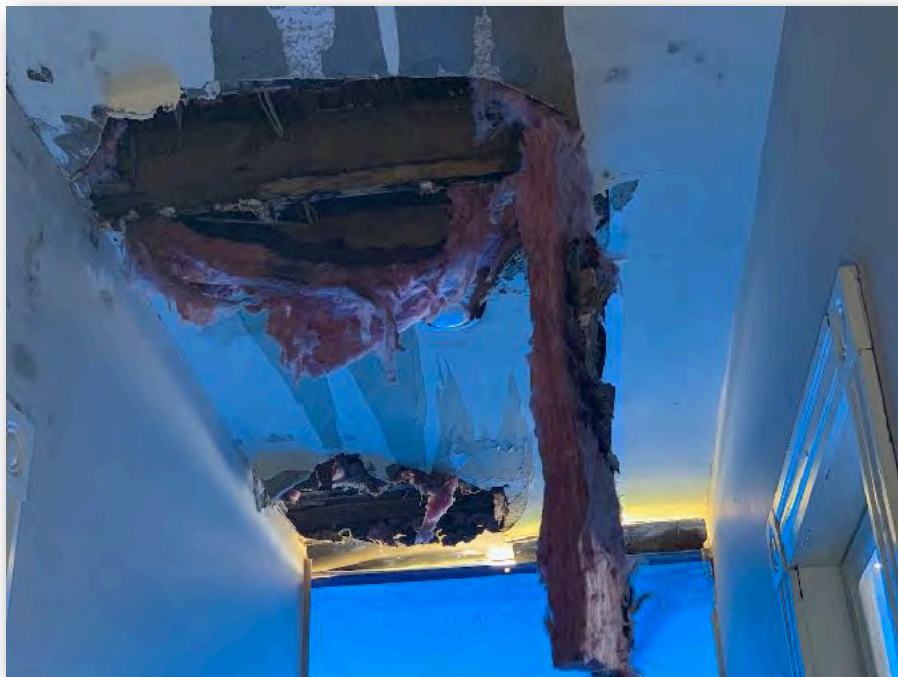
Photo 19:

Photograph 19: Rotten soffit at right rear corner.

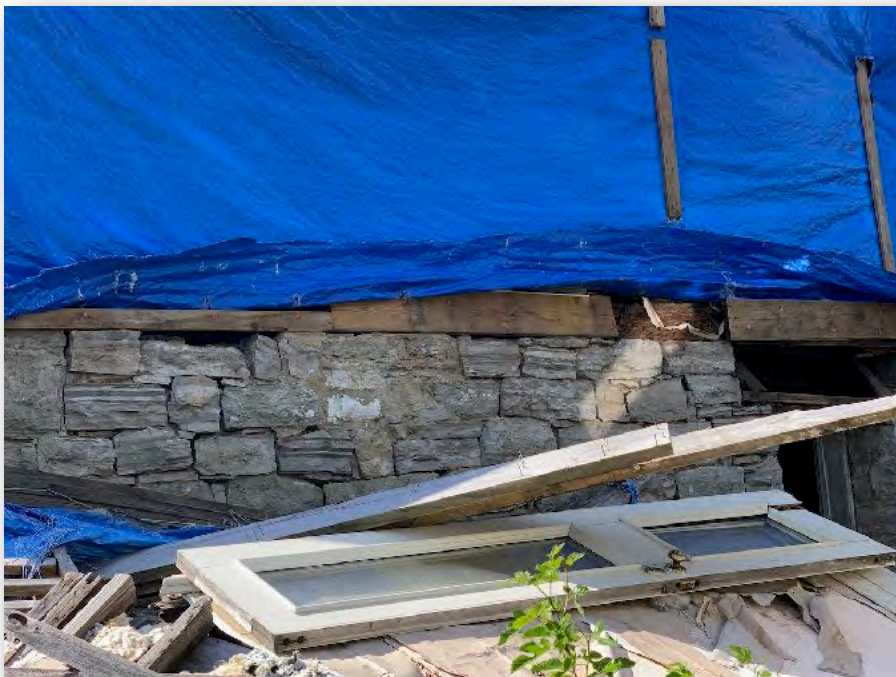
Photo 33:

- Due to the high tornadic wind forces, the left sidewall of the home was displaced vertically by approximately four inches at the base of the wall (overview in photographs 31 and 32; interior photograph 69). As can be seen in photograph 33, the wood siding common to this area has been replaced in the past as is evident by the joint.

Photograph 33: Previously replaced wood siding.

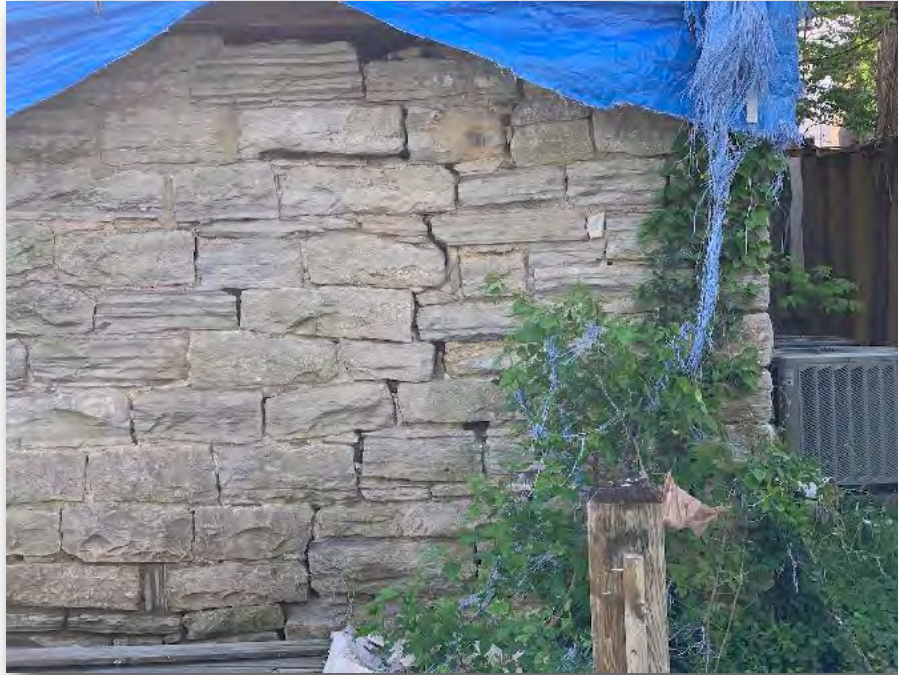
Photo 34:

- The bay window common to this left sidewall is also experiencing signs of settlement (photograph 34), which has been repaired in the past.
- As is typical for Queen Anne interior gutters, previous leaks have caused the existing wood framing common to these areas to be repaired in the past. An example of one of these repairs can be observed in photograph 35, which four different sections of wood trim had been utilized. It has been my experience that once these gutters have been removed and the wood framing is exposed, a complete reframing for this gutter will be required.

Photograph 34: Settlement of left sidewall at bay window.

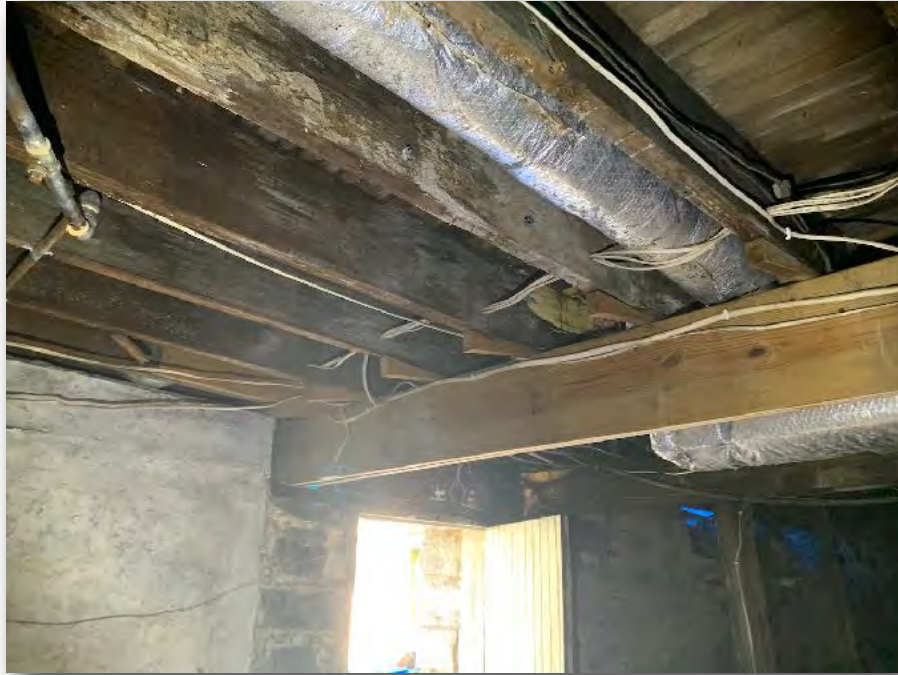
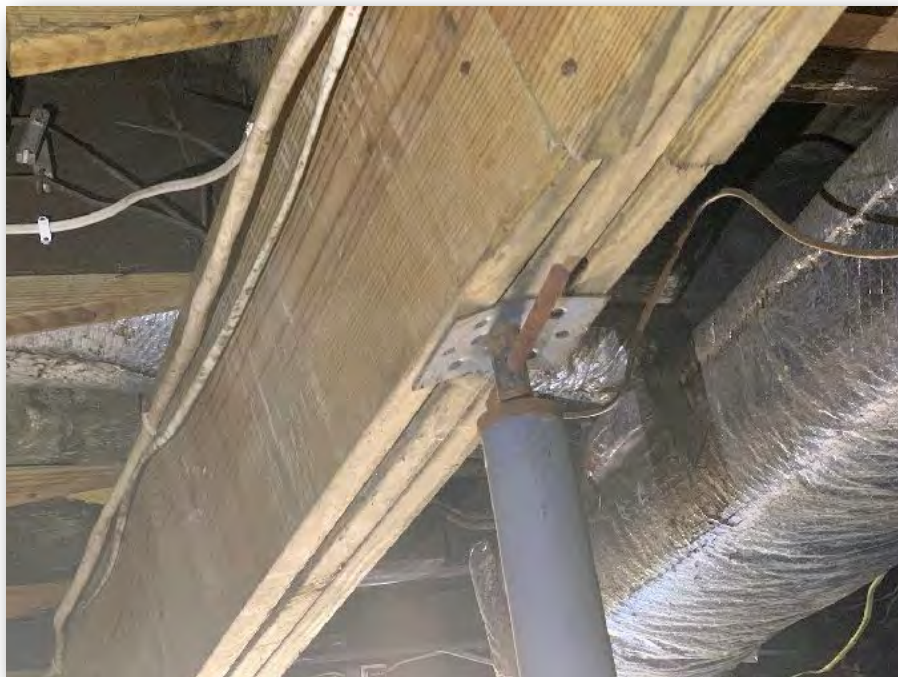
- From observing the crawlspace, multiple deficiencies were observed. The first deficiency was one of the interior wood beams that had been previously repaired in the past and is now failing (photographs 38 and 39).

Photograph 38: Previously replaced wood beam (inadequate).

Photograph 39: Previously replaced wood beam (inadequate).

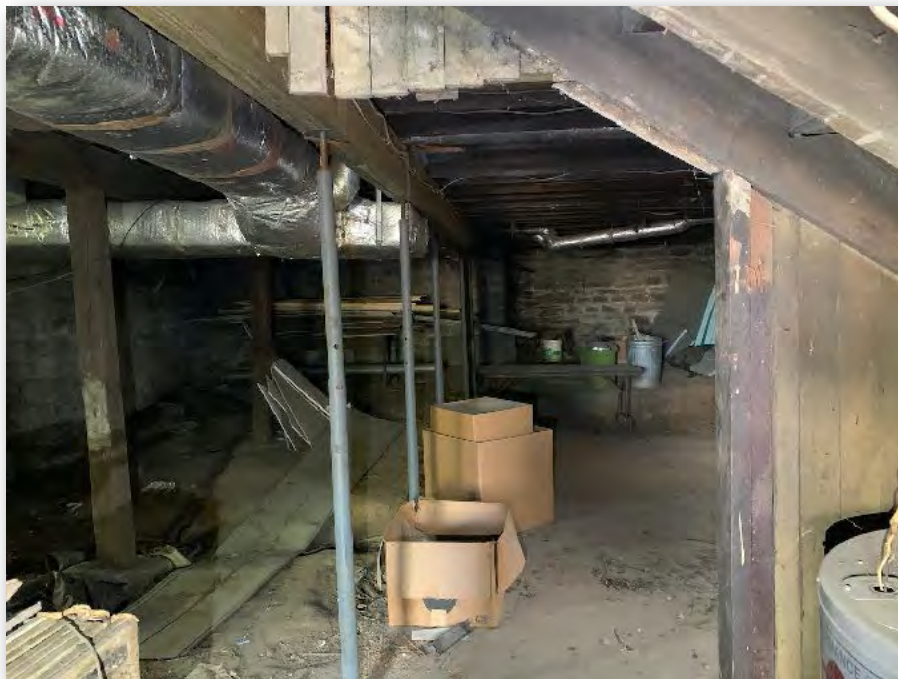
Photo 41:

- The other original wood beam, which was not replaced, is failing, and is compressing due to insect infestation (photograph 41) where the wood post is penetrating the bottom face of the wood beam.

Photograph 41: Original wood beam (inadequate).

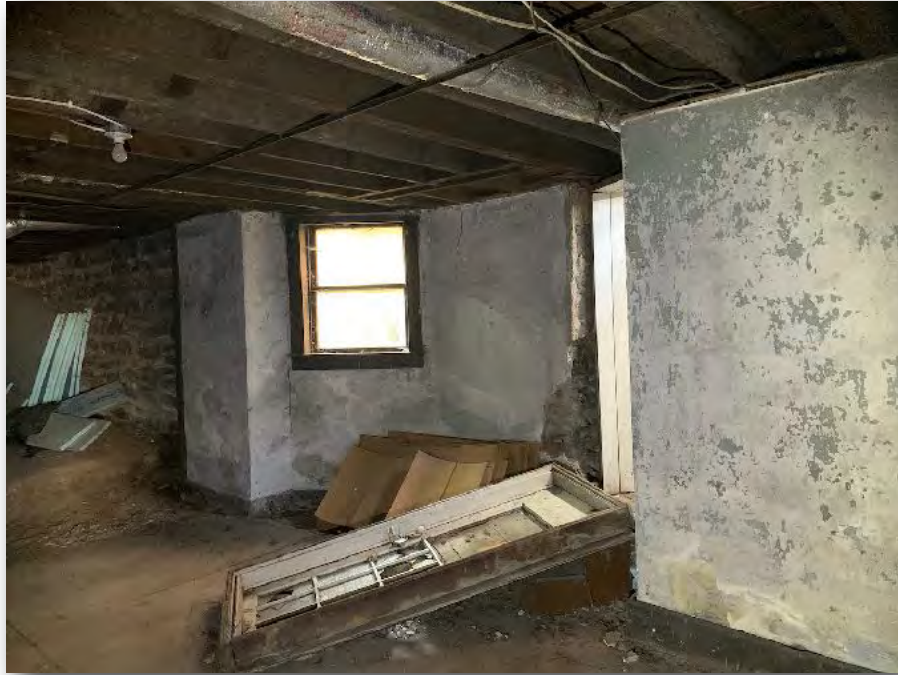
Photo 42:

Photograph 42: Previously repaired wood flooring.

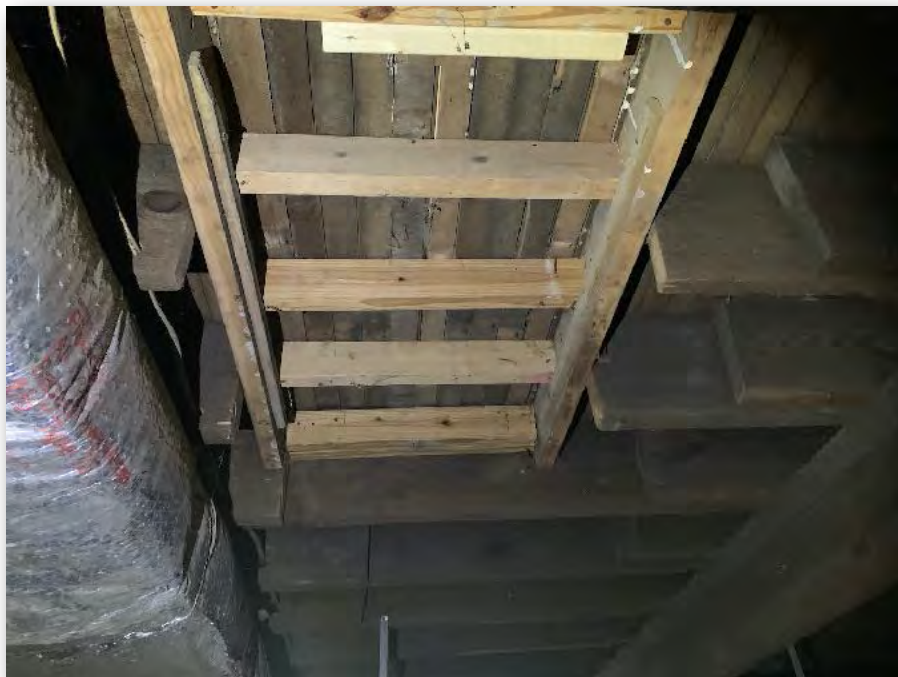
Photo 43:

- I counted over 30 floor joists that have been negatively affected by termite infestation (photographs 44, 49 through 51, and 53 through 55).
- The foundation walls for the crawlspace on the interior of the structure also revealed deficiencies, some of which were caused by the settlement issues previously discussed. Others were created due to the installation of mechanical systems. Some of these deficiencies can be observed in photographs 43, 45 through 47, and 52.

Photograph 43: Rear foundation wall issues.

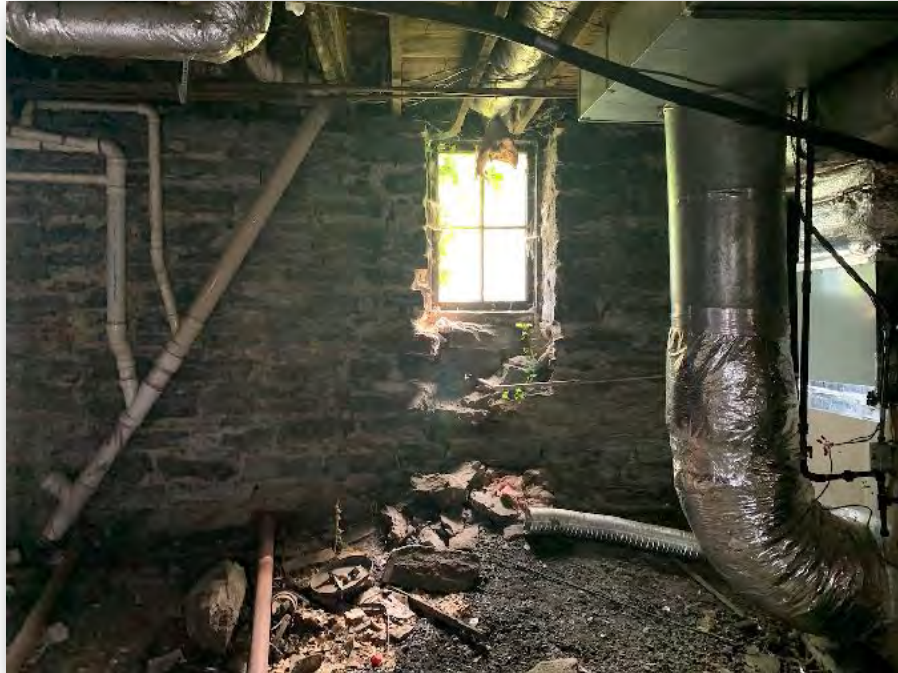
Photo 44:

Photograph 44: Right sidewall foundation wall issues.

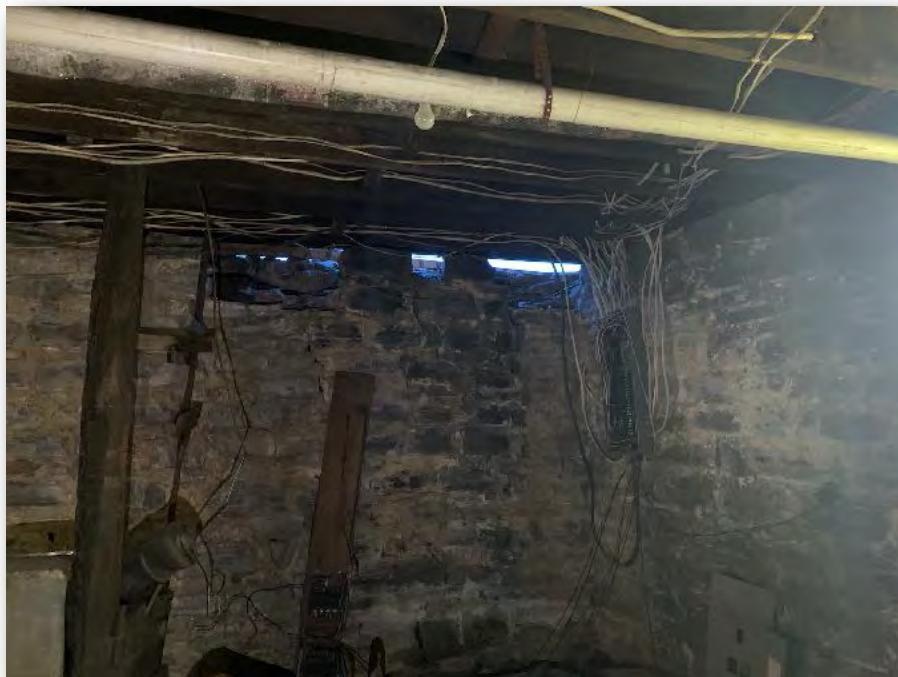
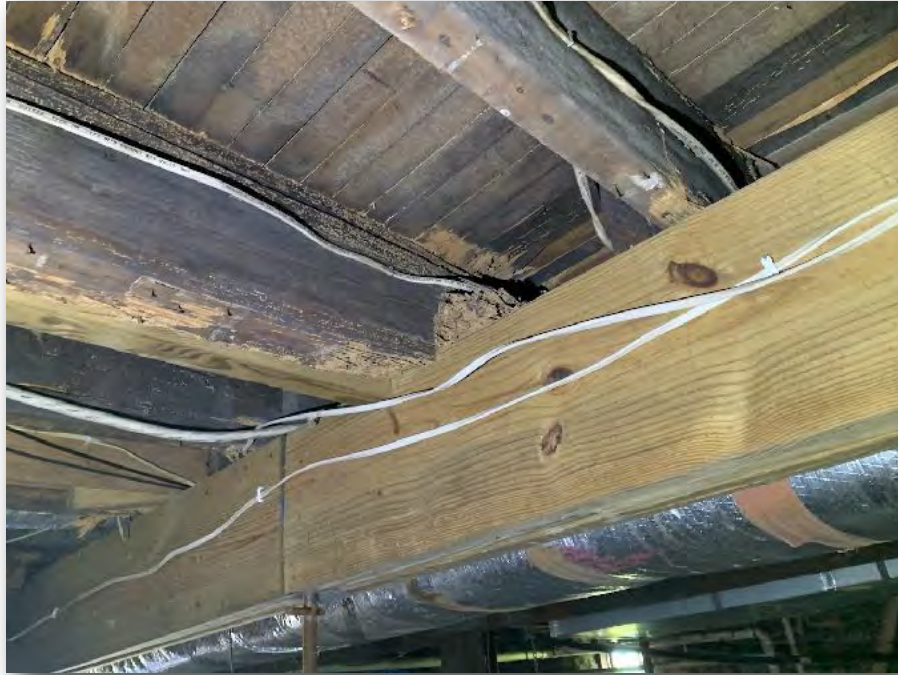
Photograph 45: Right sidewall foundation wall issues.

Photograph 46: Right sidewall foundation wall issues.

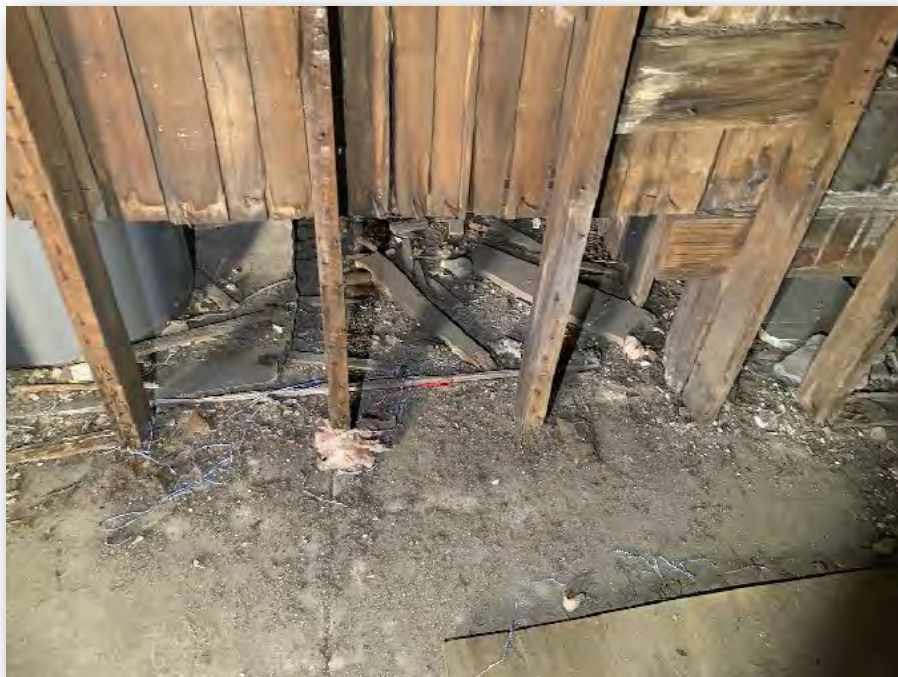
Photo 47:

Photograph 47: Front wall foundation wall issues.

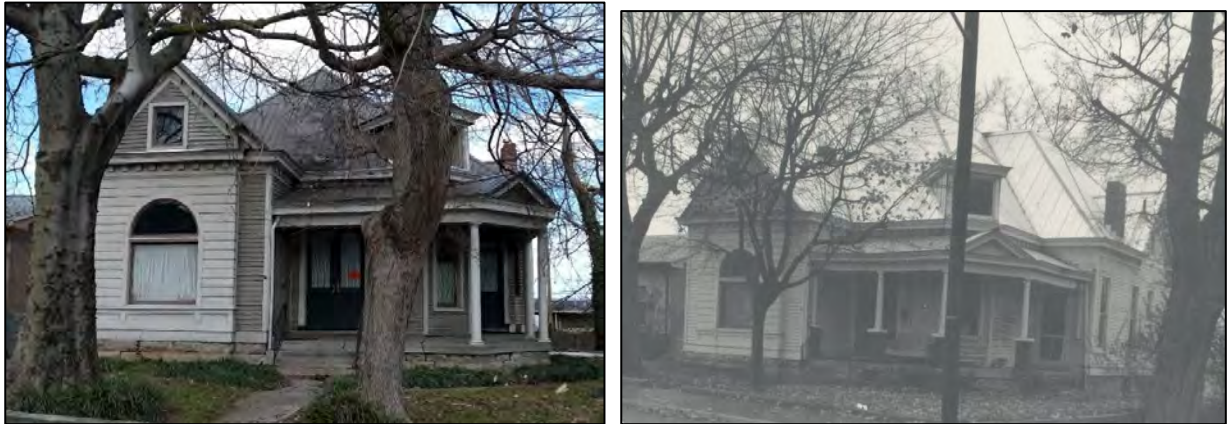
Figures 1 and 2: 949 Russell St in 2020 and in 1979

Background: 949 Russell Street is a c. 1899 contributing home in the Edgefield Historic Preservation Zoning Overlay and the National Register of Historic Place’s Edgefield Historic District nomination from 1977. The nomination describes the house as a one-story, clapboard cottage from the late 19th century with Eastlake influence. The nomination states that Edgefield contains excellent examples of the modest clapboard cottages of the middle class, displaying varying stylistic influences. It is this collection that “makes Edgefield a unique neighborhood in Nashville.”

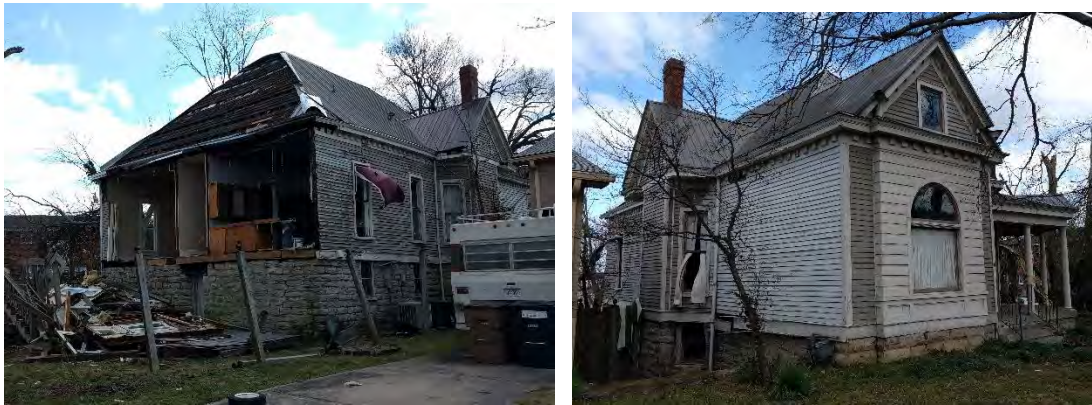
Figures 5 and 6: The house as seen after the storm on March 6, 2020.

The house was damaged in the 2020 tornado. The rear wall, roofing material, and some windows were removed by the storm.

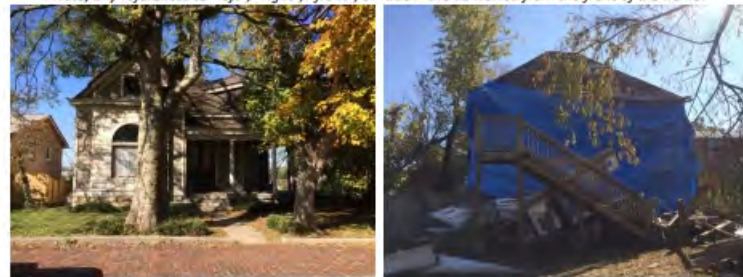
Front Elevation

Rear Elevation

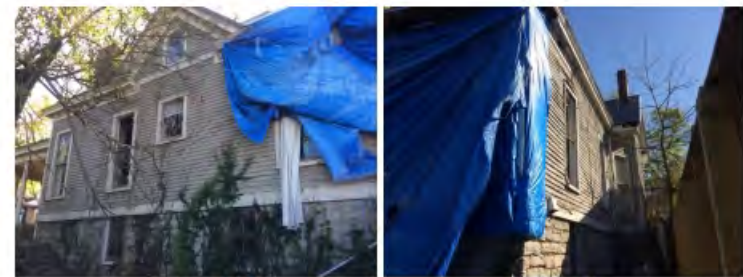
Right Hand Side

Left Hand Side

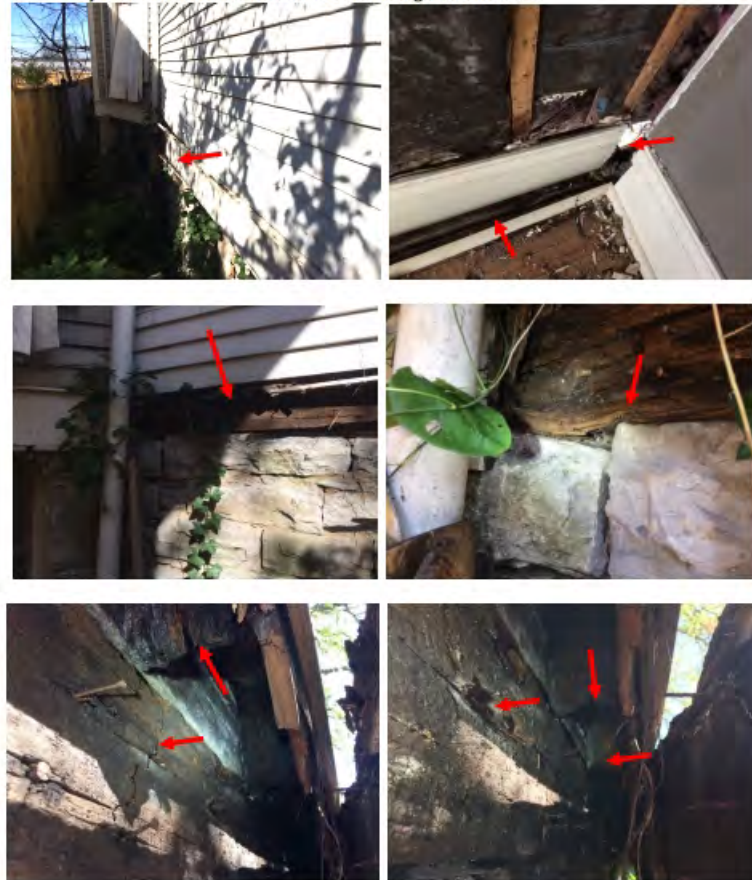
2. The wall from the left front corner of the home to the corner of the bay window in the dining room has broken free at the base and rolled outwards. Examination of the rim joists at this location determined that they have been damaged by water infiltration of the wall causing the wood to rot. The bases of the vertical 2x4 studs were also rotten.

When the home was pressurized by the storm, the weakened wall ripped free at the base, blowing outwards roughly 4". This resulted in extensive damage to the interior finishes of this wall and the ones that intersect it. For example, light can be seen coming through the joint in the exterior wall beside the dining room window.

2. Rebuild the entire rear wall of the home from the top of the repaired foundation wall to the eave.
3. Reconstruct the wall from the left front corner of the home to the fireplace in the dining room. New framing should extend from the top of the foundation wall to the eave.

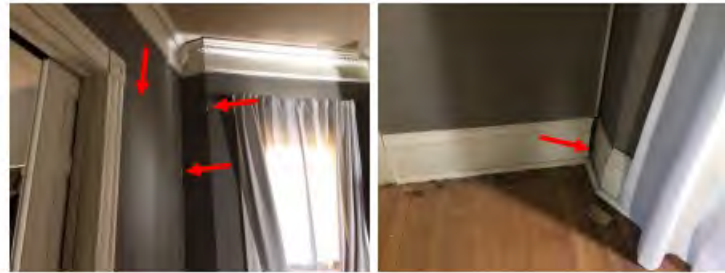
3. The walls of the front rooms of the home are leaning to the right, indicating that the wall framing has racked. The front to back walls along the hallway are 1/2" out of plumb in a 4' vertical level near the front wall tapering back to plumb at the stairwell. The racking has caused cracks to appear in the drywall around the doors and tapered gaps to open in the door trim. As the rear half of the home is plumb, the racking in the front half is apparently a function of structural weakness developing over time or the effect of the tornado's initial impact on the left front corner of the home.

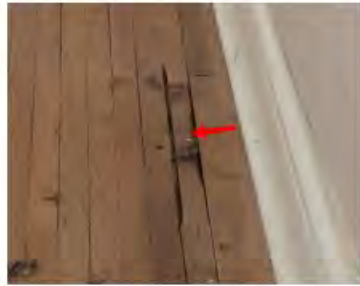
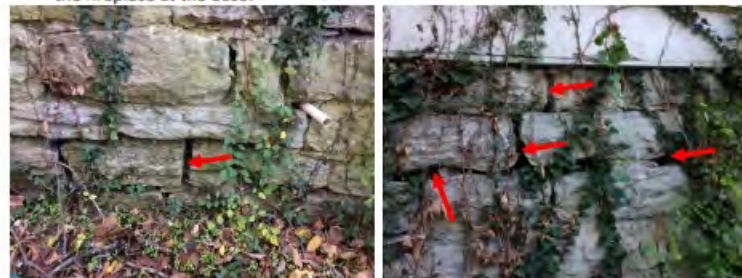
6. The foundation walls of the home are 24" thick and consist of several layers of mortared stone. The floor joists are connected to rim joists that sit on the outside edge of the foundation wall, so the bulk of the stone is of little structural value. In numerous locations along the right hand foundation wall and in the left hand foundation wall near the back corner, the mortar has eroded away between the stones of the outer layer of the walls. Several mortar joints up to ¼" wide are now completely free from their original mortar. The structural load on this outer layer of stone and the deteriorated mortar has caused this layer of the right hand foundation wall to lean outwards up to 1". This can also be seen in the drywall around the fireplace in the right center bedroom where cracks have appeared that are wider at the base, indicating that the exterior wall is pulling away from the fireplace at the base.

4. Remove the interior and exterior finishes as necessary to reconstruct the damaged framing around the window in the left hand wall of the kitchen.
5. Temporarily support the floor framing and exterior walls on the left and right hand sides so the exterior layer of the foundation stone can be reconstructed in all areas where the walls are leaning and/or the mortar has deteriorated.

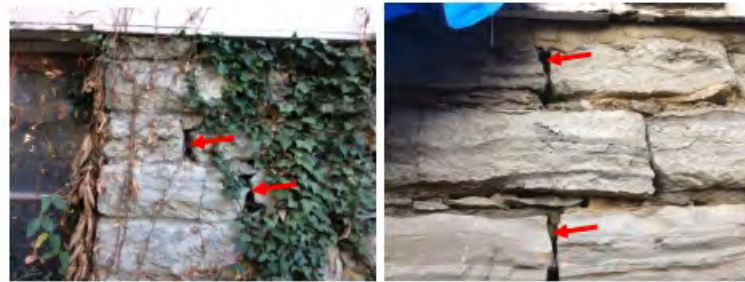
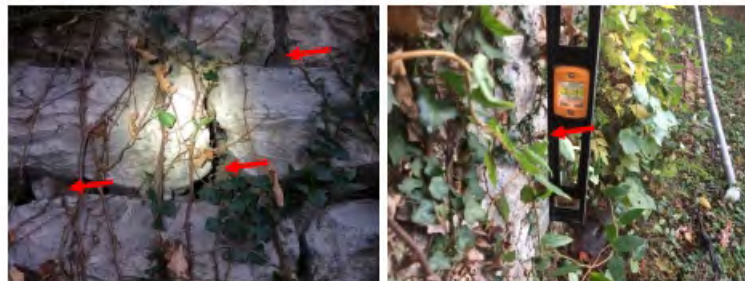
7. The weakened mortar has most likely contributed to movement in the foundation wall at the left rear corner of the home as well. A vertical crack is present in the rear face of the foundation wall at this corner indicating that the load bearing outer layer is leaning towards the left at this corner.

1. Remove the damaged sections of the foundation wall across the rear of the home at the left and right hand corners, addressing the cracks in the outer layer at the left corner and the gaps and crack in the right hand corner. Install new concrete spread footings as required, then reconstruct the wall.

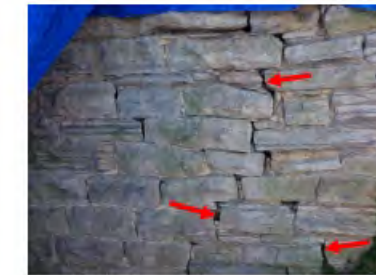
8. Sections of the rear foundation wall in the right corner are missing at the top, leaving the rim joist to support the exterior walls above across three gaps of up to three feet each.

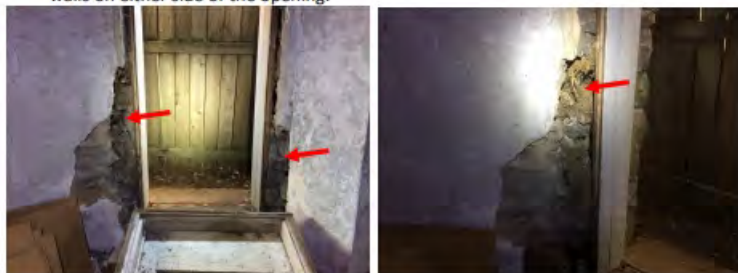
10. The door that accessed the basement level from the exterior on the left side of the home was blown in by the storm. When it fell in, it damaged the interior side of the foundation walls on either side of the opening.

6. Reinstall the basement access door. Repair the damaged foundation walls as needed.
7. Reconstruct the damaged portions of foundation wall at the HVAC condensate line penetration and around the window in the right hand foundation wall.

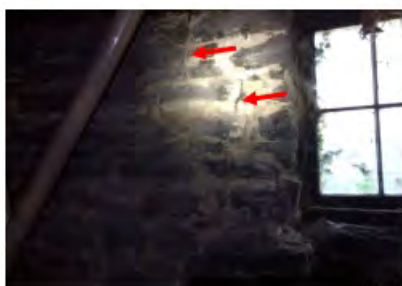
11. Damaged foundation walls were also noted under a window on the right hand side of the basement, in the wall adjacent to that window, and where the HVAC condensate lines were run through the wall.

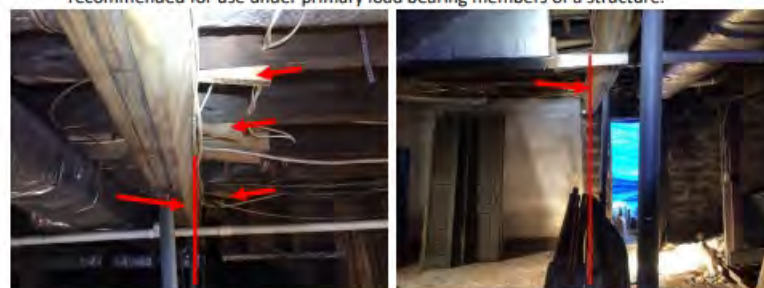
12. The first floor framing of the home is 2x10 joists on 16" centers spanning from the left and right hand foundation walls to two intermediate pier and beam systems running from front to back under the two walls of the central hallway. The original beams are triple 2x10's with 6x6 columns on approximately 9' centers. The columns are supported by single large stones as footings. It appears that the majority of the original left hand beam was heavily damaged by wood destroying insect activity and had to be replaced from the first original 6x6 column in the front to the rear foundation wall. The replacement beam is constructed out of three 2x12's with light-duty adjustable steel support piers on between 4'-8" and 8'-0" centers. When further tightening of the screw top of the pier only served to bend the top plate, wooden wedges were driven between the top of the beam and the bottom of the floor joists it supports. The wedges were only driven in from one side which imparts a rotating force onto the top of the beam. Over time, this has caused the beam to twist along approximately 25' of its length at the rear of the home, pushing the support piers severely out of plumb and further bending their top and bottom plates. The light gauge material from which these piers are made are why they are not recommended for use under primary load bearing members of a structure.

8. Replace the new left hand main floor framing beam with a properly sized beam and permanent heavy duty support columns with cast reinforced concrete footings.

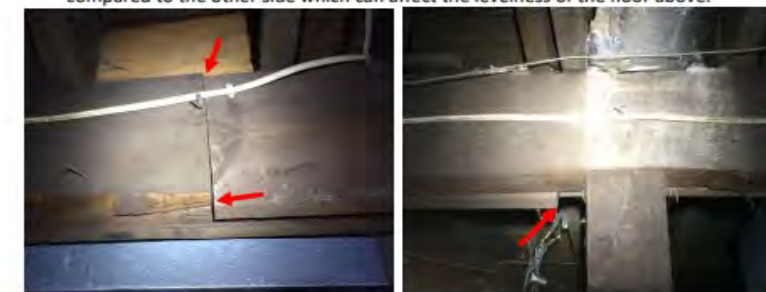
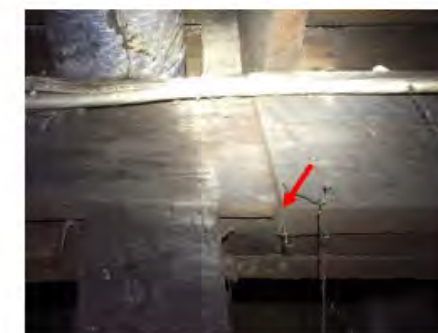
13. The right hand main beam is still original. The three laminated plies of the beam have periodic butt joints along its length which are weak points in the beam. Most of these joints do not fall directly over a support column, so one side of the joint is sagging compared to the other side which can affect the levelness of the floor above.

9. Install additional support columns or modify the existing to provide support to all butt splices in the right hand main floor framing beam.
10. Replace or properly repair the 31 insect-damaged floor joists, the 6 water damaged joists at the rear of the home, the improperly "headered off" joist under the living room, the rotted joist under the bathroom, and the cut joist for the ductwork under the kitchen.

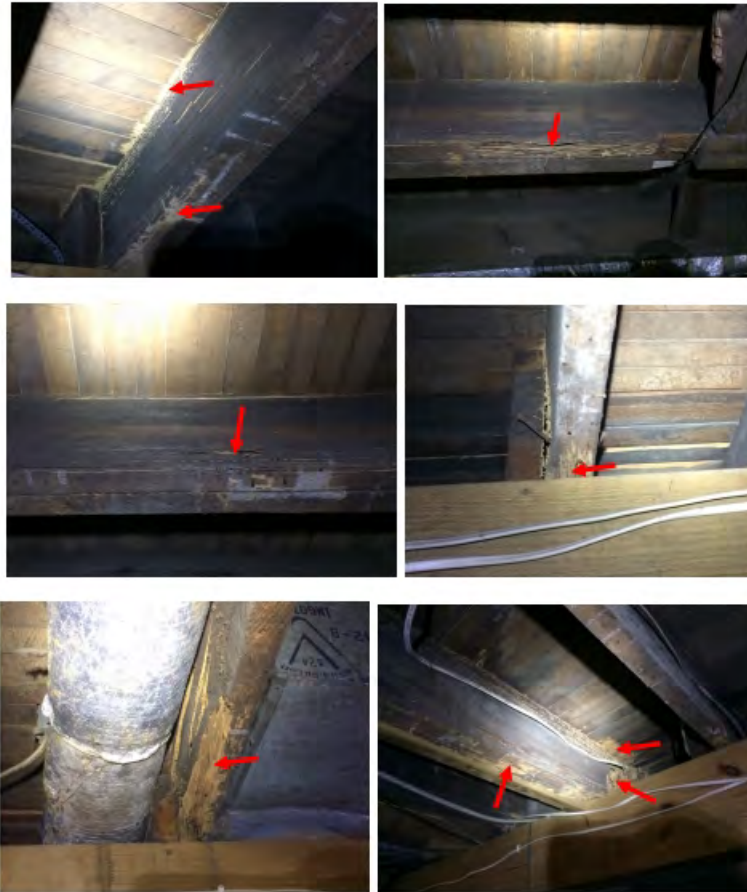
14. The wood destroying insect damage was not limited to the left hand beam only. Thirty one of the floor joists under the left half and central hallway of the home were also damaged. Some attempts were made to supplement the damaged members through the installation of short sections of 2x10's and 2x12's beside the damaged ends of the joists. These supplements were not attached to the original joists, so the damaged members are still supporting the majority of their original structural load. In one location, the flooring beneath the wall cavity was also damaged, greatly reducing the support available for the wall framing.

Undermined wall framing due to insect damaged floor

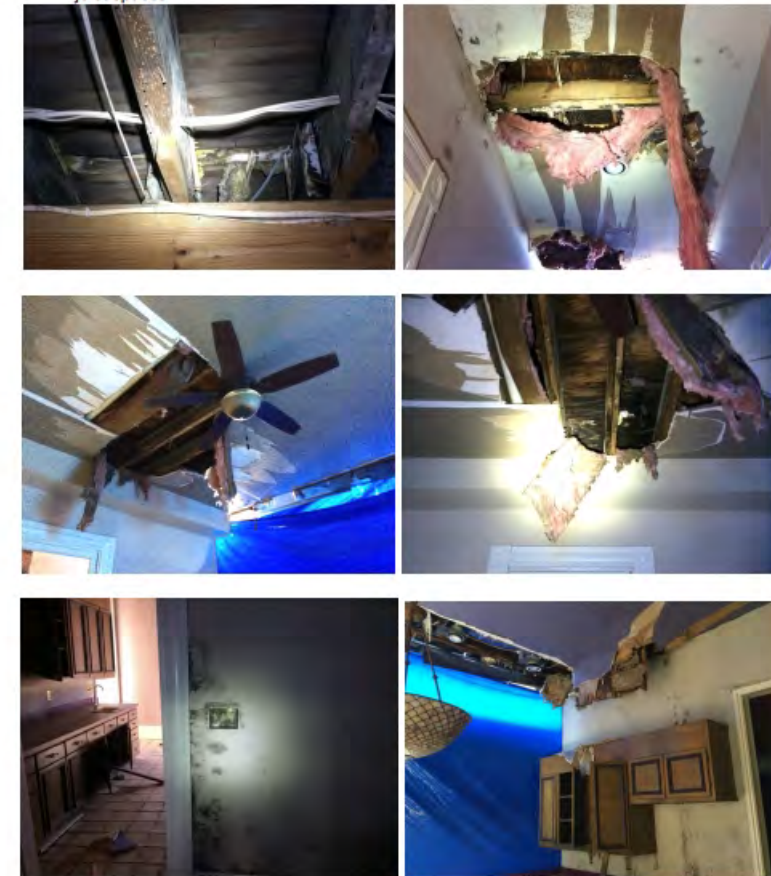
walls on the first floor between the kitchen, hallway, and back bedroom and in the ceiling joist spaces.

11. Remove the water damaged drywall walls and ceilings from the kitchen, back end of the central hallway, back bedroom, and upstairs closet. Remediate any mold found. Replace water or mold damaged framing where found.
