METROPOLITAN GOVERNMENT OF NASHVILLE AND DAVIDSON COUNTY

STAFF RECOMMENDATION 949 Russell Street July 21, 2021

Application: Demolition
District: Edgefield Historic preservation Zoning Overlay
Council District: 06
Base Zoning: R8
Map and Parcel Number: 082120038300
Applicant: Troy Harper
Project Lead: Robin Zeigler, robin.zeigler@nashville.gov

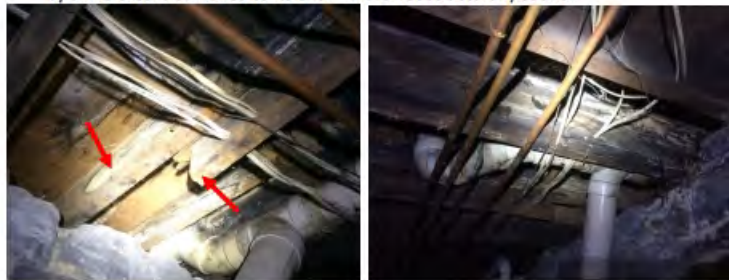
16. Historic evidence of water damage was also noted in the floor framing of the first floor bathroom. The end of one floor joist has completely rotted away and been re-supported by a 2x6 extension nailed to its end. This is not structurally sound.

9. Install additional support columns or modify the existing to provide support to all butt splices in the right hand main floor framing beam.
10. Replace or properly repair the 31 insect-damaged floor joists, the 6 water damaged joists at the rear of the home, the improperly "headered off" joist under the living room, the rotted joist under the bathroom, and the cut joist for the ductwork under the kitchen.

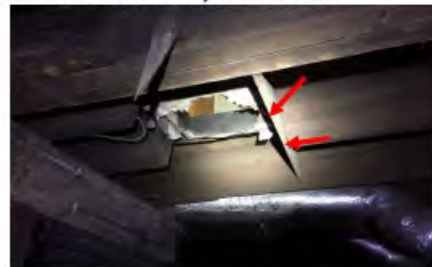
17. One floor joist under the front left living room of the home was cut to provide clearance for a HVAC duct. It was "headered-off" with a smaller 1x that is insufficient to transfer the cut joist's structural load to the adjacent members.

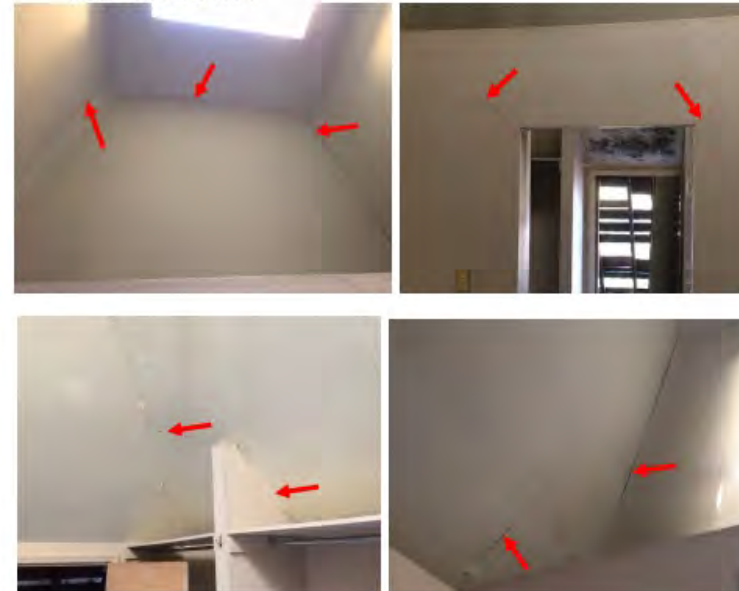
19. When the home's original attic space was converted into the master suite, the original 2x4 roof rafters were not supplemented structurally. Drywall was added and the ridge modified to include a skylight at the peak. The rafters are undersized, so they are relying on the additional interior vertical walls of the master suite for intermediate support. When the home was damaged by the tornado, the stress placed on the overall structure caused the roof framing to flex, damaging the drywall at virtually all angled seams and at the corners of the doors.

13. While the roof framing does not appear to be appreciably damaged, it will not support the structural load dictated by modern codes. If the building department requires the exposed structure to be brought in compliance with current building standards, it will be necessary to reframe part of the roof. The wood available today is not as structurally strong as the wood used to build the home originally, so the replacement materials will have to be larger, which will complicate the framing where the old wood meets the new.

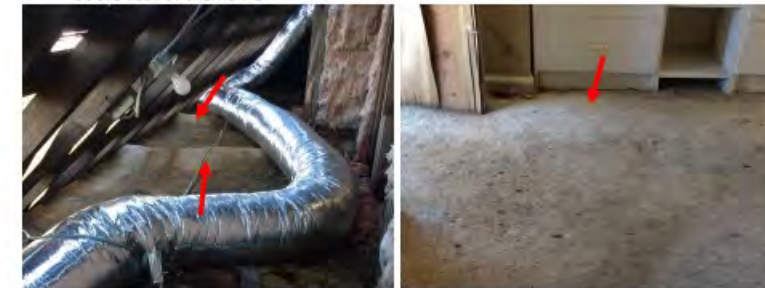
20. The second floor subfloor is particle board. The roof was removed from the rear of the home by the storm, exposing the subfloor in this area to the weather. The material has swollen due to water saturation, causing humps in the floor of the closet and attic areas at the rear of the home.

12. Replace the water damaged particle board subfloor on the second floor. This will require the removal of some of the interior second floor walls across the rear of the structure.

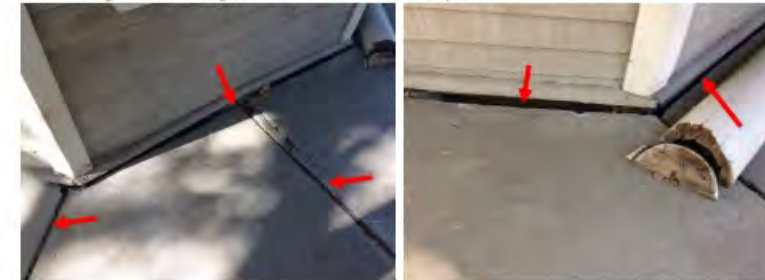
21. The front porch of the home is a concrete slab with a mortared stone foundation wall on the outside perimeter. The porch deck supports the framing for the shed roof above it through wooden columns. The foundation wall apparently does not have a sufficient footing because several of the blocks have broken free from the wall and the slab has cracked into large sections at the expansion joints. The cracks are up to 1" wide. The slab sections have dropped and pulled away from the house by more than 1". The movement is significant enough to tilt the columns out of plumb.

14. Remove and reconstruct the front porch and stairs as the current one cannot be repaired.
15. Patch the damaged hardwood floors.
16. Rebuild the eave gutter on the left hand side of the home on the front side of the bay.

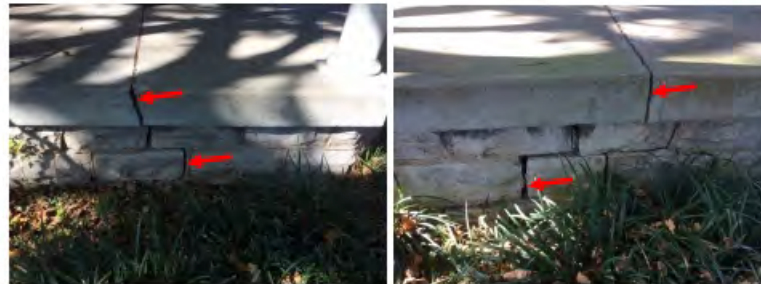
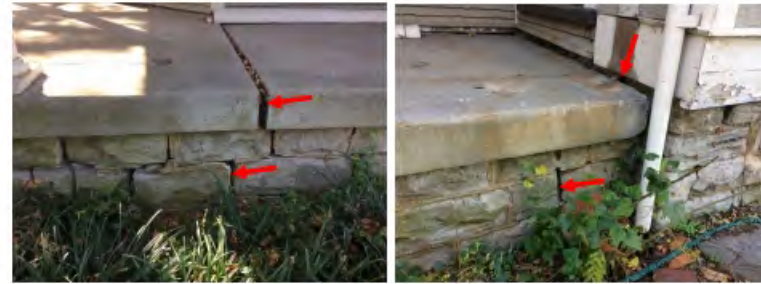
22. The porch section at the front door is cracked in the center and sloping towards the left, directing any water that blows onto the porch surface towards the right side wall of the front living room.

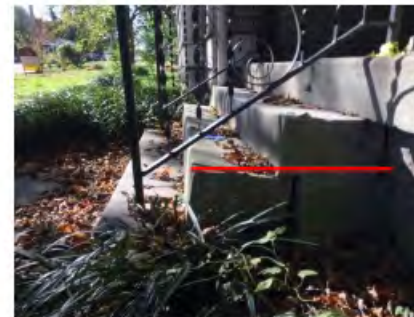
24. The steps to the front porch are stacked monolithic concrete blocks. Their footing is insufficient, so they are moving and sinking, sloping back towards the front porch up to 1/8".

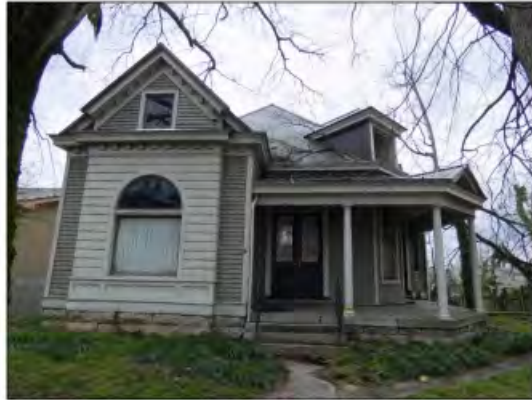
Photograph 1
South (front) elevation of the residence.

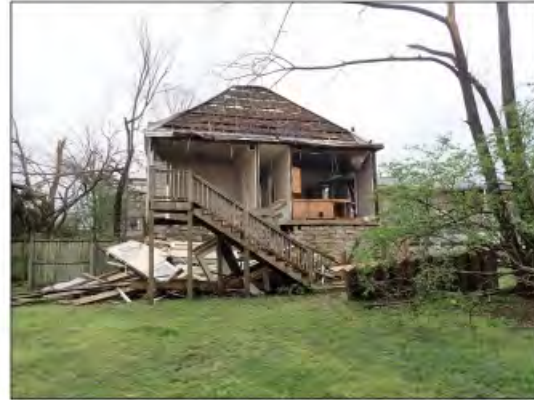
Photograph 3
North (rear) elevation of the residence.

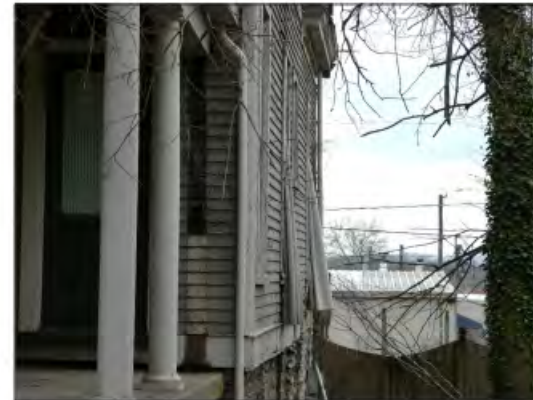
- Portions of the wood siding and trim had been partially displaced, and in some instances completely separated from the residence. The siding had a generally wavy appearance. The lower portion of the east wall was visibly bulged outward near the middle portion of the wall (**Photograph 5**).

Photograph 5
Outward deflection of the wood siding on the east elevation.

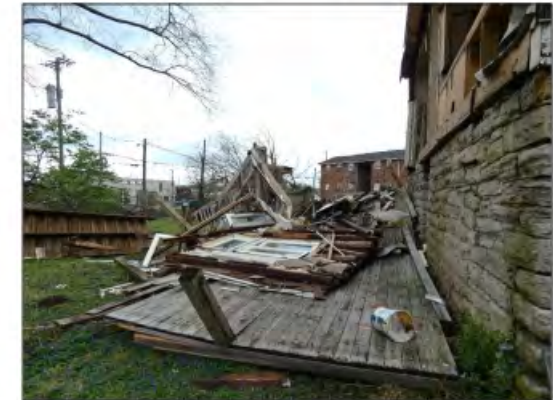
- The entirety of the north exterior wall had fallen away from the residence. Debris from the wall, along with that of the back deck, were resting on the north lawn. The exterior stairs of the deck remained intact but were deflected out of plane (**Photographs 6 and 7**).

Photograph 7
Debris from the north wall resting on the failed deck.

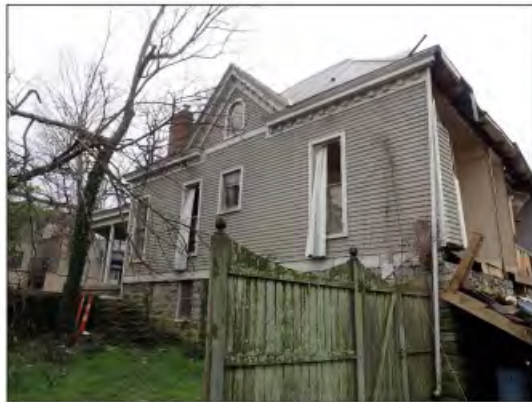
Photograph 2
East elevation of the residence.

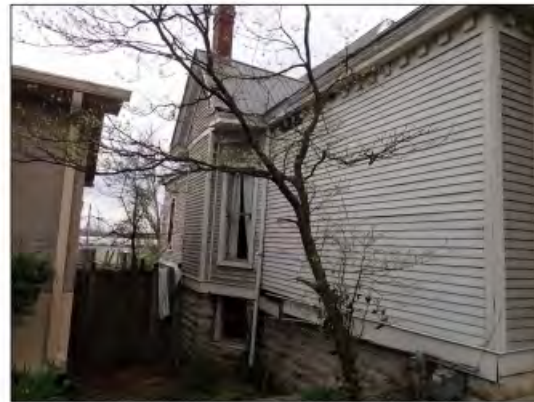
Photograph 4
West elevation of the residence.

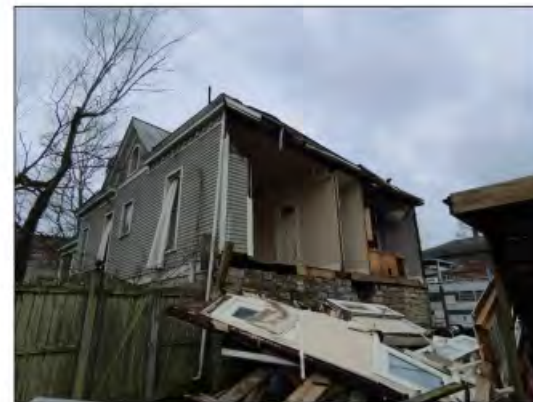
Photograph 6
The north wall had fallen away from the residence.

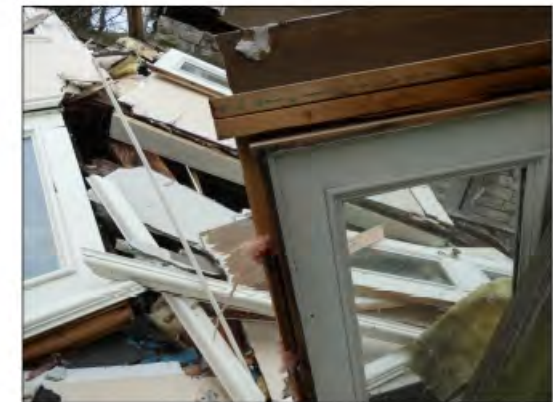
- Glass panes of the wood-framed windows that had fallen away from the north wall remained intact (**Photograph 8**).
- The exposed wood framing around the perimeter of the fallen north wall exhibited widespread deterioration with dark discoloration and soft, friable wood. Isolated sections of relatively newer, undeteriorated dimensional lumber remained attached to the underlying wood framing along portions of the north wall (**Photographs 9 and 10**).

Photograph 8
Typical intact windows in the north wall debris.

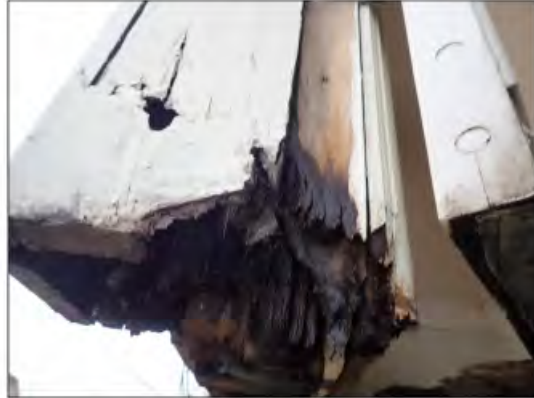
Photograph 9
Deterioration of the wood framing in an exposed portion of the wall.

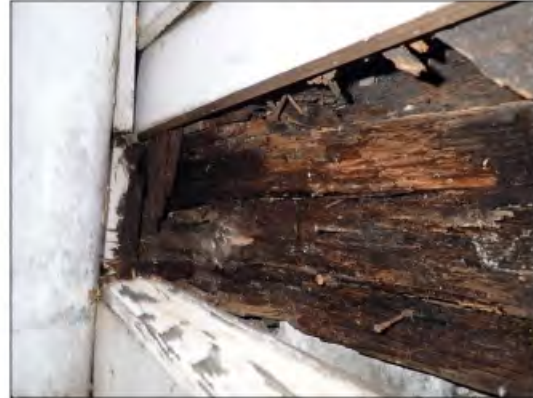
- Exposed wood framing along the lower perimeter of the exterior walls exhibited extensive deterioration and dark discoloration. The wood had widespread regions that were soft to the touch (**Photograph 11**).

Photograph 11
Typical deterioration of the floor framing near the perimeter.

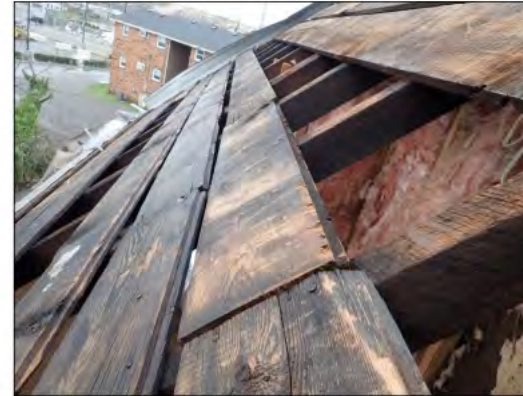
- The metal roof panels and a portion of the wood plank sheathing were missing on the north roof slope (**Photographs 12 and 13**).
- The foundation walls consisted of limestone masonry. The mortar in the joints was very soft to the touch and crumbled in response to light manipulation. Multiple joints around the perimeter of the foundation were cracked and deteriorated. The

Photograph 13
Close-up view of the exposed wood planks on the north slope of the roof.

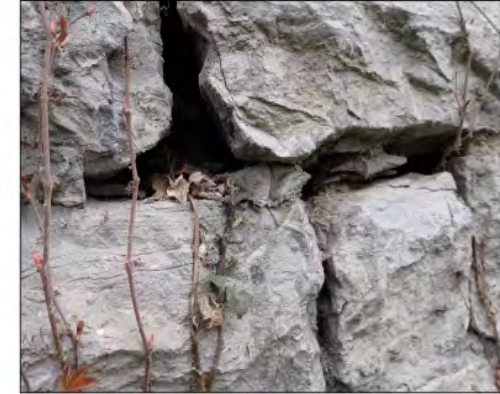
cracks had rounded, weathered edges and vegetation was present in and around many of the cracks and gaps (**Photographs 14 through 16**).

Photograph 15
Close-up view of the open mortar joints in the stone foundation wall.

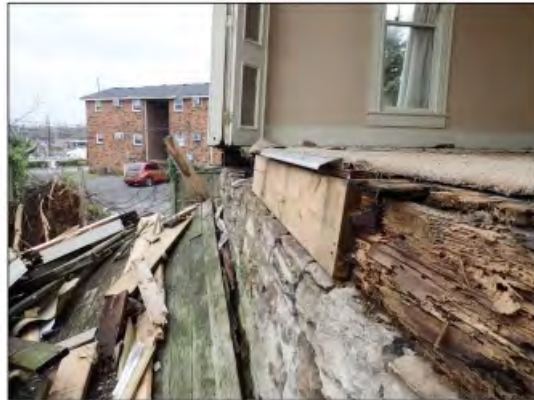
Photograph 10
Deterioration and a former repair along the bottom of the north elevation.

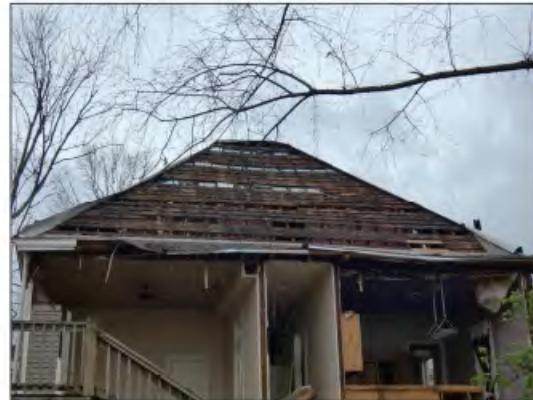
Photograph 12
Roof covering and a portion of the wood planks were missing on the north slope.

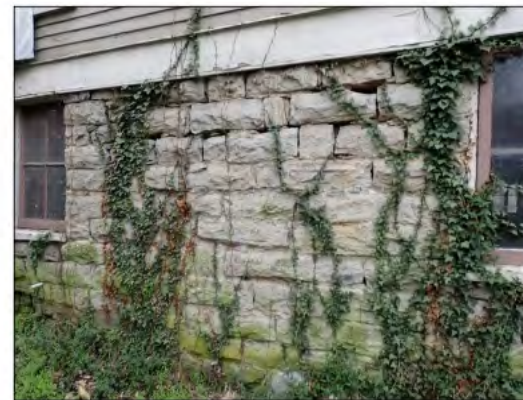
Photograph 14
Cracks and deterioration in the mortar joints and organic growth on the foundation wall.

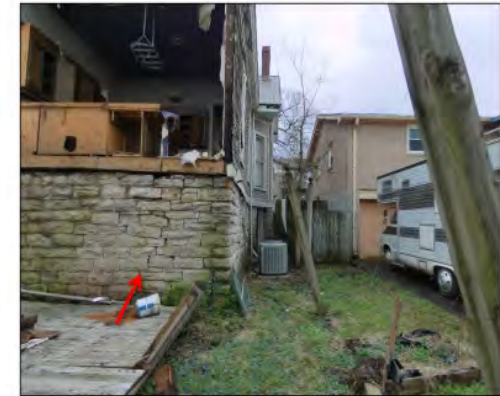
Photograph 16
Cracks in the stone foundation wall near the northwest corner of the residence (red arrow).

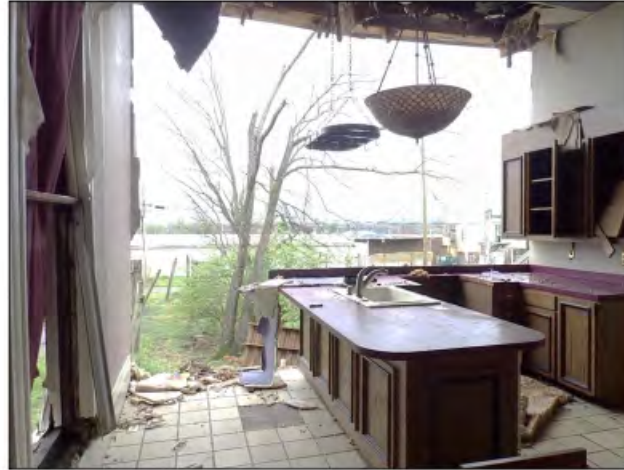
- The north wall of the kitchen, north hallway, and north lower bedroom had fallen away from the residence. The exterior was visible through the opening (**Photograph 17**).

Photograph 17
View of the fallen north wall from the kitchen.

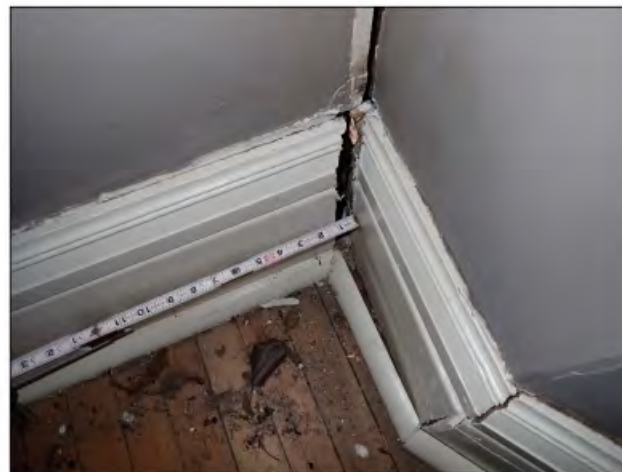
- The lower portion of the west wall of the dining room was displaced outward by approximately 1 inch with additional separation between adjacent wall sections surrounding the fireplace. The region of separation along the bottom of the wall extended the entire length of the dining room (**Photographs 19 and 20**).

Photograph 20
Gap between adjacent wall sections near the fireplace in the dining room.

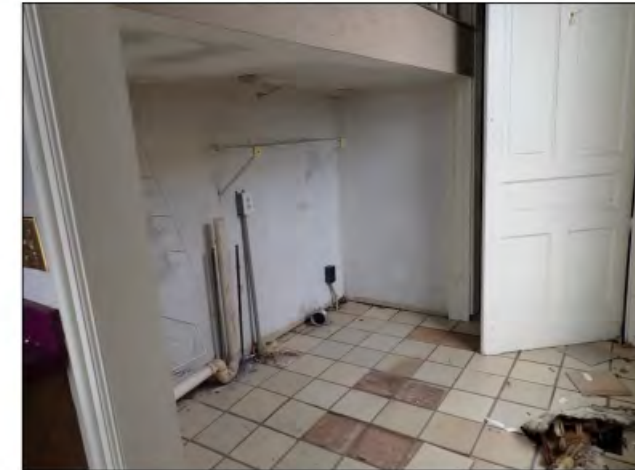
- Multiple floor tiles were separated from the floor of the pantry. The door frame had been deformed such that the door between the pantry and the dining room was bound and did not operate freely (**Photographs 21 and 22**).

Photograph 21
Dislodged floor tiles and the bound door in the pantry.

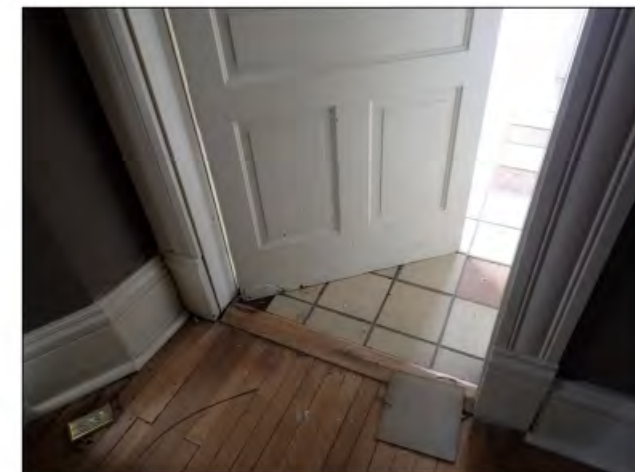
Photograph 22
View of the bound door at the doorway between the dining room and the pantry.

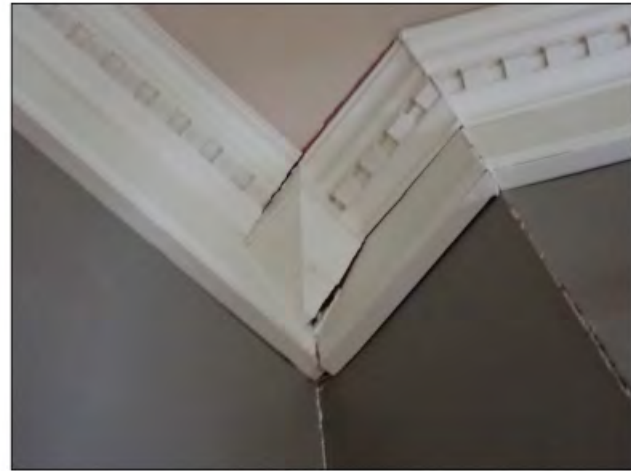
- Cracks and separation in the upper portion of the walls and crown molding were present in the living room, dining room, foyer, and north bedroom on the first story (**Photograph 23**).

Photograph 23
Cracking and separation at the crown molding and upper wall joints.

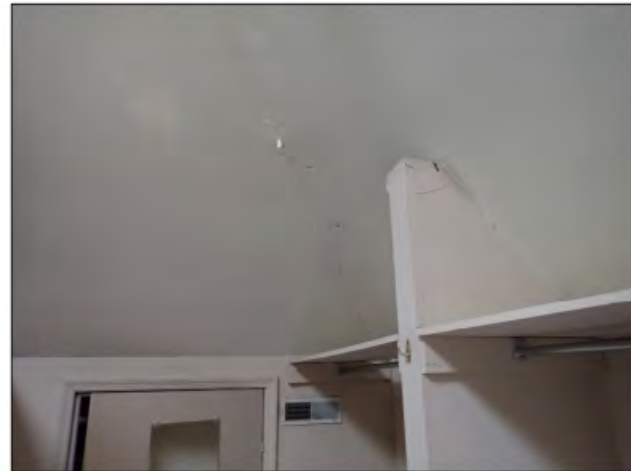
width. In isolated areas, the cracks were accompanied by flaking of the surface of the wall covering (Photographs 24 and 25).

Photograph 24
Typical cracks in the ceiling and upper wall areas on the second story.

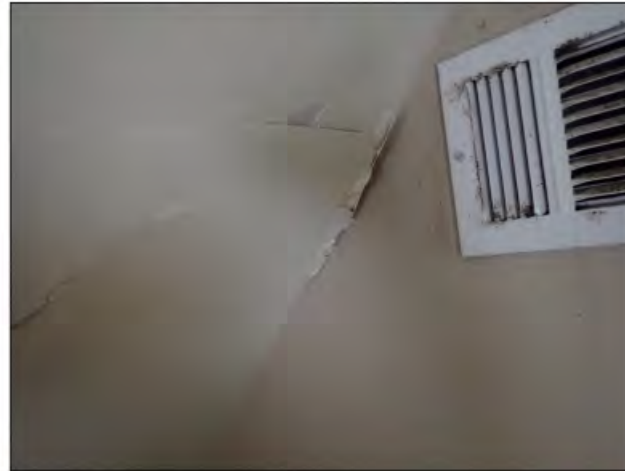
Photograph 25
Typical cracks in the ceiling and upper-wall areas on the second story.

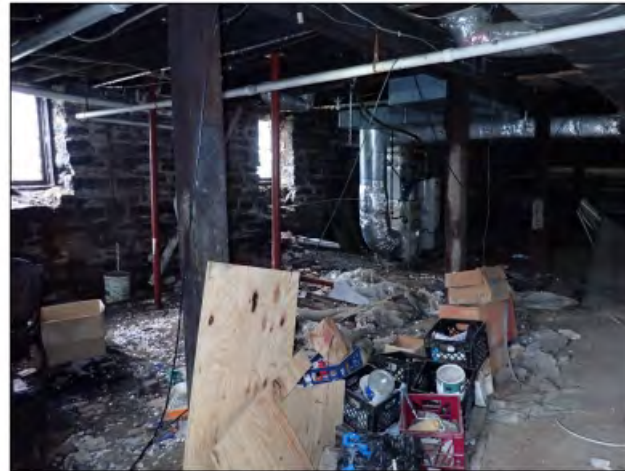
- The basement was unfinished with the interior faces of the stone masonry foundation walls and the underside of the floor framing visible. Multiple windows had been broken and were open to the exterior, as well as the west door which had fallen inward and was resting on the floor of the basement (Photographs 26 and 27).

Photograph 26
Overview of the basement.

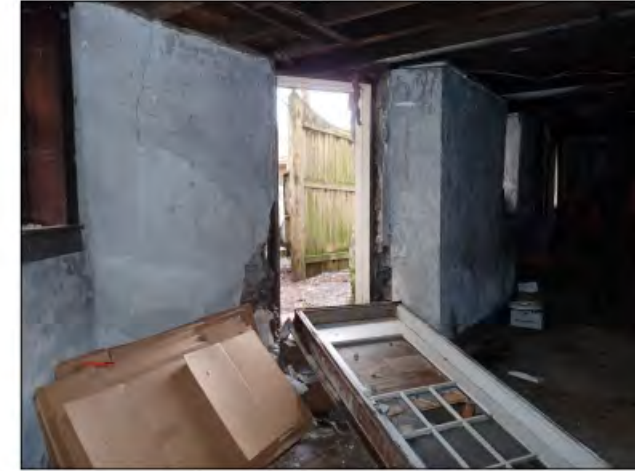
Photograph 27
Detached and fallen door at the west side of the basement.

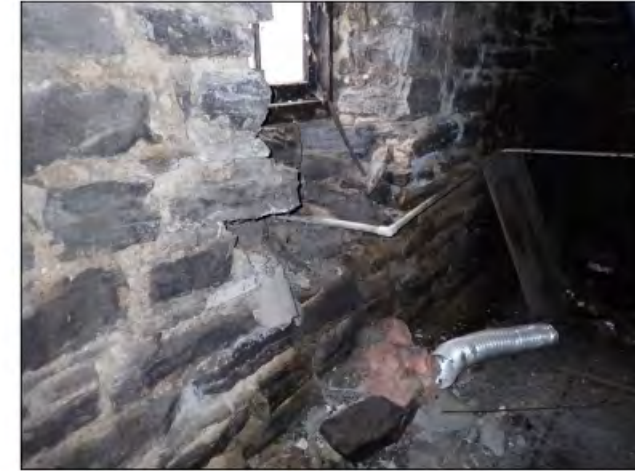
- Portions of the stone walls had multiple displaced and broken stones, particularly concentrated around windows (Photograph 28).
- Multiple stones had fallen from the upper portion of the north wall near the northeast corner of the basement (Photograph 29).

Photograph 28
Crumbling and fallen stone near a window on the east side of the basement.

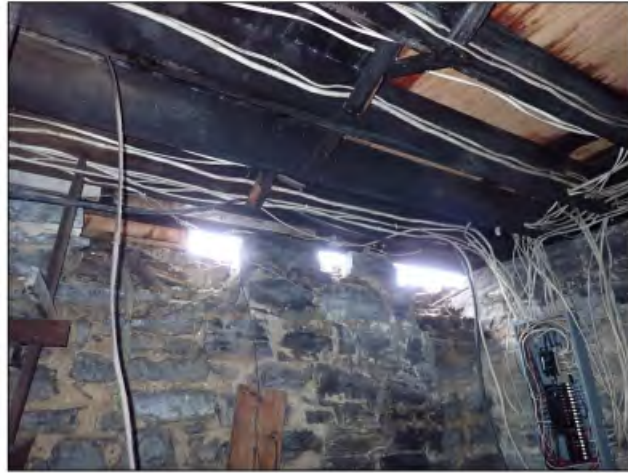
Photograph 29
Daylight visible through fallen stones near the top of the north wall of the basement

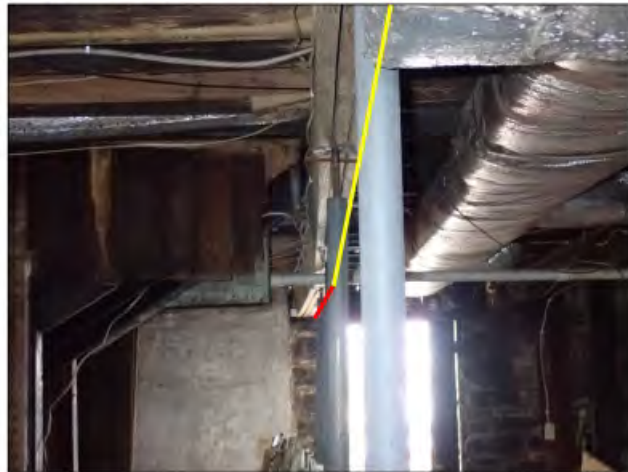
- A structural beam spanning north-south along the center of the basement exhibited a severe westward deflection near the north end. The beam consisted of 2x10 dimensional lumber spliced together with nails. The beam was also rotated out of vertical alignment by as much as 12 degrees near the north end (Photograph 30).

Photograph 30
View along the previously spliced and repaired beam in the basement, facing north. Note deflection at the north end, indicated by the red line.

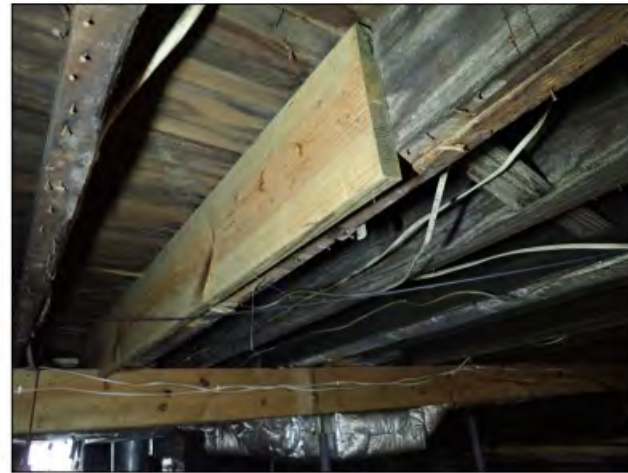
- The deflected beam was spliced into a timber beam near the south end of the basement. The beam was supported by steel posts which were not fastened to the beam at the upper plates (Photograph 31).

Photograph 31
Splice near the south end of the previously repaired beam.

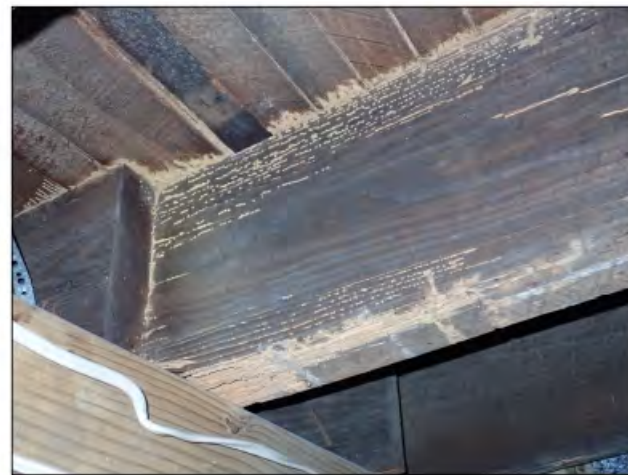
- Insect tunnel galleries were present in multiple regions of the wood framing in the basement. The galleries were accompanied by areas of soft, friable wood (Photographs 32 through 34).

Photograph 32
Damage from wood-boring insects.

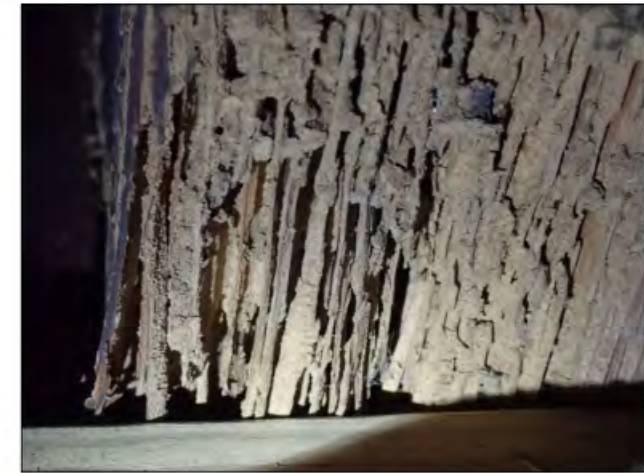
Photograph 33
Insect galleries in a structural beam.

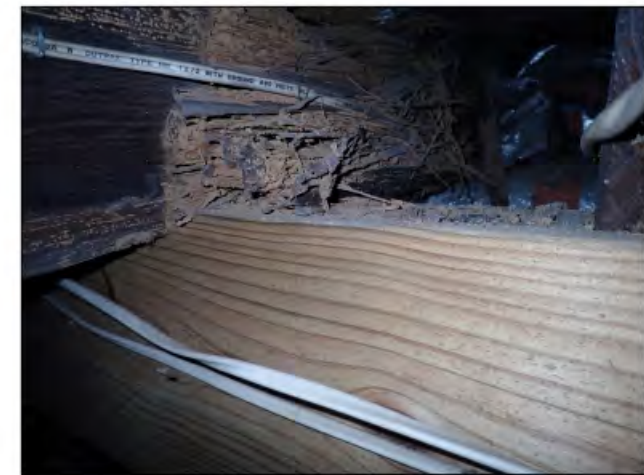
Photograph 34
Extensive wood boring insect activity and deteriorated wood.
